Inspection Photos
Location Name: Thomal L Russel 'D'2
API: 05-123-08818

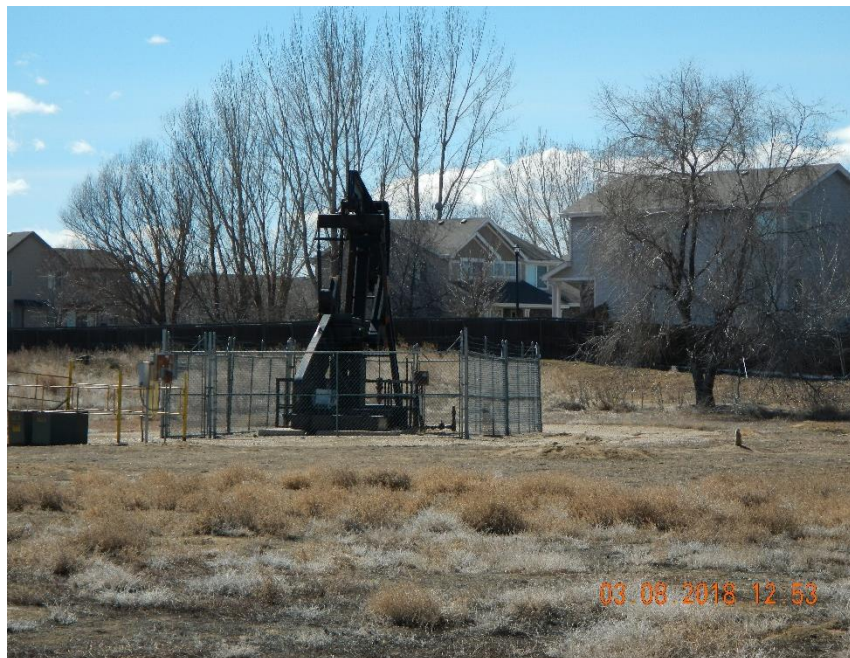
Pump jack site from NE view

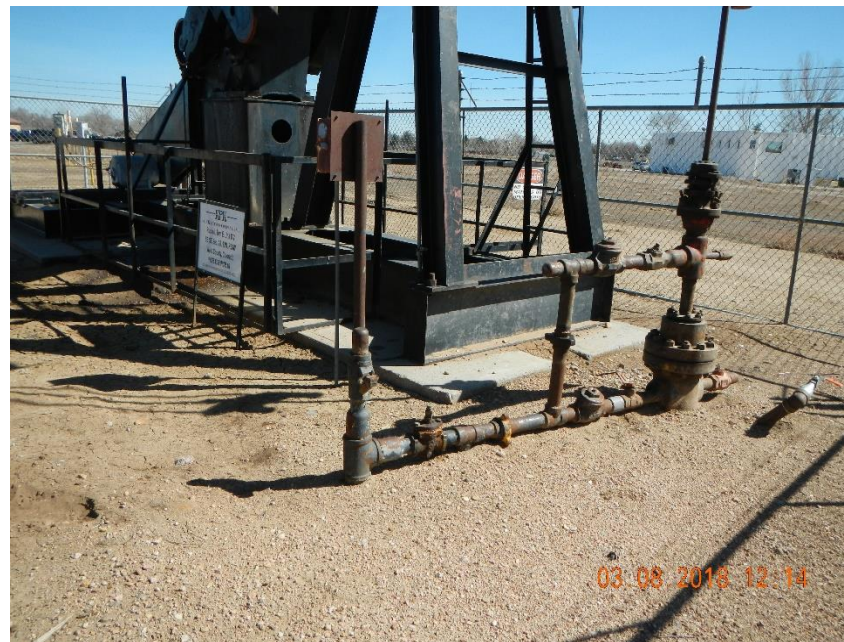
Wellhead from NW view

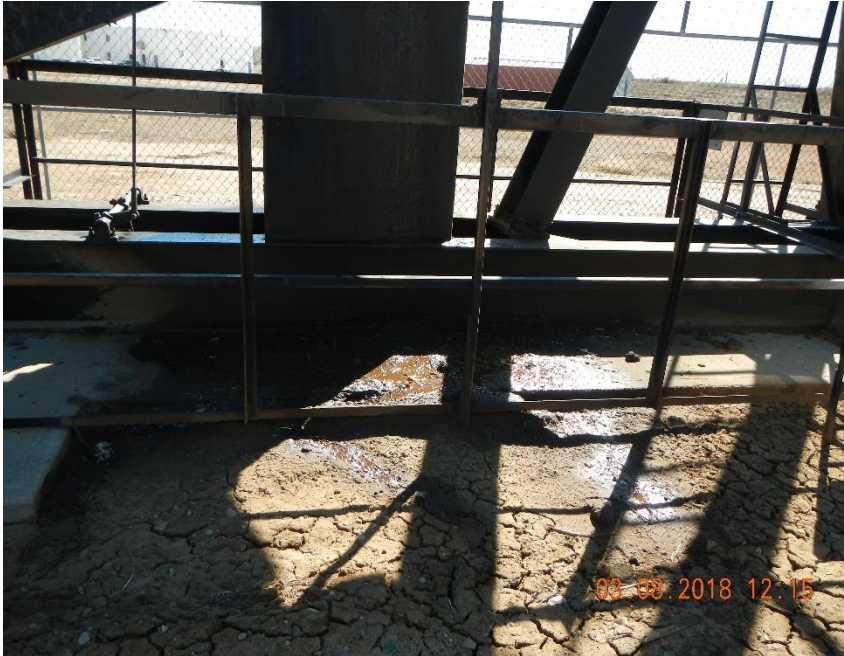
Stained soil

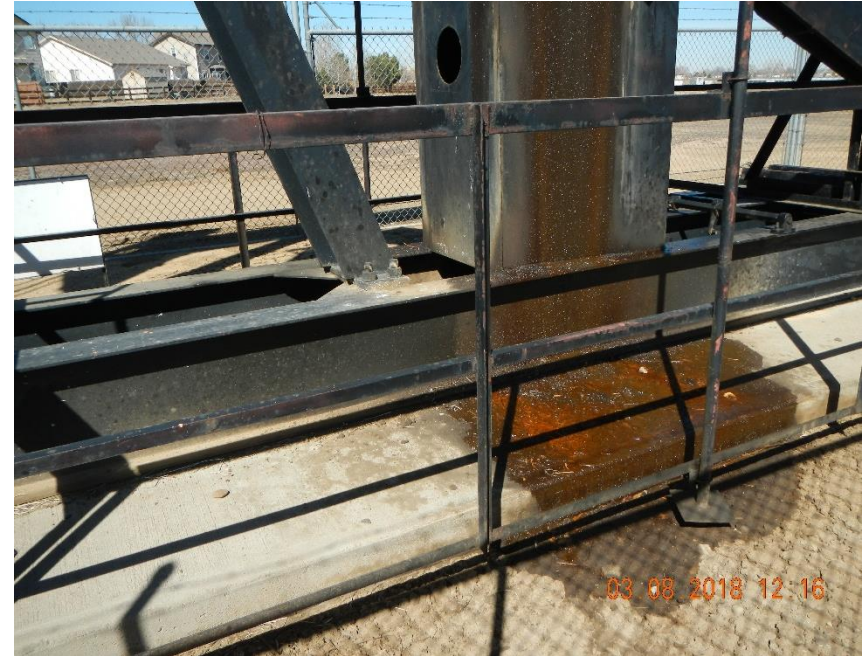
Leak from pump jack; view from SW
