Inspection Photos
Location Name: Hays 31-1H5
API: 123-11327

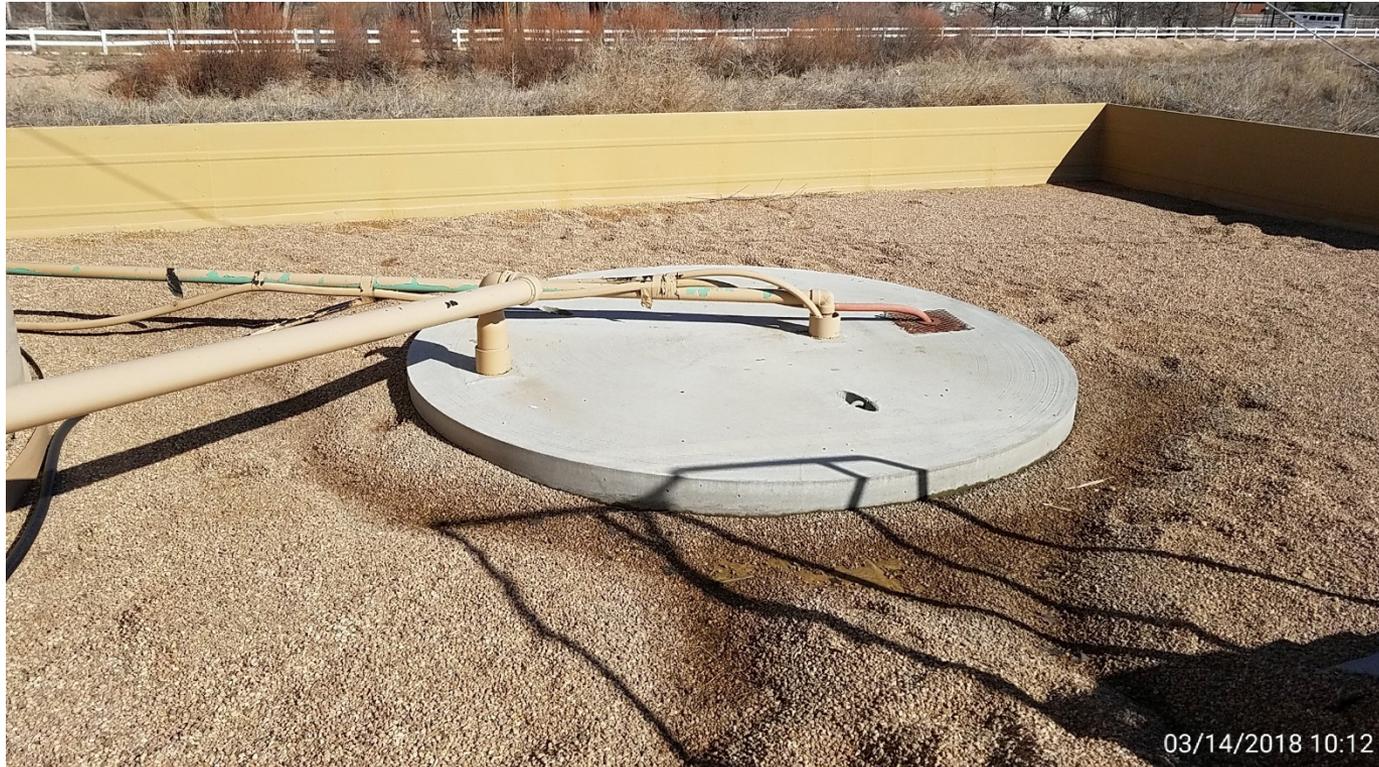
Produced water vault. Corrective Action: Anchor equipment ensuring anchors are engineered so the equipment will resist flotation, collapse, lateral movement, or subsidence per Rule 603.h.(2)B. Refer to the 603.h guidance document for further details.
