Inspection Photos

API: 05-007-06212

Operator: SOUTHLAND ROYALTY COMPANY

Inspection Date: 2/28/2018

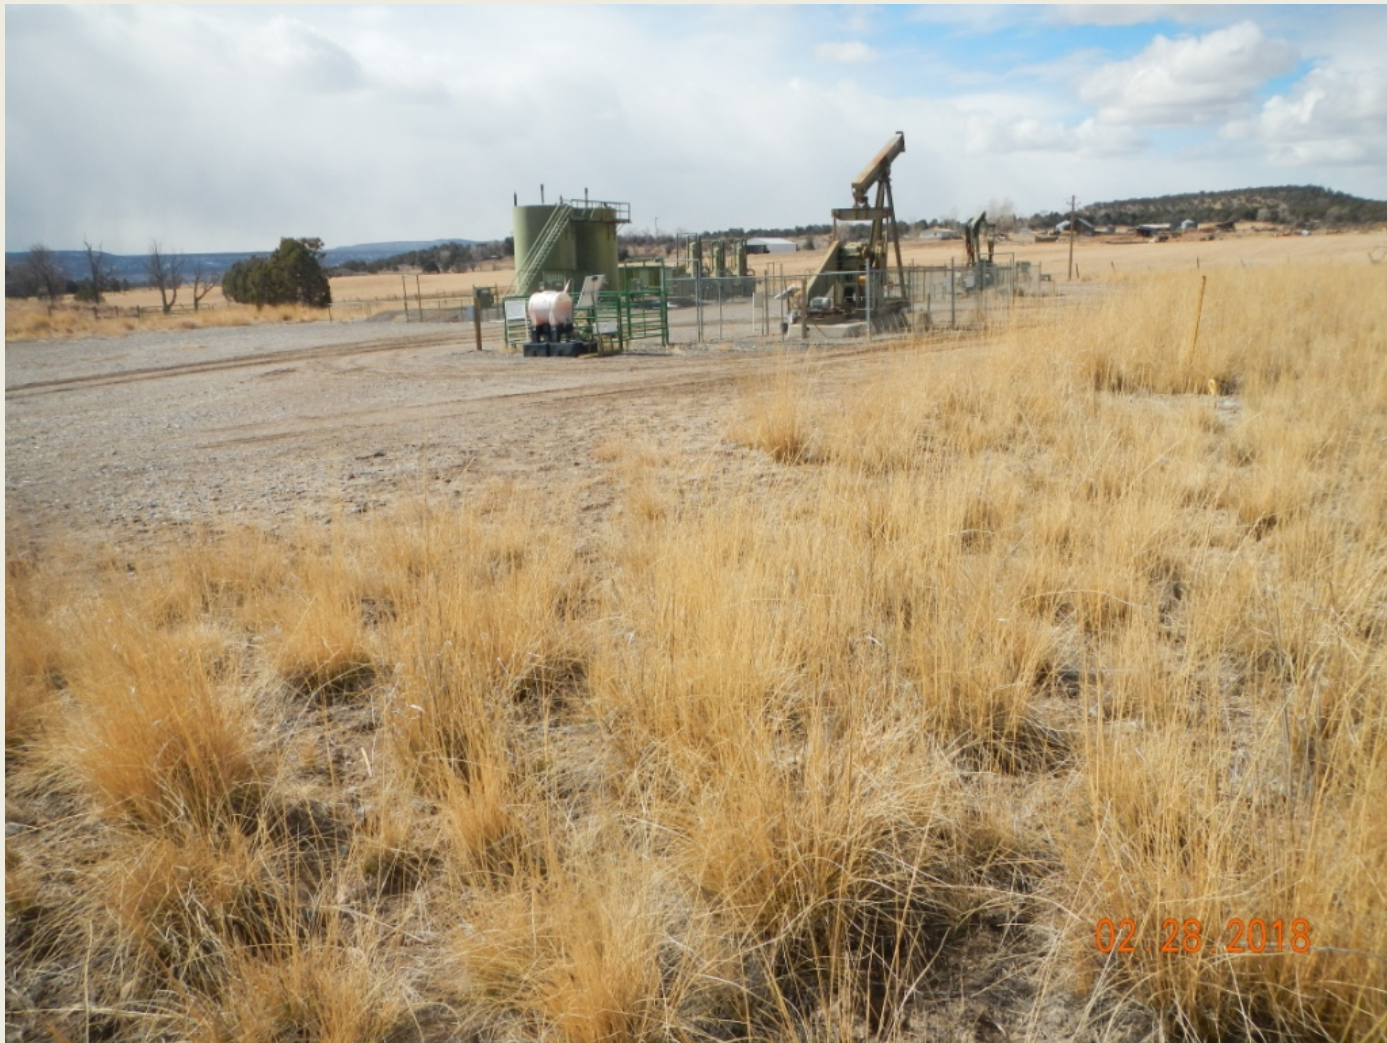
Photo 1. View of the project area from the northeastern corner facing center.

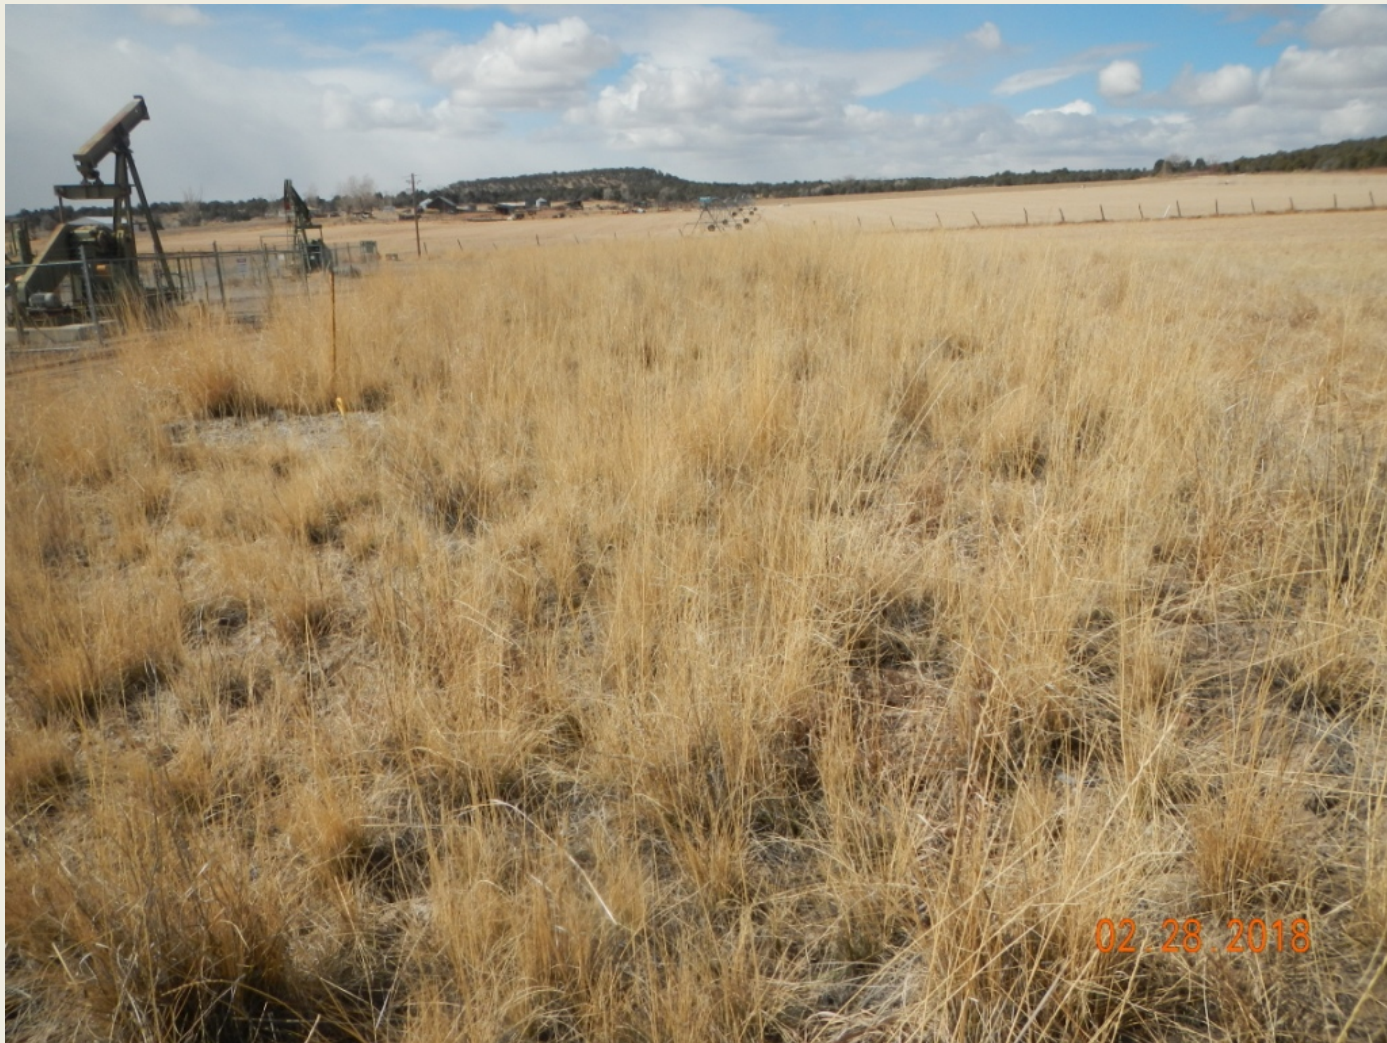
Photo 2. View of the northern portion of the project area from the northeastern corner facing westward. Revegetation is sparse with grasses such as intermediate wheatgrass (*Thinopyron intermedium*).

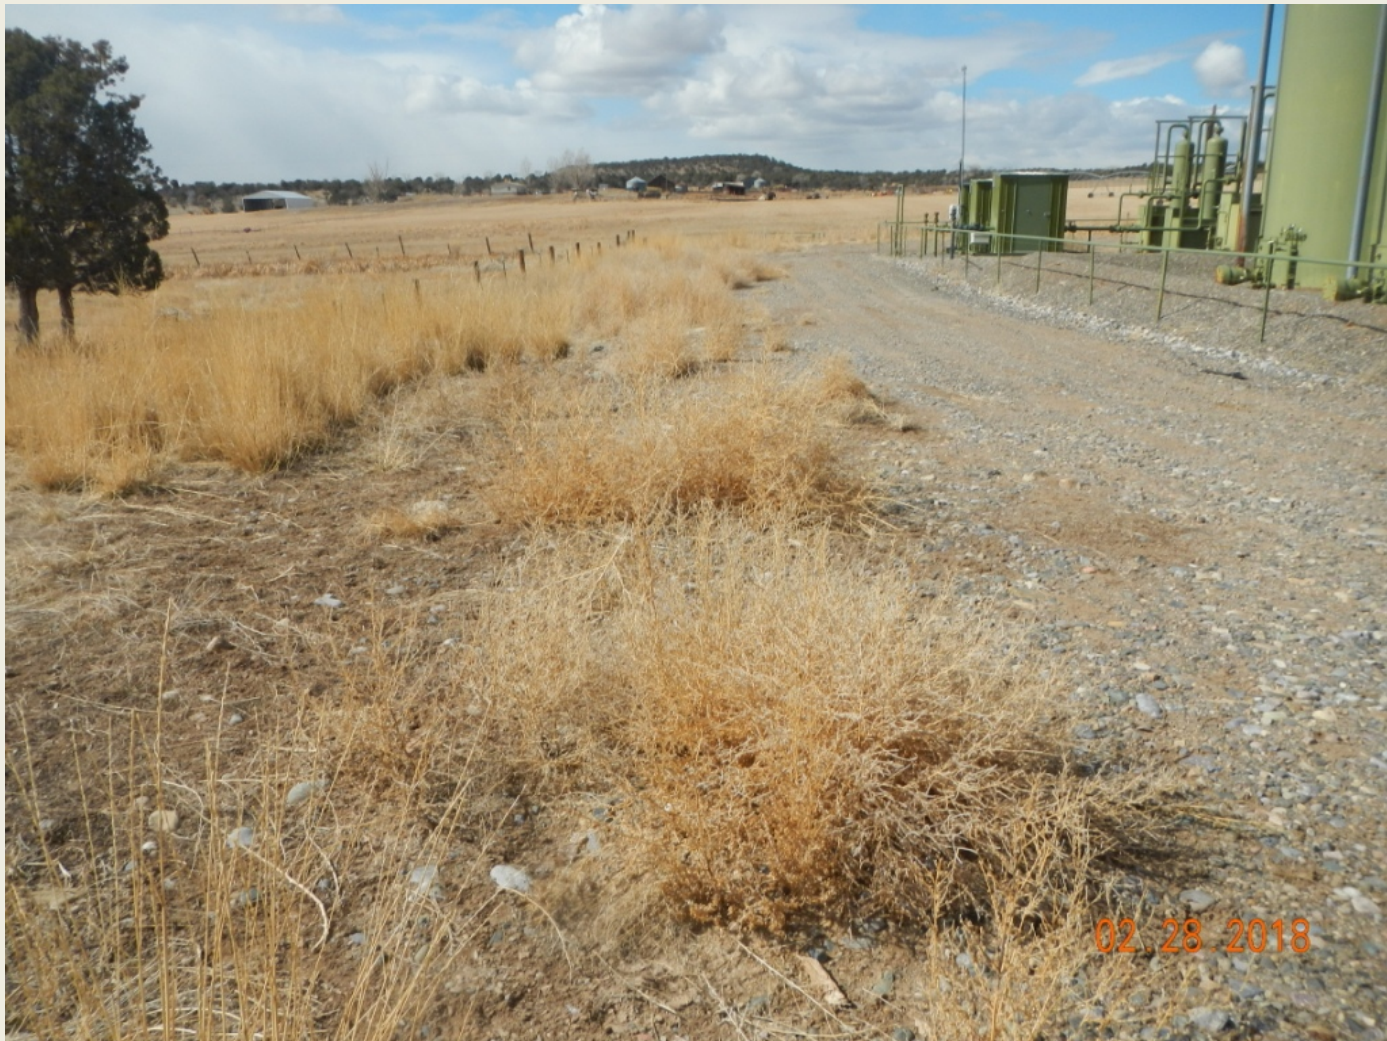
Photo 3. View of the southern portion of the project area from the southeastern corner facing westward. Kochia debris needs to be removed and properly disposed of.
