Inspection Photos

API: 05-007-06221

Operator: BP AMERICA PRODUCTION COMPANY

Inspection Date: 2/28/2018

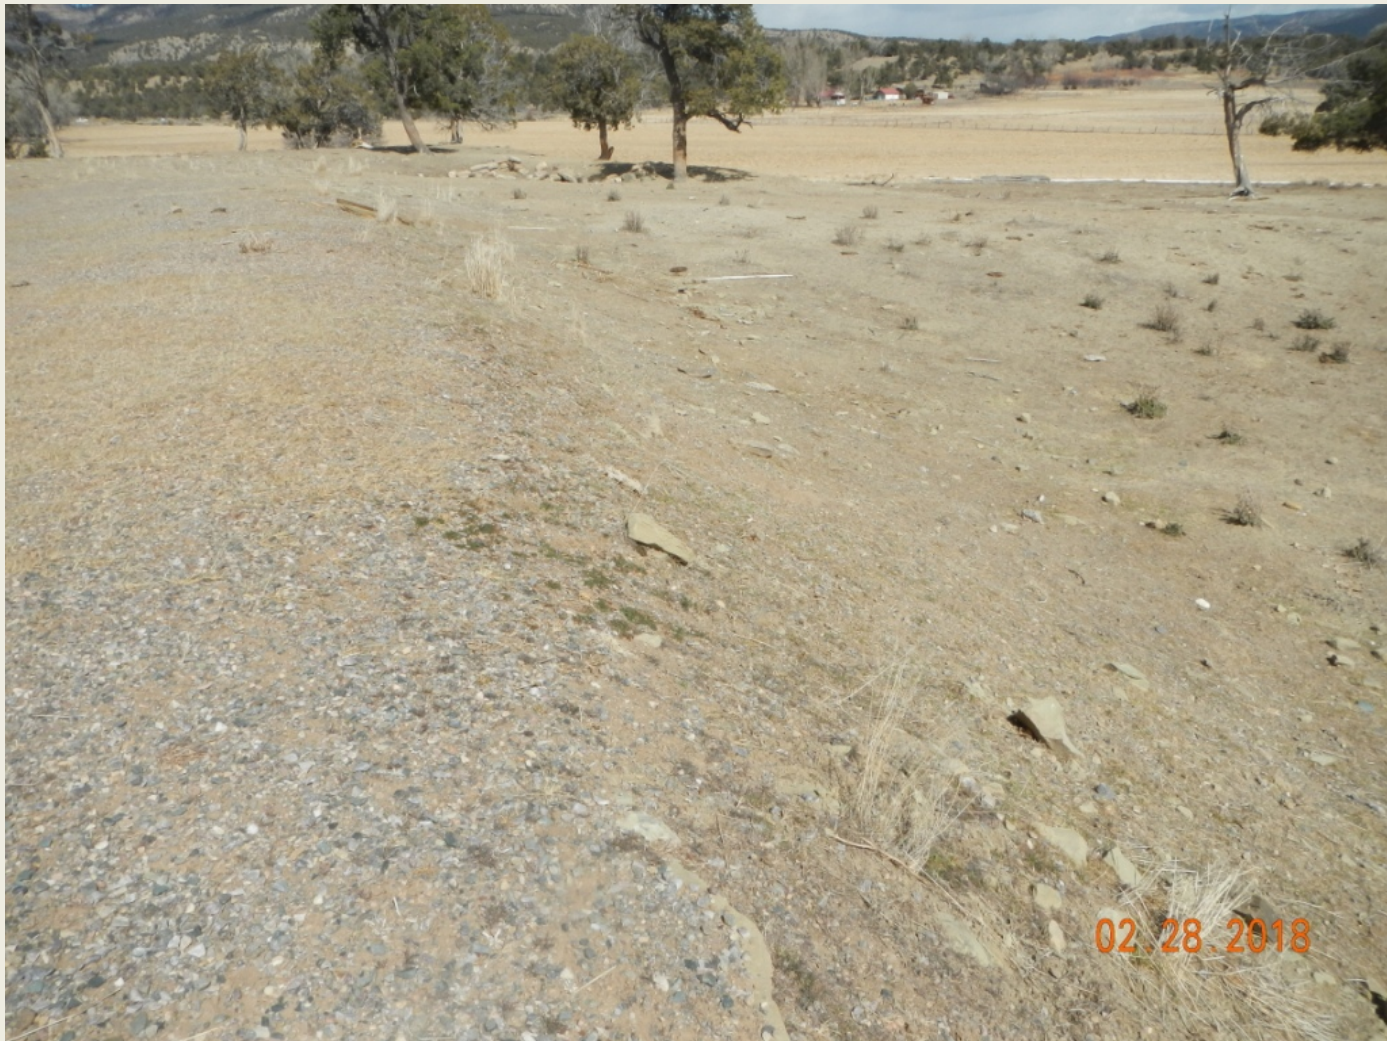
Photo 2. View of the eastern portion of the project area from the southeastern corner facing northward. Revegetation is sparse and appears grazed.

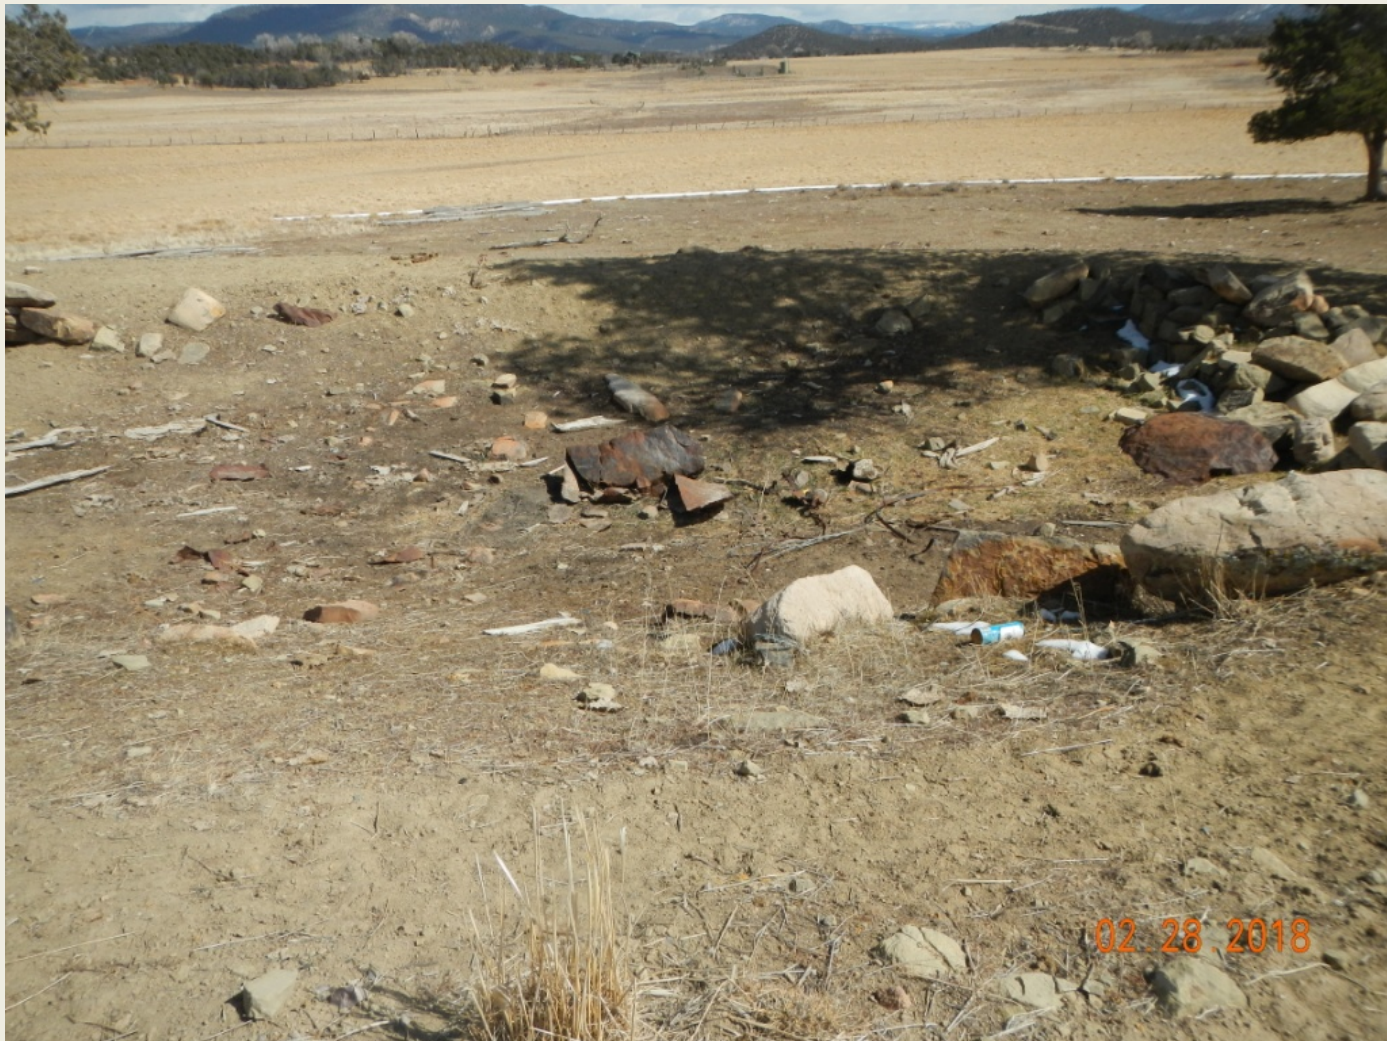
Photo 4. View of debris in silt northeastern silt trap. Needs to be removed and properly disposed of.

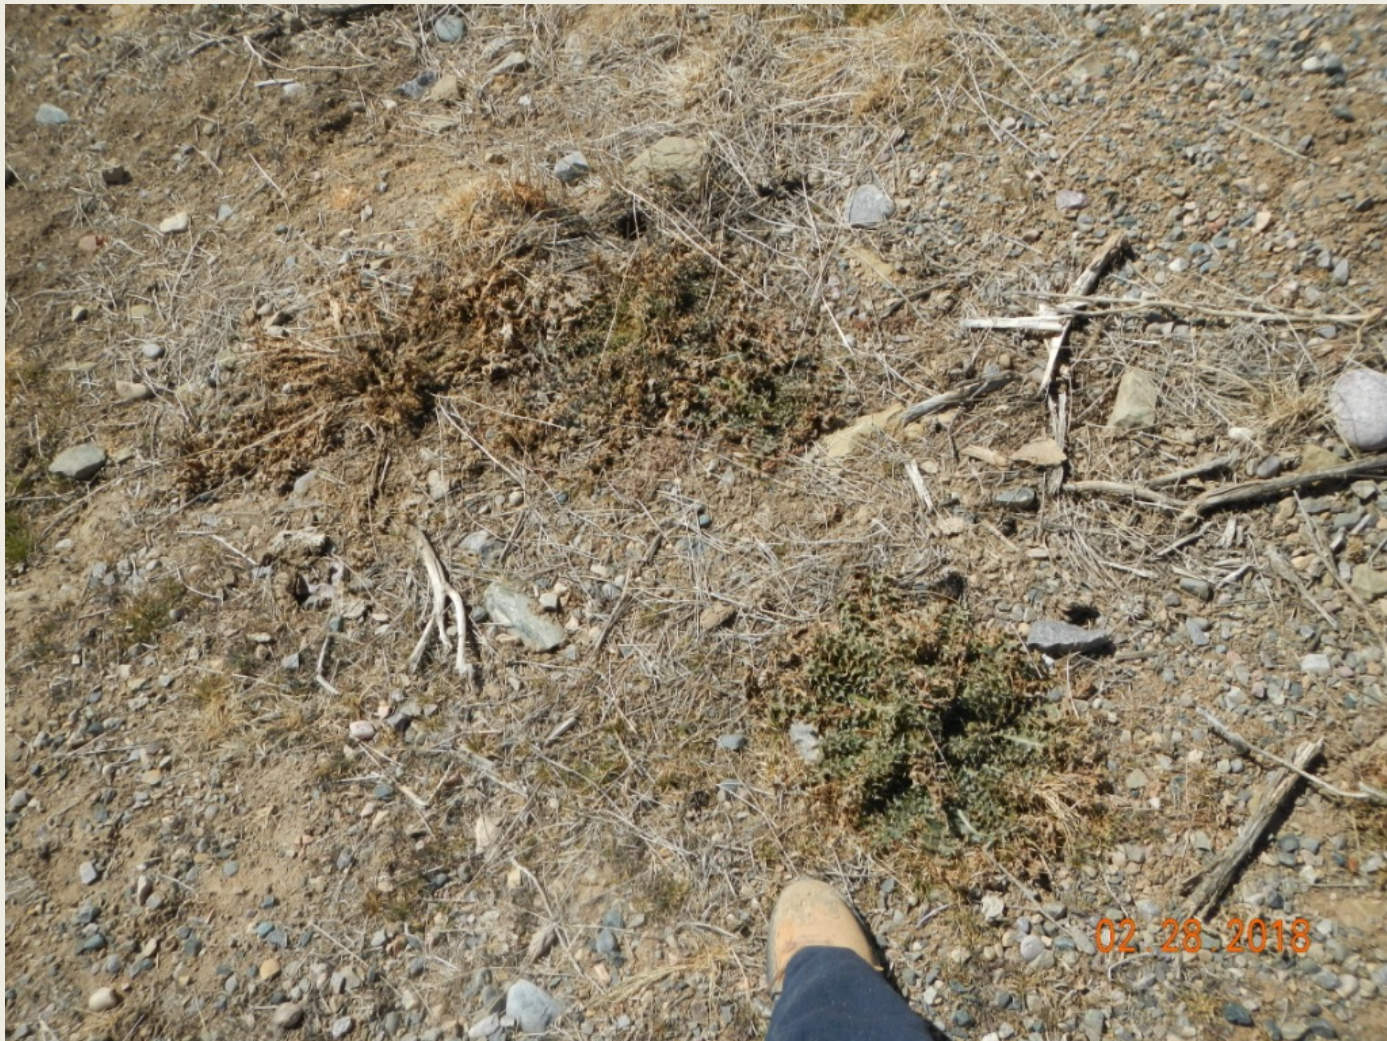
Photo 6. View of musk thistles (*Carduus nutans*) scattered throughout the interim reclamation area need to be controlled.
