Inspection Photos
Location Name: Schmitt #3-36
API: 05-067-06775

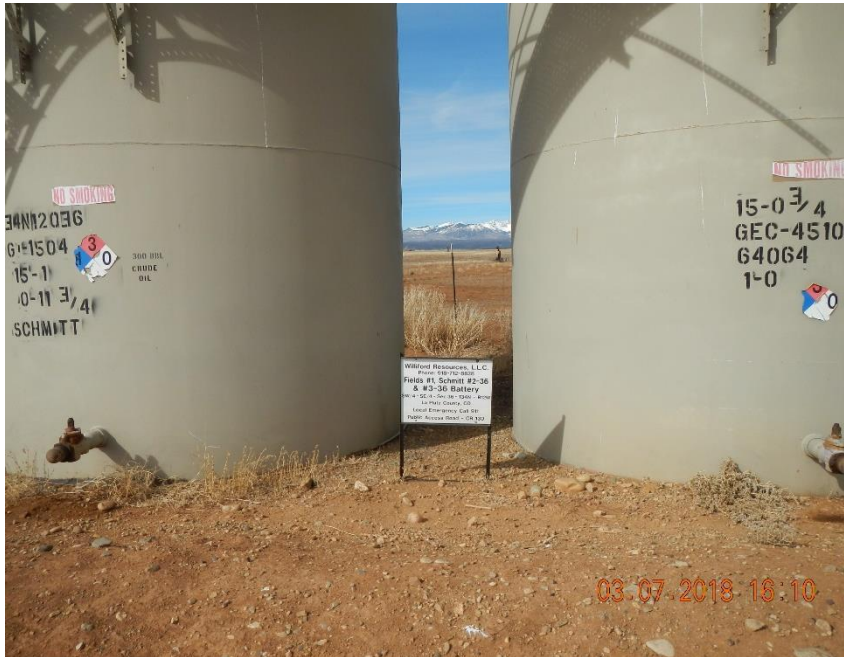
2 – 300 bbl. ASTs labeled crude oil at tank battery. Note stained soil below load out valves

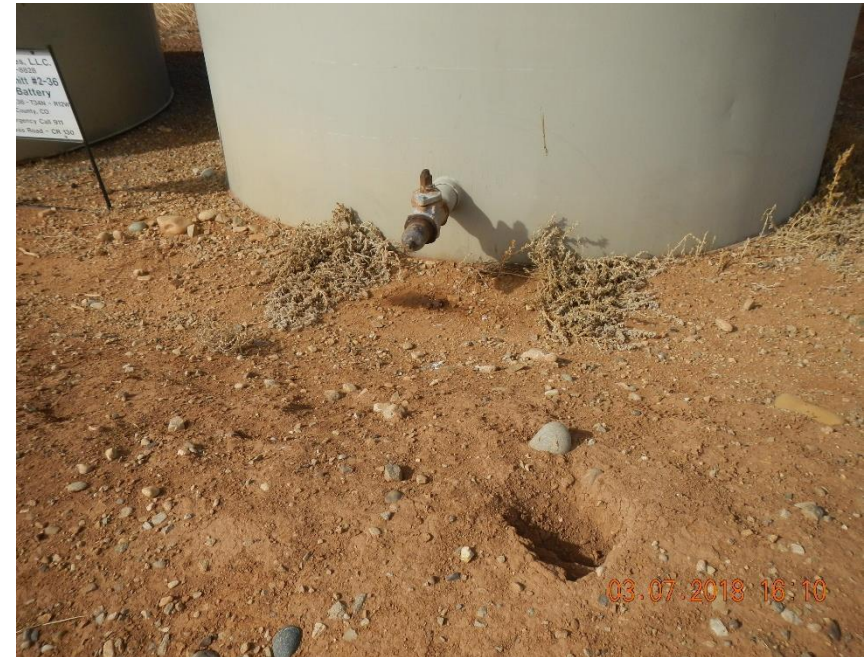
Stained soil below load out valve on eastern tank. Animal burrow in secondary containment berm.

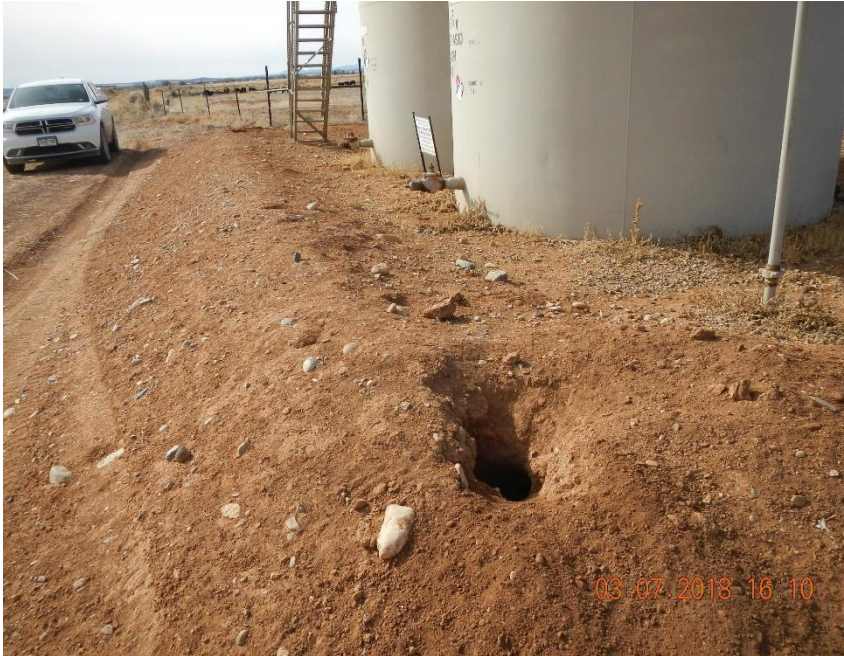
Animal burrow in secondary containment berm. Capacity of secondary containment does not appear to be adequate.

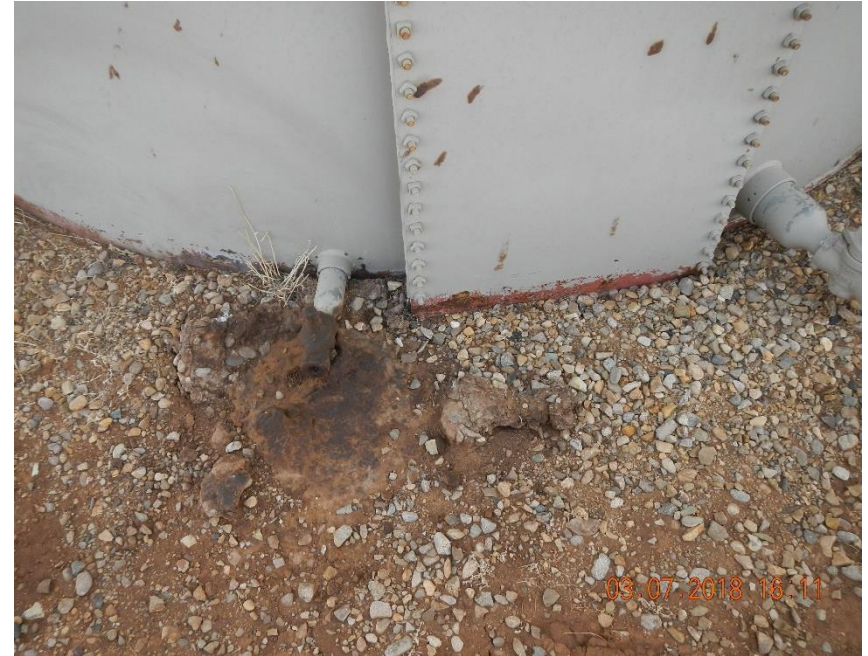
Stained soil below tank valves.

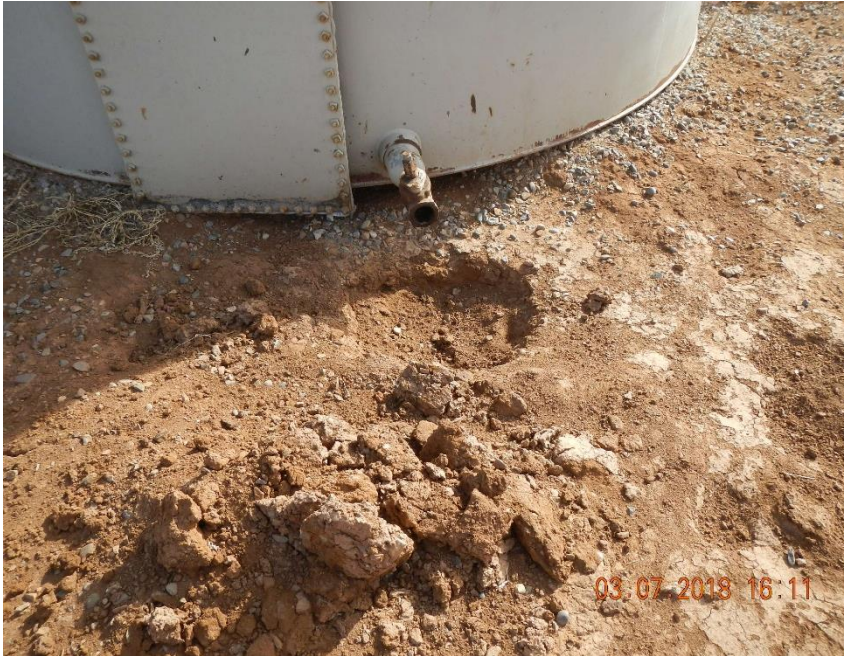
Soil below valve on western tank has been excavated.

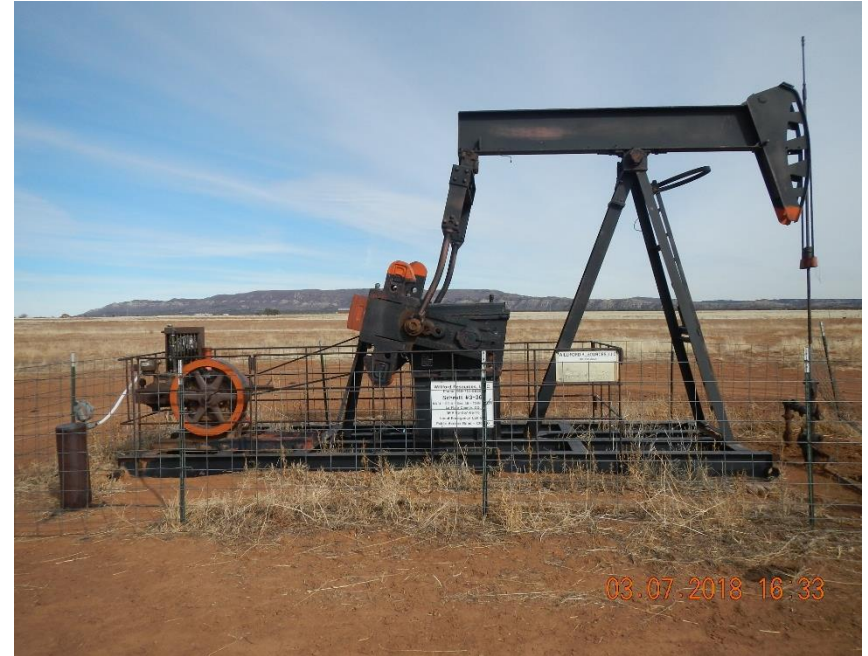
Schmitt #3-36 pump jack and well head.

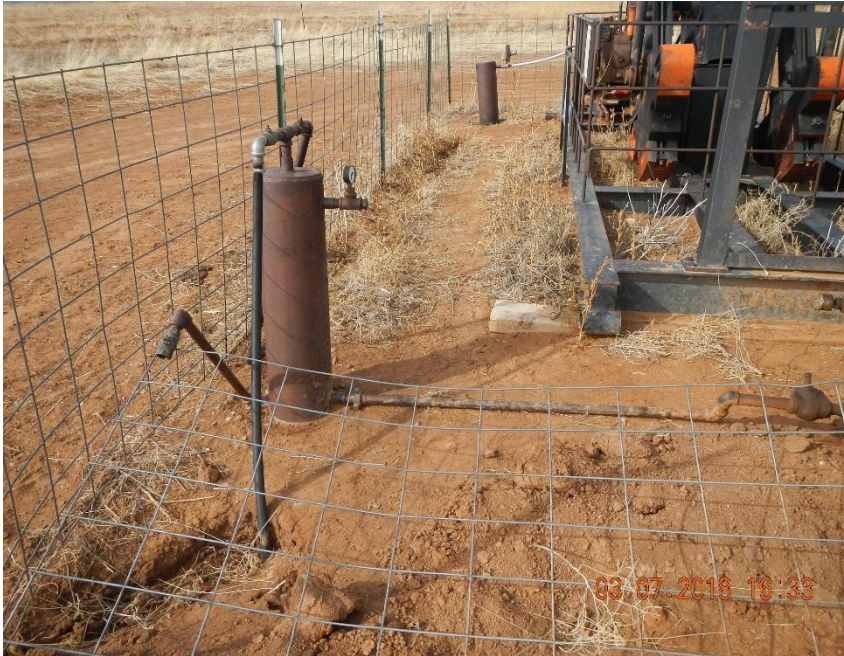
**Southern drop out tank with evidence of recent dirt work.
Dirt work leading to the west has recently been performed.**

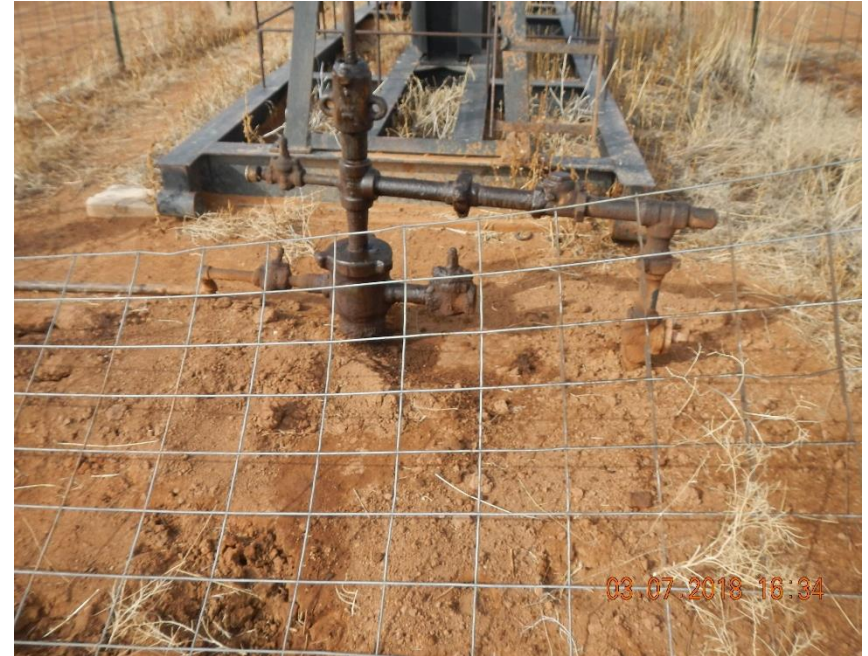
Well head is wet and surrounding area is stained.

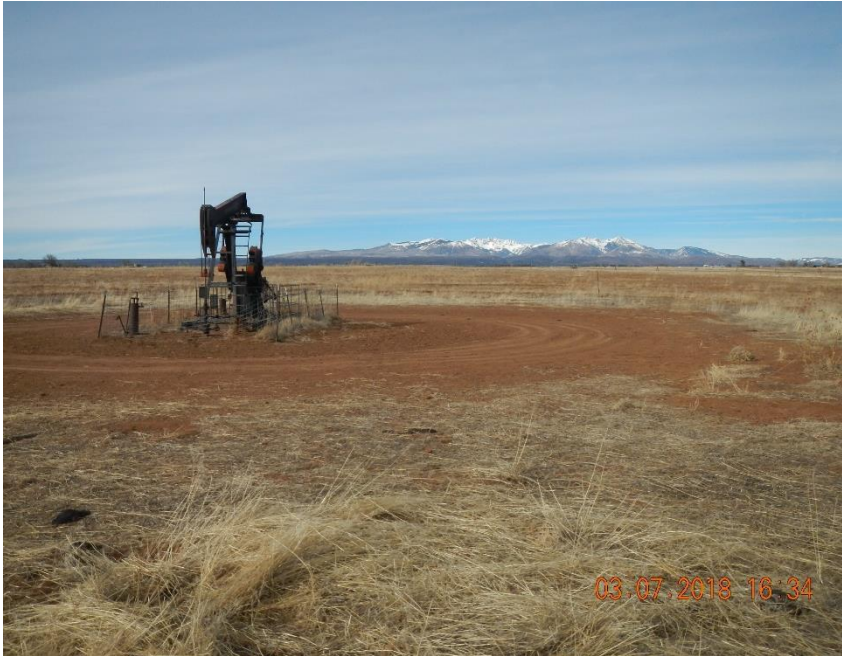
Schmitt #3-36 location photo. No surface indication of pit #115434.

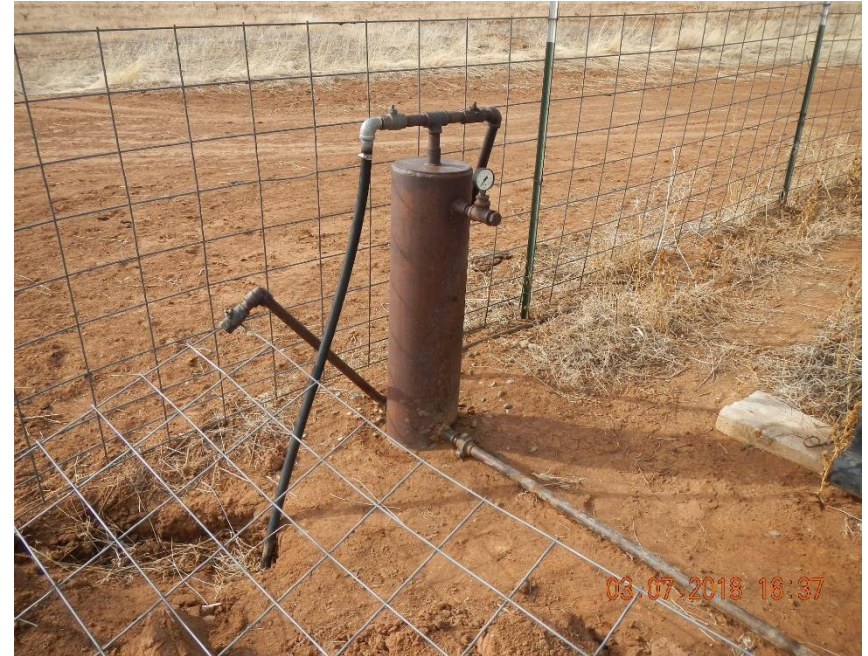
Fencing has been knocked down on southern side of pump jack.
