Inspection Photos

API: 05-007-09914

Operator: CATAMOUNT ENERGY PARTNERS LLC

Inspection Date: 2/28/2018

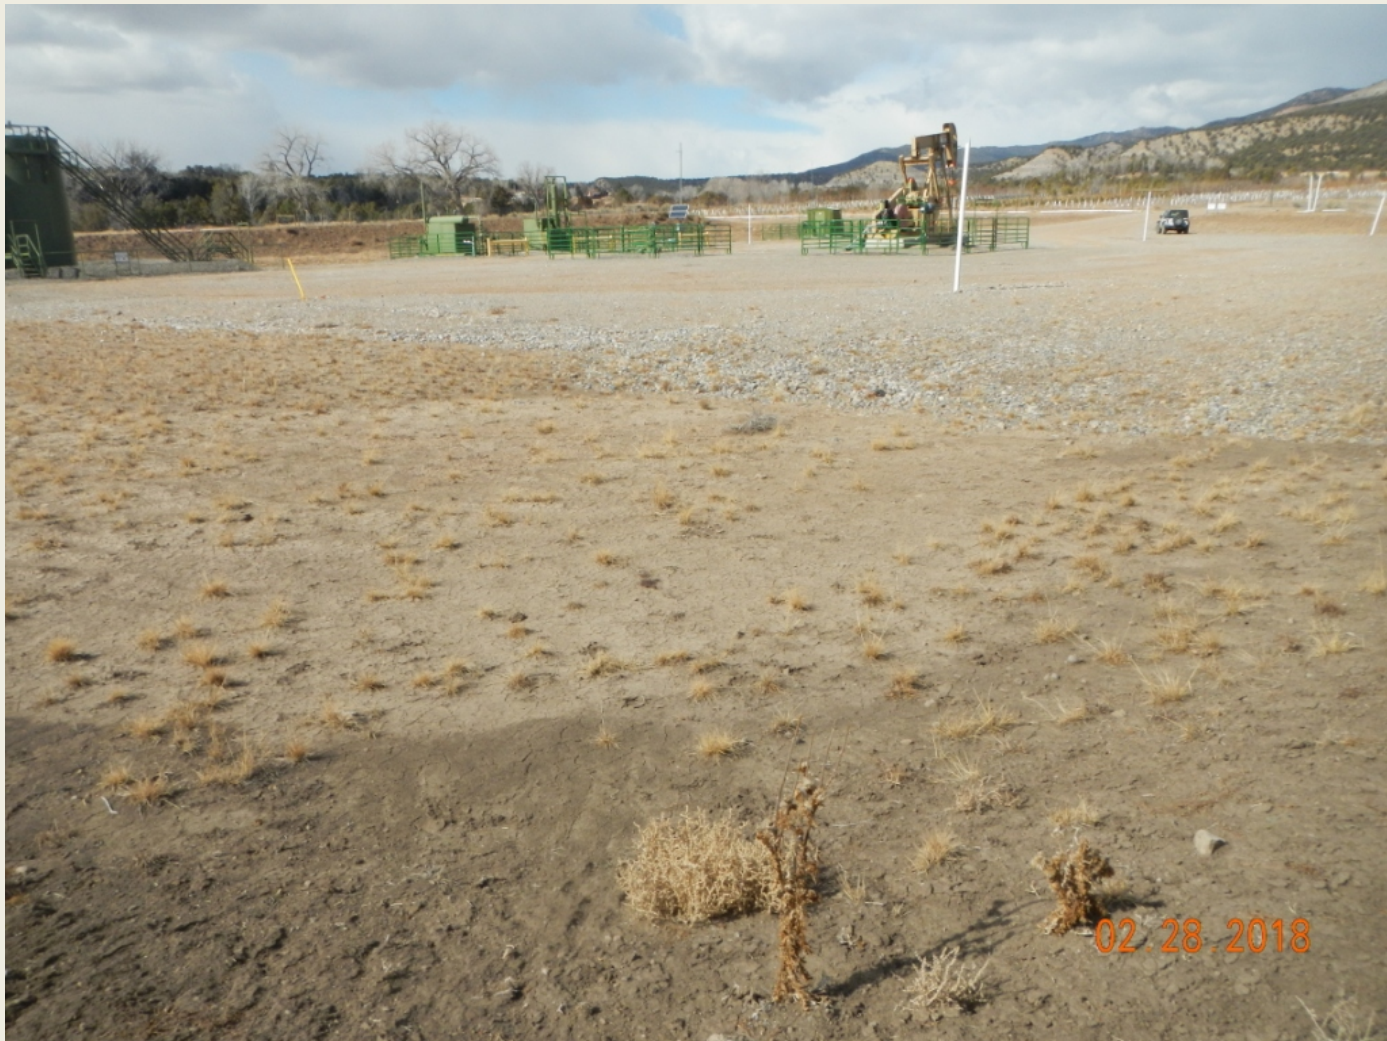
Photo 1. View of the project area from the southeastern corner facing center.

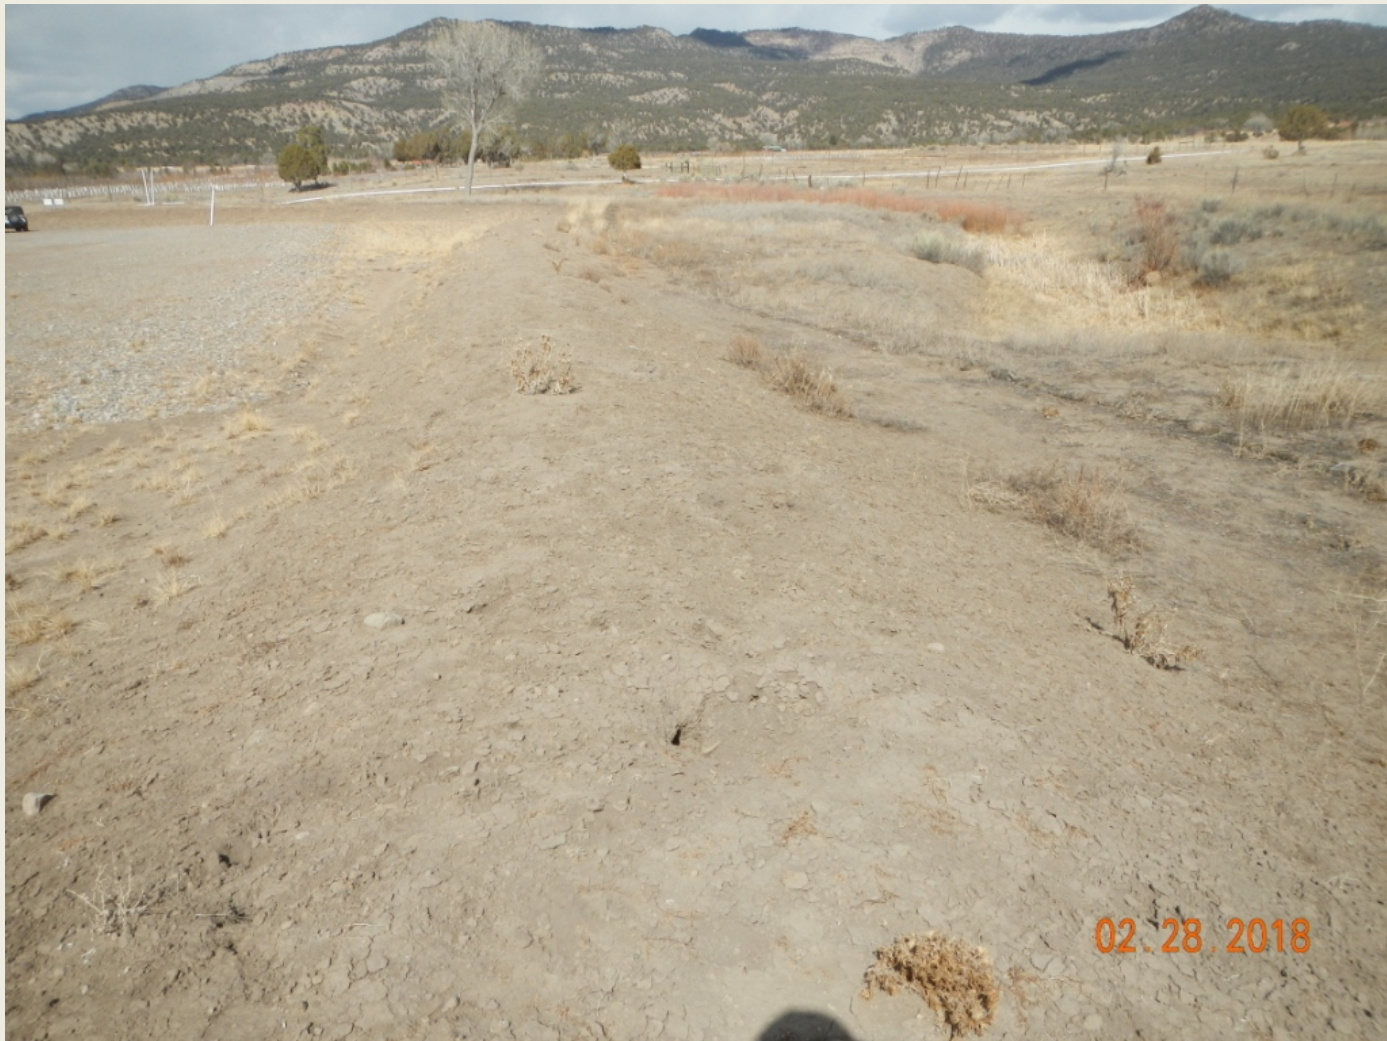
Photo 2. View of the eastern portion of the project area from the southeastern corner facing northward. Revegetation on bermed areas is poor and does not appear to be progressing.

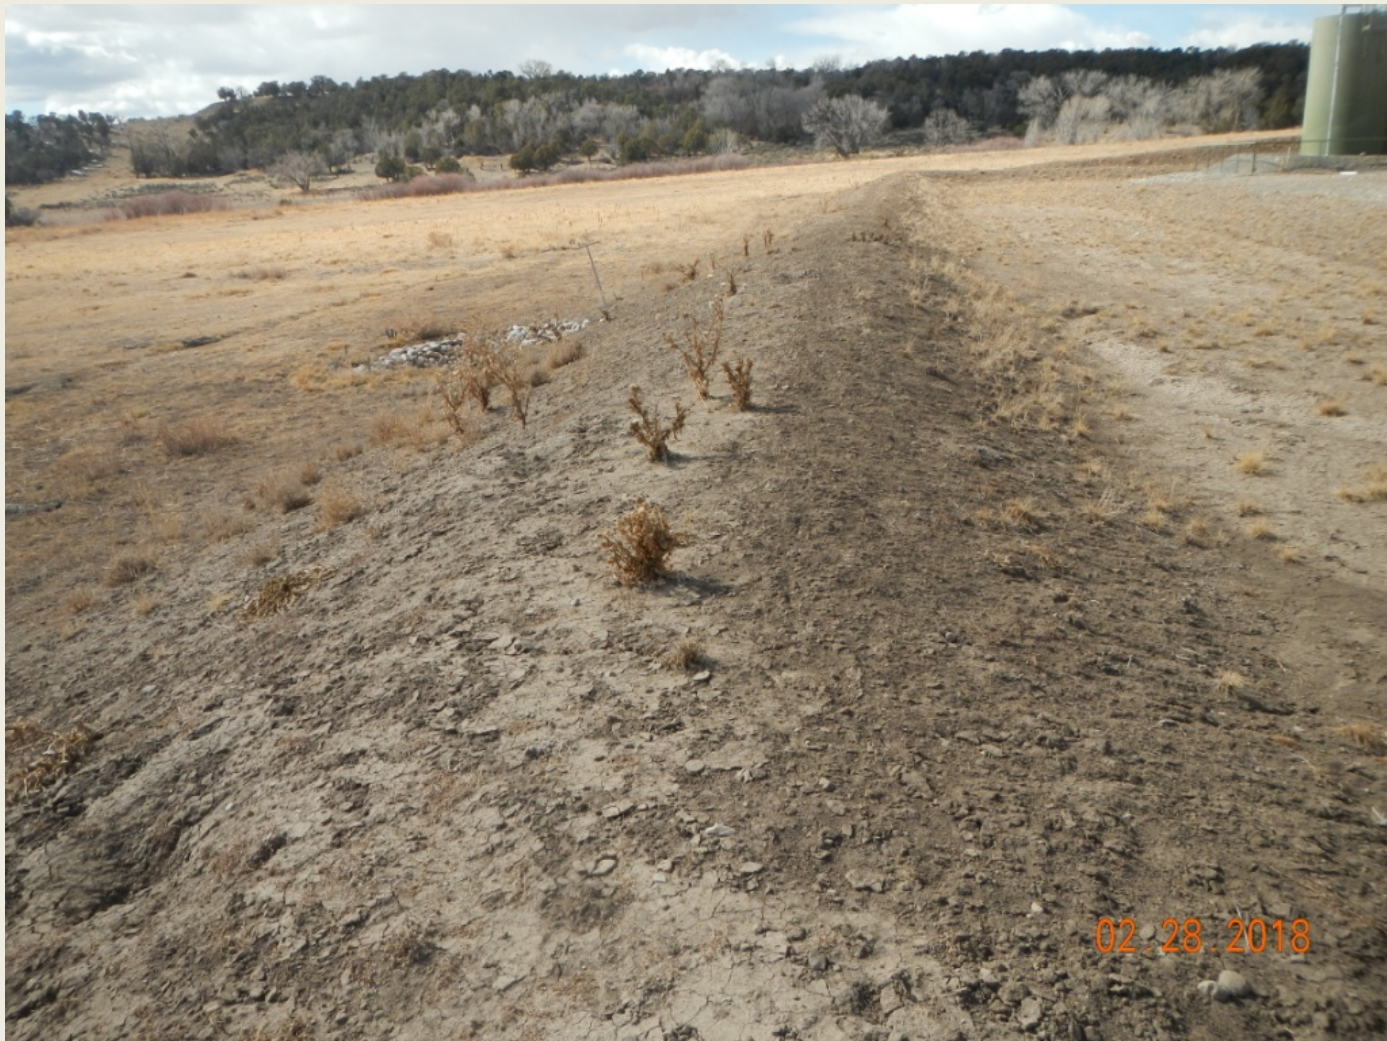
Photo 3. View of the southern portion of the project area from the southeastern corner facing westward. Poor revegetation in bermed areas. Approximately 100 musk thistles (*Carduus nutans*) observed.

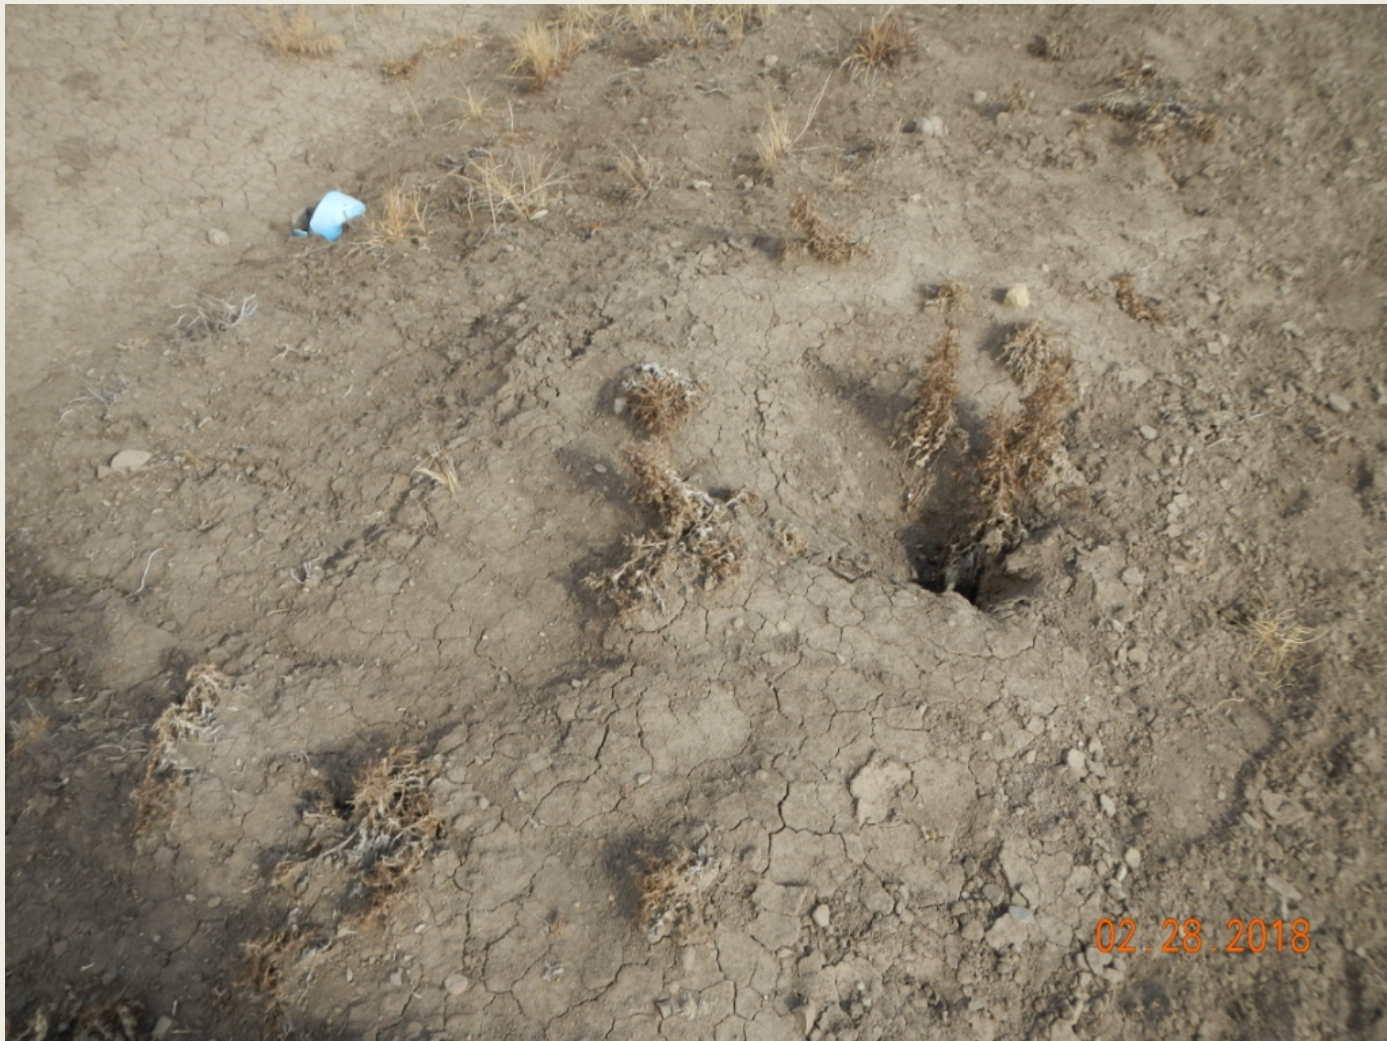
Photo 4. View of Canada thistles (*Cirsium arvense*) within the southern portion of the project area.

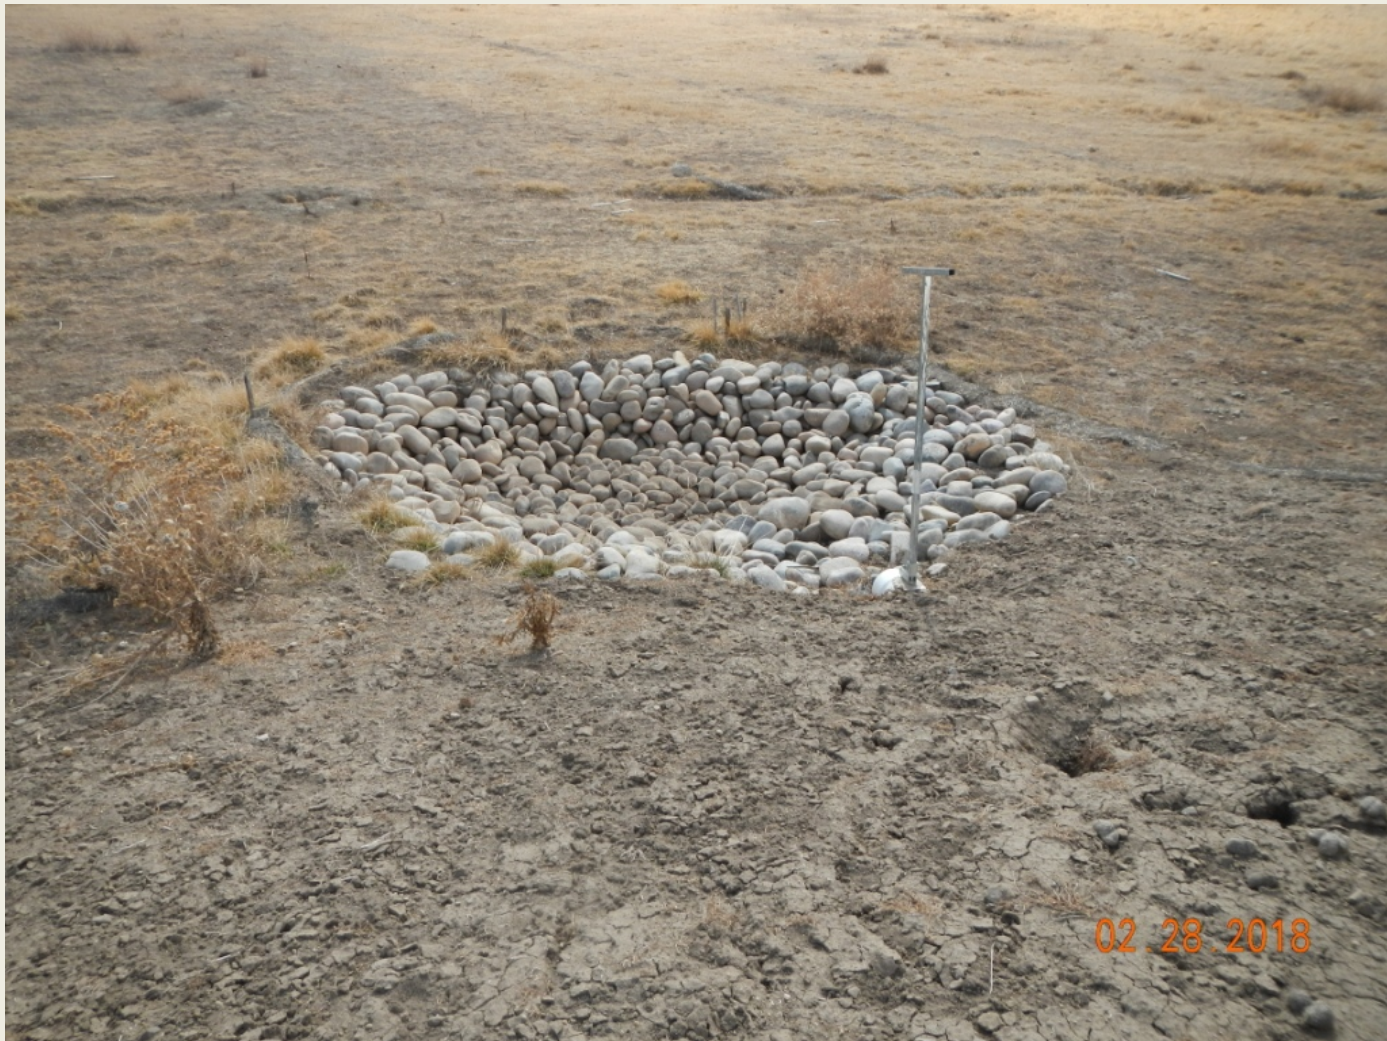
Photo 5. View of silt trap in the southern portion of the project area, appears to be functioning.

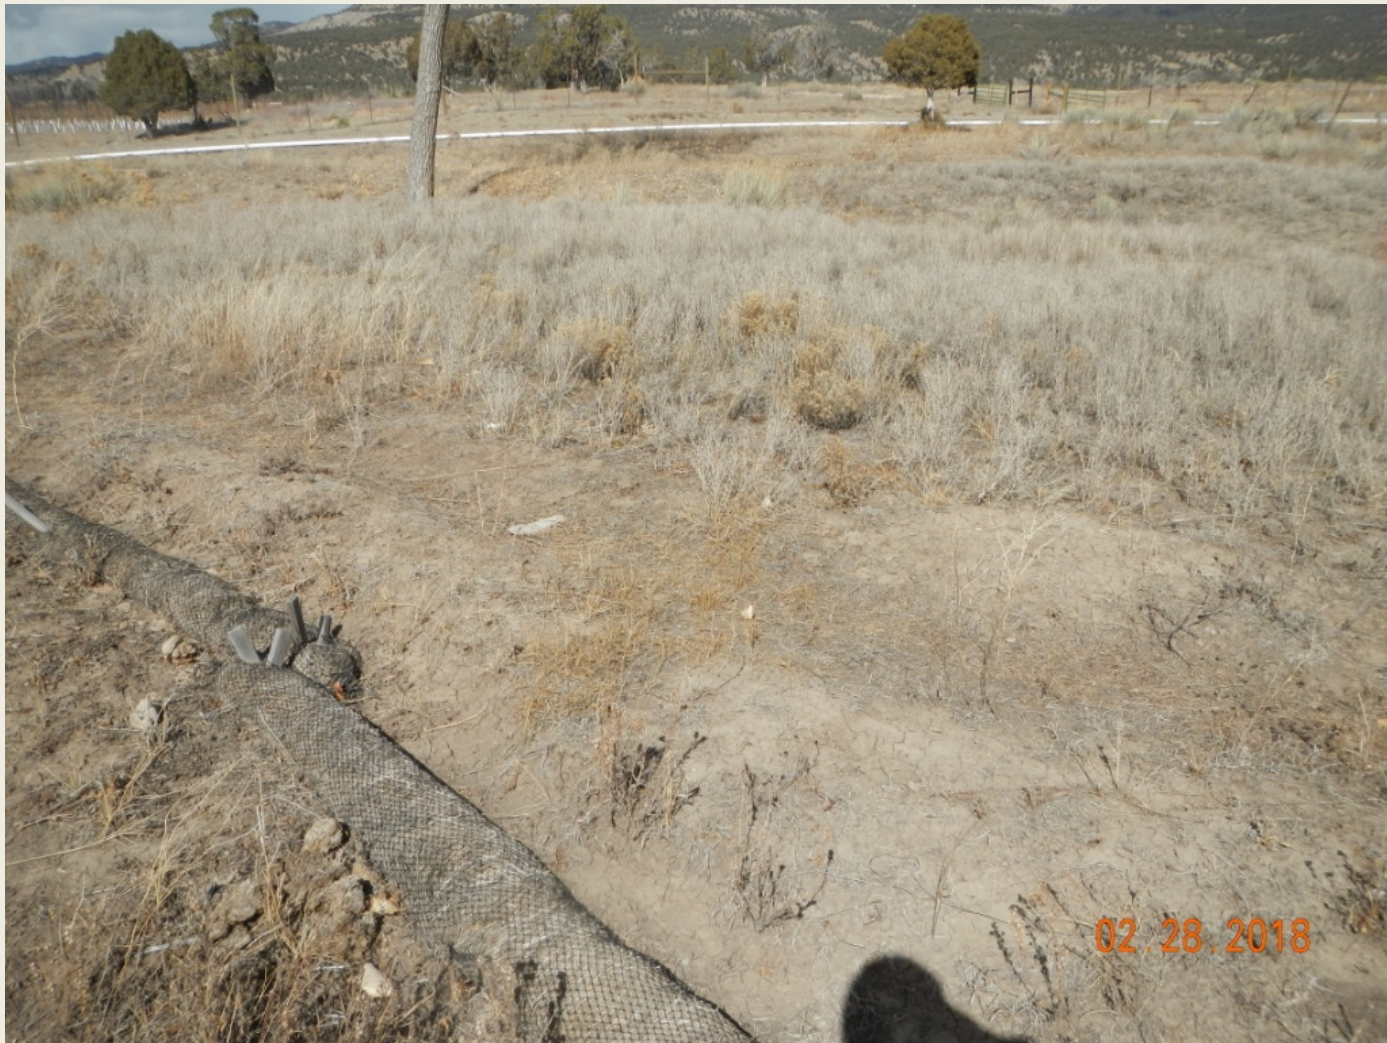
Photo 6. View of Russian knapweed (*Acroptilon repens*) infestation adjacent to the northeastern portion of the project area.
