Inspection Photos
Location Name: Hodges Pool Unit #1
API: 05-067-05539

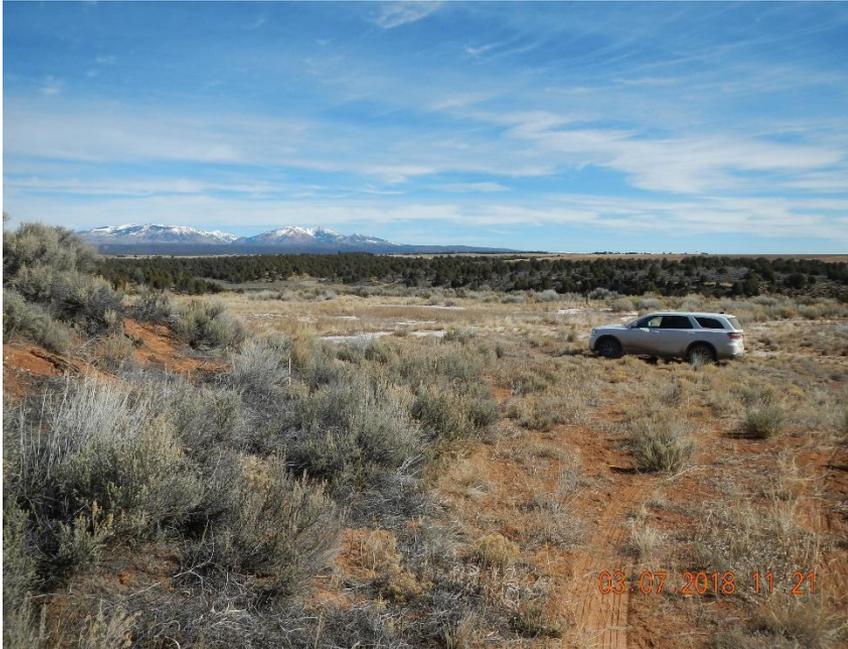
Meridian Hodges Pool Unit #1 location photo.

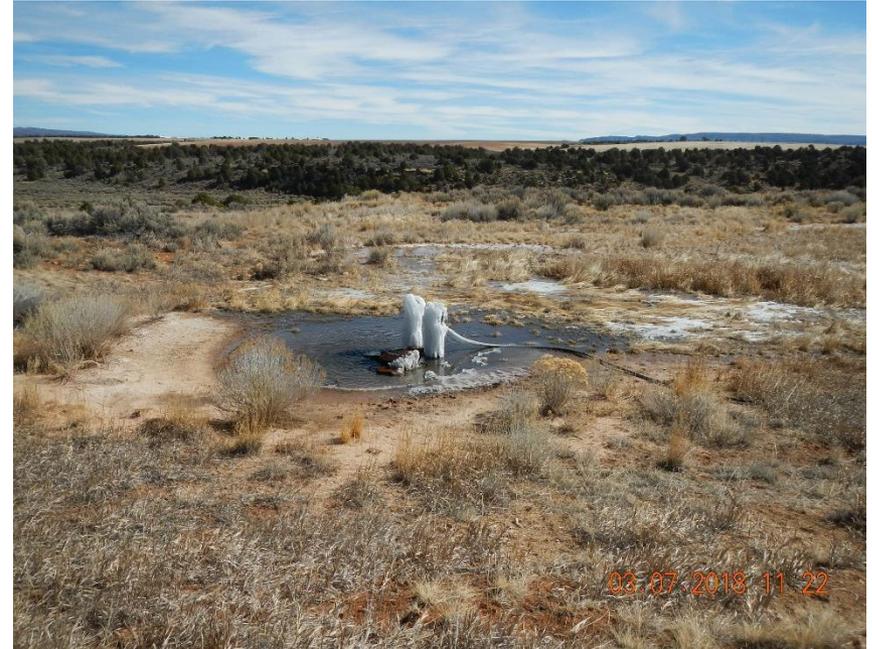
Cathodic protection well releasing gas and water.

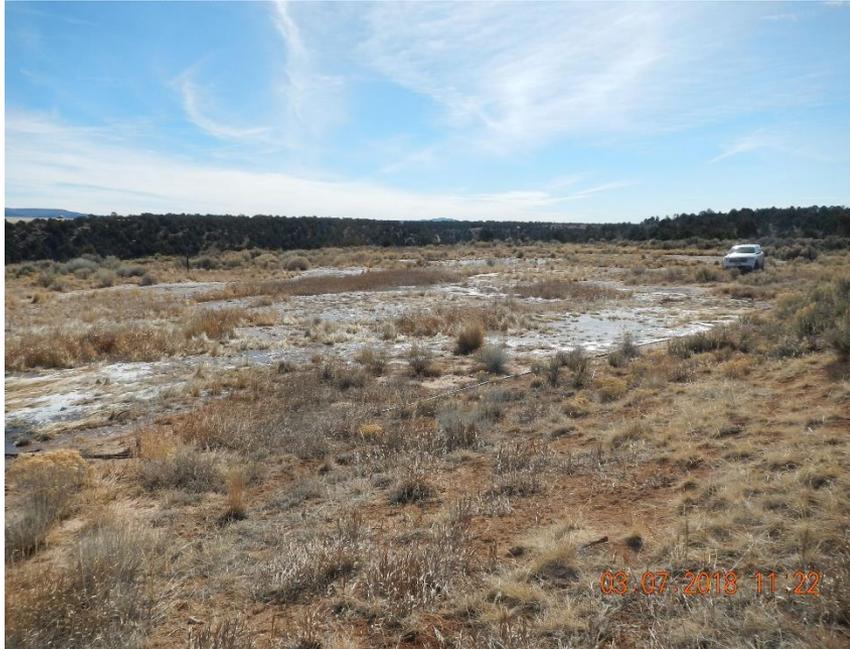
Majority of location has been impacted by ongoing release.

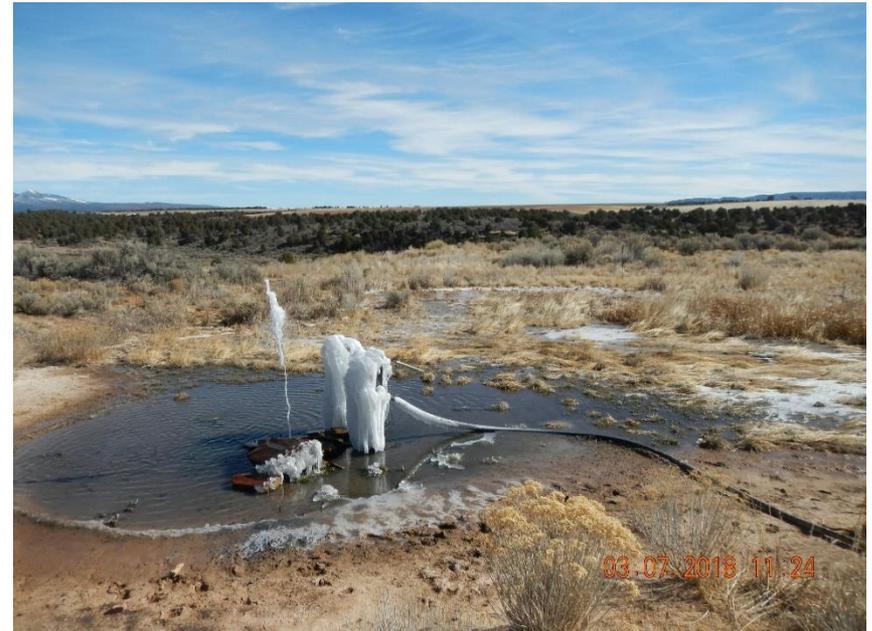
Fluids and gas venting from PVC pipe.

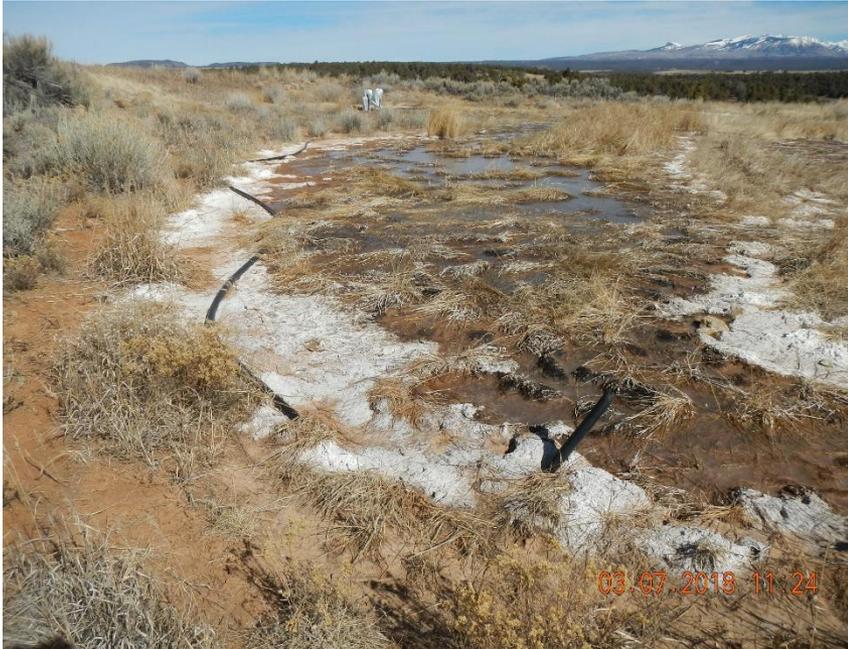
Termination of poly line attached near well.

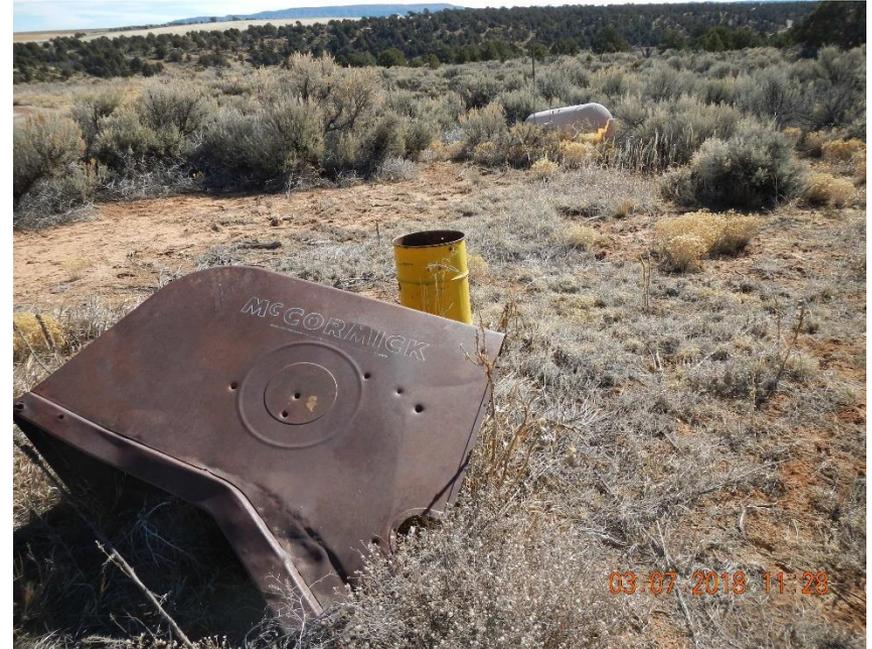
Debris near location entrance.

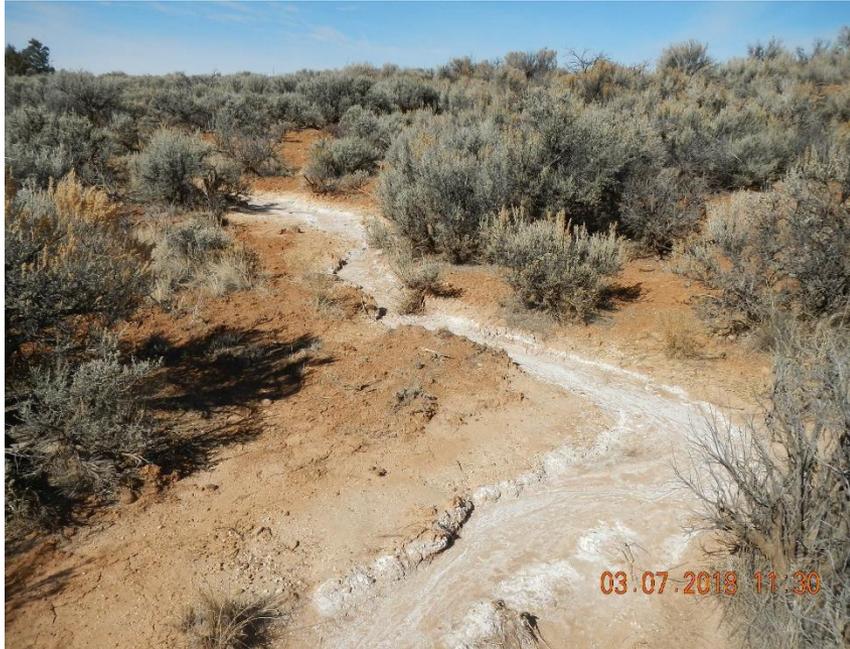
Impacted area south of location.

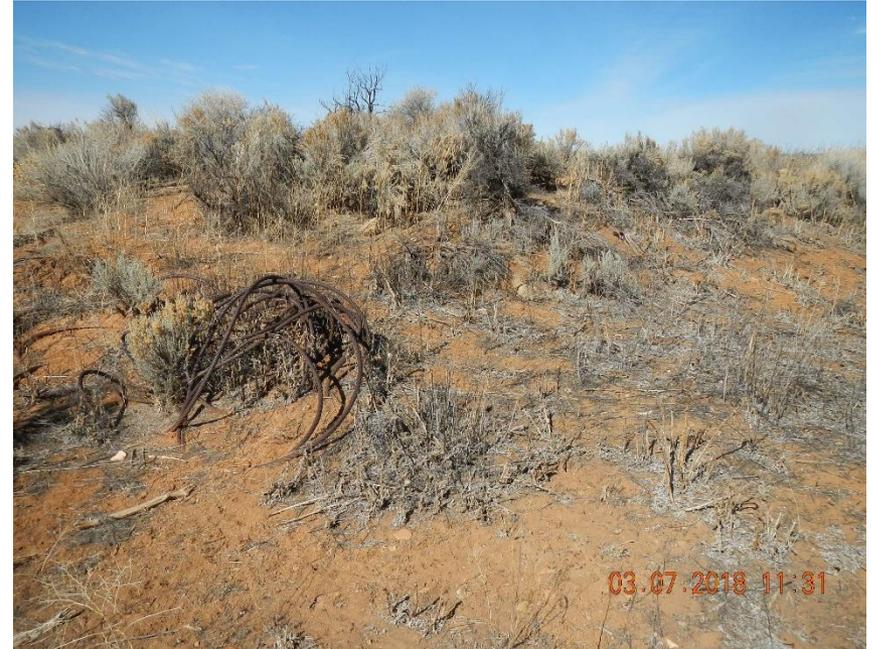
Wire rope, rig anchors, and other debris observed south of location.

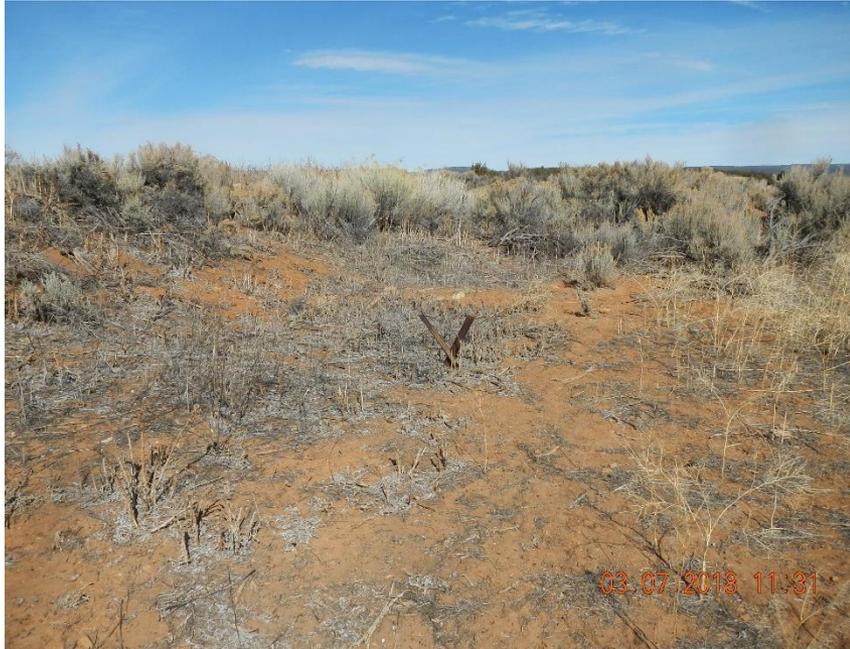
Abandoned rig anchors observed on site.

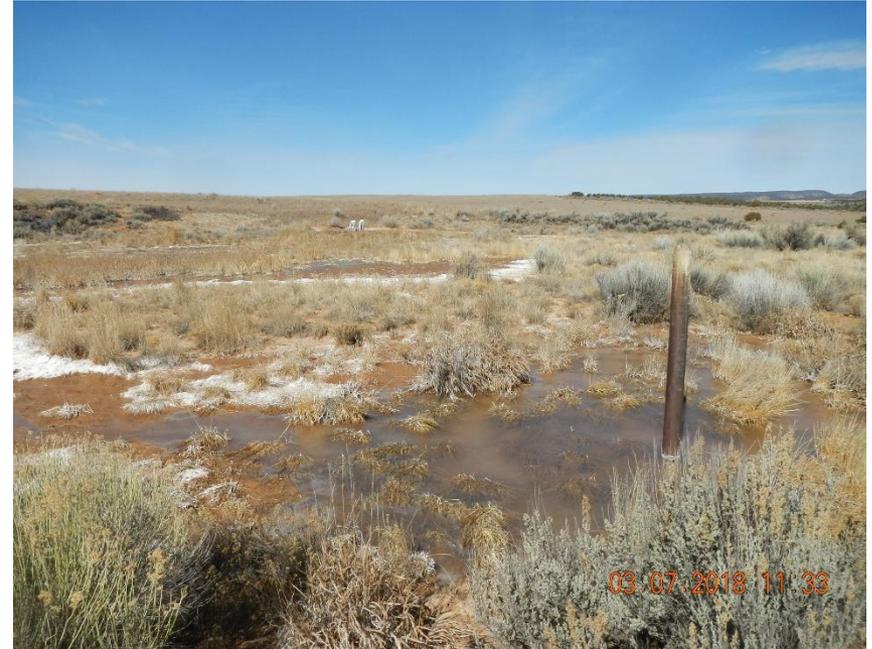
Meridian Hodges Pool Unit #1 PA marker.

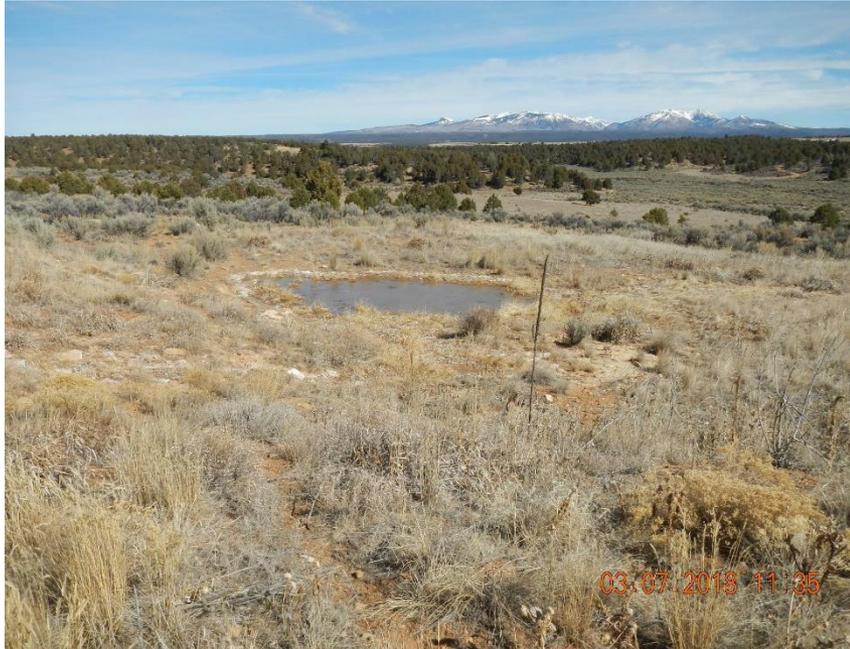
Pool of water to the north of the location. Flow path from cathodic protection well observed.

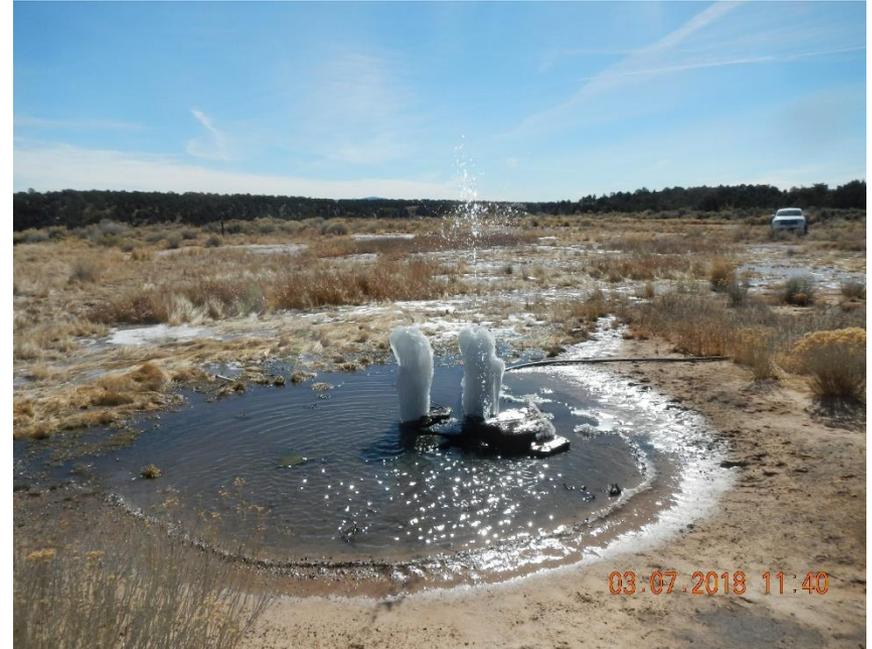
Cathodic protection well intermittently spraying water into the air.

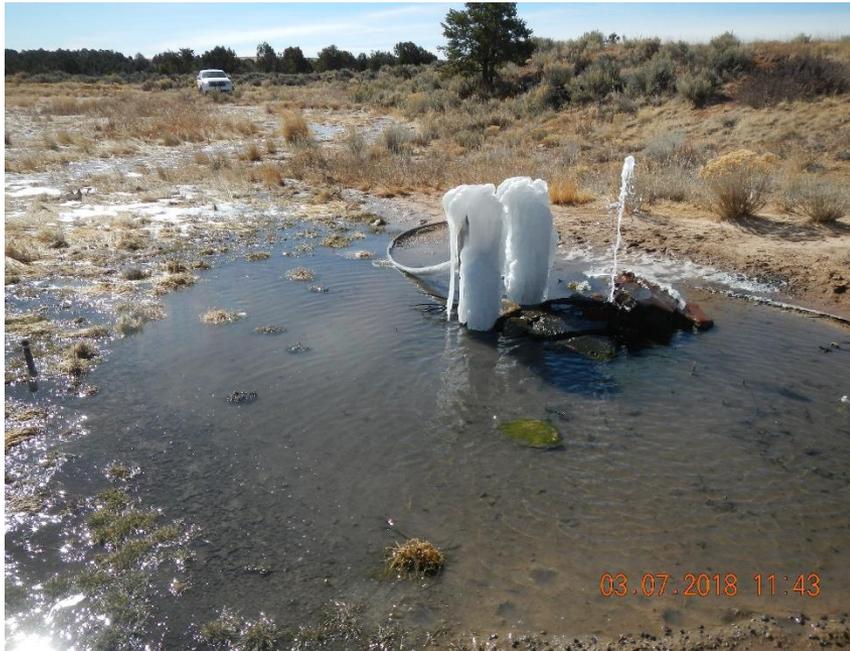
Stream of water coming out of PVC pipe.

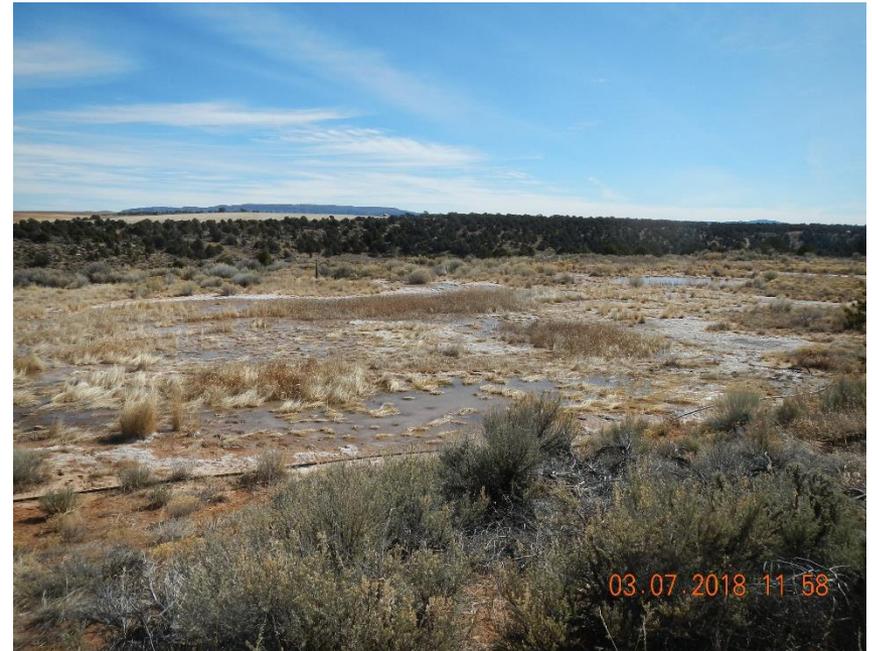
Location overview, PA marker located left of center in this photo.
