Inspection Photos

API: 05-067-05470

Operator: LOGOS OPERATING LLC

Inspection Date: 3/7/2018

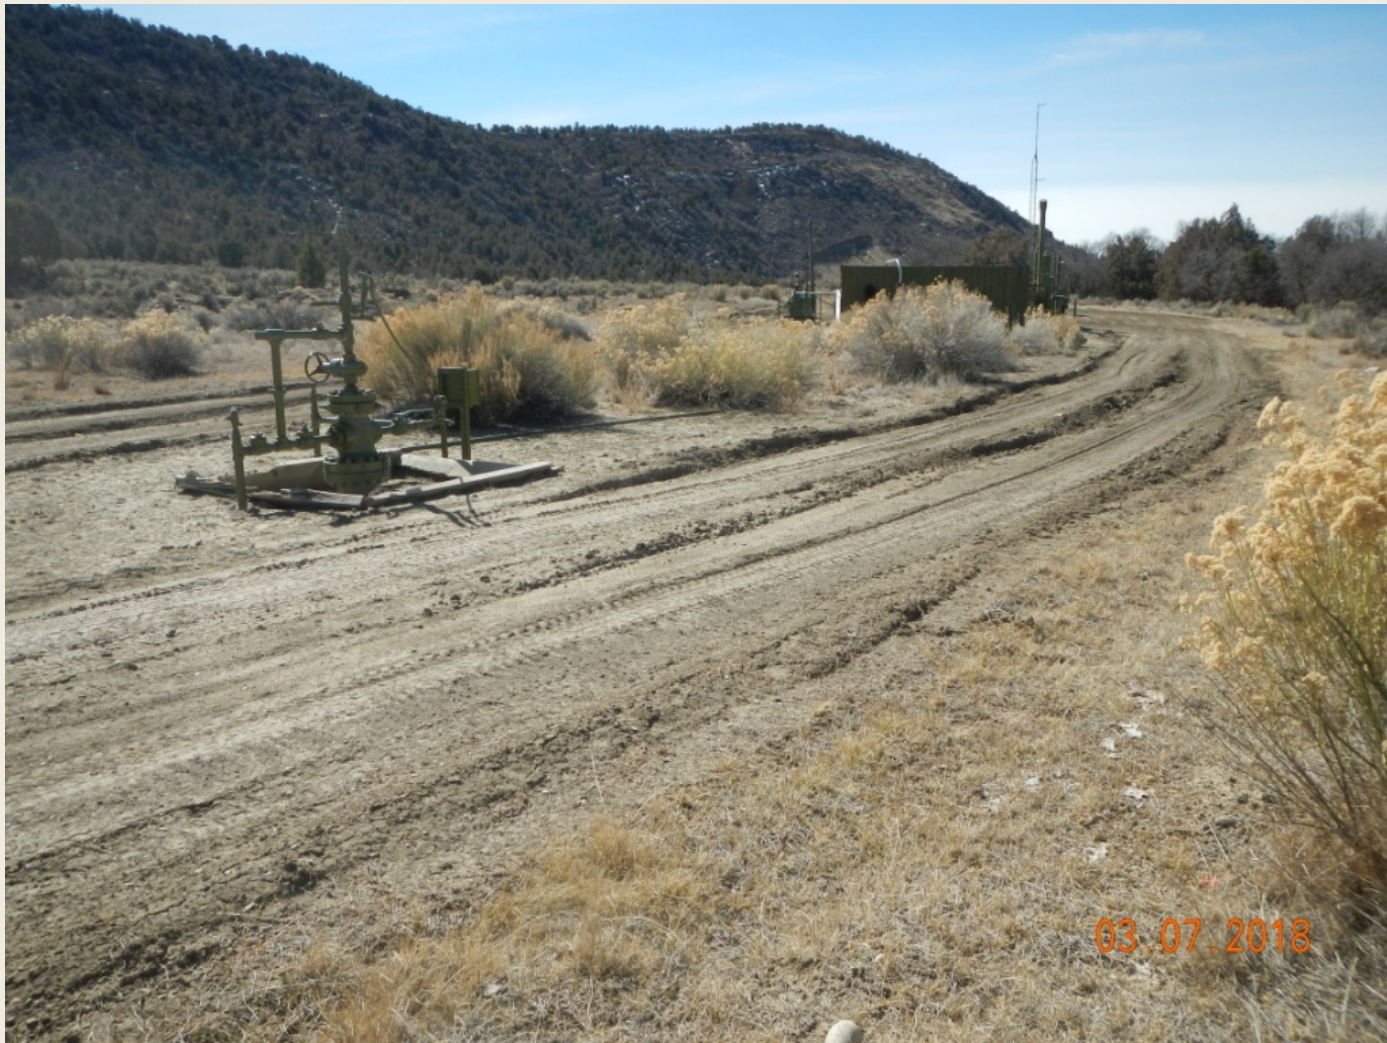
Photo 1. View of the project area from the northwestern corner facing center.

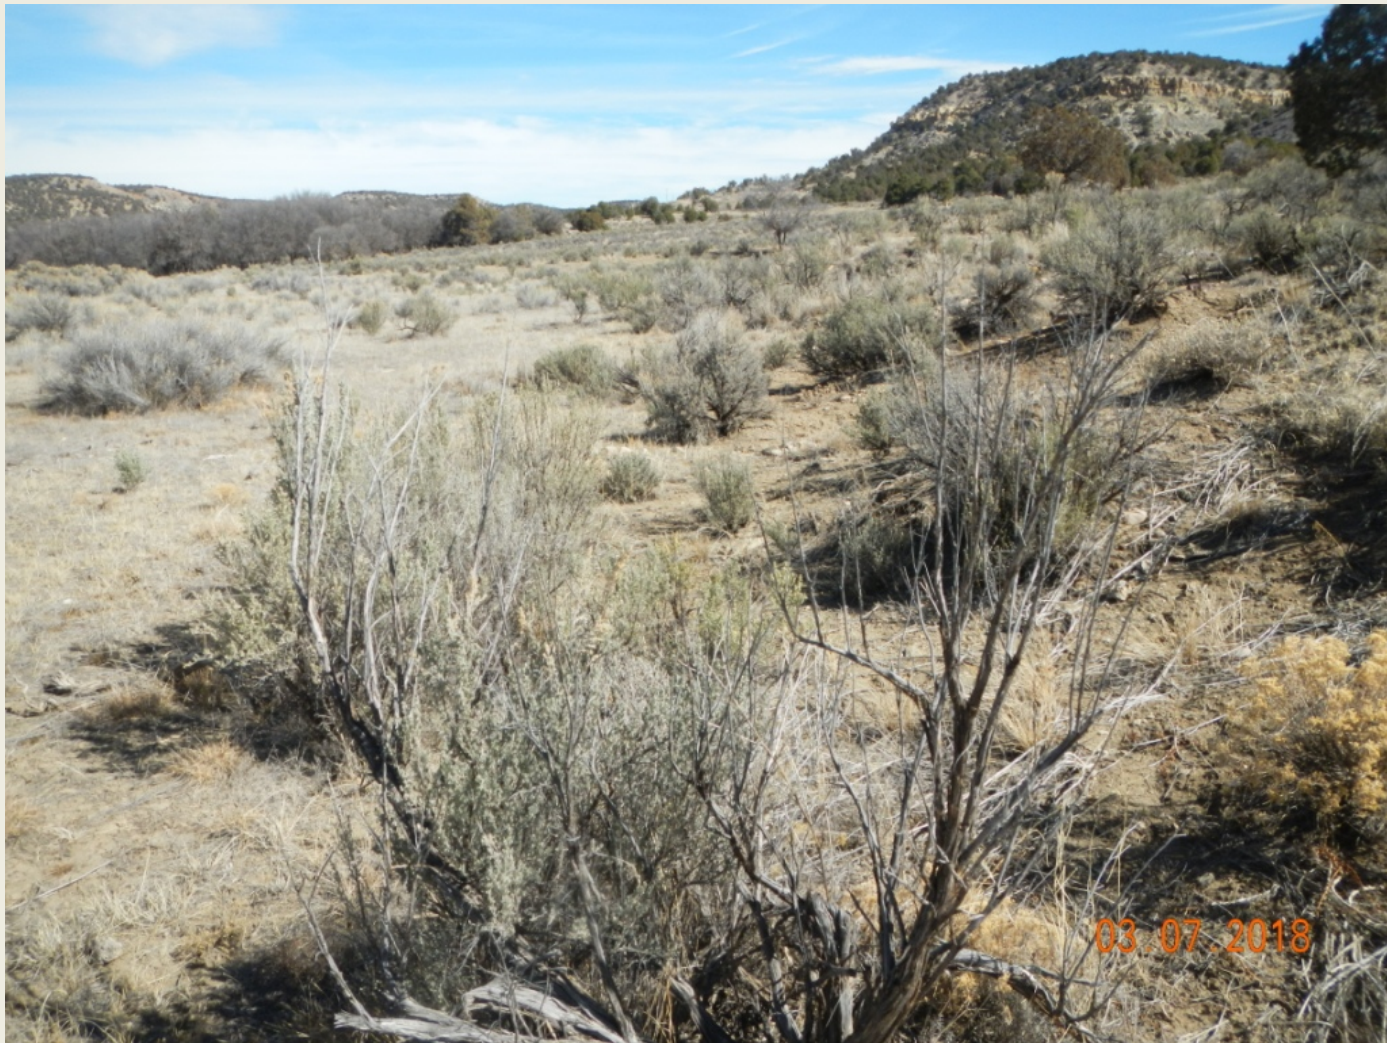
Photo 2. View of the eastern portion of the interim reclamation area from the southeastern corner facing northward. Revegetation is comprised of big sagebrush (*Artemisia tridentata*) with cheatgrass (*Bromus tectorum*) and western wheatgrass (*Pascopyrum smithii*) understory.

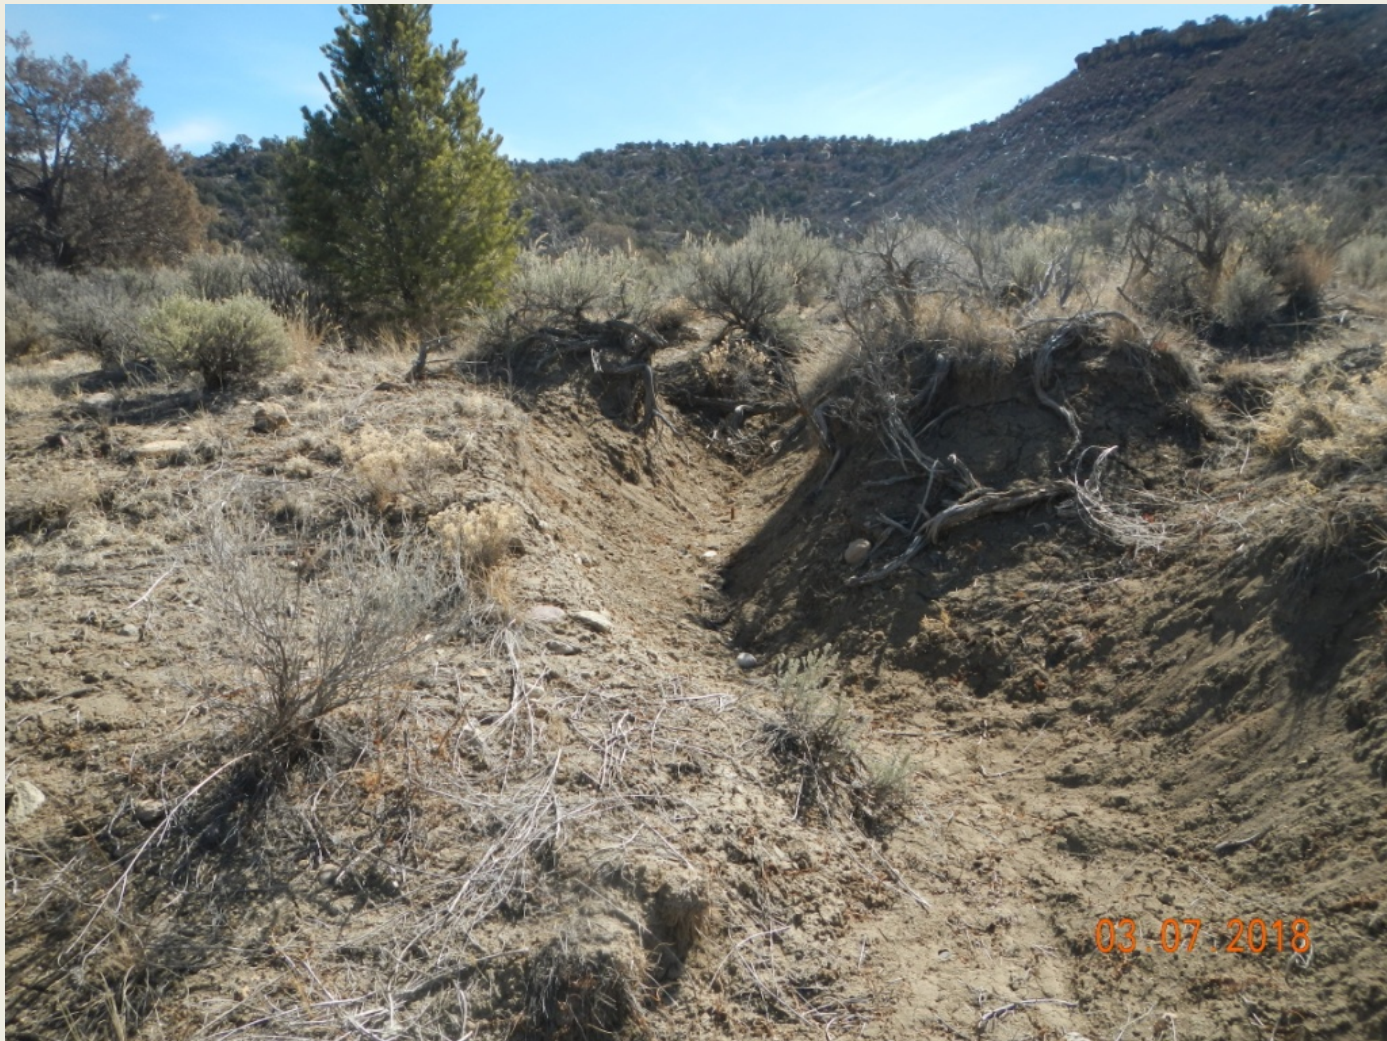
Photo 3. View of erosional channels in the southeastern portion of the project area where concentrated stormwater flows have eroded the cut-slope. Stormwater controls are needed to stabilize erosion here.

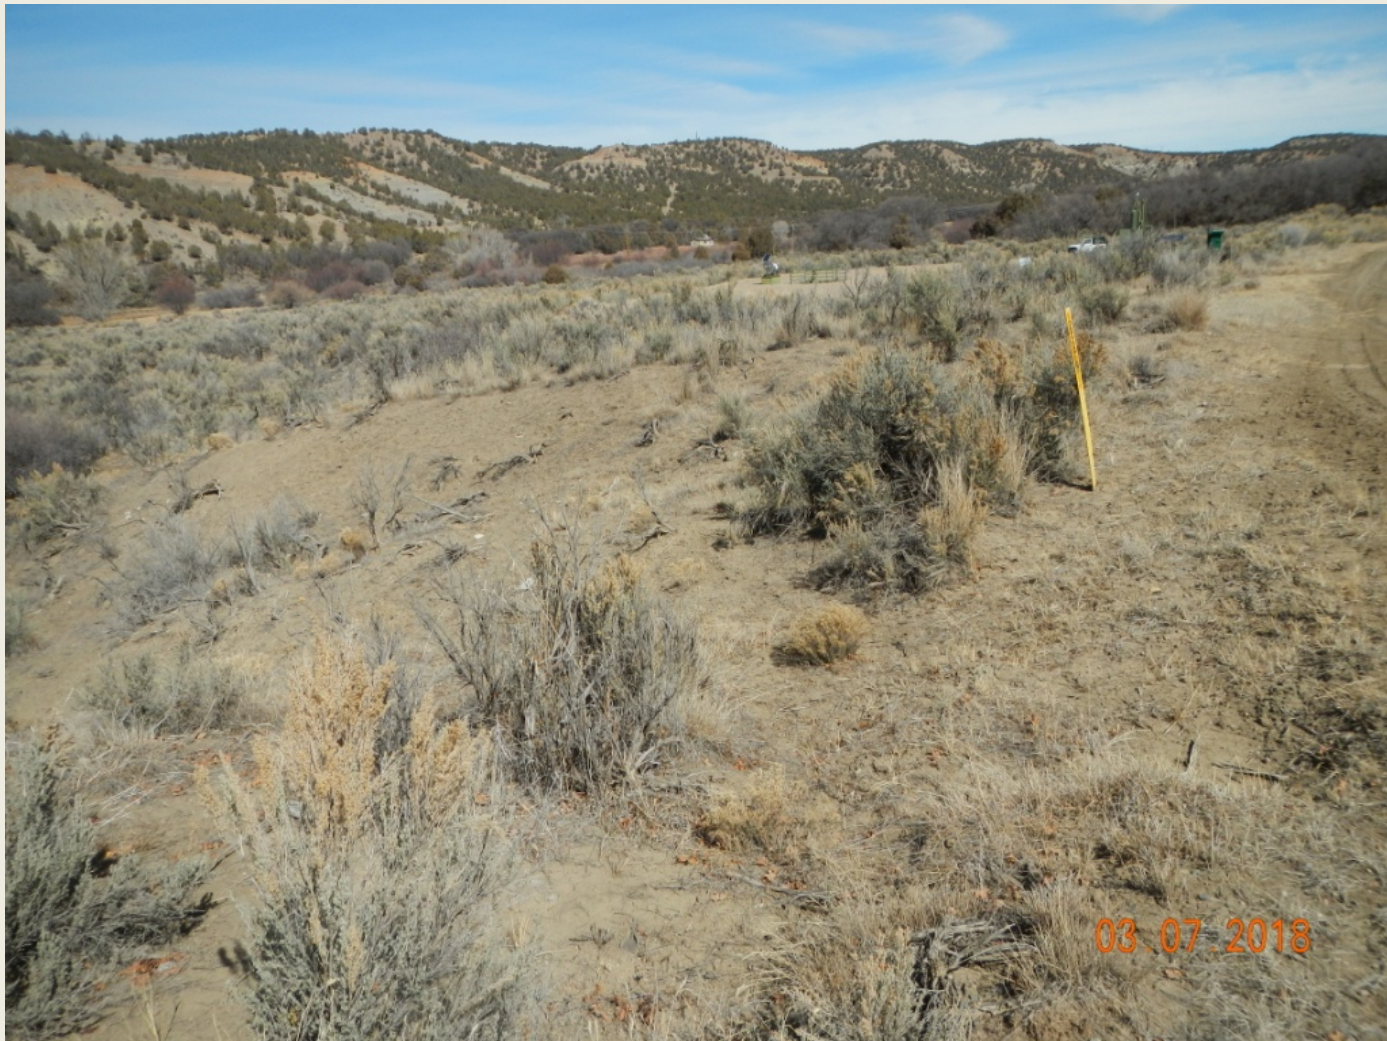
Photo 4. View of the western portion of the project area from the southwestern edge of the well pad facing northward.

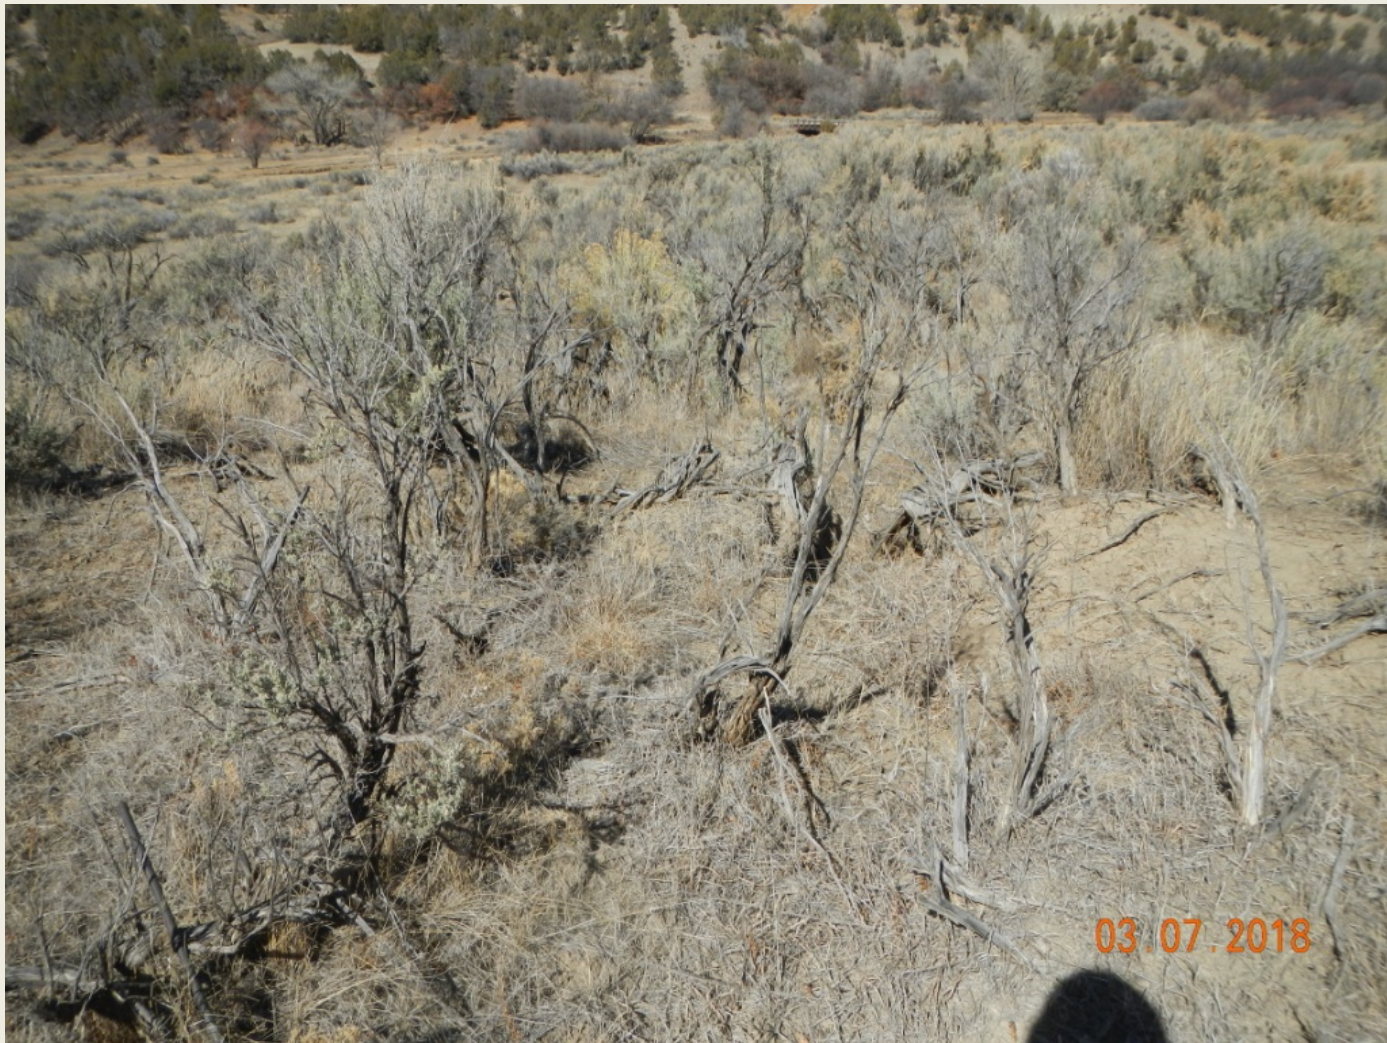
Photo 5. View of dead sagebrush (*Artemisia tridentata*). Sagebrush die-off appears to be the result of project activities as it is downwind of separator. Reclamation in this area may be needed.

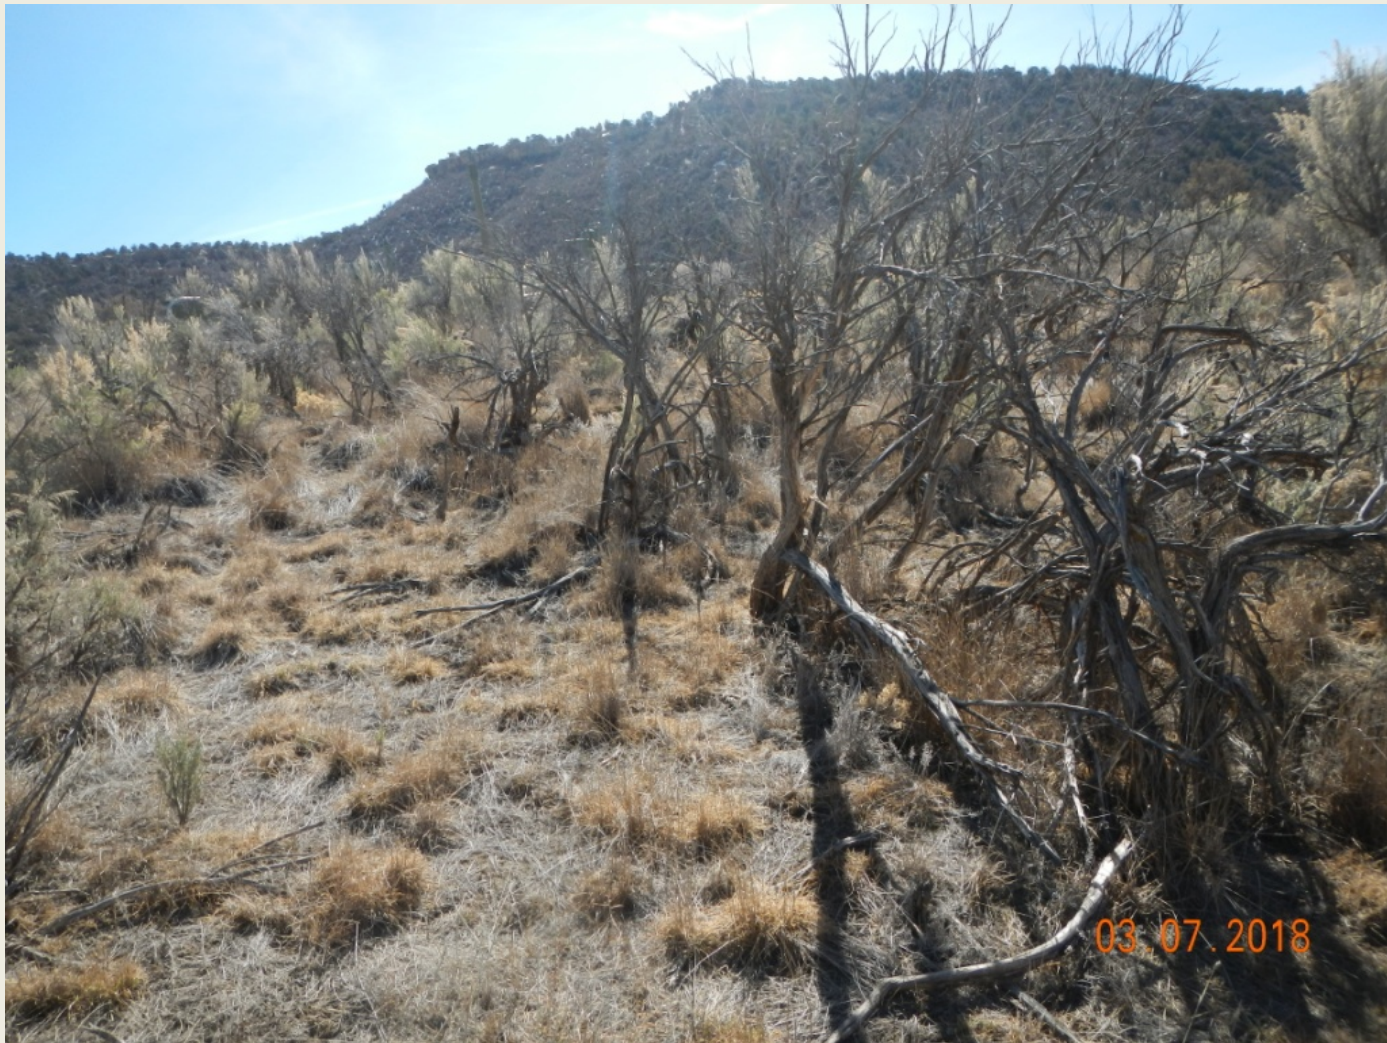
Photo 5. Another view of sagebrush die-off west of the separator (in background).
