Inspection Photos

API: 05-067-07128

Operator: BP AMERICA PRODUCTION
COMPANY

Inspection Date: 3/7/2018

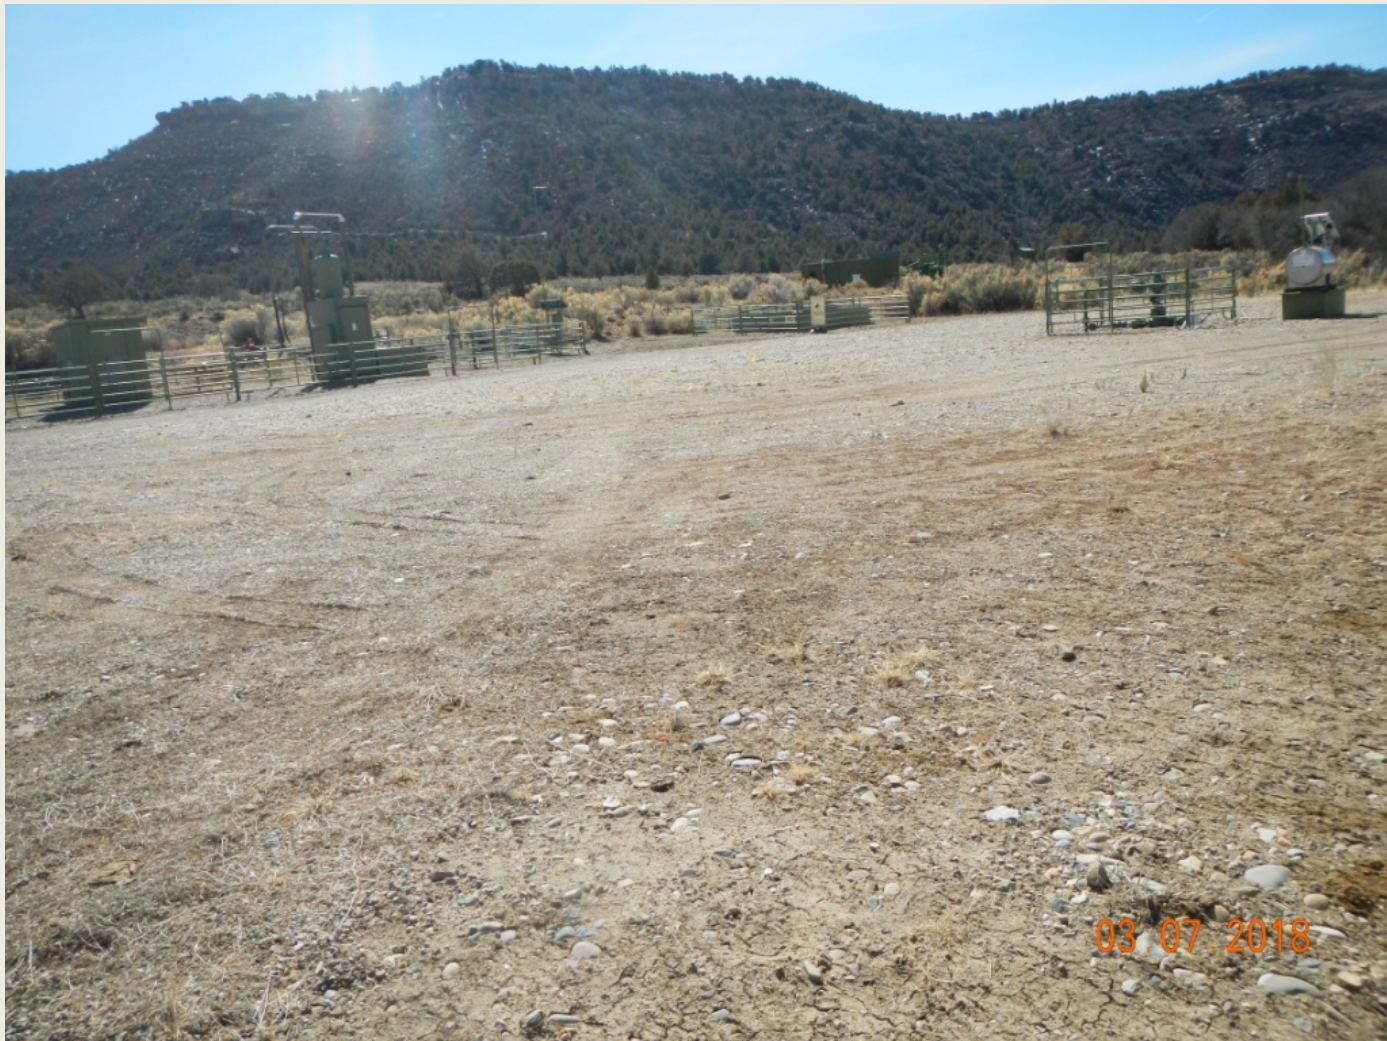
Photo 1. View of the project area from the northwestern corner facing center.

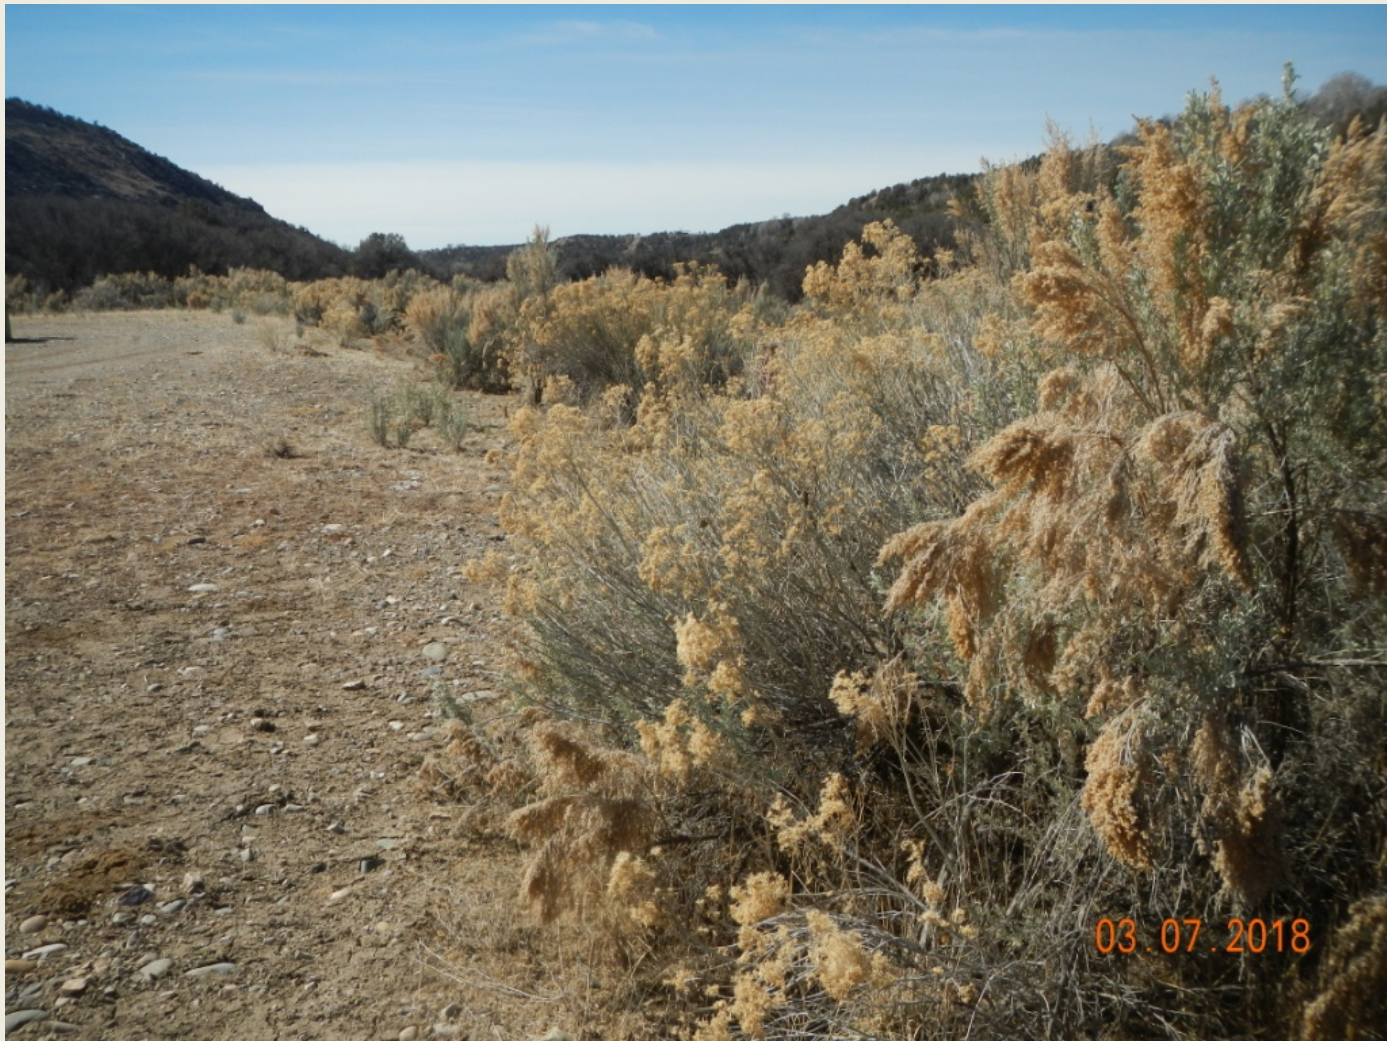
Photo 2. View of the western portion of the interim reclamation area from the northwestern corner facing westward. Revegetation is comprised of big sagebrush (*Artemisia tridentata*) with cheatgrass (*Bromus tectorum*) and western wheatgrass (*Pascopyrum smithii*) understory.

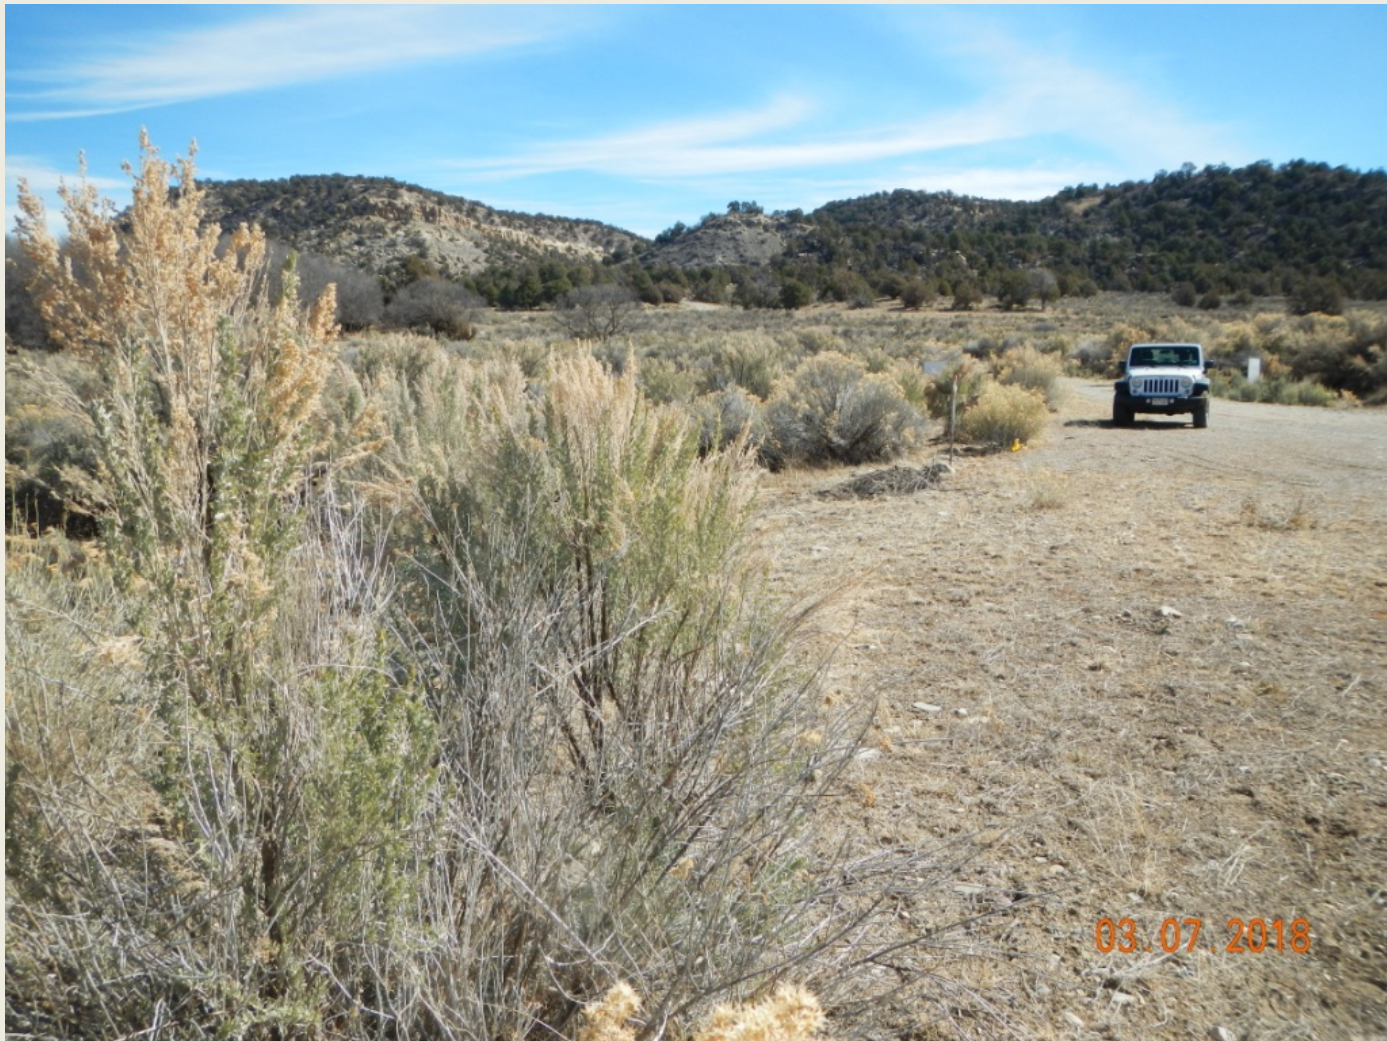
Photo 3. View of the northern portion of the project area from the northwestern corner facing eastward.

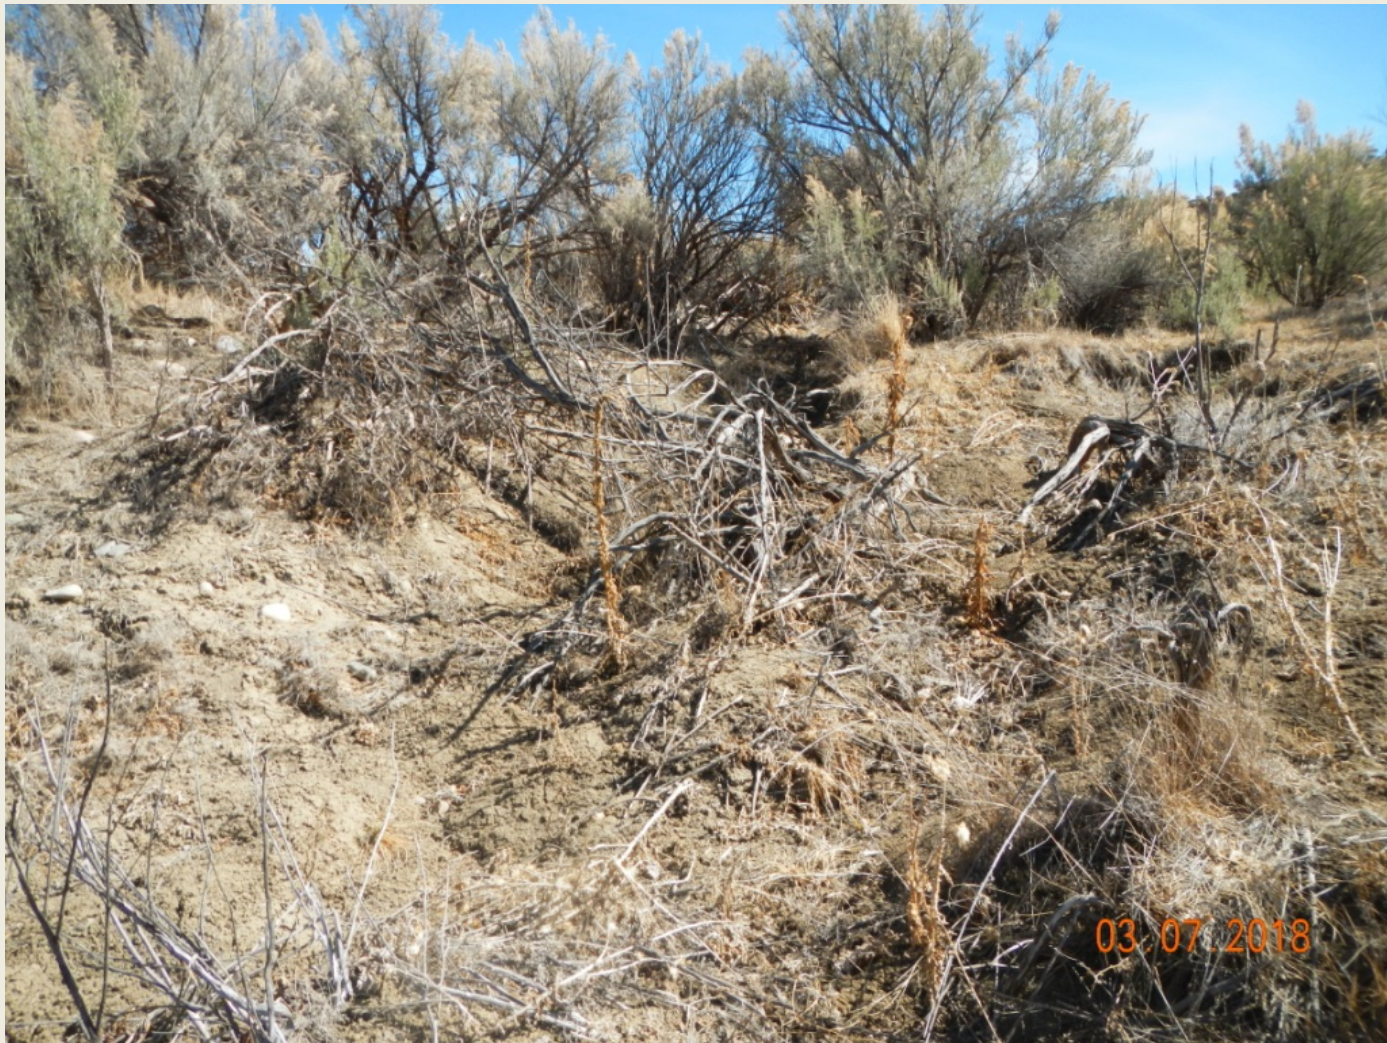
Photo 4. View of erosion in the southern portion of the project area. Appears to result from concentrated stormwater that flows off of the southern well pad.

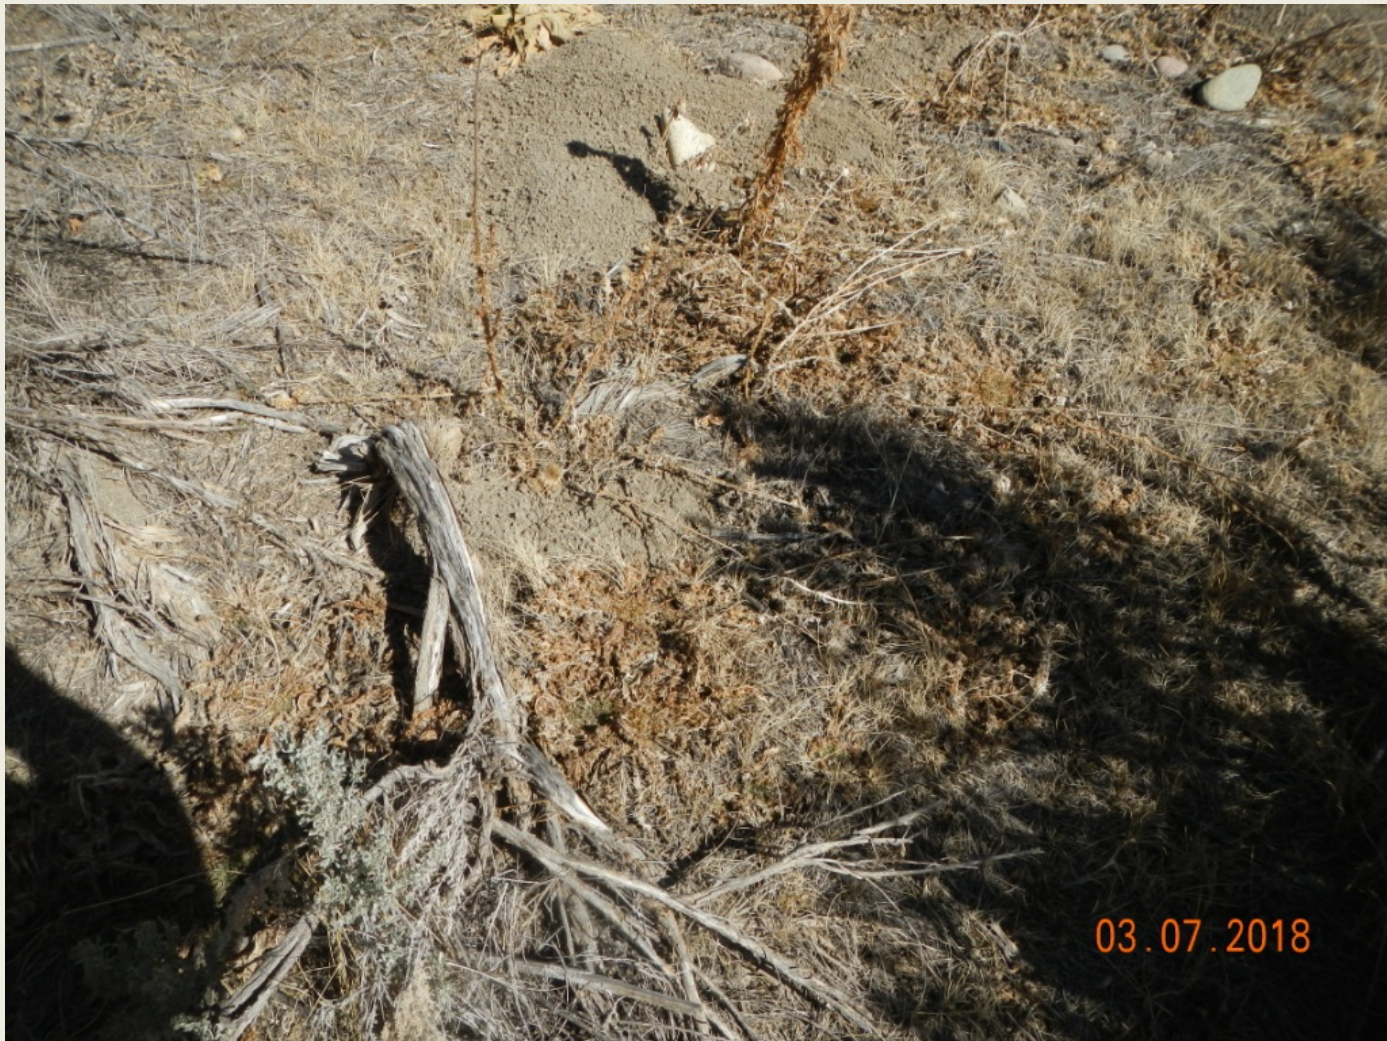
Photo 5. View of musk thistles (*Carduus nutans*) in the southern portion of the project area. Approximately 150 individuals observed.
