Inspection Photos

API: 05-067-07950

Operator: LOGOS OPERATING LLC

Inspection Date: 3/7/2018

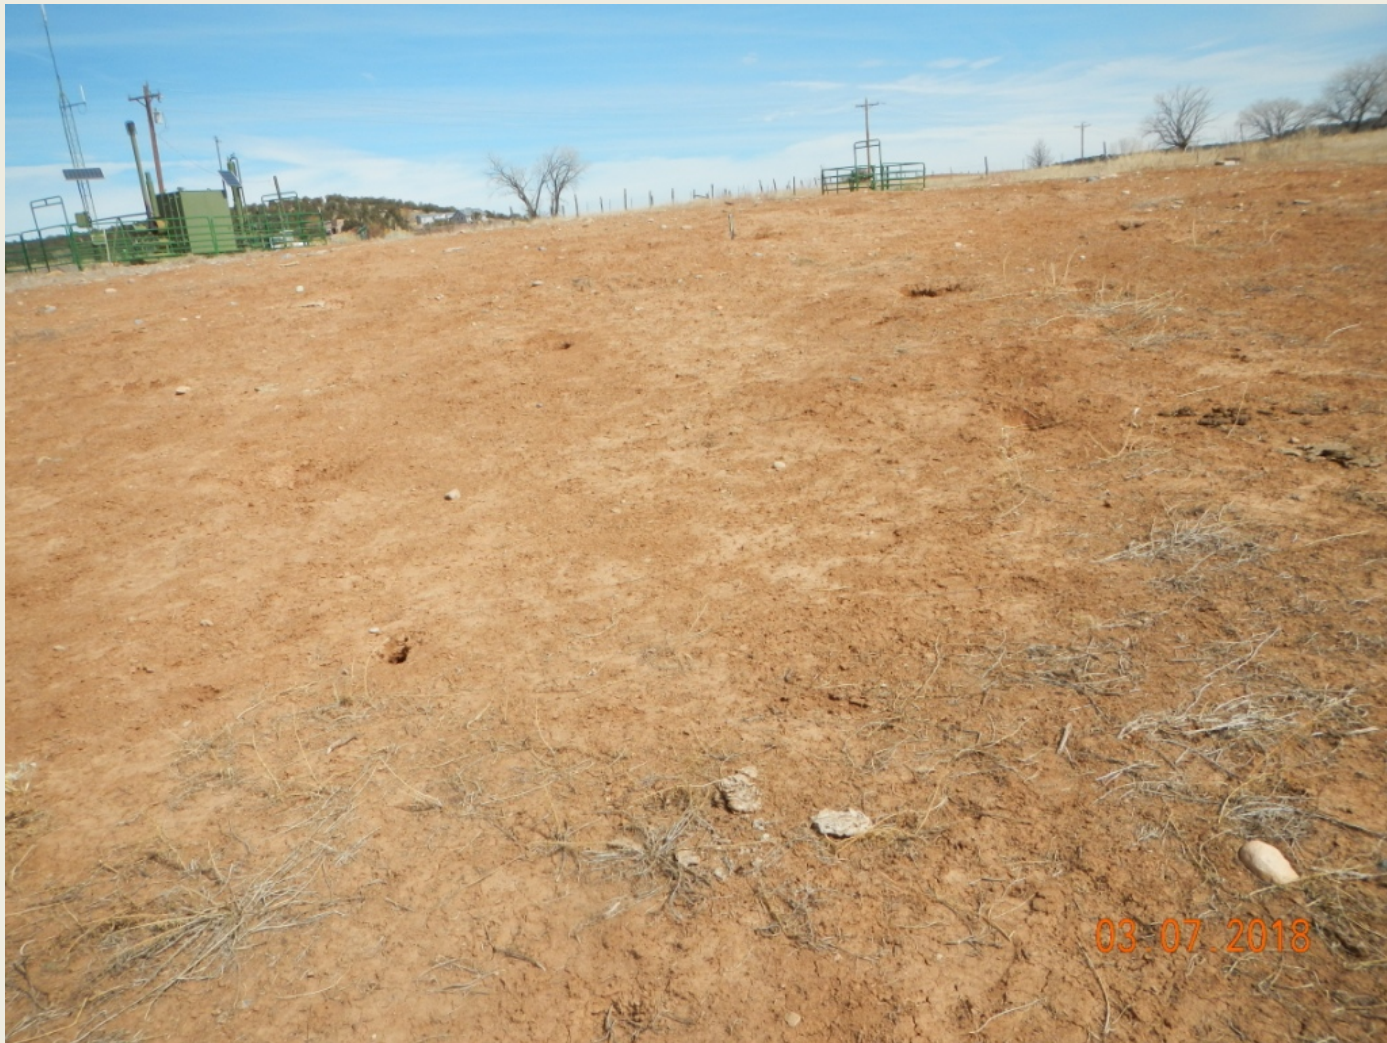
Photo 1. View of the project area from the southwestern corner facing center.

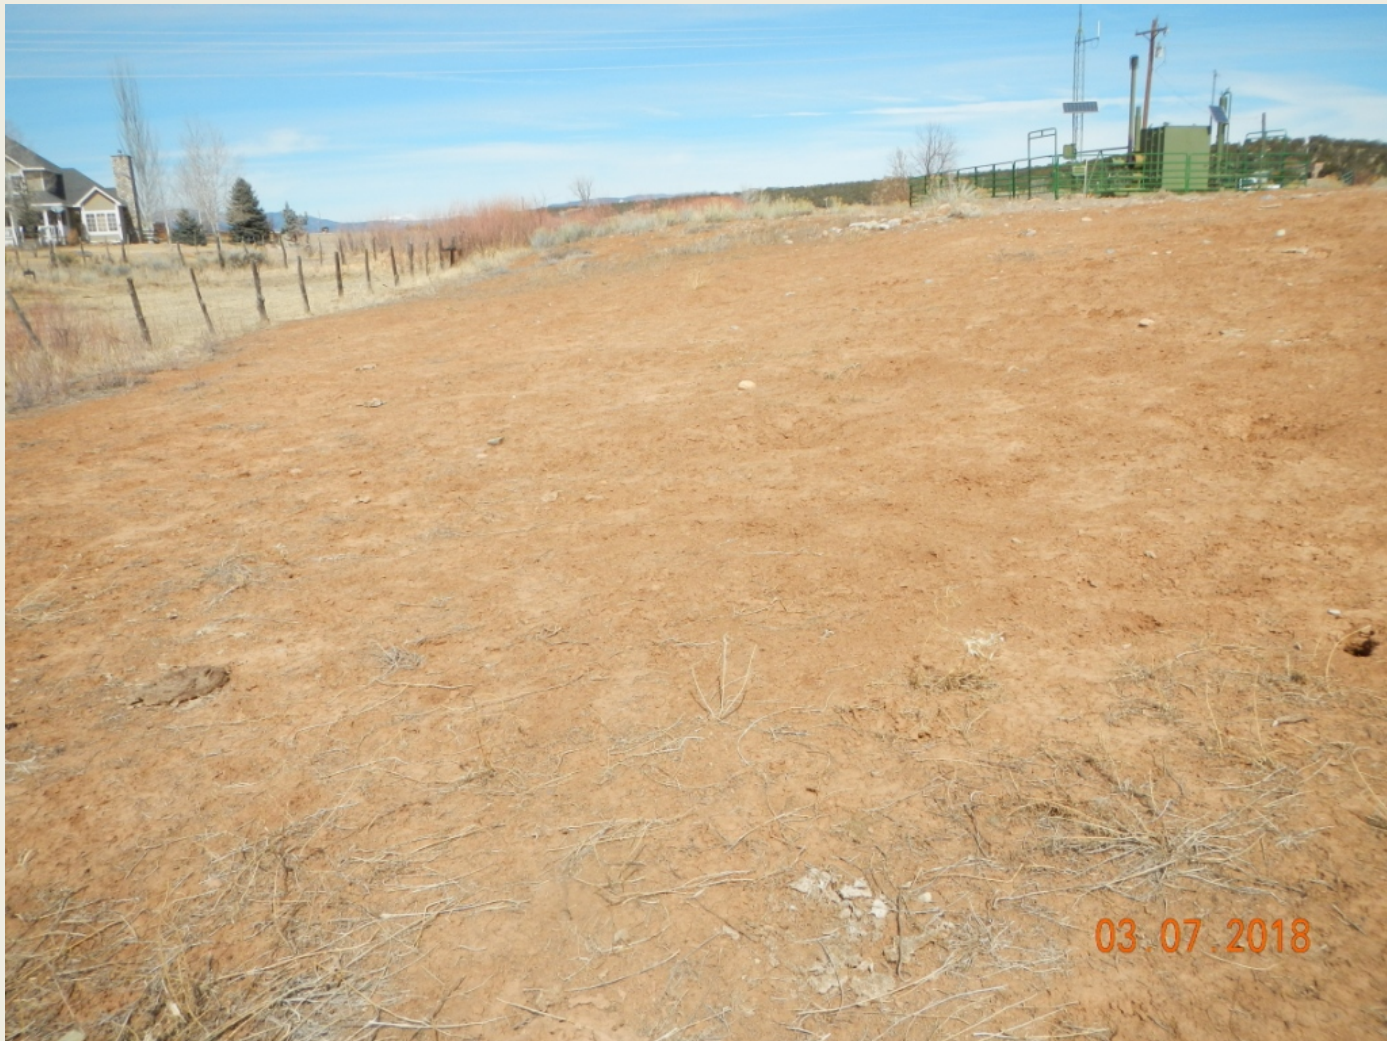
Photo 2. View of the western portion of the project area from the southwestern corner facing northward. Little to no desirable vegetation here.

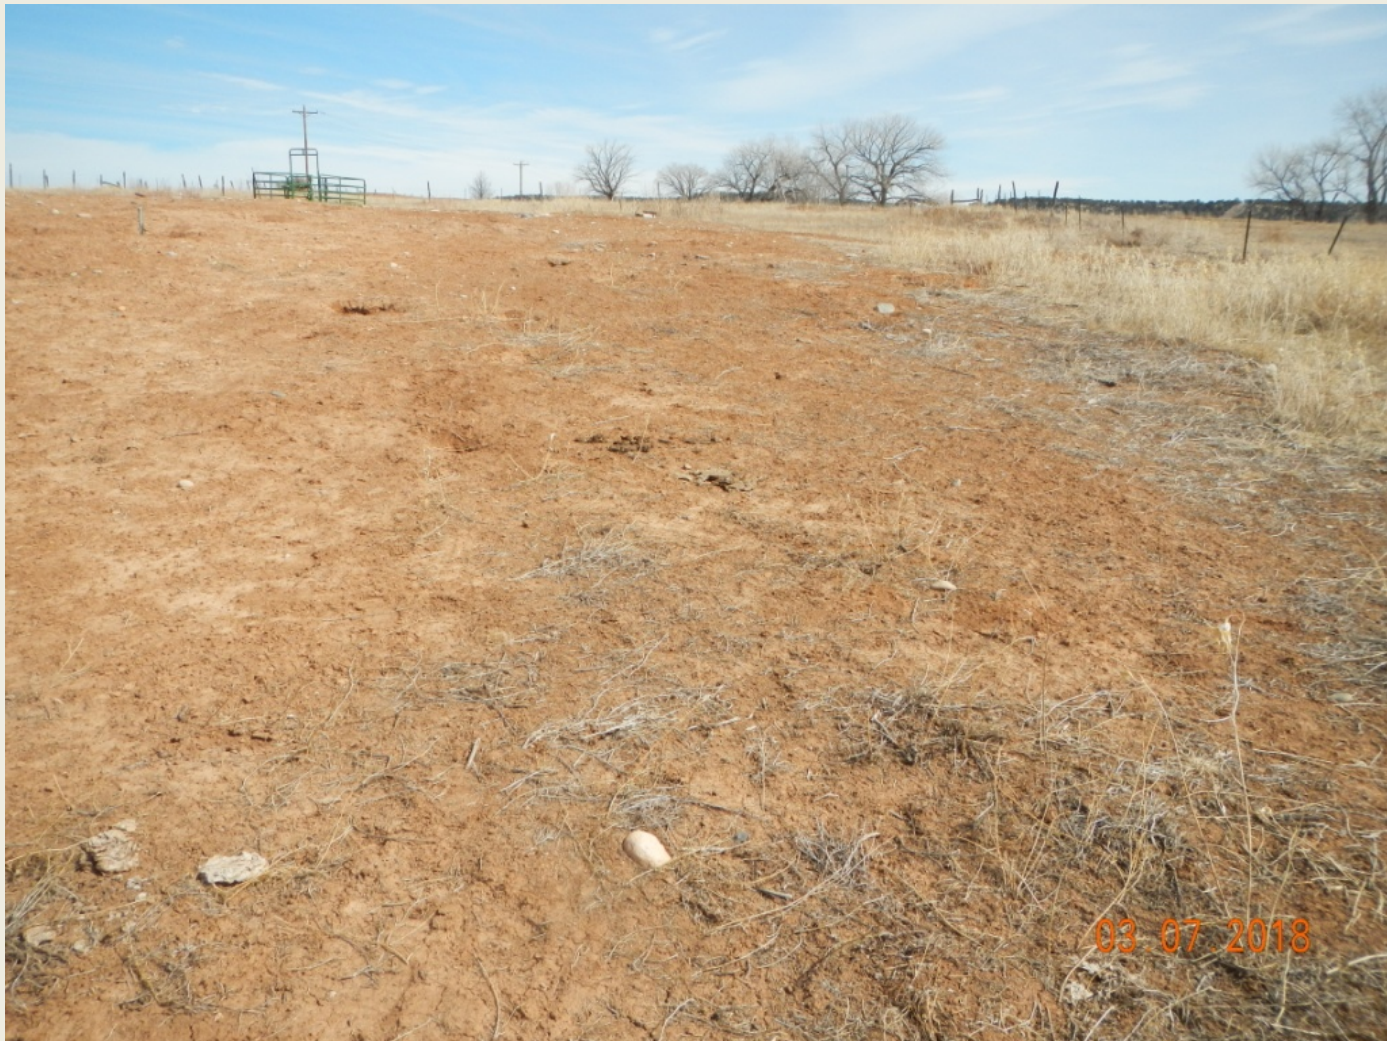
Photo 3. View of the southern portion of the project area from the southwestern corner facing eastward. Little desirable vegetation observed.

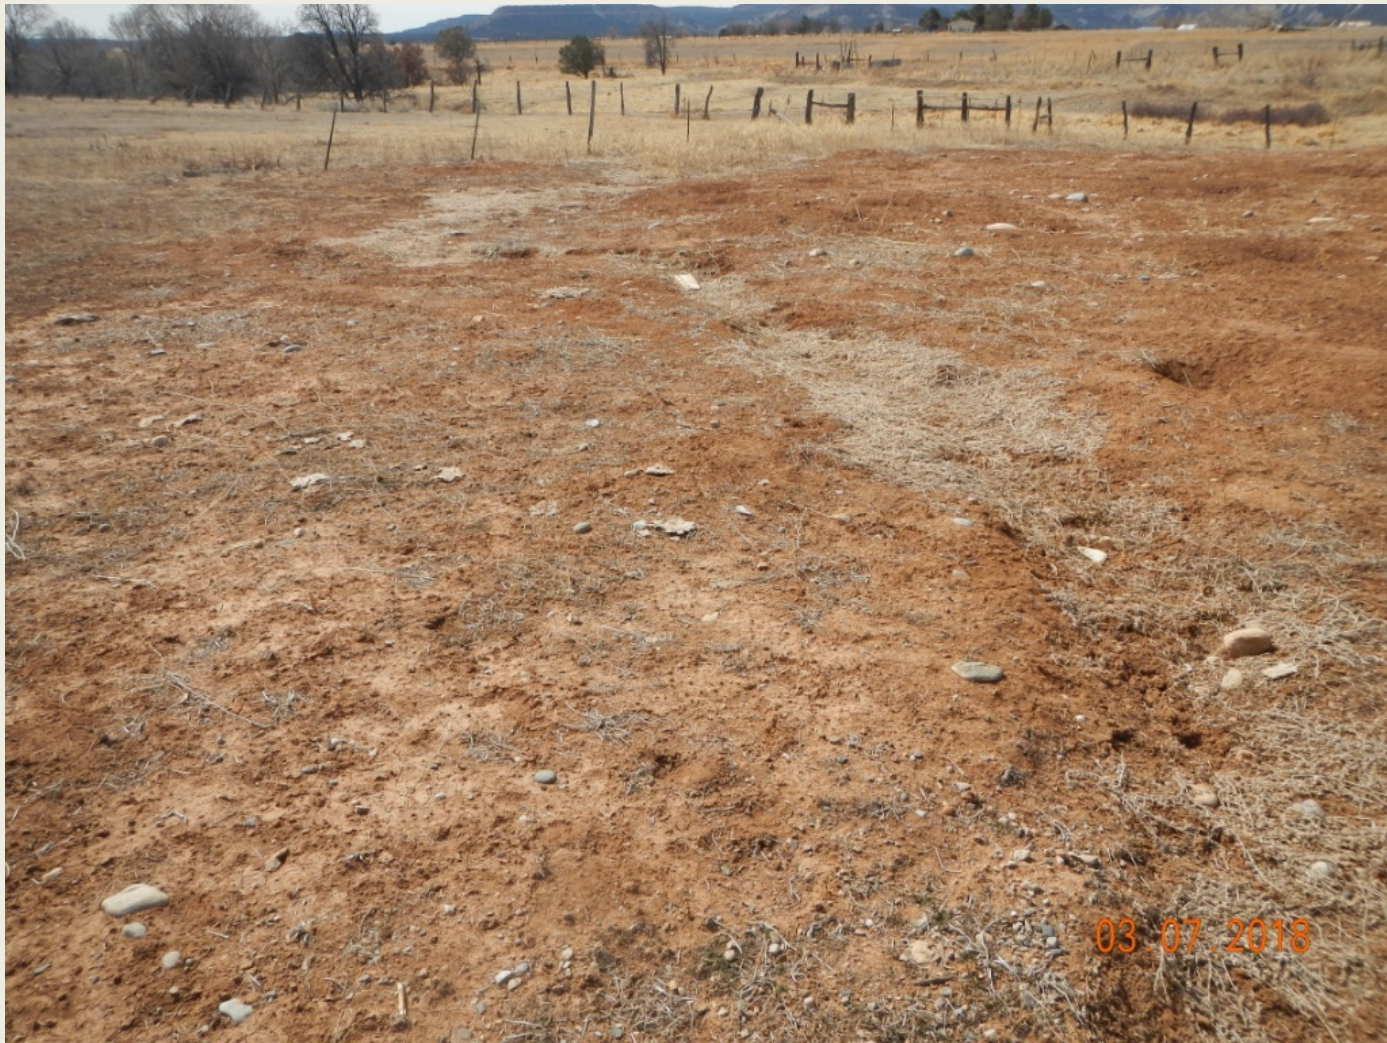
Photo 4. View of drainage area where erosion is occurring in the south-central portion of the project area. Stormwater controls are needed.

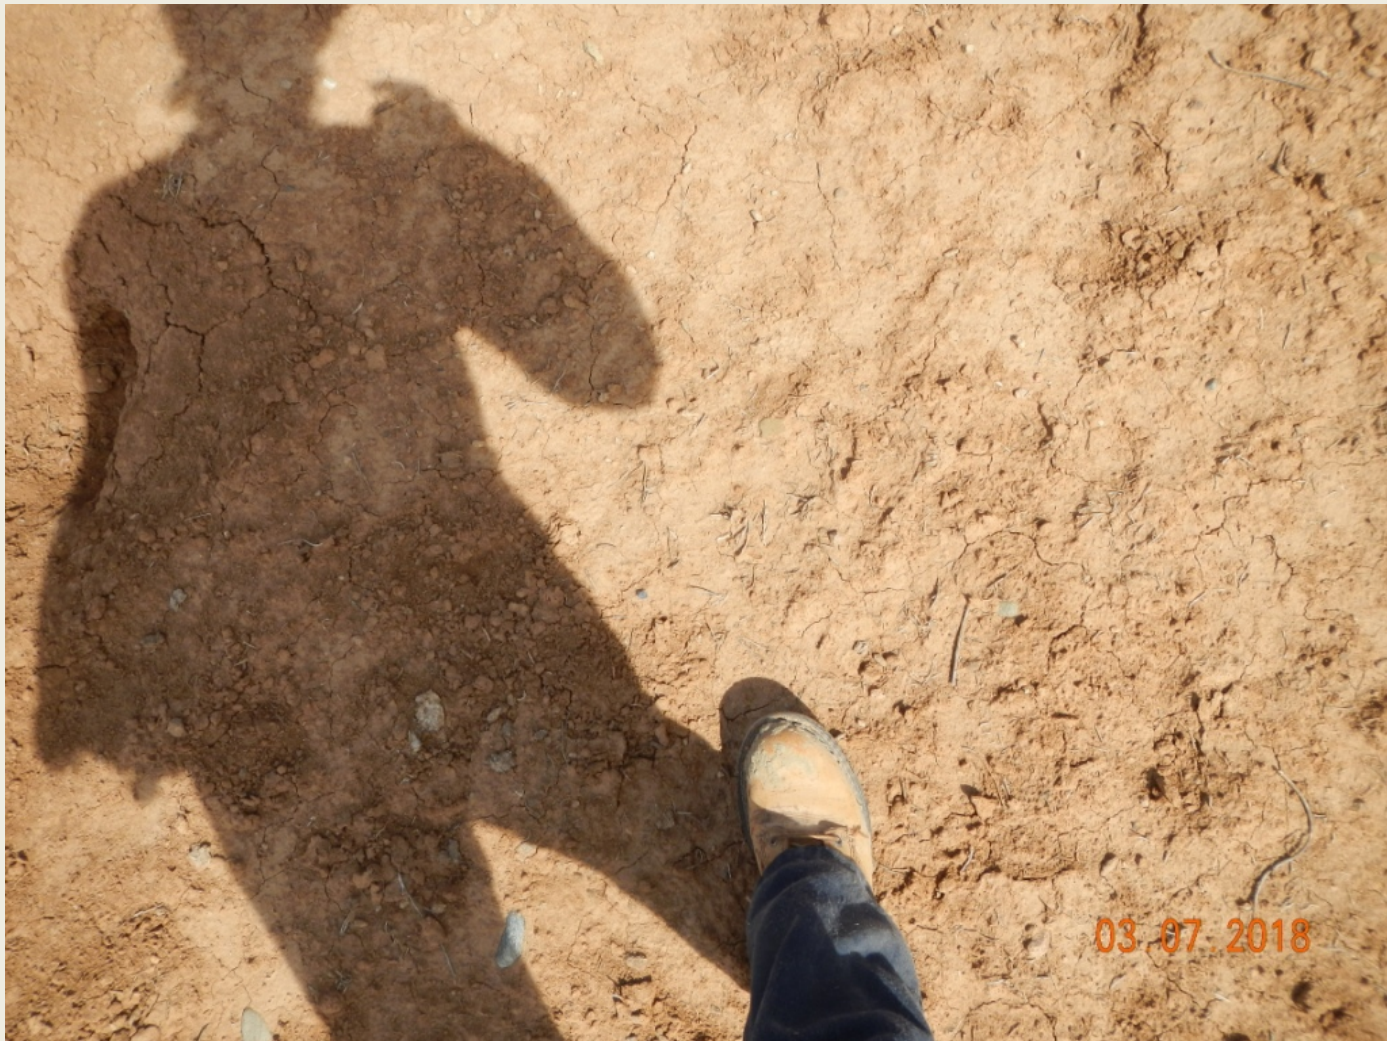
Photo 5. Birdseye view of little to no revegetation within the areas not needed for production operations.

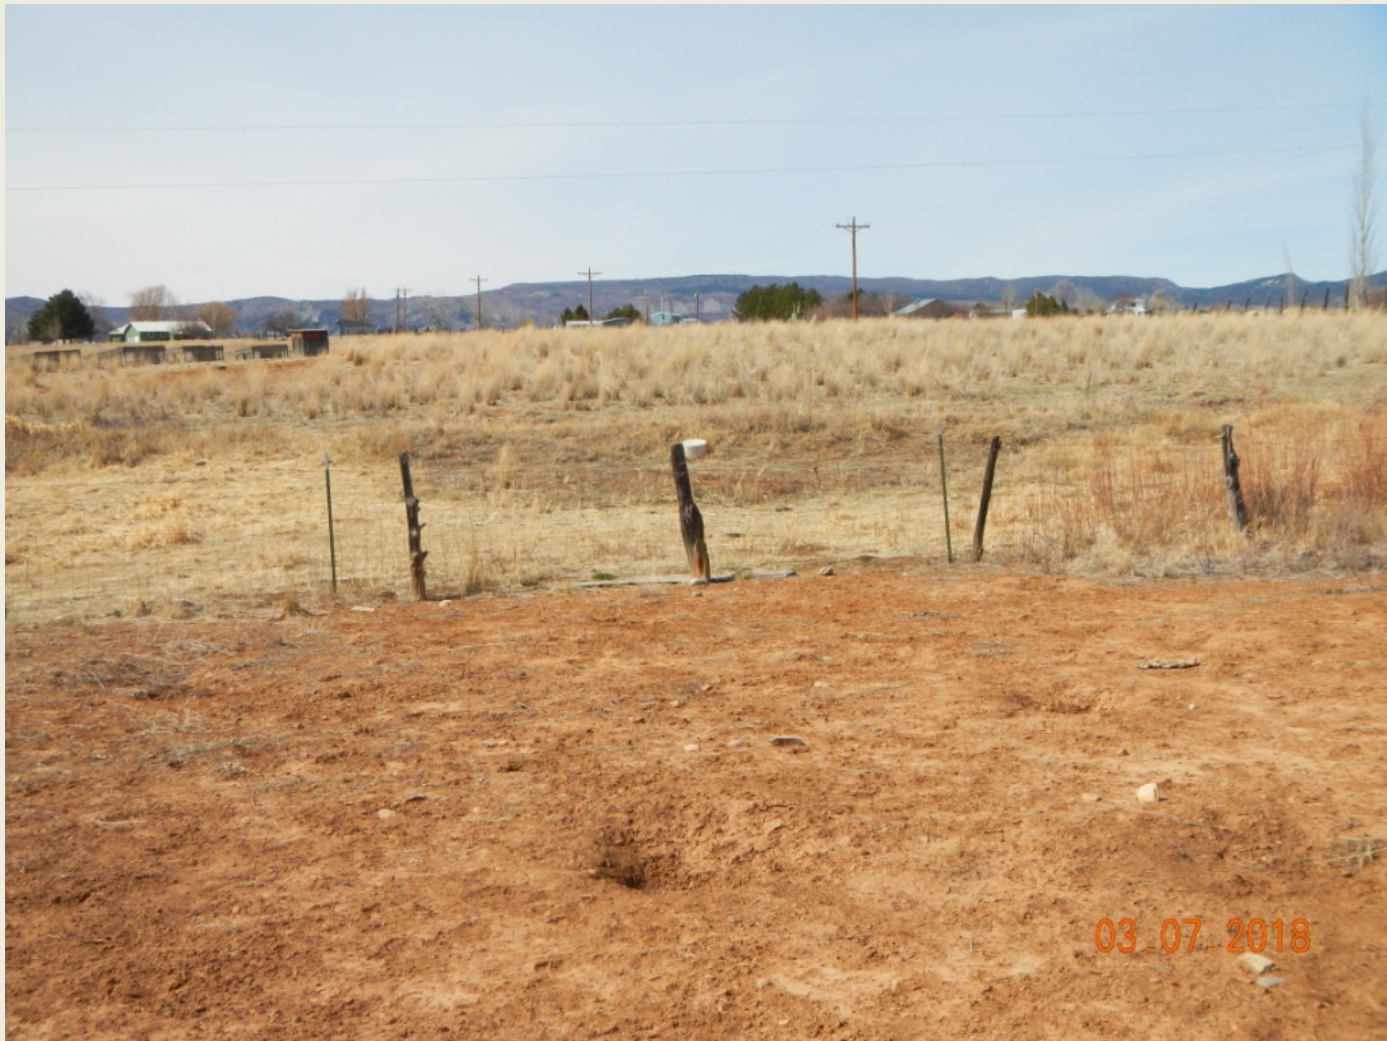
Photo 6. View of project area in the foreground with little to no vegetation, and reference area that is vegetated outside of fenced area.

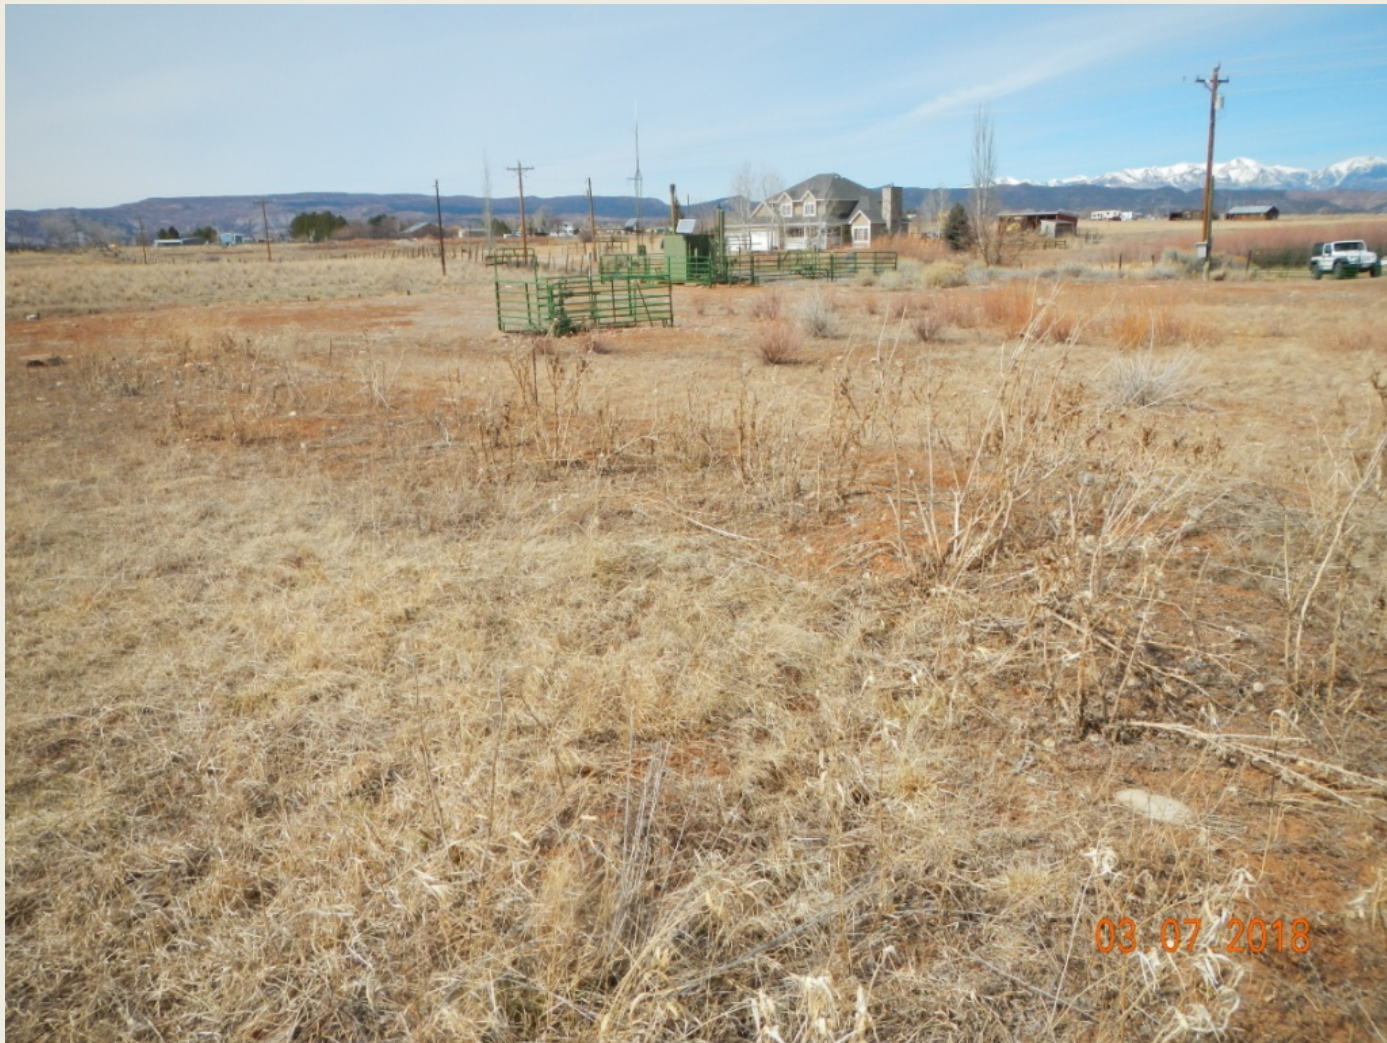
Photo 7. View of approximately 100 musk thistles within the eastern portion of the project area.

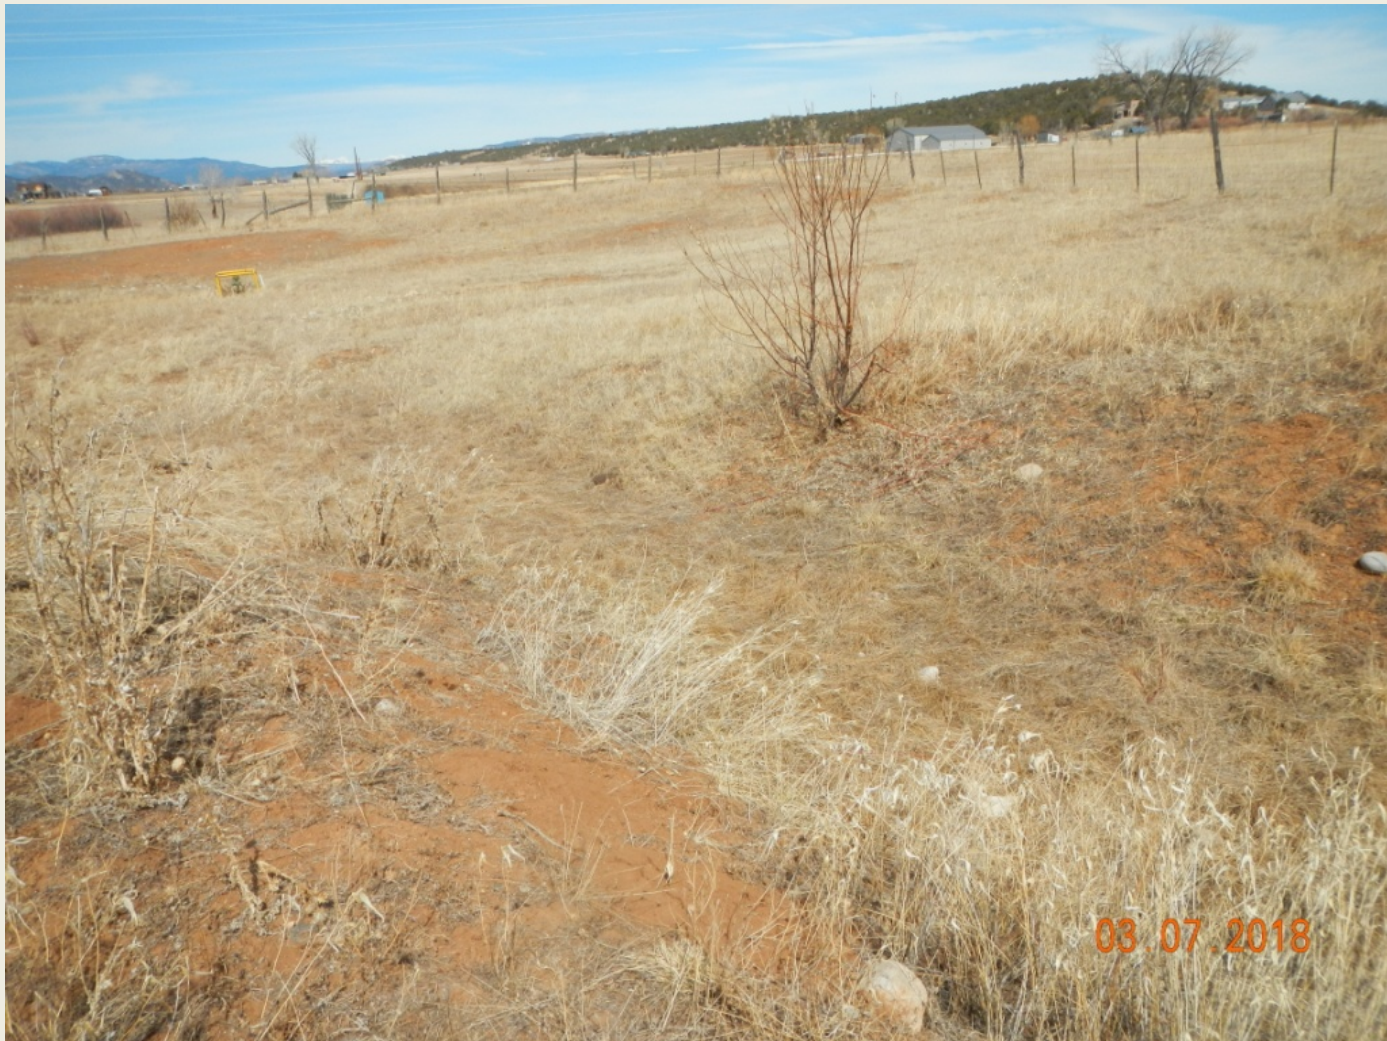
Photo 8. View of the eastern portion of the project area that is largely revegetated with western wheatgrass (*Pascopyrum smithii*).
