Inspection Photos

API: 05-067-05486

Operator: LOGOS OPERATING LLC

Inspection Date: 3/7/2018

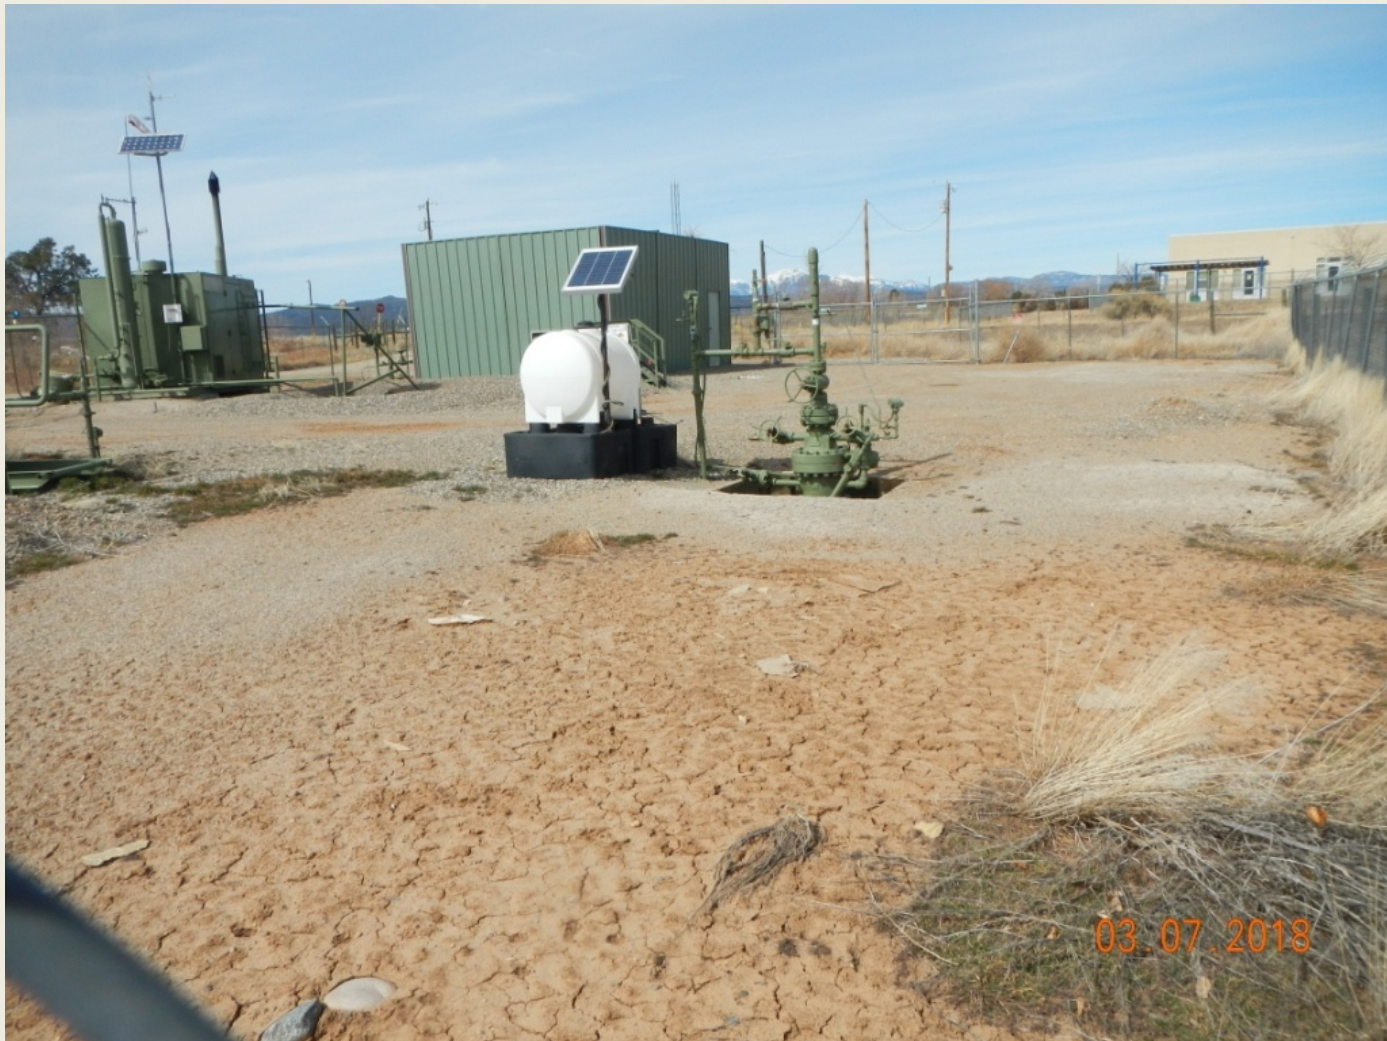
Photo 1. View of the project area from the southeastern corner working area.

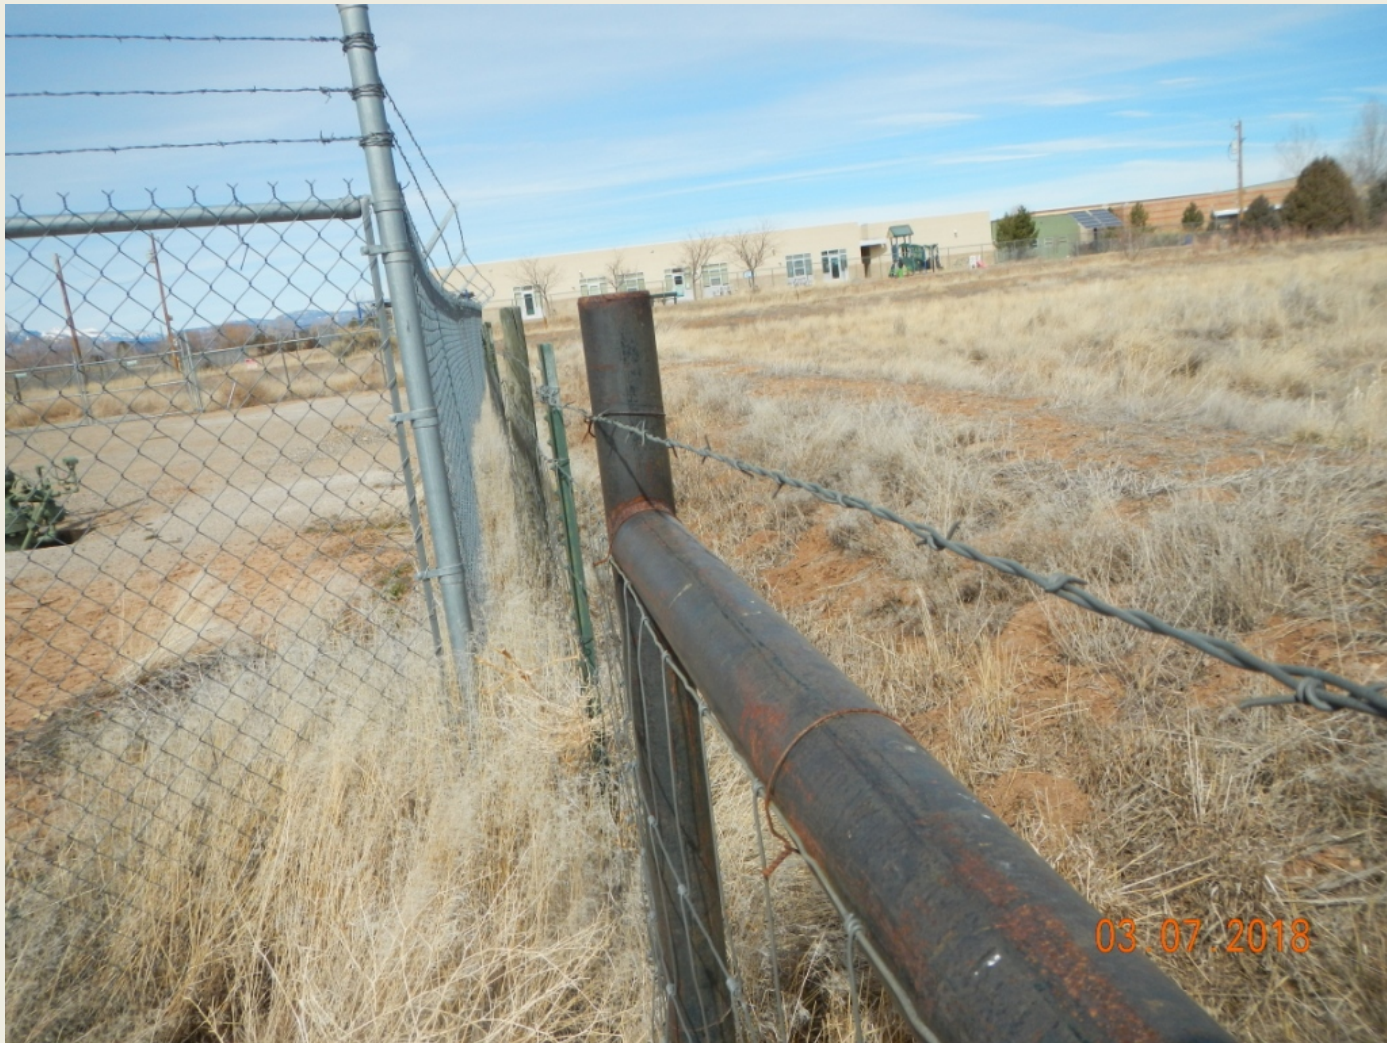
Photo 2. View of the eastern edge of the project area from the southeastern corner facing northward.

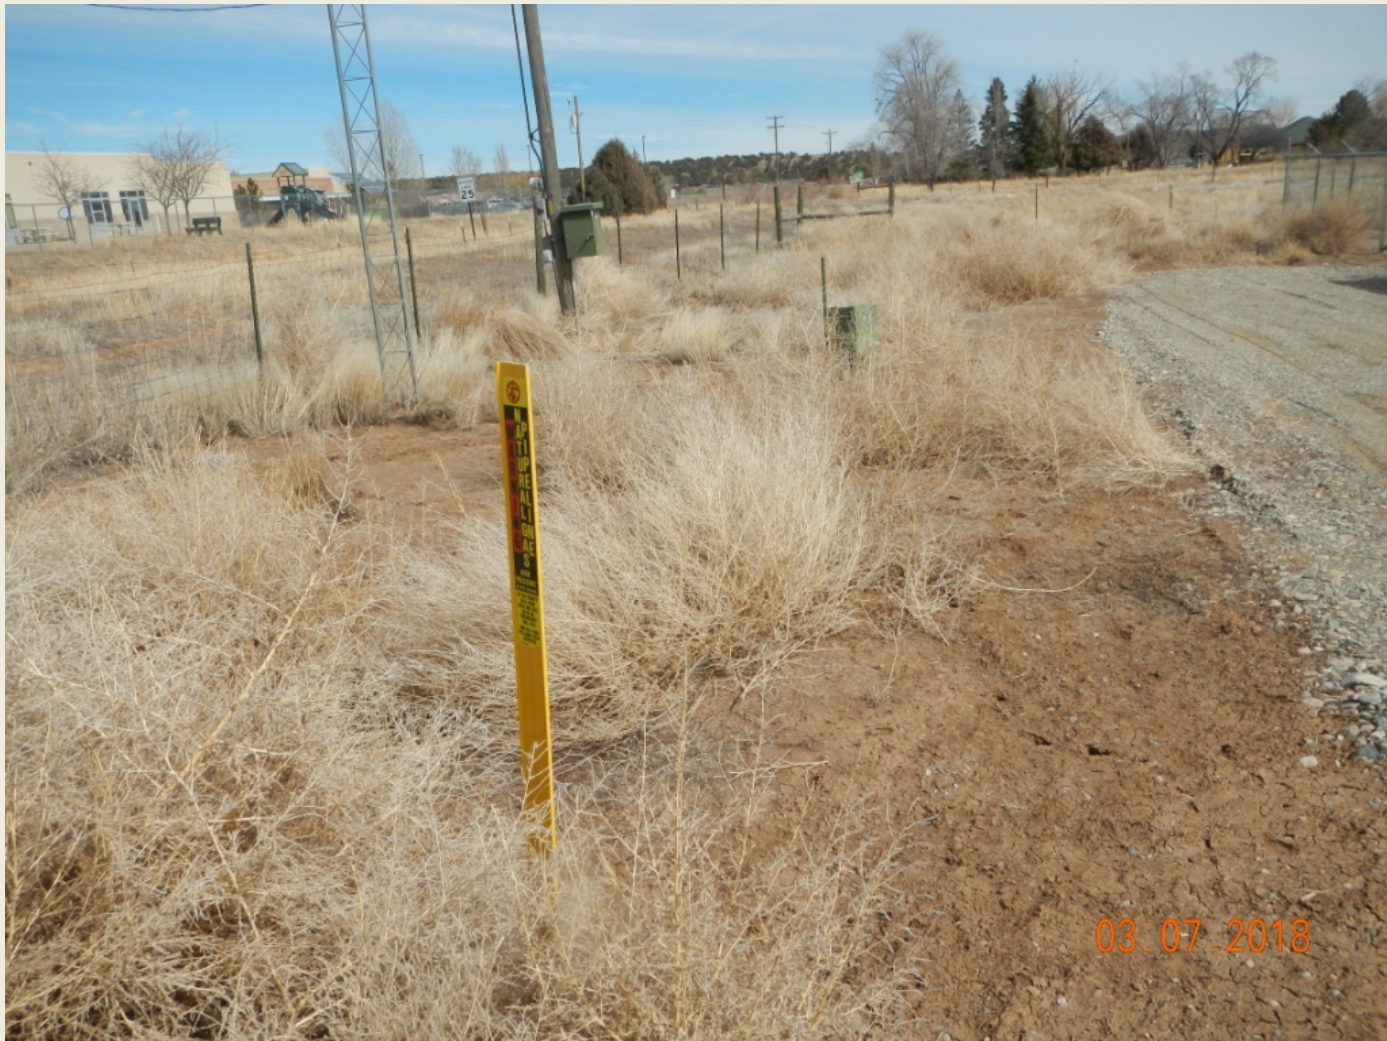
Photo 3. View of the northern portion of the project area from the northwestern corner facing eastward. Large kochia (*Kochia scoparia*) debris present, and needs to be removed.

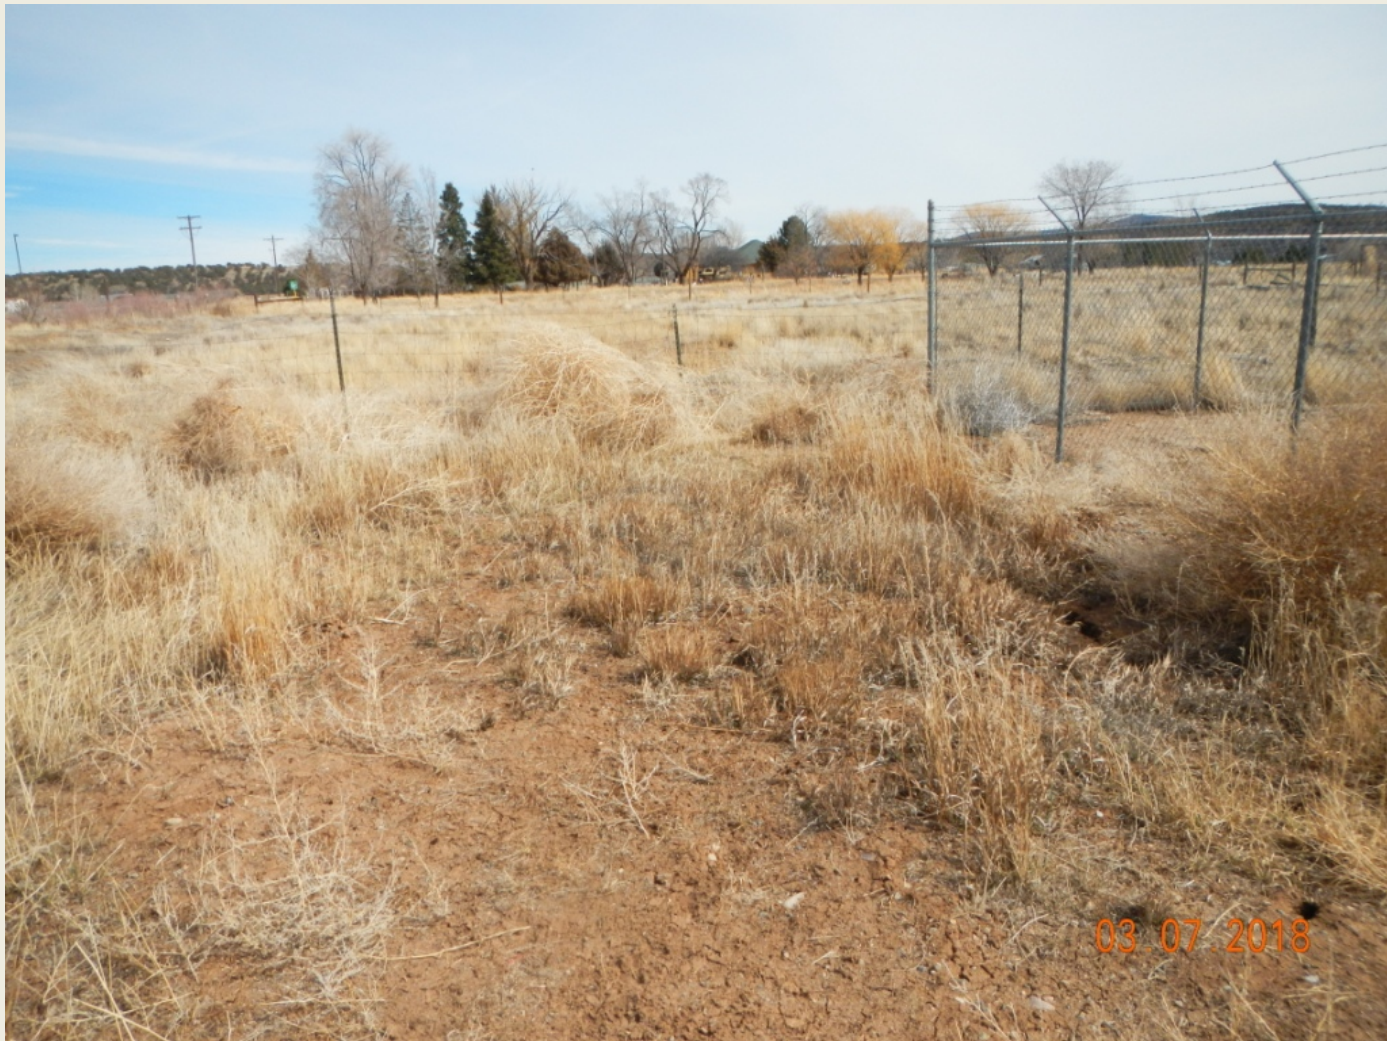
Photo 4. View of kochia debris that is broken off and stuck on northeastern fenceline.
