**Inspection Photos**  
**Location Name: Rudnik #33-27 (Tank Battery)**  
**API: 05-121-08687**  
**Inspection Date: March 22, 2018**

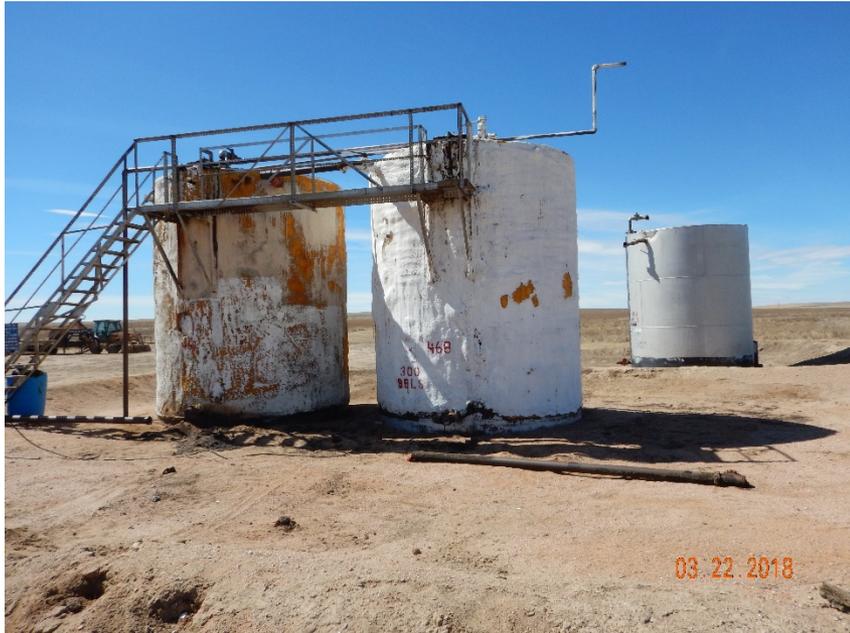
**Photo #1 – Crude oil tank battery, looking west. Note eroded berms, lack of content labels, and damaged/faded NFPA placards.**

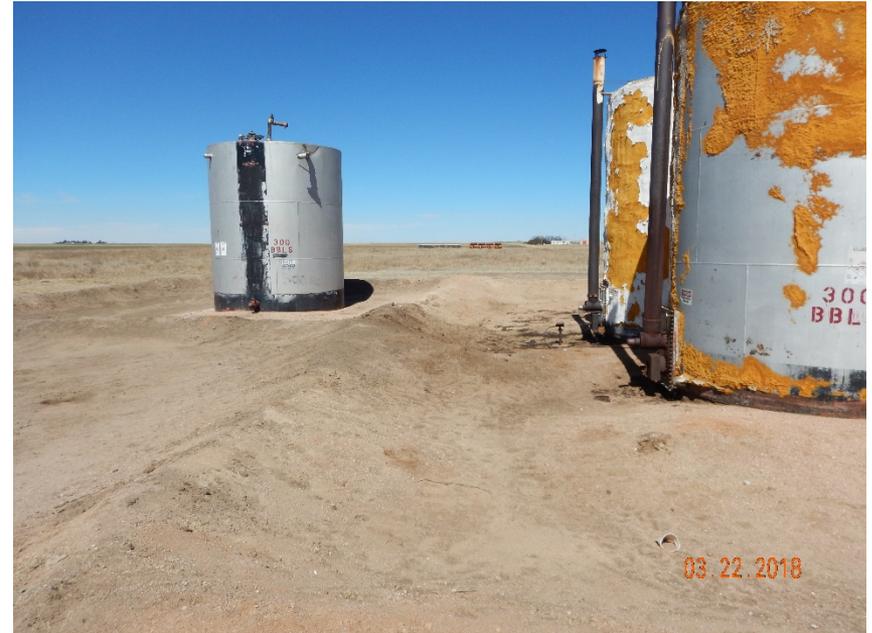
**Photo #2 – Shallow earthen berms and oil-stained soil remaining between 300 bbl crude oil ASTs. Note west steel AST lacks content label and has conflicting NFPA placards (left side).**

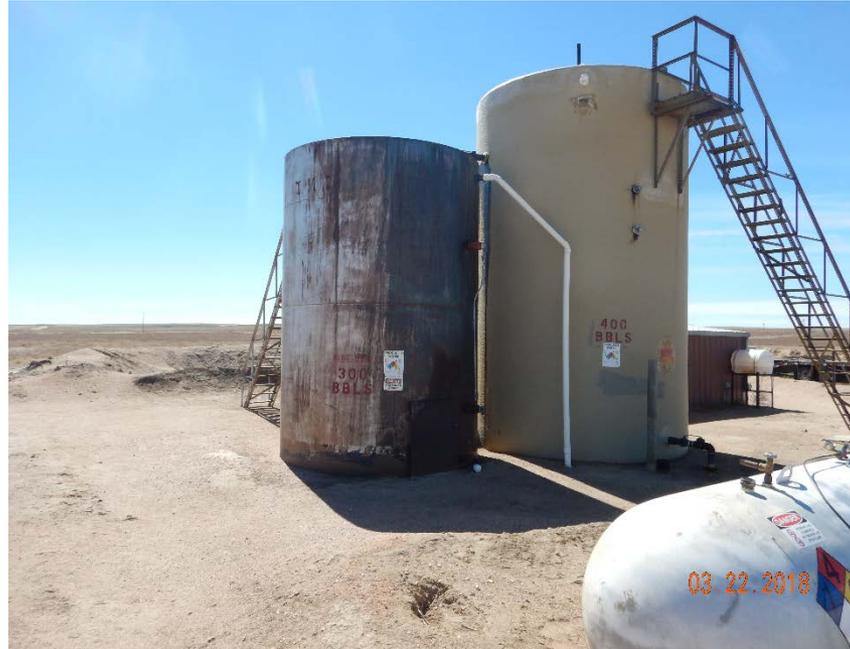
**Photo #3 – Produced water steel ASTs. Note shallow earthen berms.**
