Inspection Photos

Location Name: Pierce Unit #2 API: 05-123-07596

Inspection Date: 3/30/2018

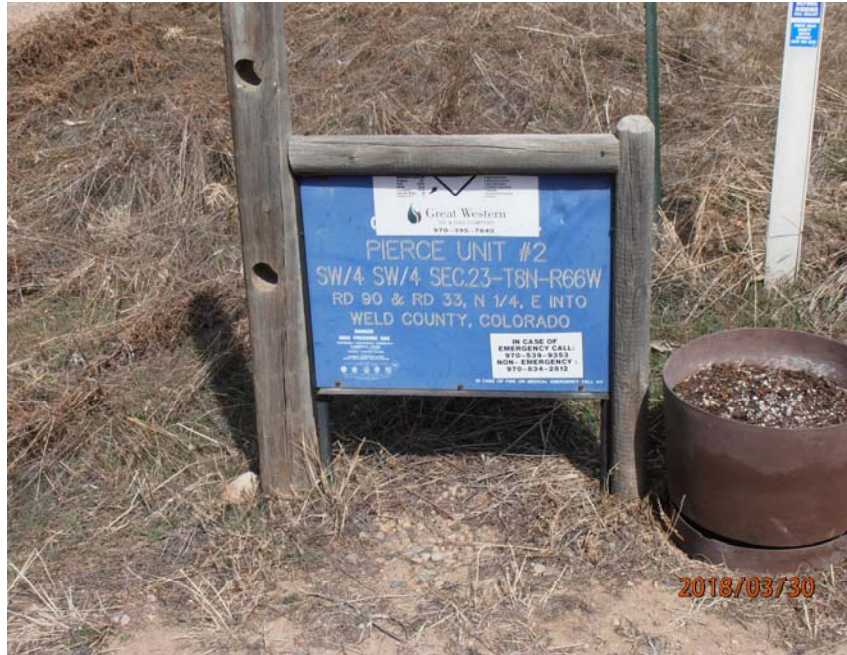
Photo 1 – Well sign at County Road

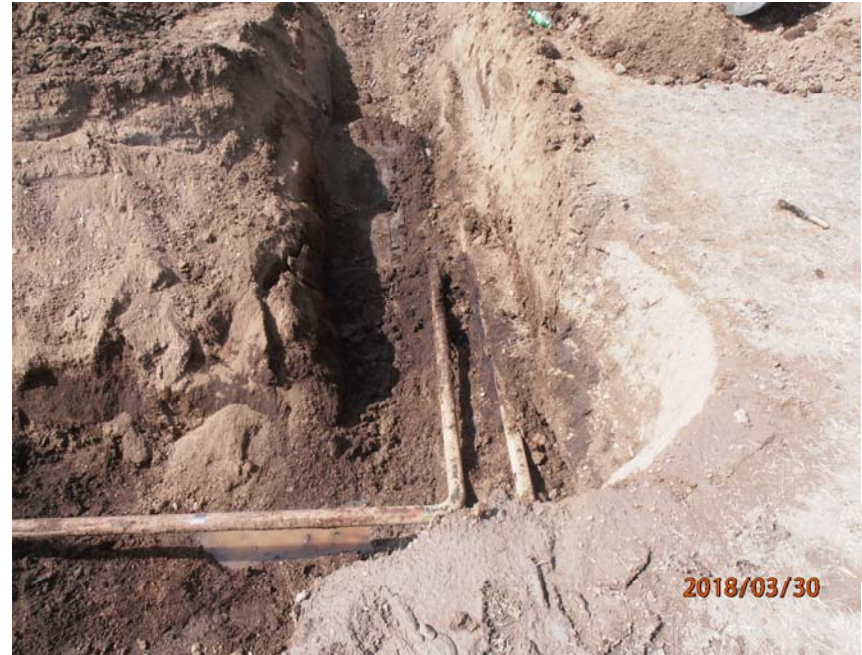
Photo 2 – Excavation at release area, looking west. Pipeline on right is apparently abandoned line from the plugged Priddy #1

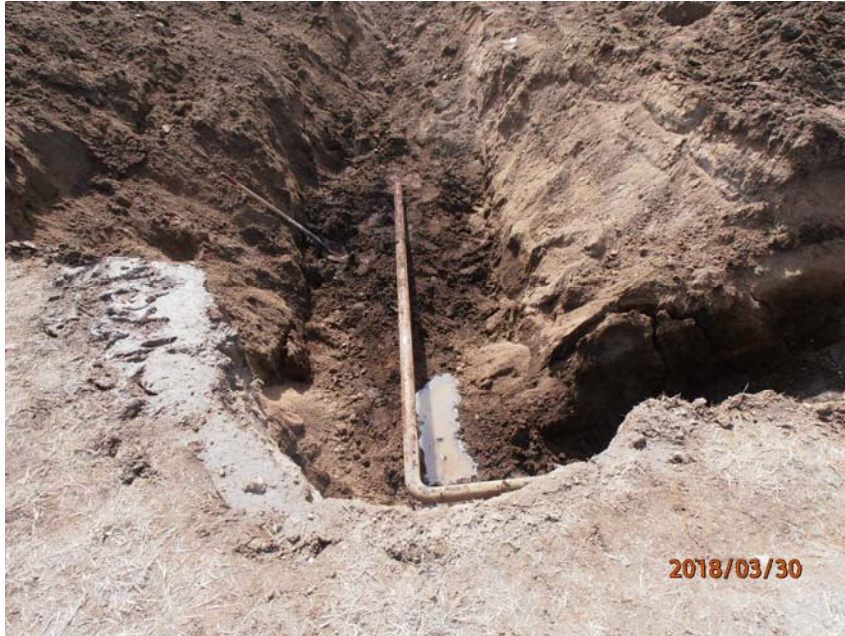
Photo 3 – Excavation at release looking south. Release was apparent at/near elbow in flowline.

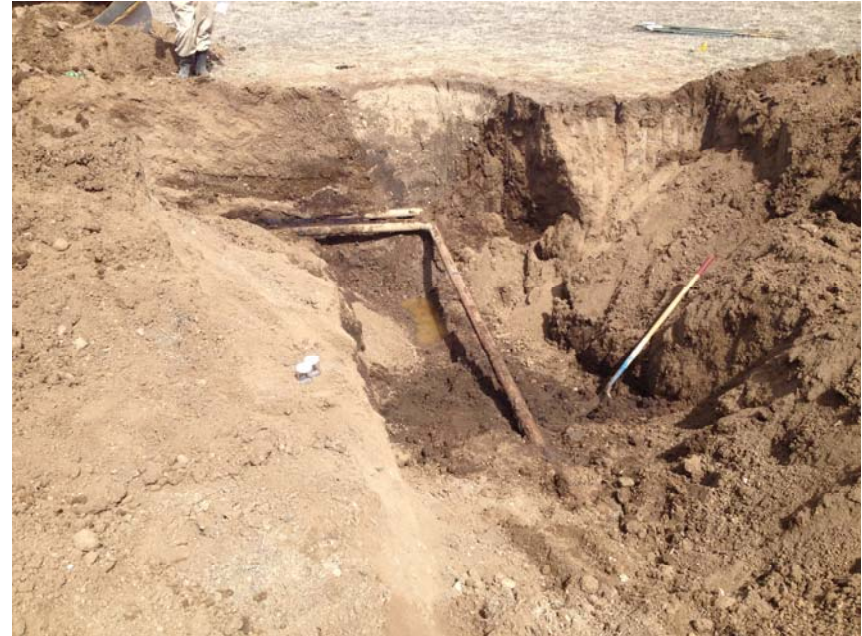
Photo 4 – Excavation at release looking north.

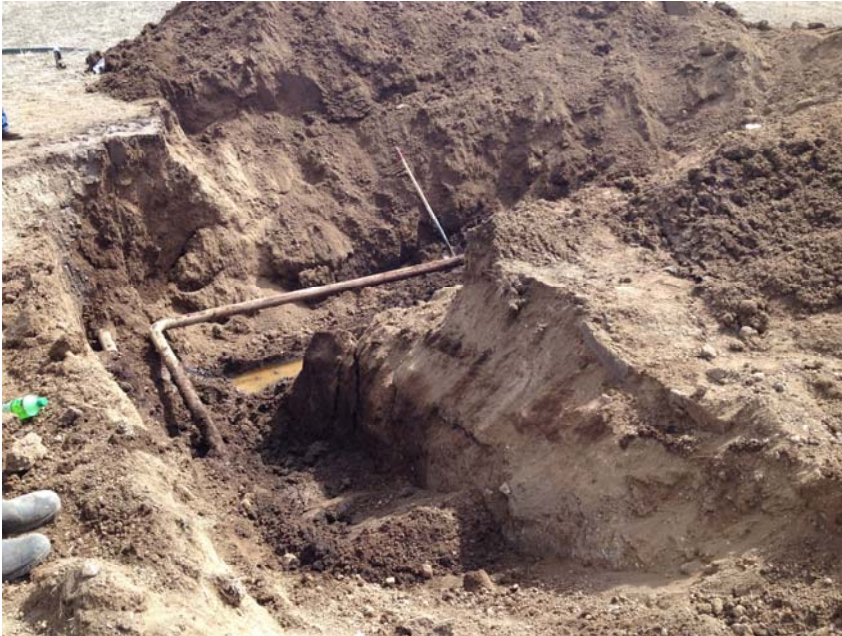
Photo 5 – Excavation at release looking approximately east-southeast. Impacted material remains in excavation.

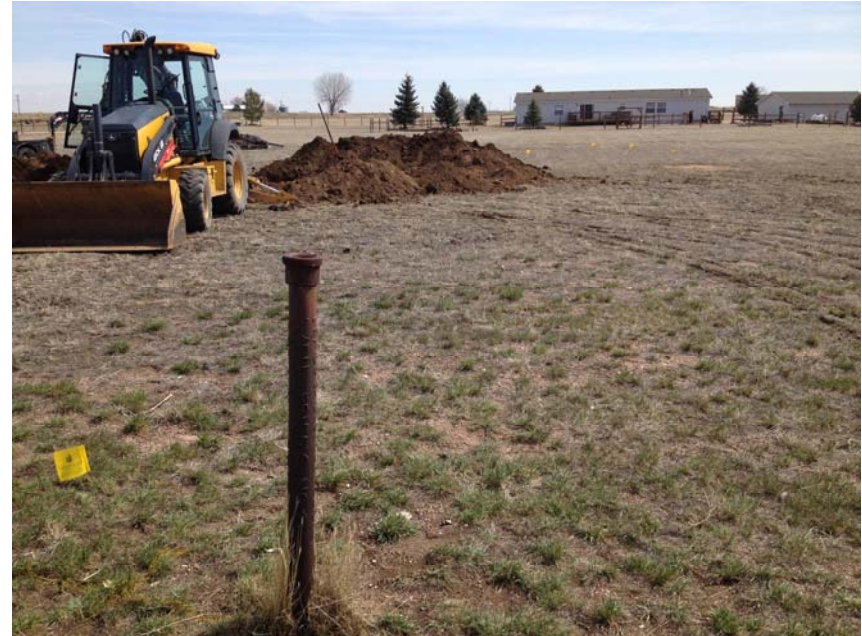
Photo 6 – Photo of the plugged Priddy #1 marker looking east toward excavation on flowline for Pierce Unit #2.
