Inspection Photos

Loc# 433573

Operator: Caerus

Inspection Number: 680102819

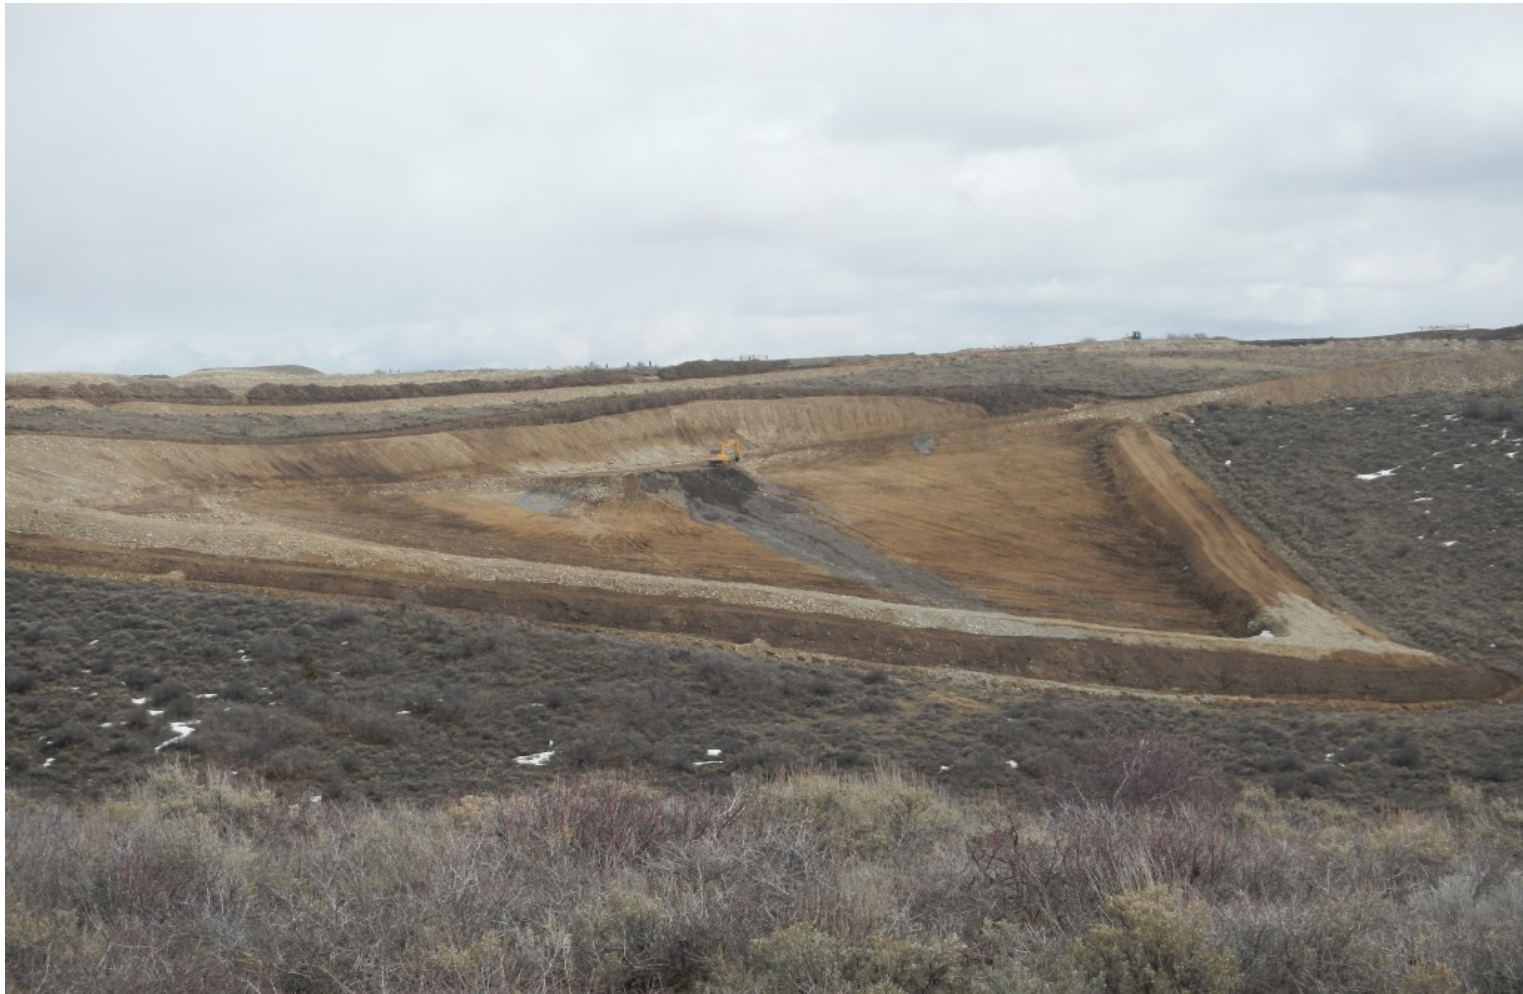
Photo#1:
Overview of Location from main road to Southeast.

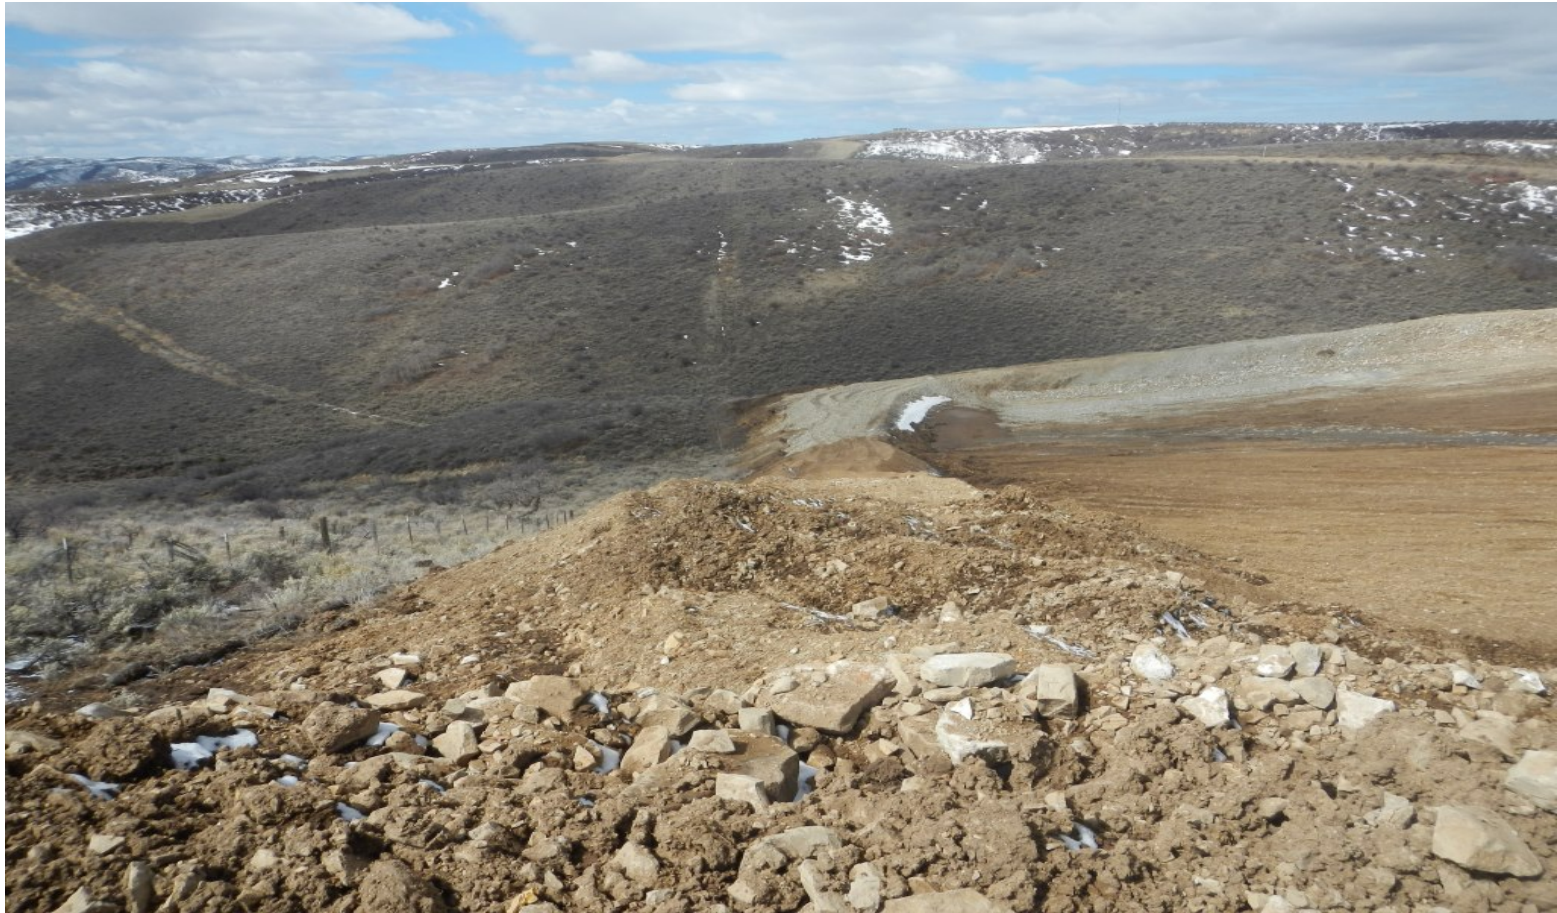
Photo#2:
Looking West along South Location Berm.

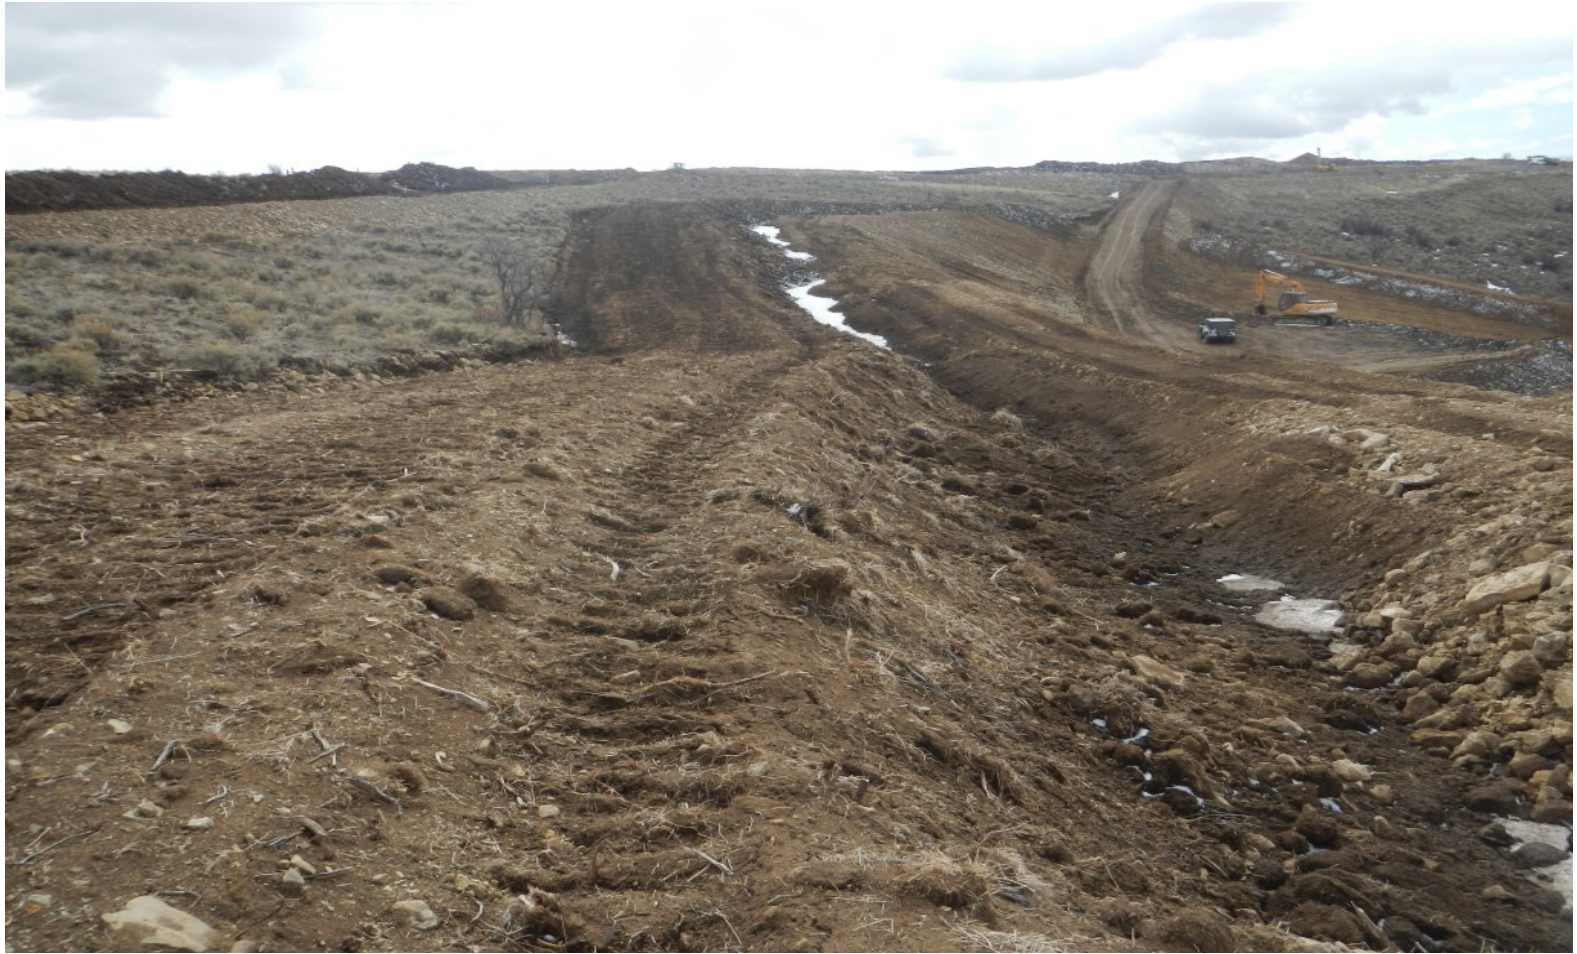
Photo#3:

Looking South along Location East Perimeter Berm.

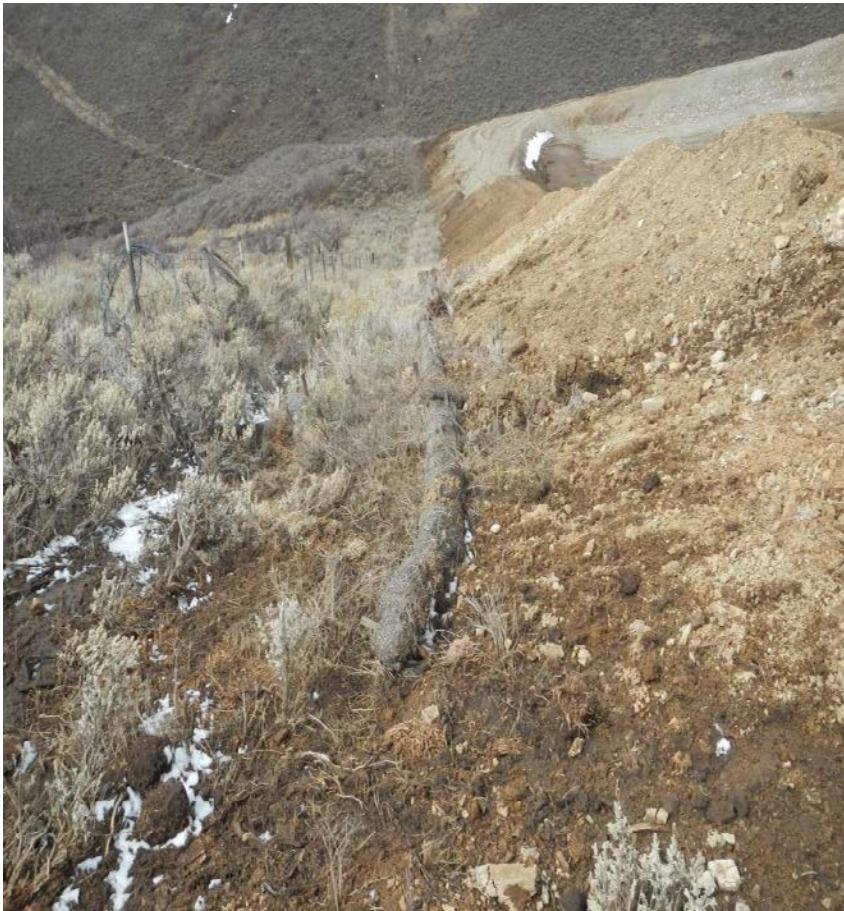
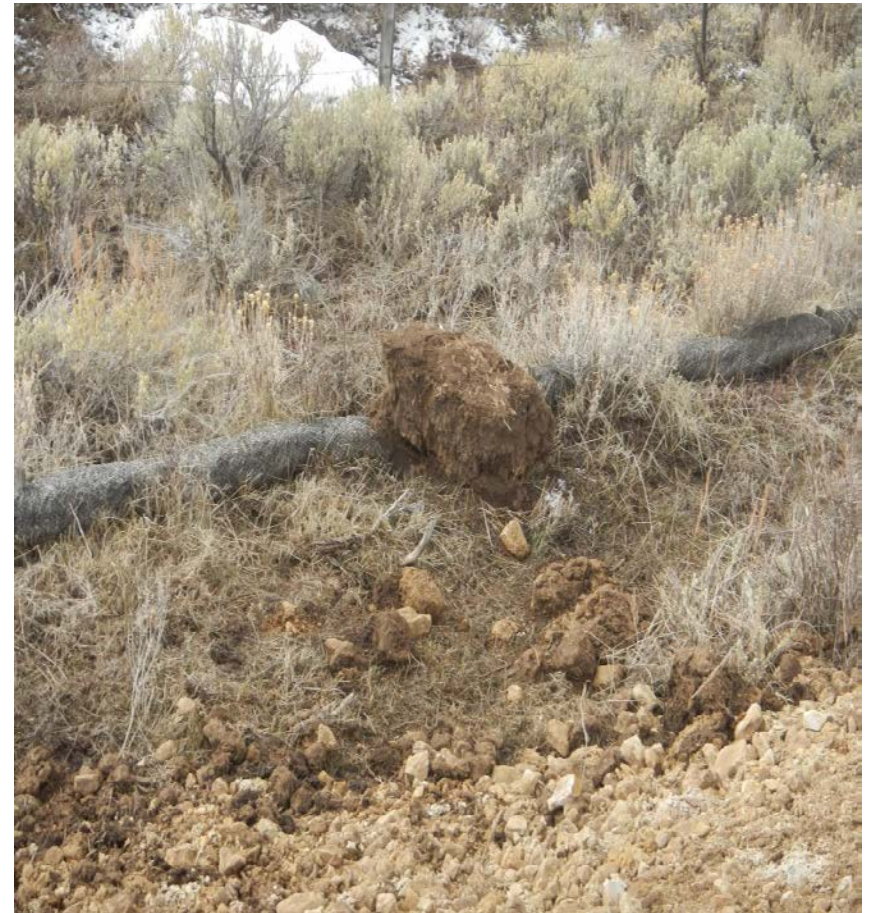
Wattles should be monitored as it appears they may have been installed at previous start date of Construction Notice in 2013.

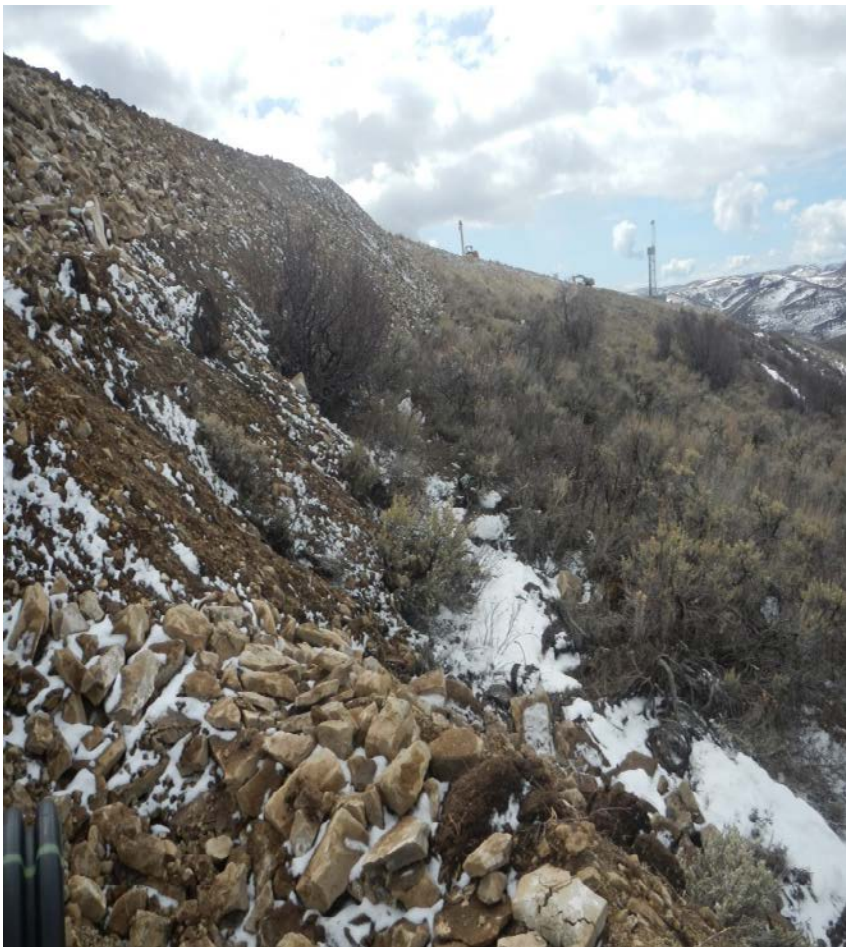
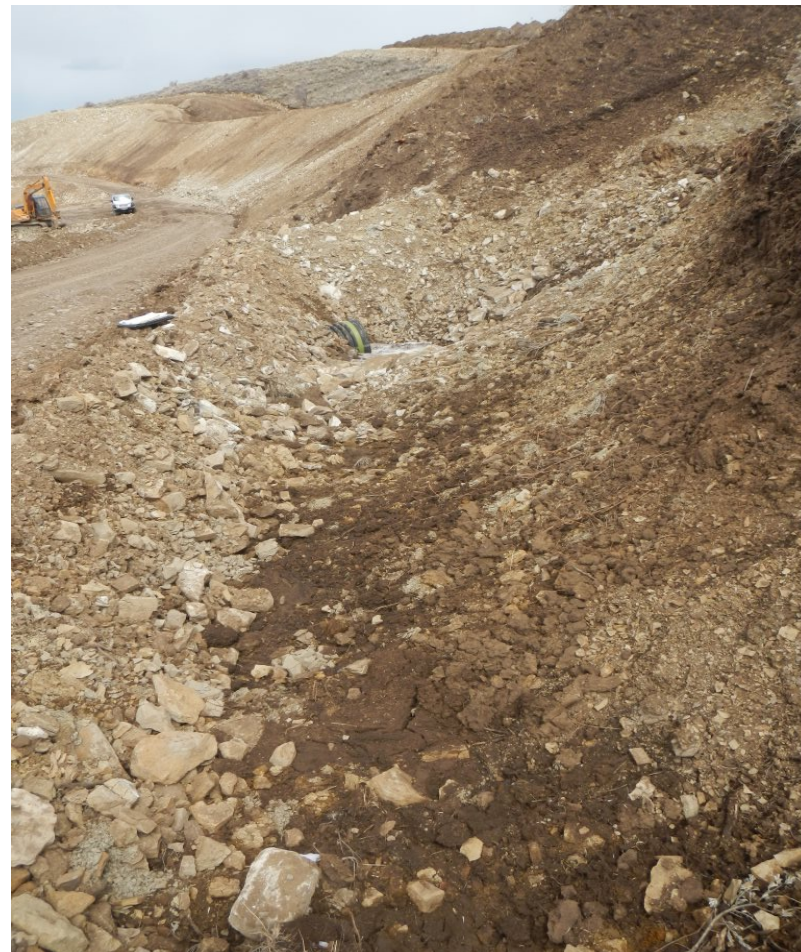
There is a Lack of BMPs on Access road Cut & Fill Slope sides & ditches.

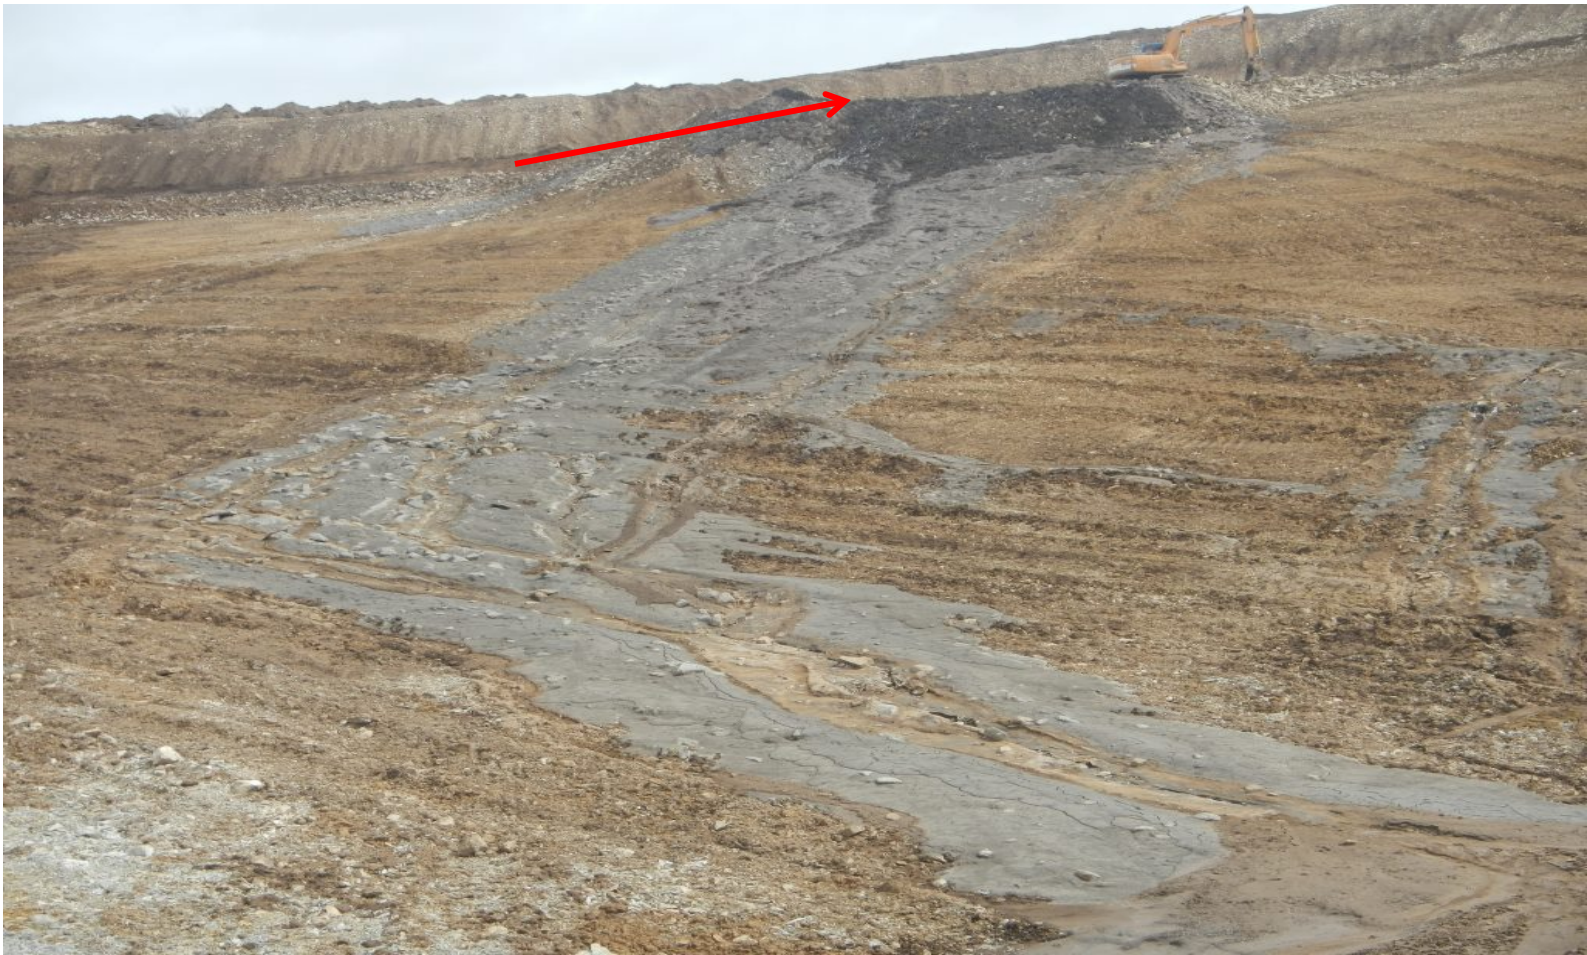
Photo#7:

Sediment & materials migration was noted from top of pad (flat staging/dump Point indicated by arrow) to Southwest corner of Pad.

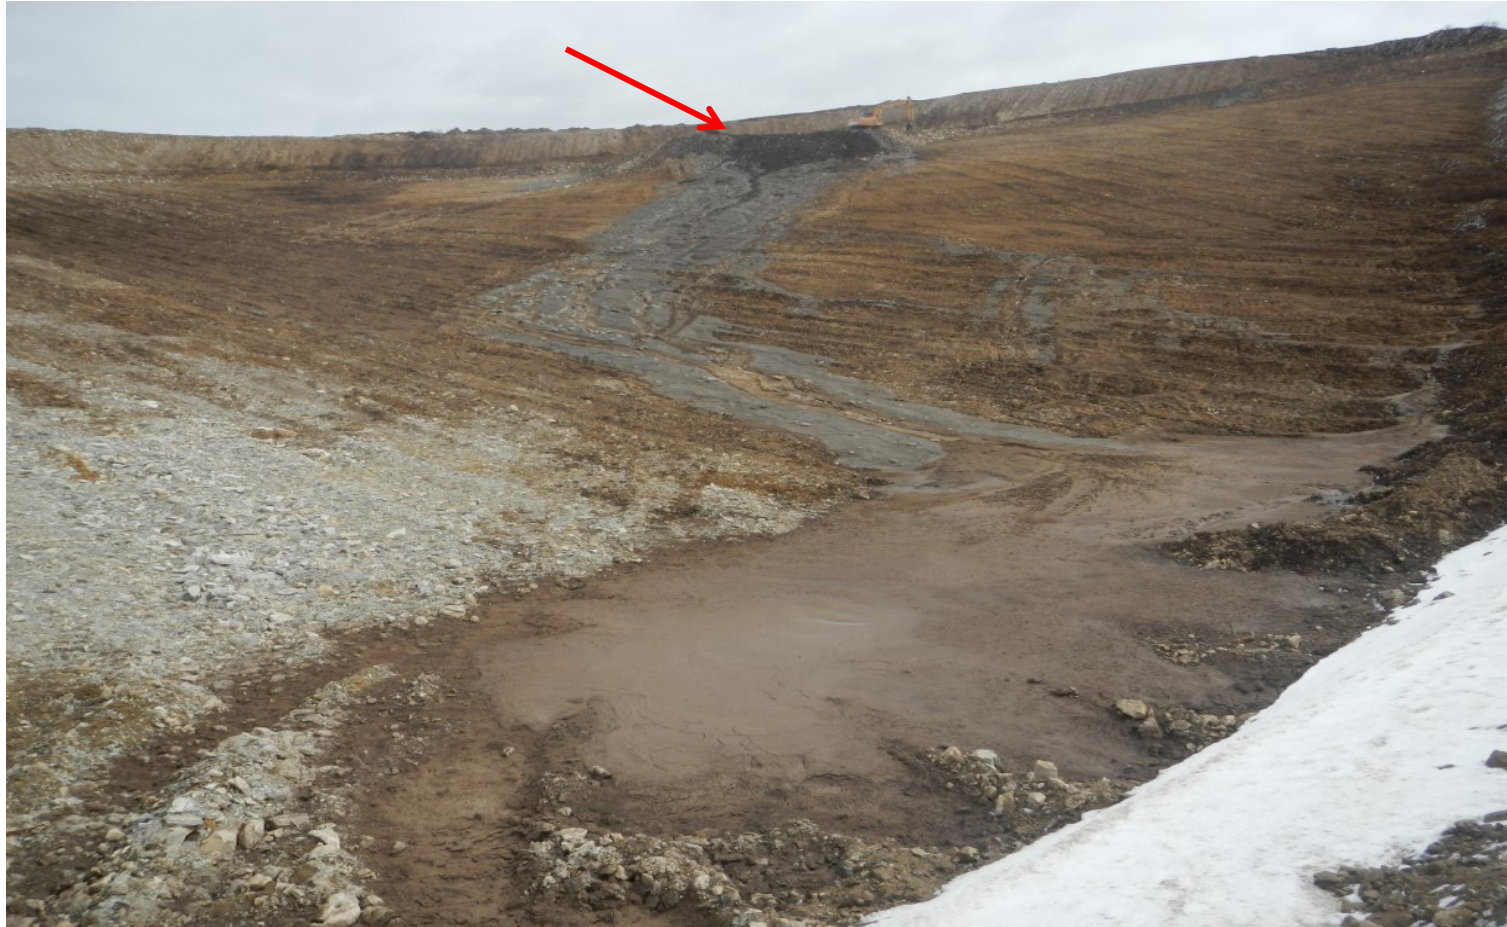
Photo#8:

Sediment & materials migration was noted from top of pad (flat staging/dump Point, indicated by arrow) to Southwest corner of Pad.
