Inspection Photos

API: 05-067-07732

Operator: ENDURING RESOURCES LLC

Inspection Date: 3/21/2018

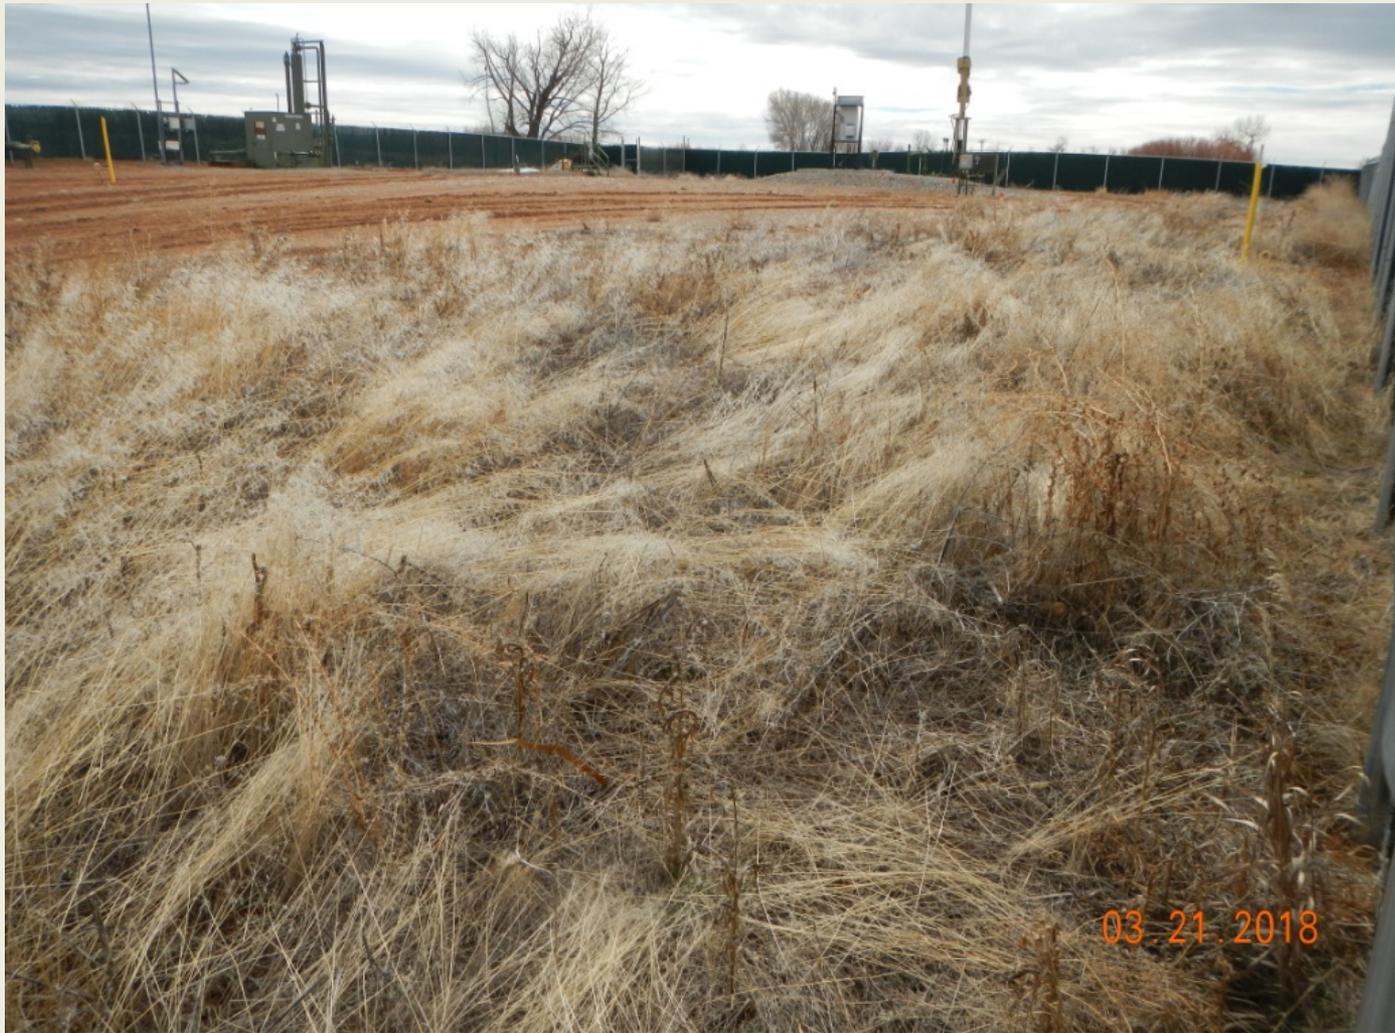
Photo 1. View of the project area from the northwestern corner facing center. Vegetation within the fenced in working area is largely comprised of cheatgrass (*Bromus tectorum*) and prickly lettuce (*Lactuca serriola*).

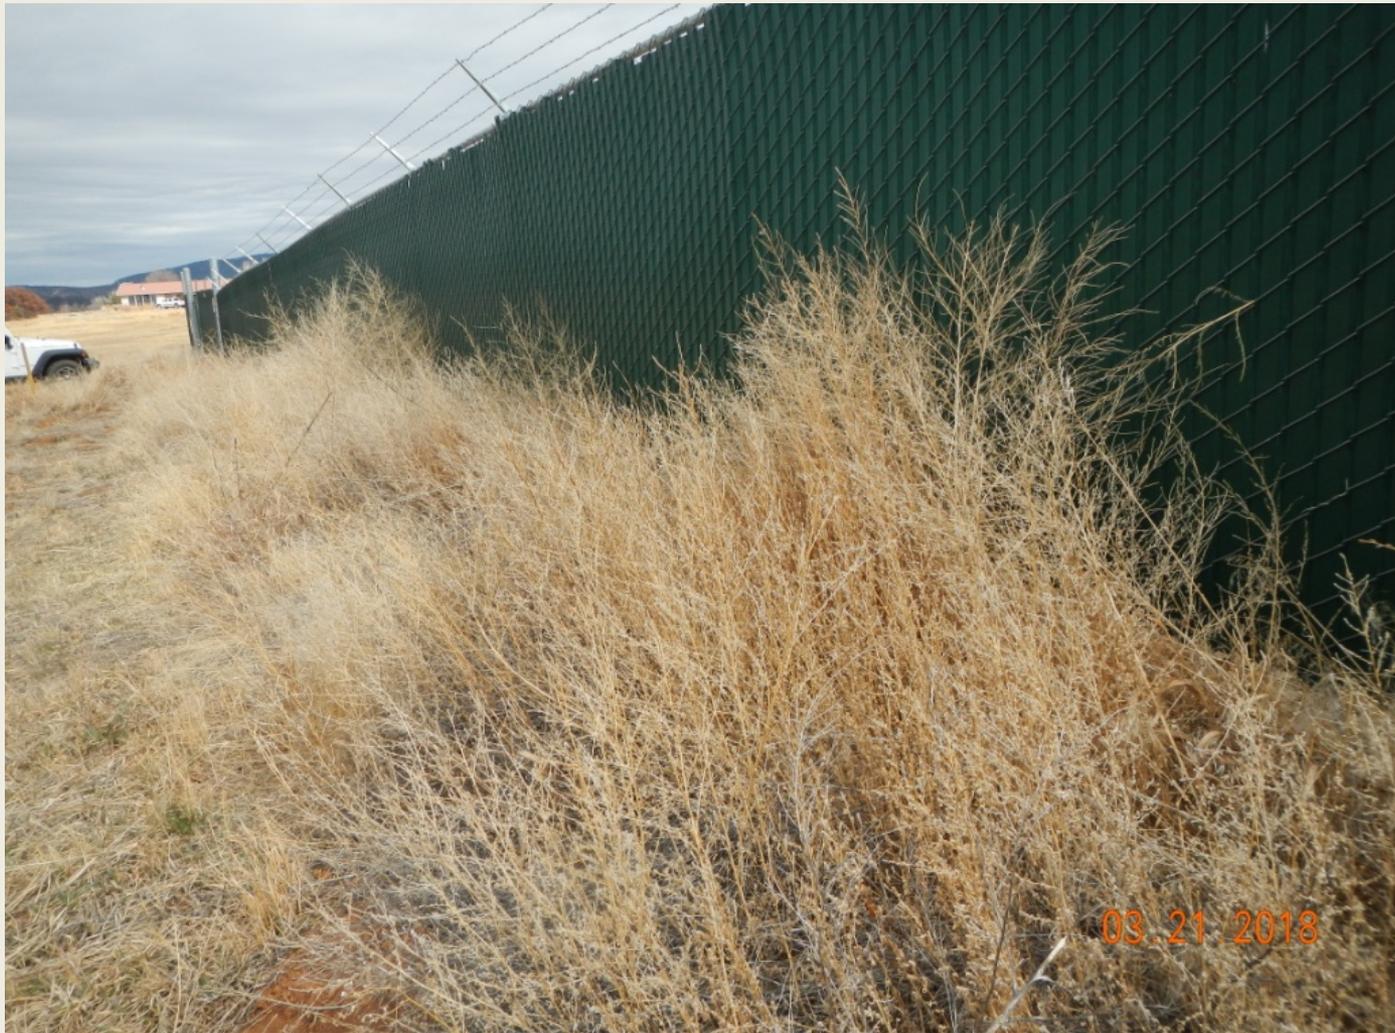
Photo 2. View of kochia (*Kochia scoparia*) debris along the western edge of the project area, outside of the fenced working area.

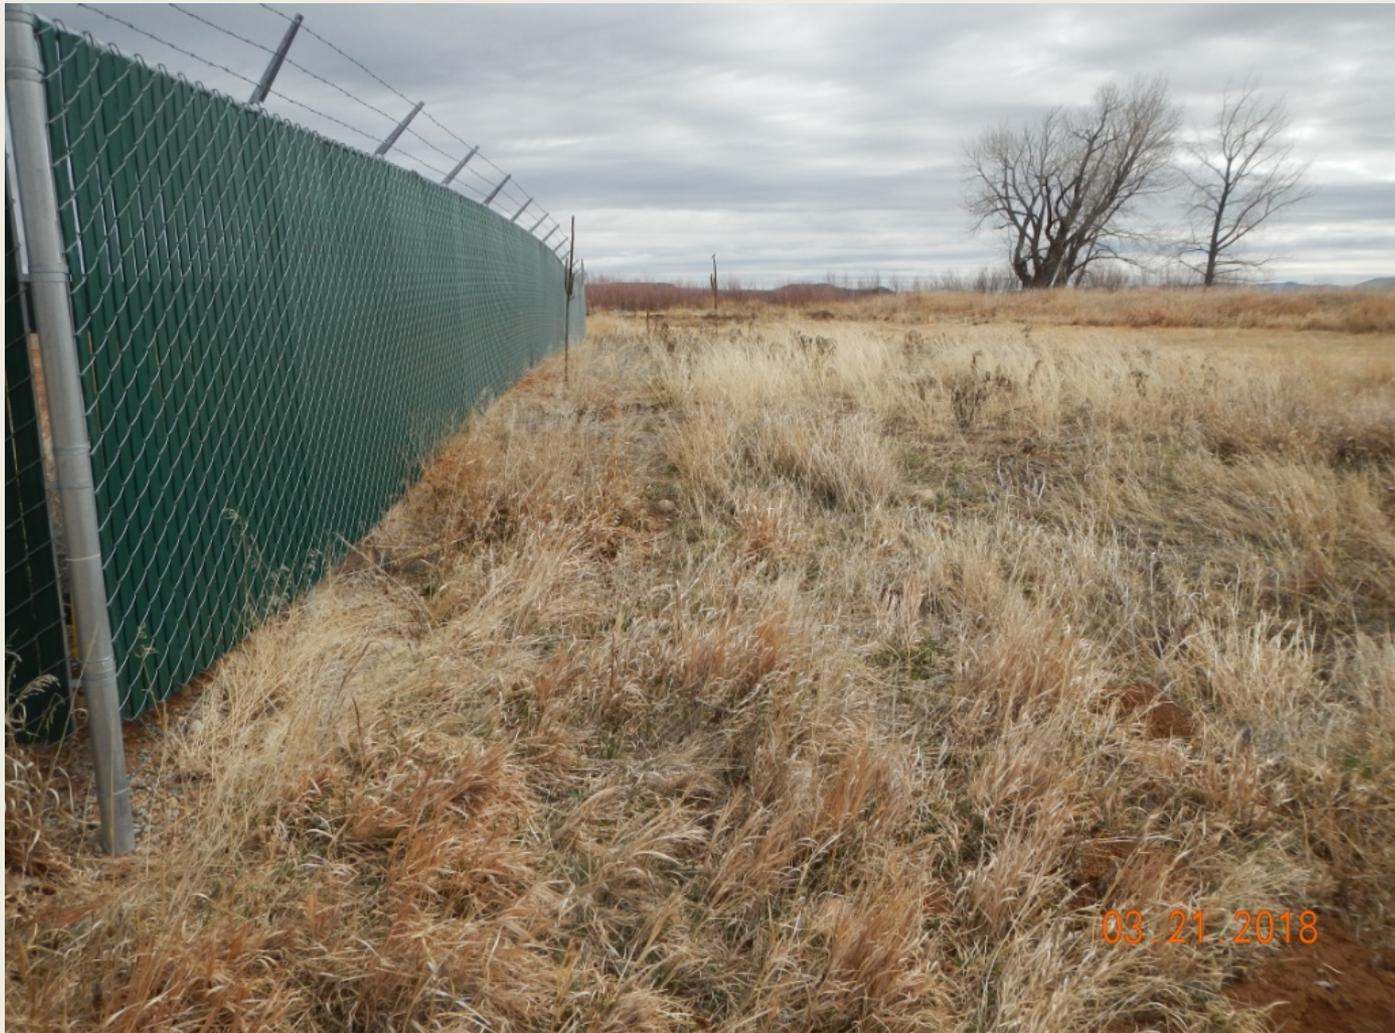
Photo 3. View of the southern portion of the project area from the southwestern corner facing eastward. Revegetation is progressing with grasses such as smooth brome (*Bromus inermis*) and intermediate wheatgrass (*Thinopyron intermedium*).

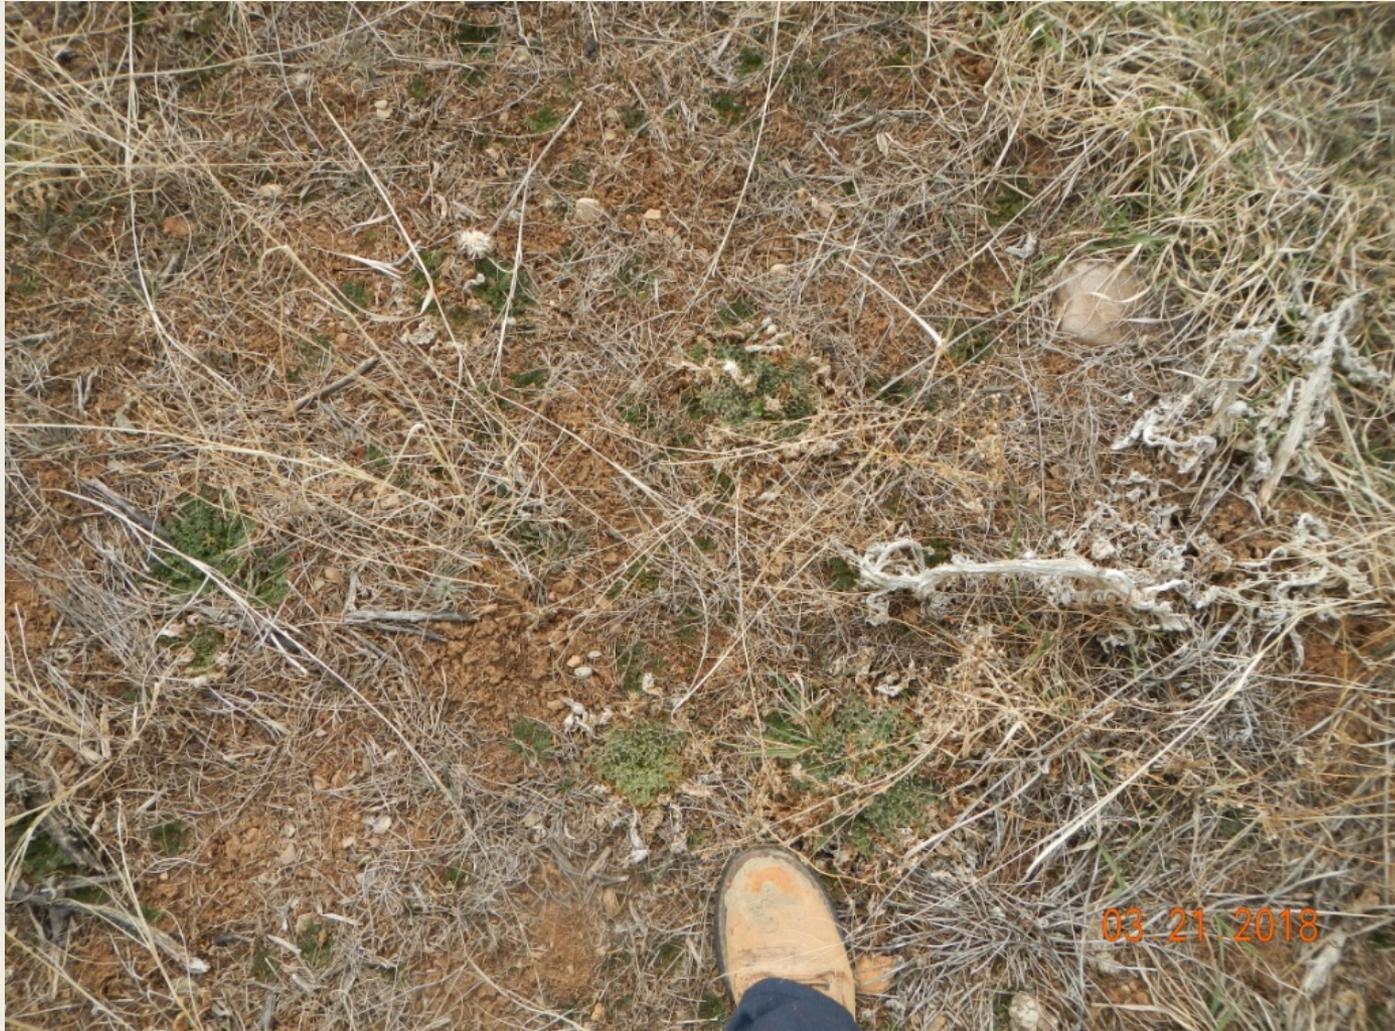
Photo 4. View of musk thistles (*Carduus nutans*) in the southern portion of the project area. Approximately 200 individuals observed.

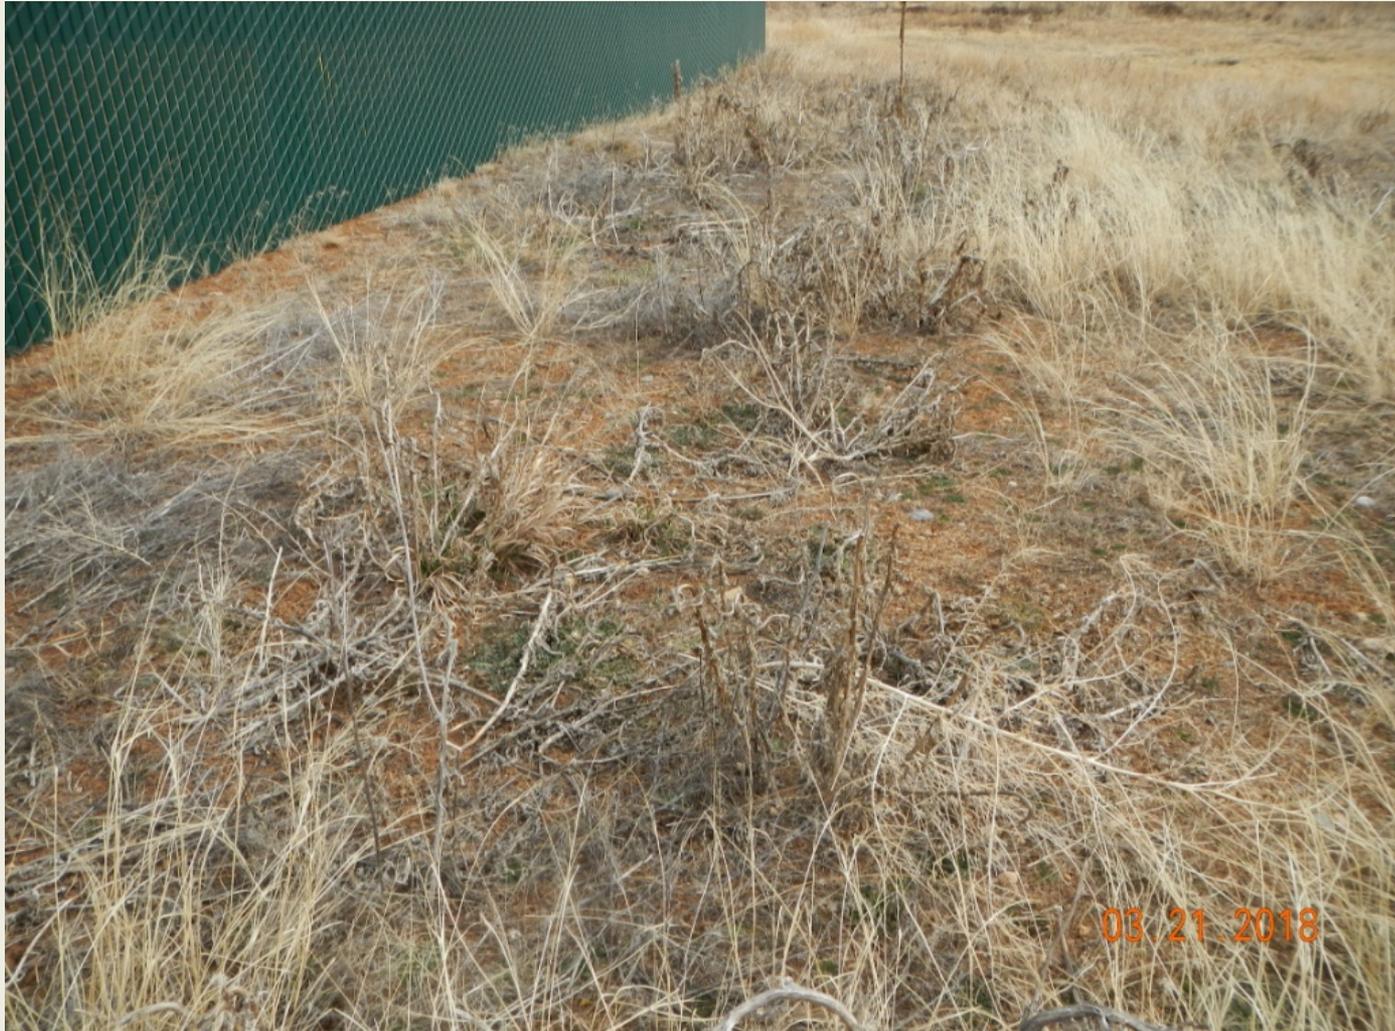
Photo 5. Another view of musk thistles in the southern portion of the project area.

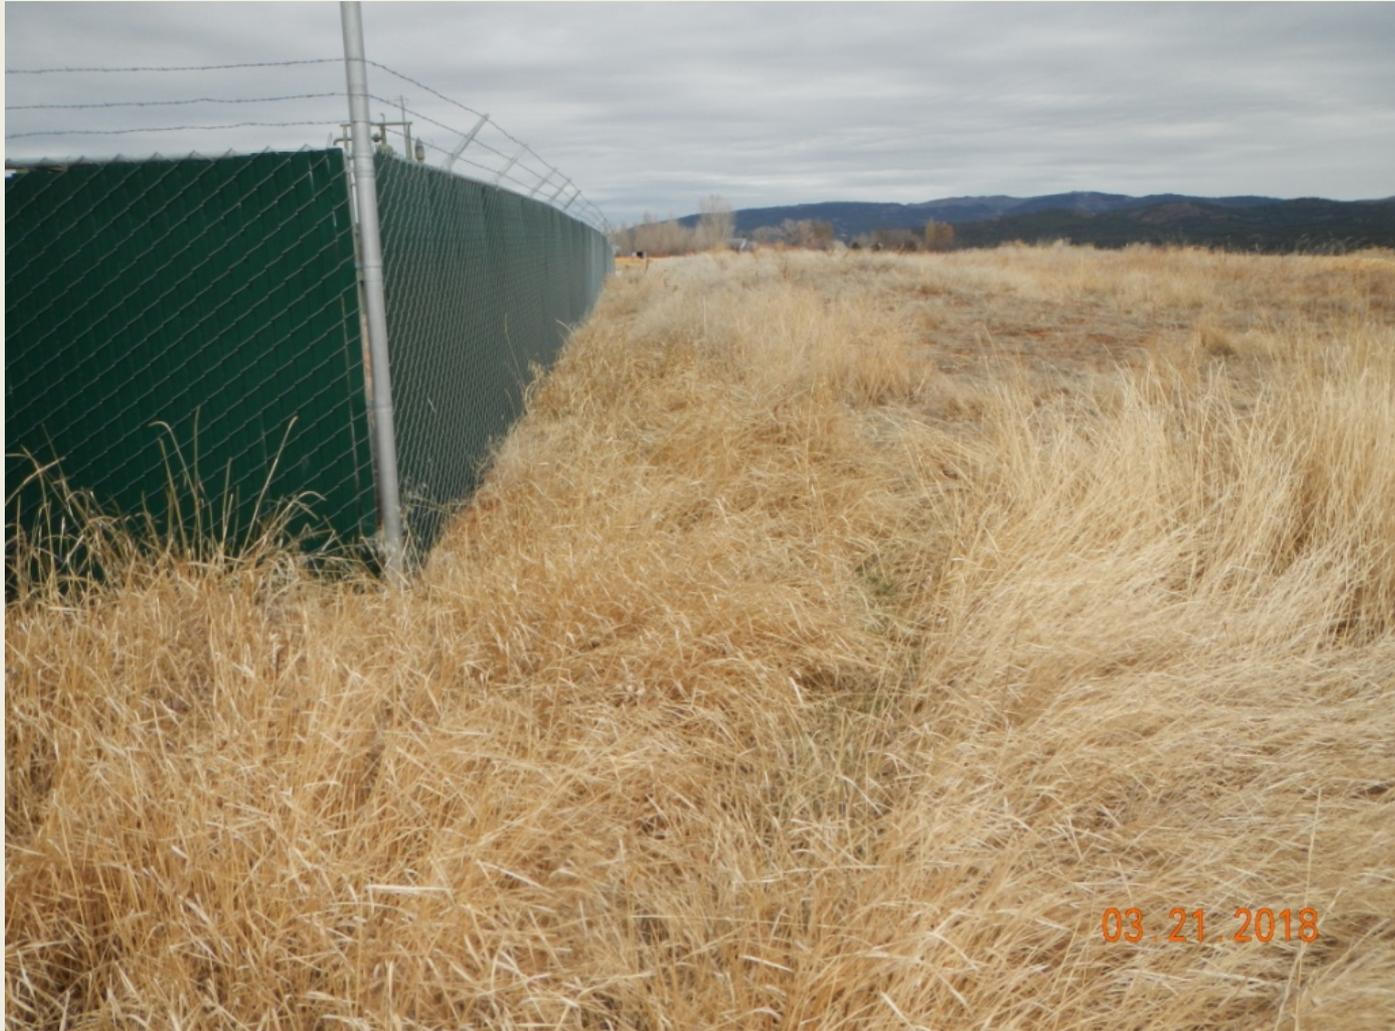
Photo 4. View of the eastern portion of the project area from the southeastern corner facing northward.
