Inspection Photos

Operator: HRBEK* RANDALL L - 41365

Location ID: 387770

Inspection Doc. Number: 682503216

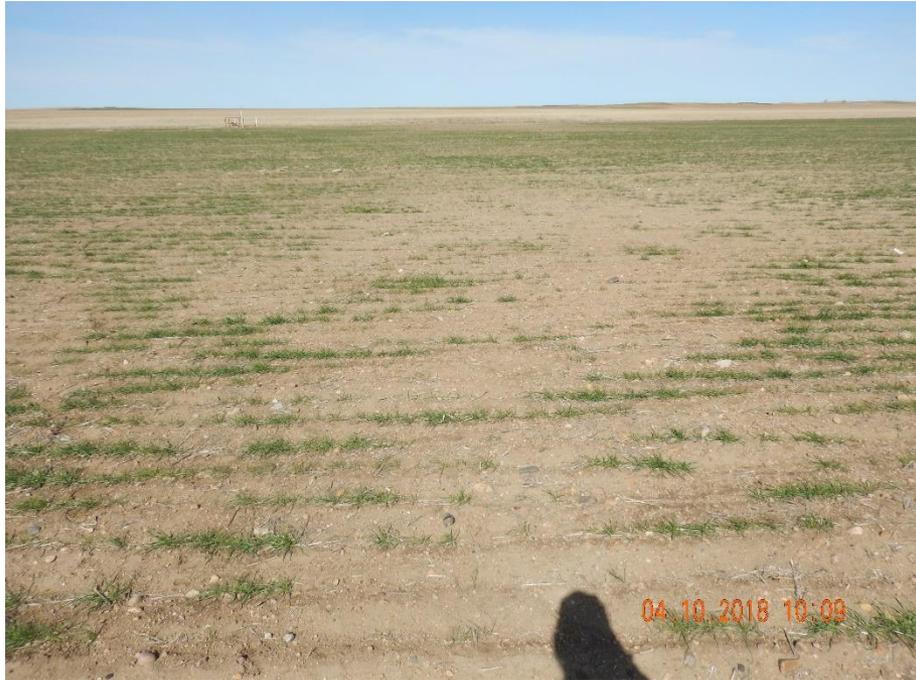
Photo 1: Photo taken from the well location, facing west. Photo shows crop growth/establishment on the area of the well. Crop germination appears sparse when compared to that of the reference area (photo 2).

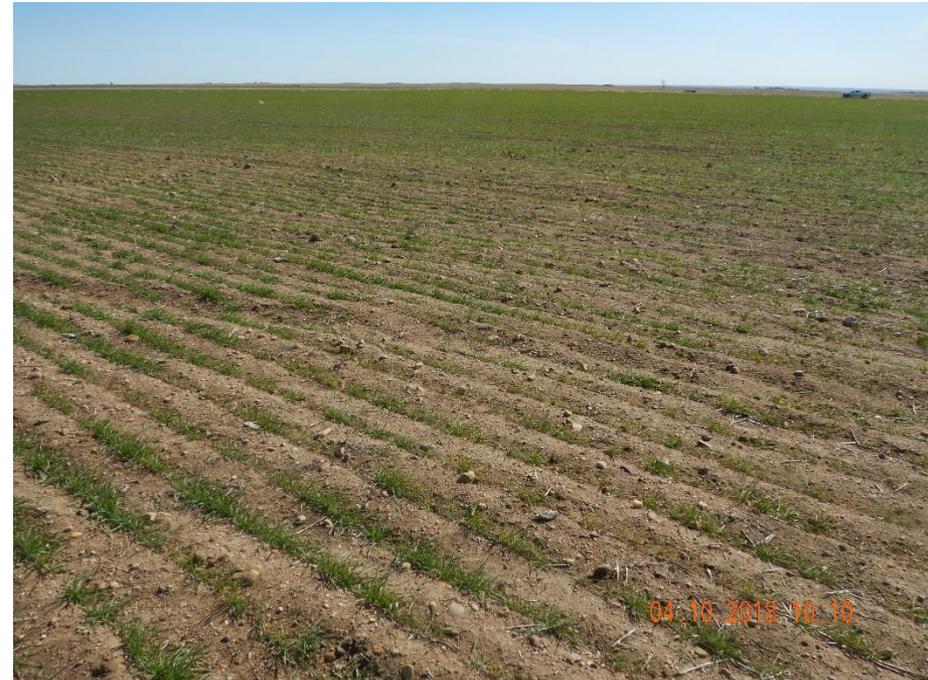
Photo 2: Photo taken from the immediate adjacent reference area, facing northeast. When compared to the disturbance area of the well, crop germination, growth and establishment throughout the reference area appears uniform

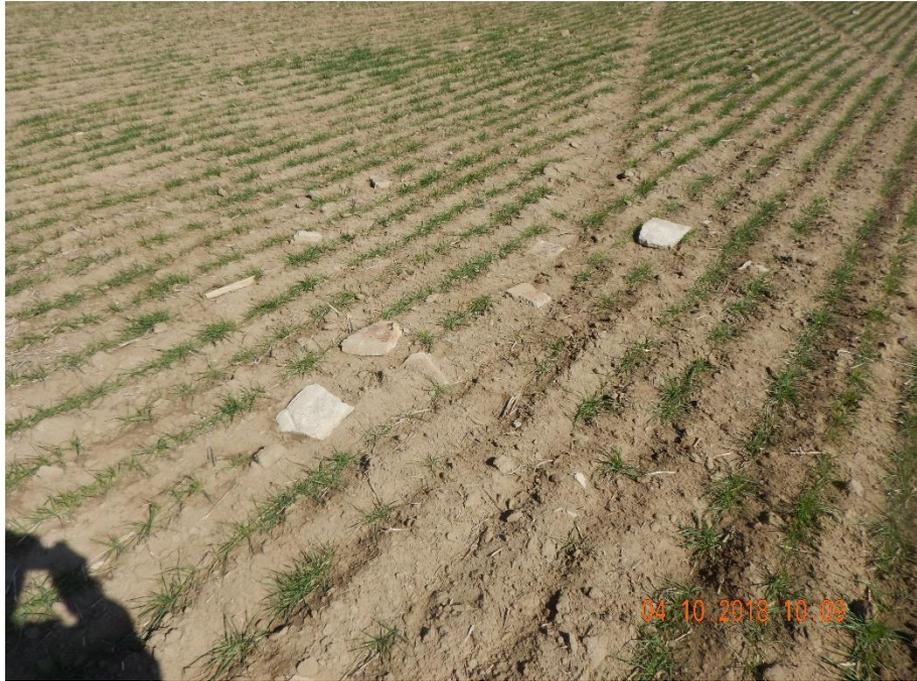
Photo 3: Photo taken from the well area. Photo concrete block and various other debris found in the vicinity of the well location.

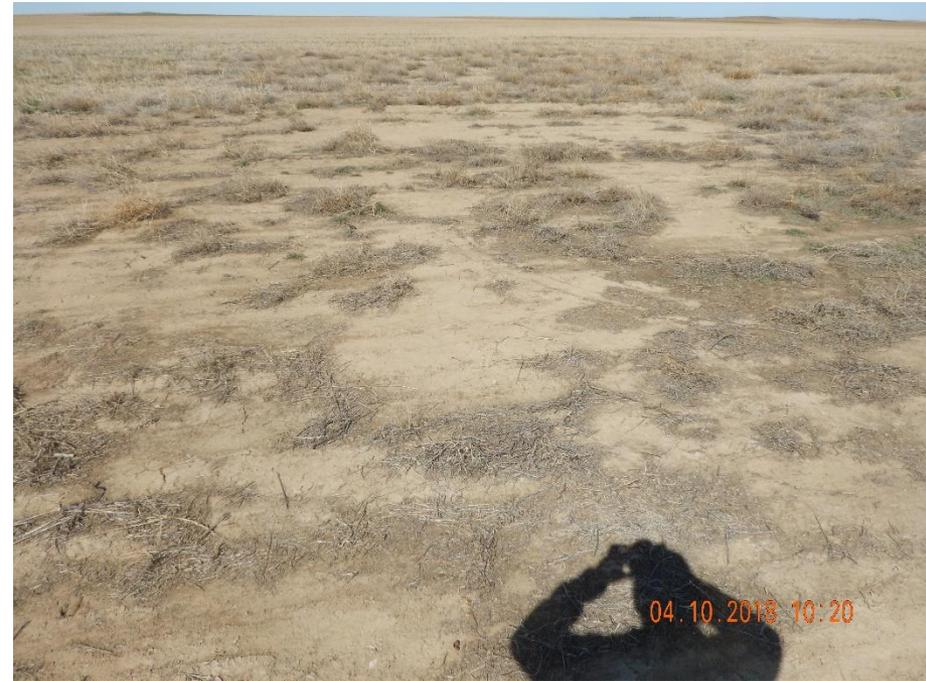
Photo 4: Photo taken from the east end of the former tank battery/pit location, facing west. Though cropland field is currently fallow, observations indicate area of the former battery/pit location remains predominantly bare, or composed of undesirable weedy plant species.

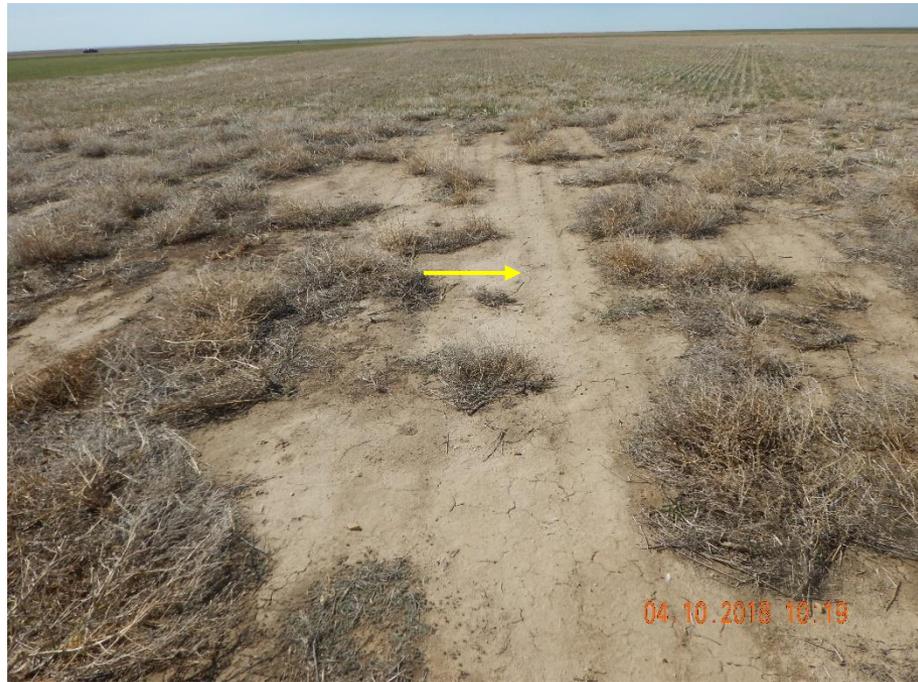
Photo 5: Photo taken from the west end of the former tank battery/pit location, facing south. Though cropland field is currently fallow, observations indicate area of the former battery/pit location remains predominantly bare, or composed of undesirable weedy plant species. This photo shows striations in the soil; based on inspectors professional experience, these soil striations were likely caused by a seeder (farmer attempting to plant new crop). Photo also shows that there is no residual crop growth within areas of the location where the seeder passed. This suggests that crop from previous agricultural activities was unable to establish and produce within the former battery/pit location.

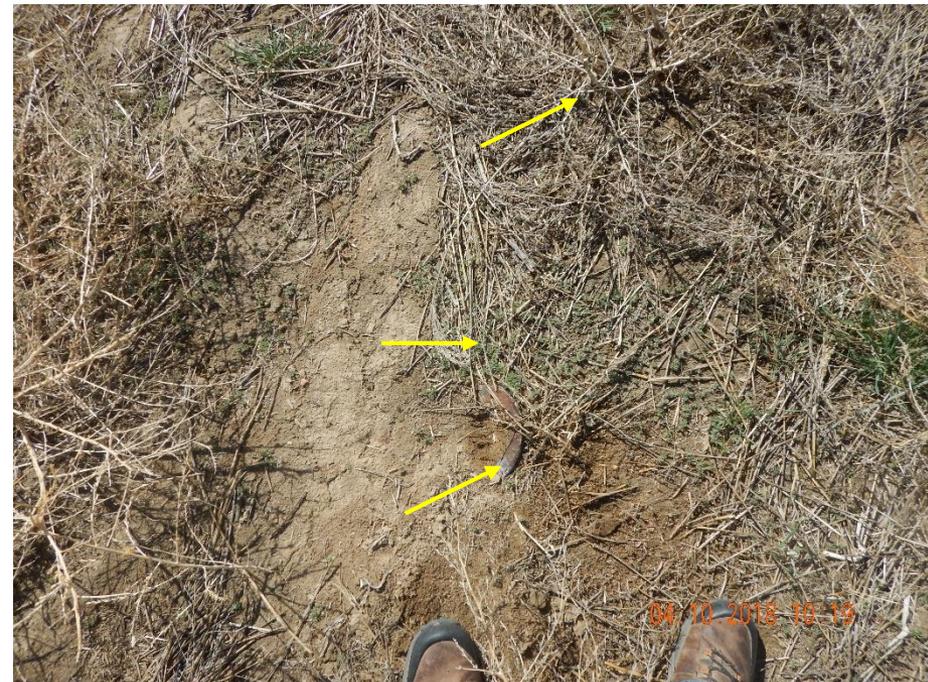
Photo 6: Photo taken from the former tank battery/pit location. Photo shows previous crop establishment by the farmer does not appear to have been successful. Location appears to be predominantly undesirable weedy plant species, or bare and exposed soil. The top arrow in the photo shows weed debris (kochia) from last years growing season. Middle arrow is pointing at new kochia growth on location. Bottom arrow shows metal debris remaining from production equipment.

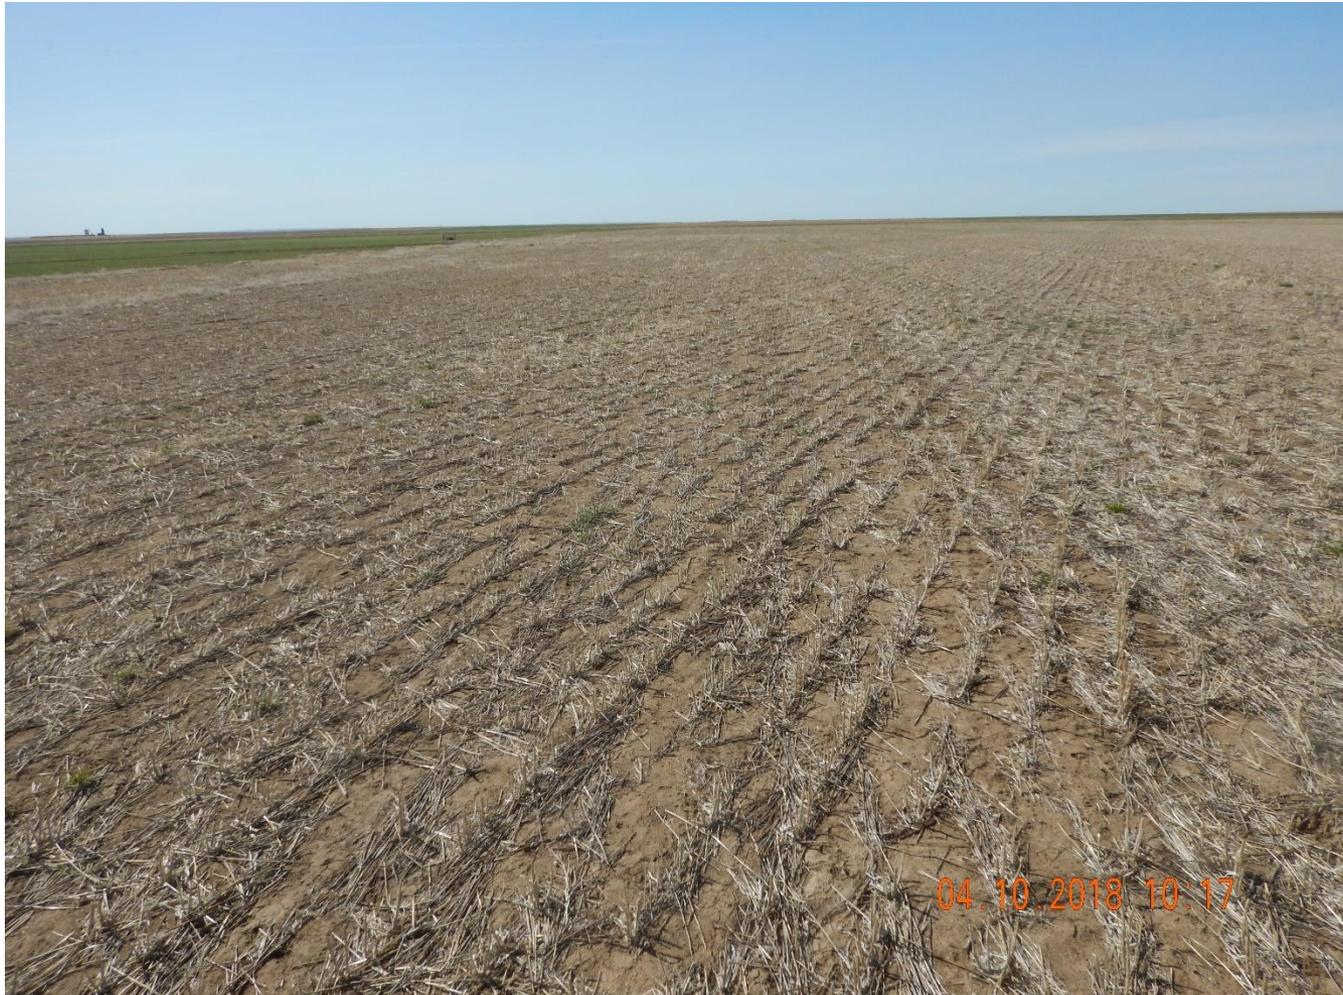
Photo 7: Photo taken from the adjacent reference are of the former battery/pit location. Photo shows that undesirable weedy plant growth is minimal to non-existent. Vegetation seen in photo is residual crop remaining from a previous harvest (wheat). When compared to the disturbance area, crop growth and establishment throughout the reference appears to have been uniform.

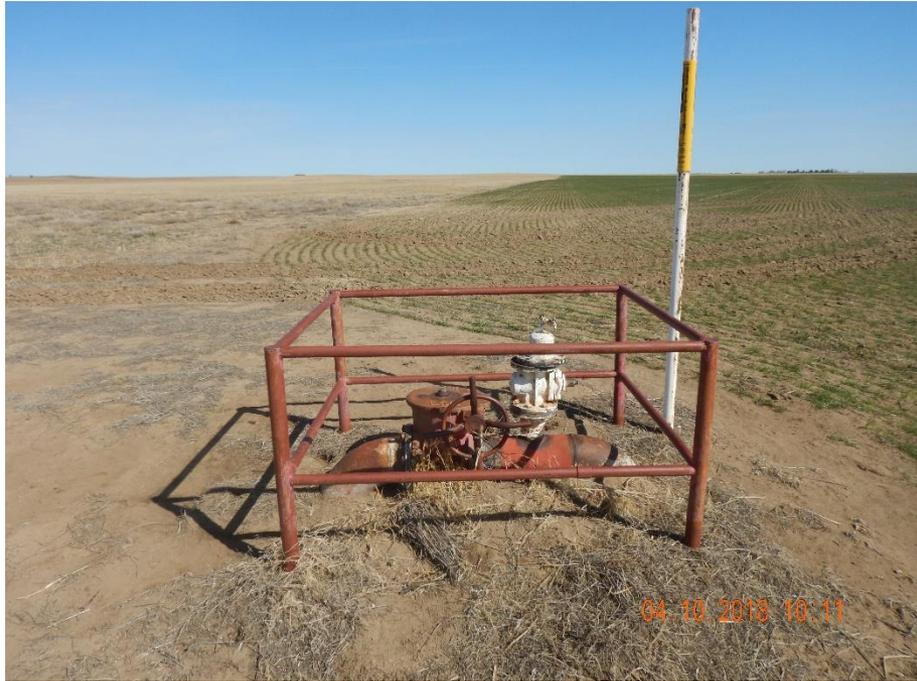
Photo 8: Photo taken from the west end of the well location. Photo shows a riser remaining on location. Riser appears to be associated with a pipeline.

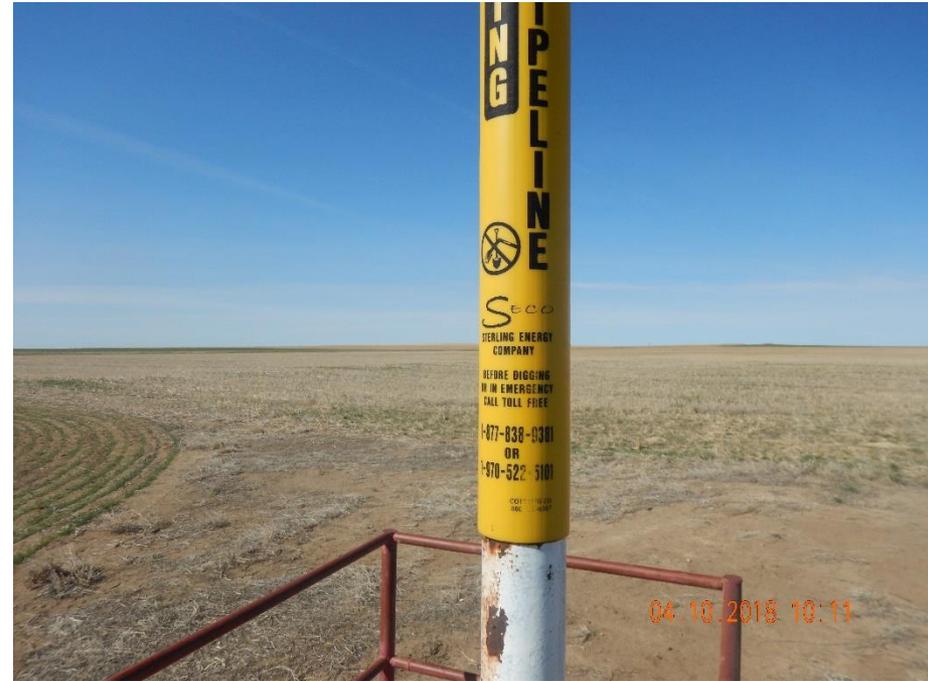
Photo 9: Photo taken from the west end of the well location. Photo shows a riser remaining on location. Riser appears to be associated with a pipeline.

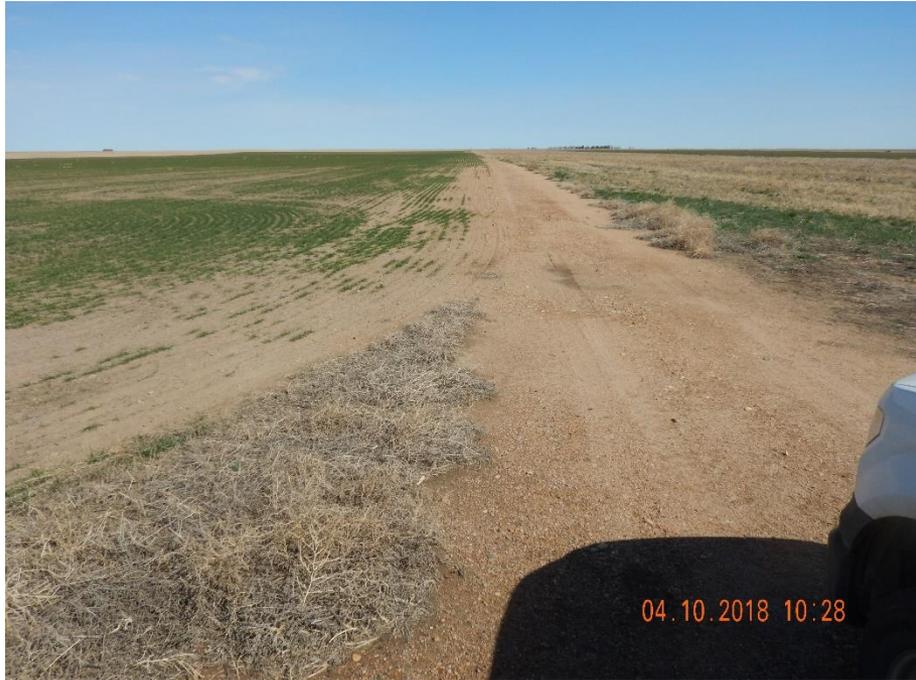
Photo 10: Photo taken from Hwy 14, facing north. Photo shows the North/South access road leading to location has not been reclaimed. Remaining access road is approximately 200 yards, and immediately ends where access road turned west towards the well.

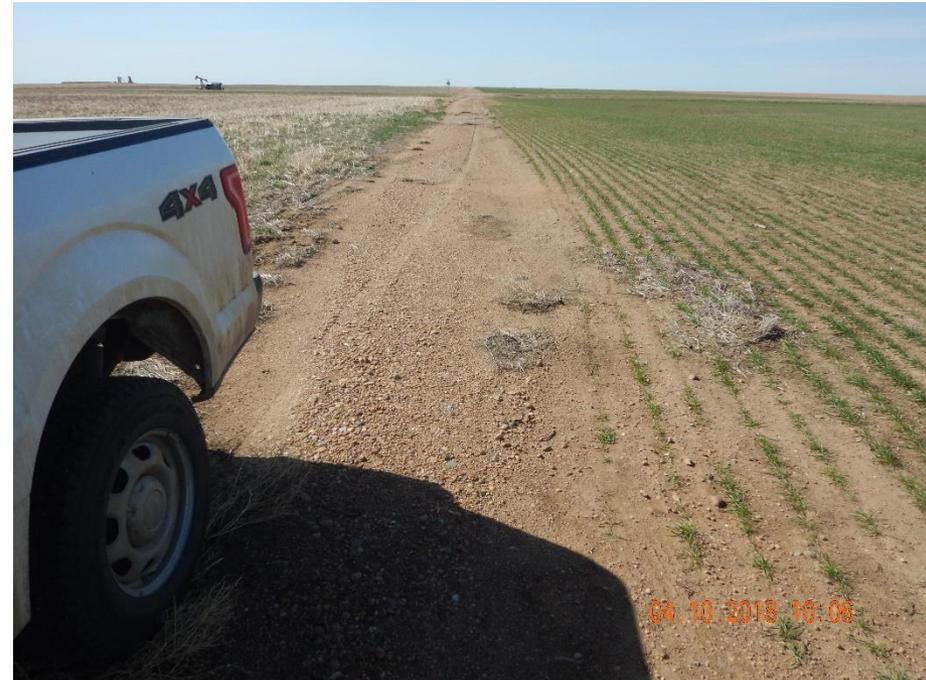
Photo 11: Photo taken from there the north/south access road ends, facing south. Photo shows access road has not been reclaimed.

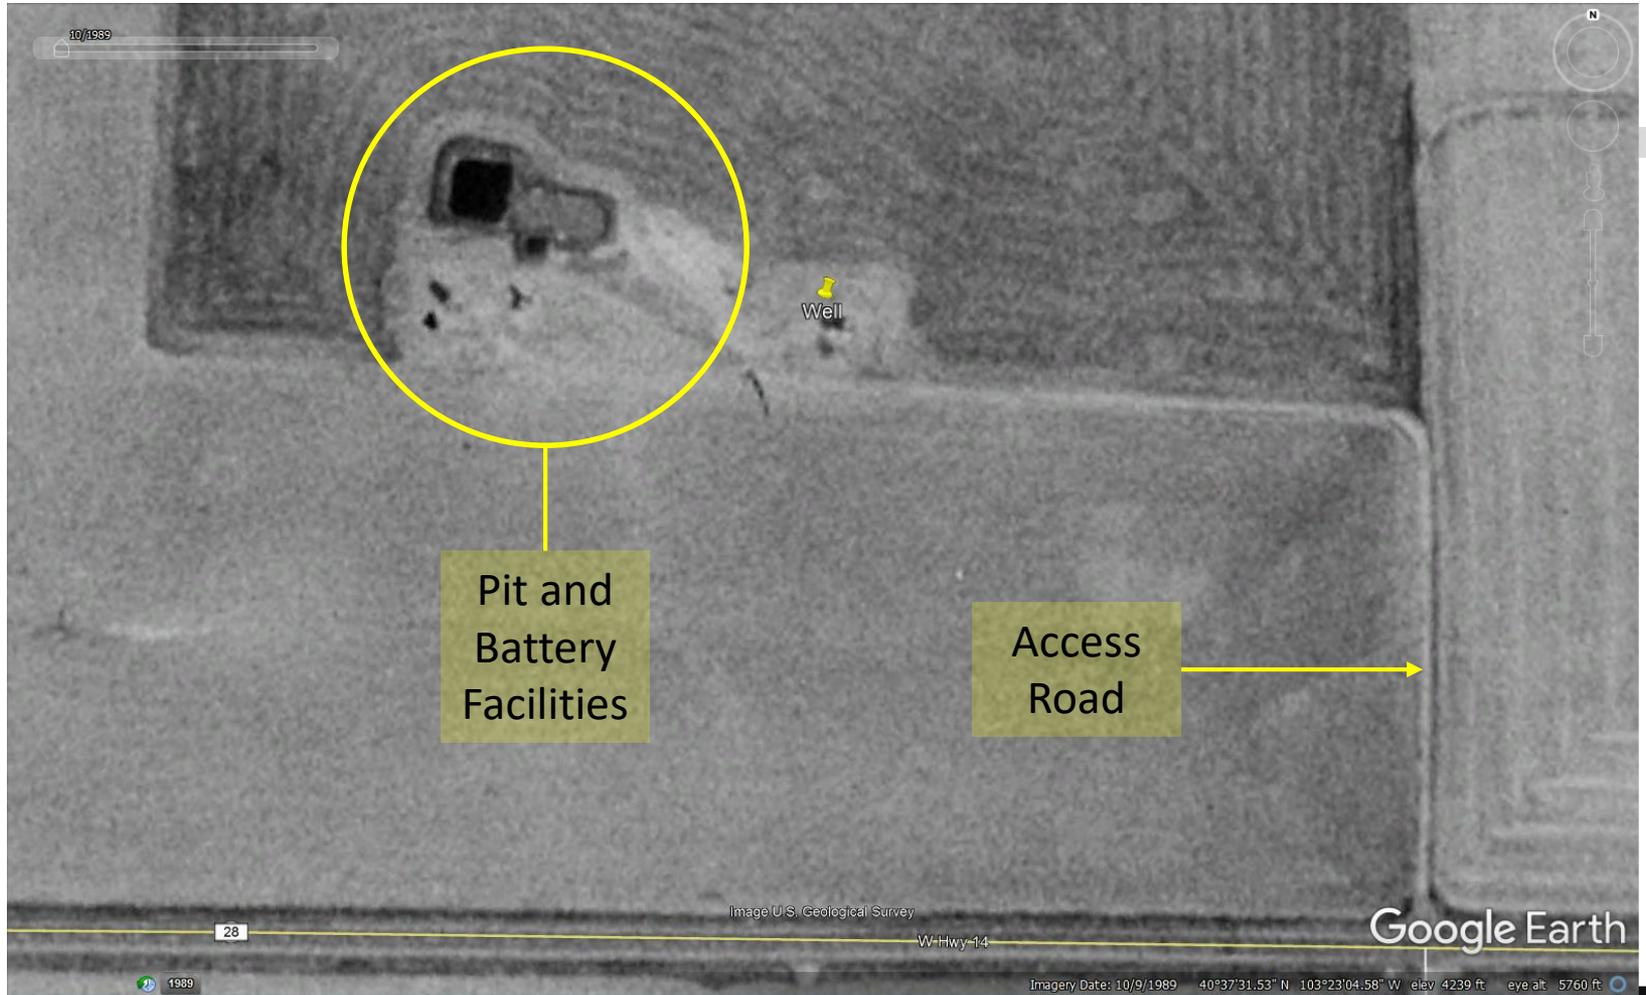
Photo 12: 1989 aerial imagery. Well was plugged and abandoned in 1994. Photo shows access road, well and facilities/pit when location was active.

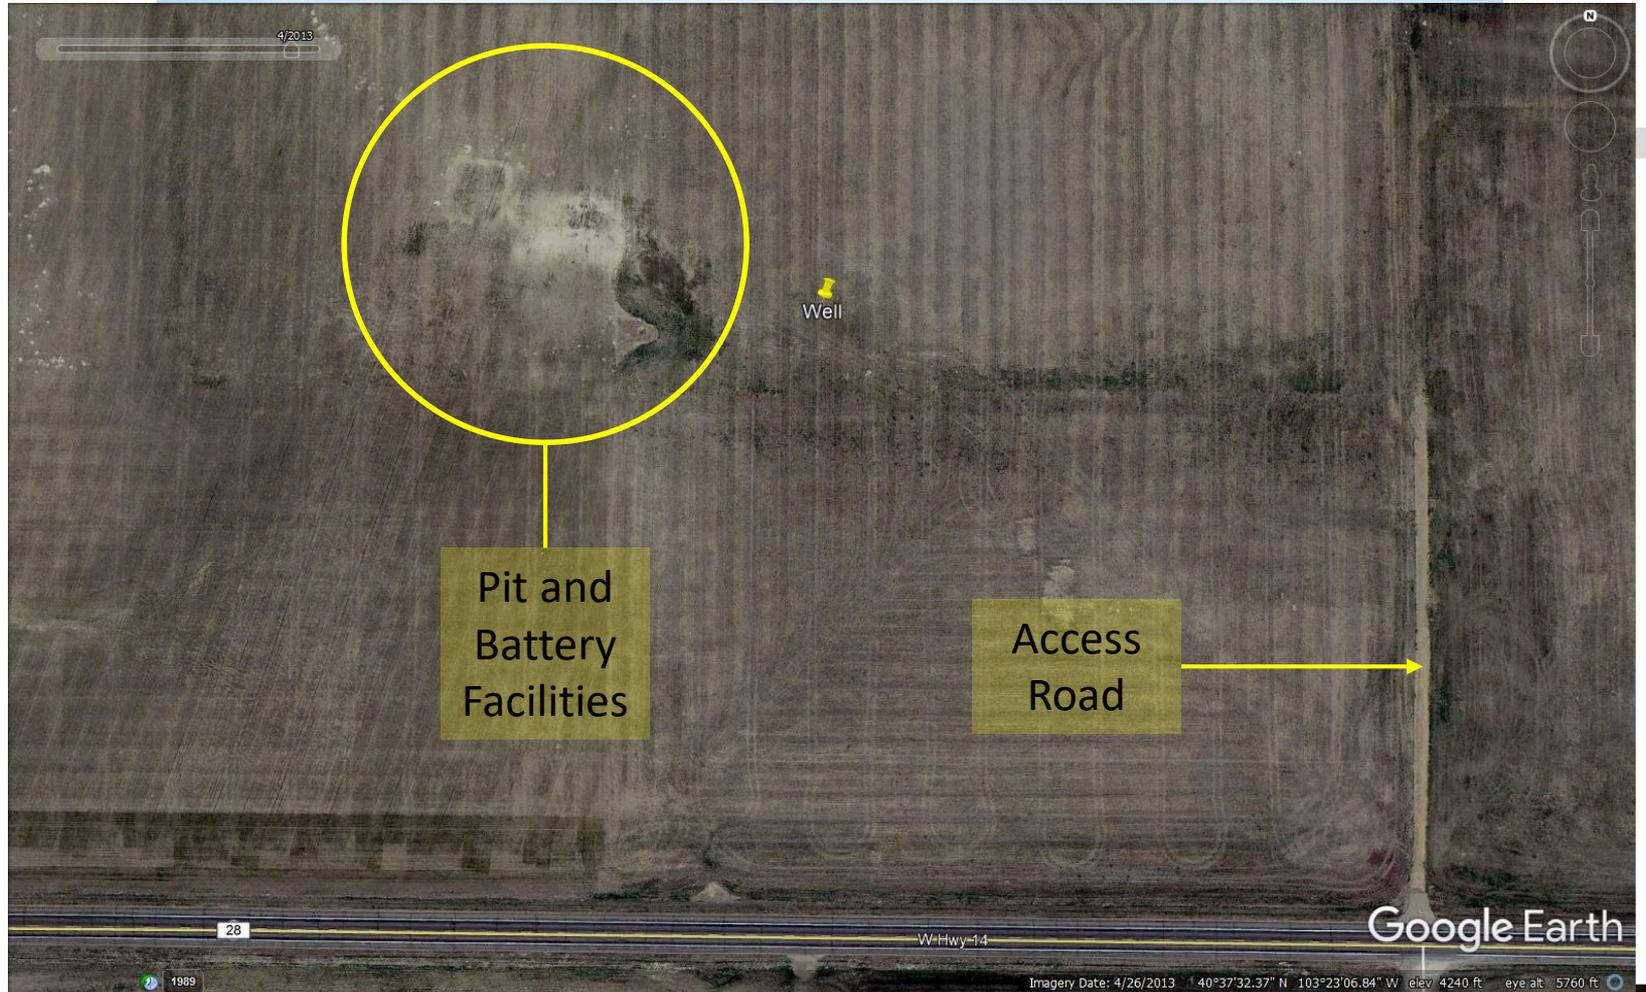
Photo 13: 2013 Aerial imagery. Photo shows areas of disturbance from the former pit and battery facility remains evident. Photo also show the un-reclaimed areas of the access road.
