Inspection Photos  
Location Name: Nielson #3  
API: 05-007-06116

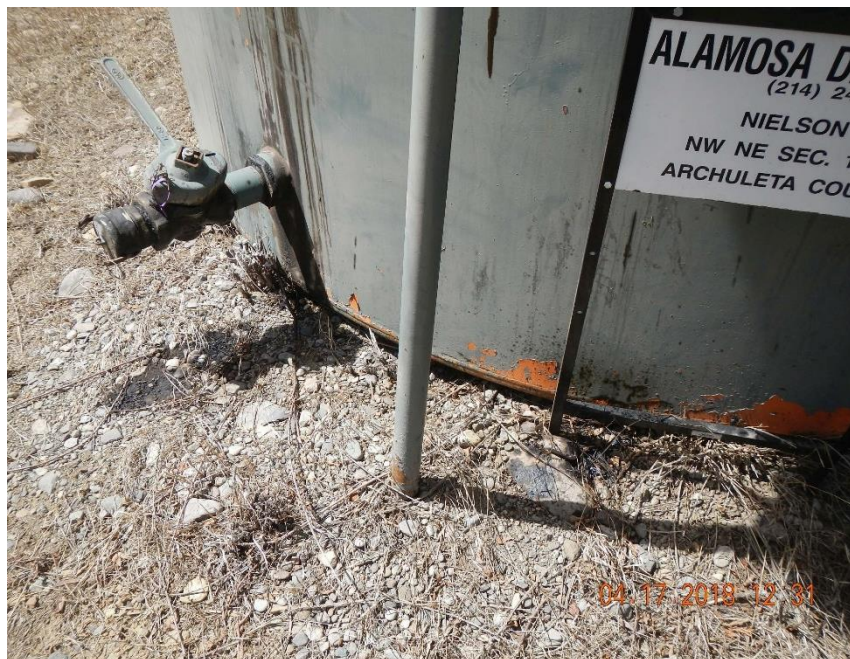
Stained soil beneath load out valve and below hammer union on flow line.

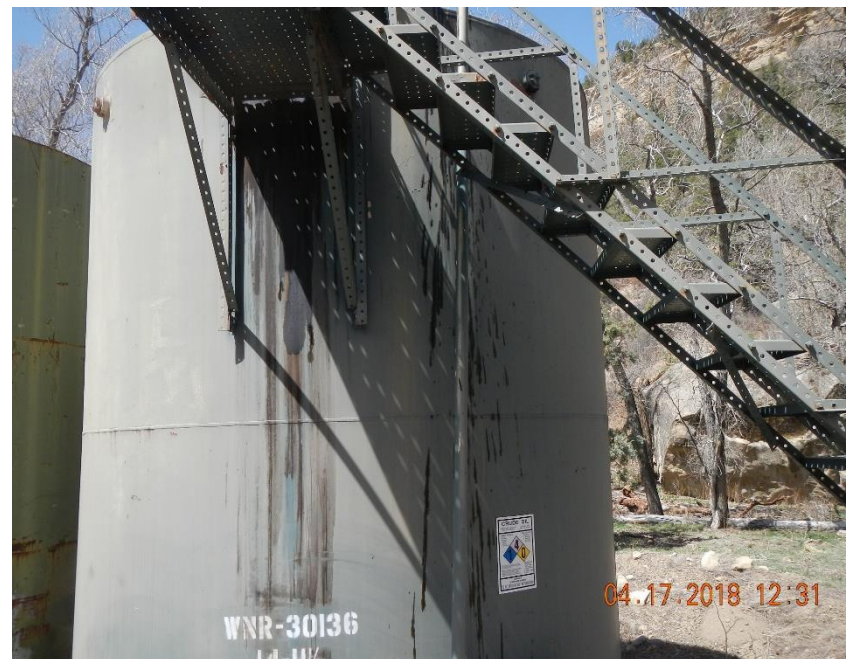
Oil stained AST.

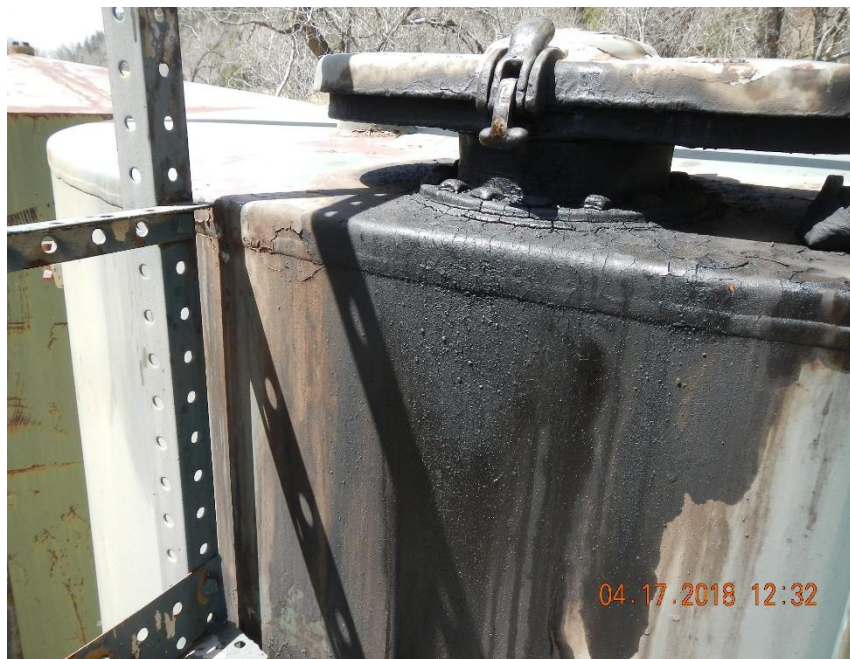
**Oil staining on AST near thief hatch.**

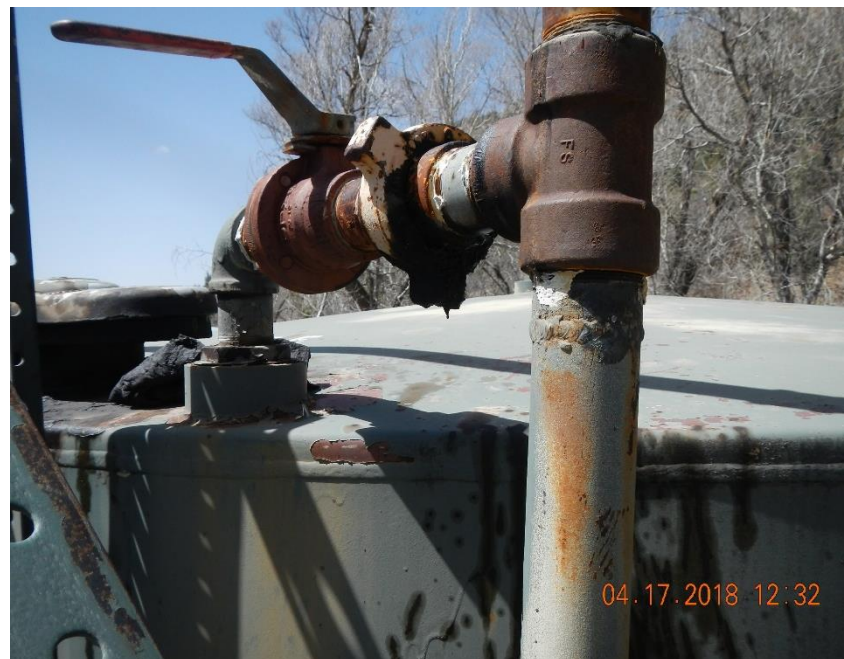
**Leaking hammer union on flow line.**

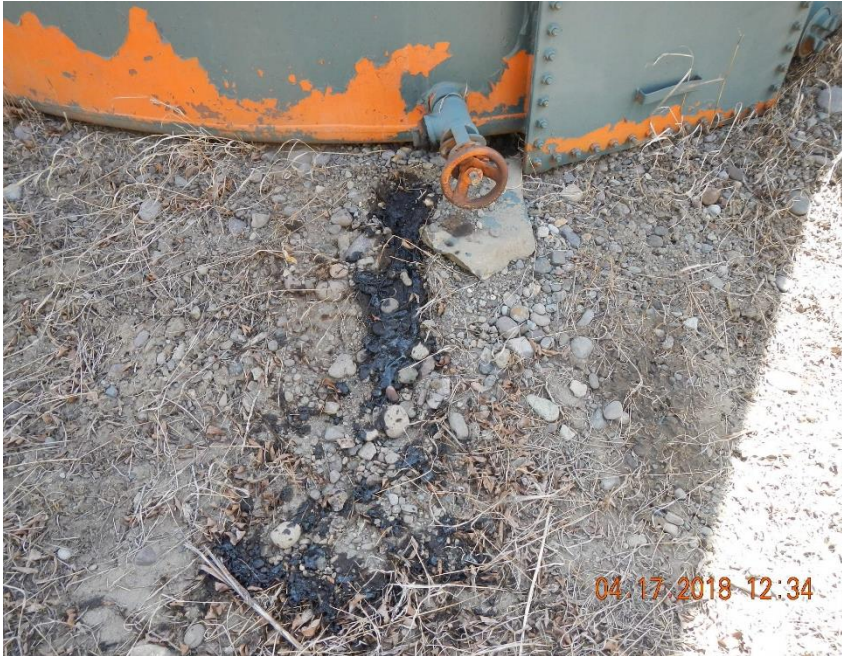
**Stained soil beneath tank valve.**

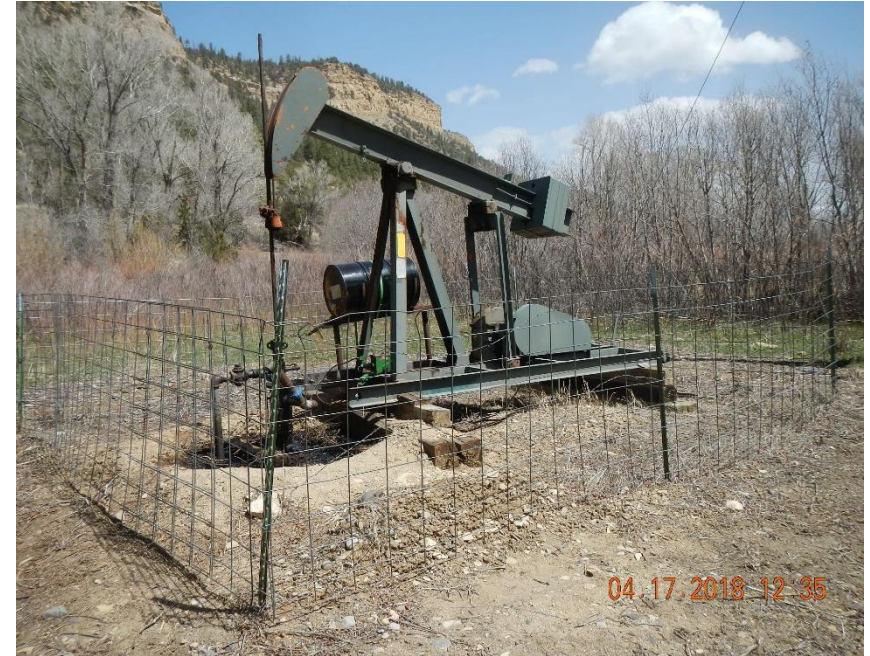
**Nielson #3 well head and pump jack.**

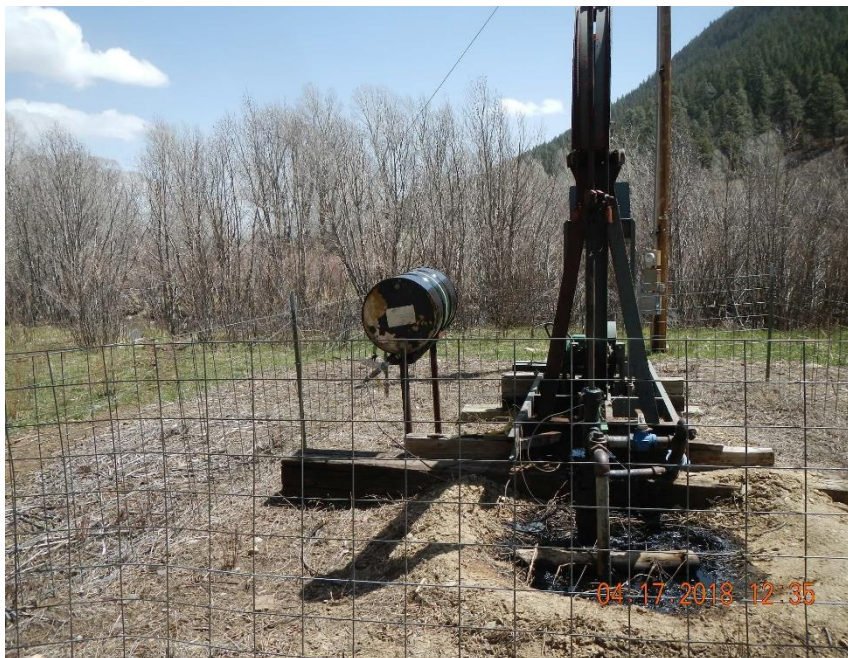
**Nielson #3 well head with oil staining.**

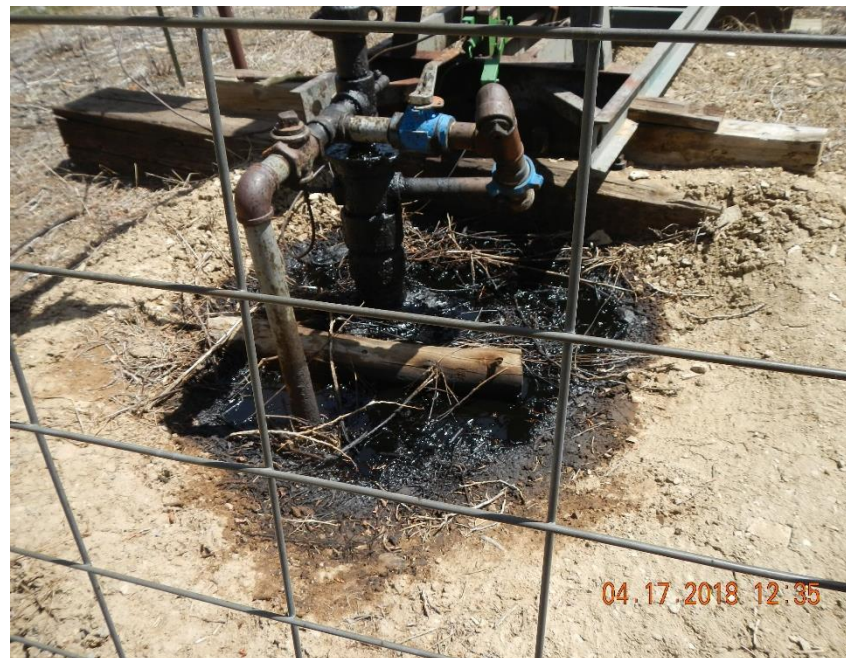
**Oil stained well head and impacted soil.**

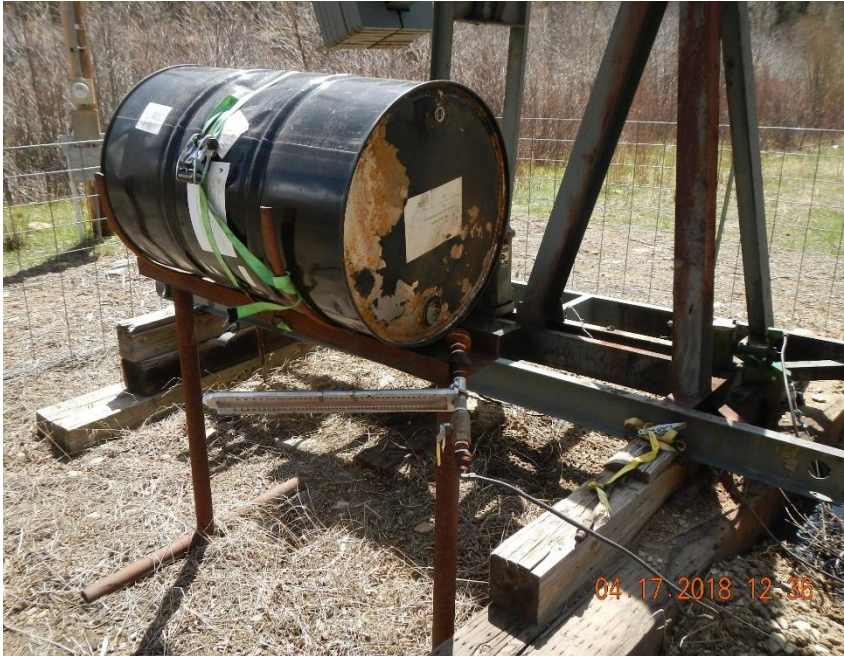
**Unused 55 gal. drum chemical injection system.**

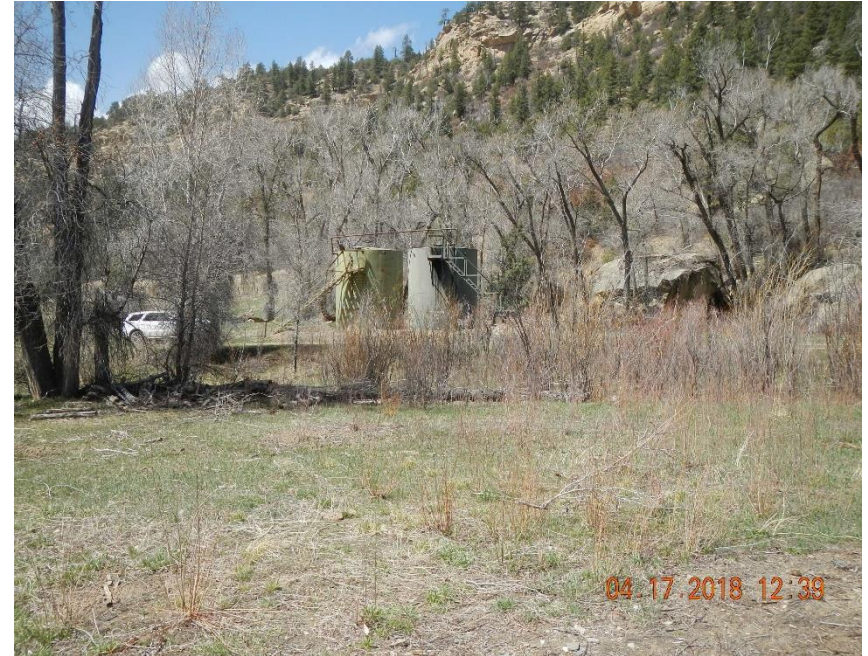
**Proximity of tank battery to well head.**
