Inspection Photos
Location Name: Chavez #2
API: 05-007-06136

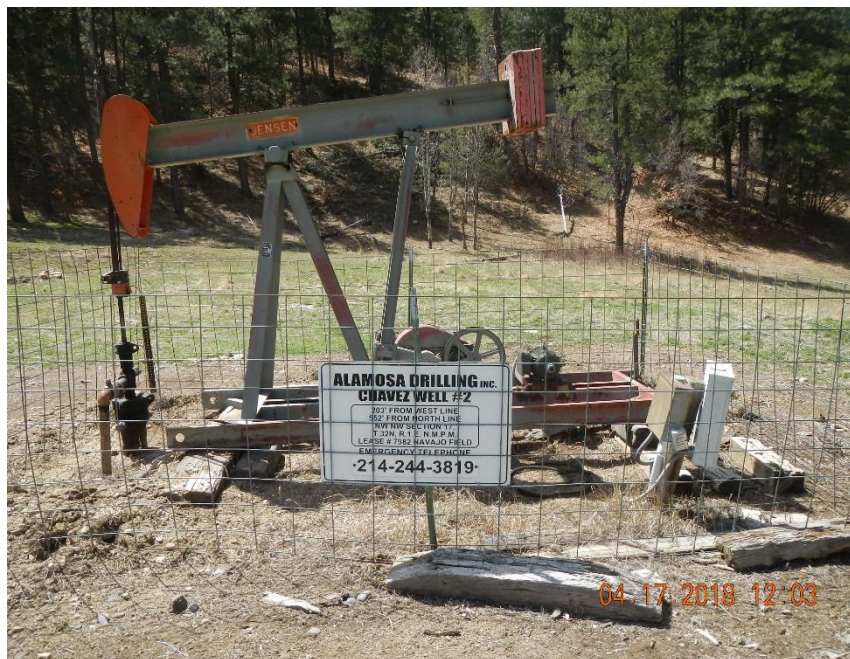
Chavez #2 well head and pump jack.

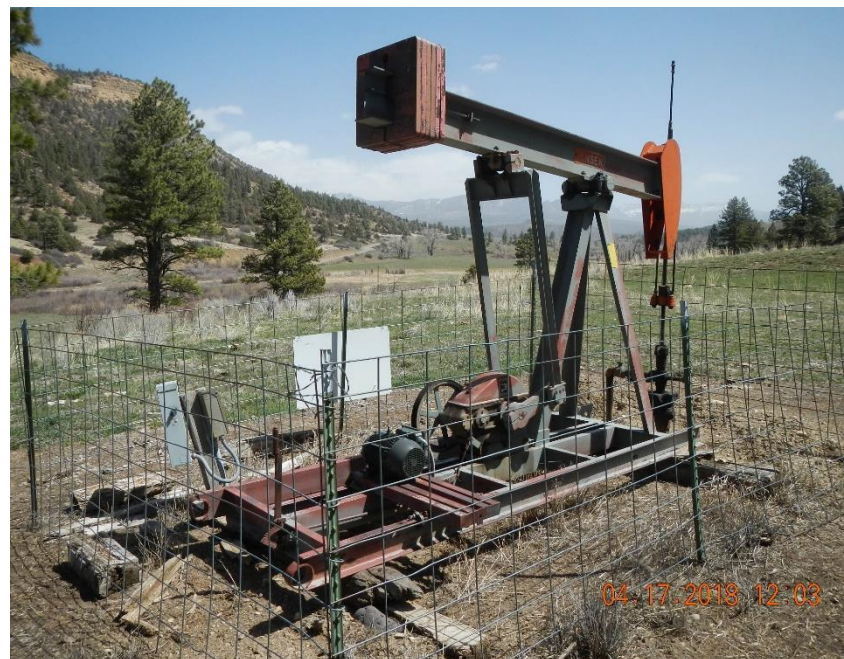
Chavez #2 pump jack and electric prime mover.

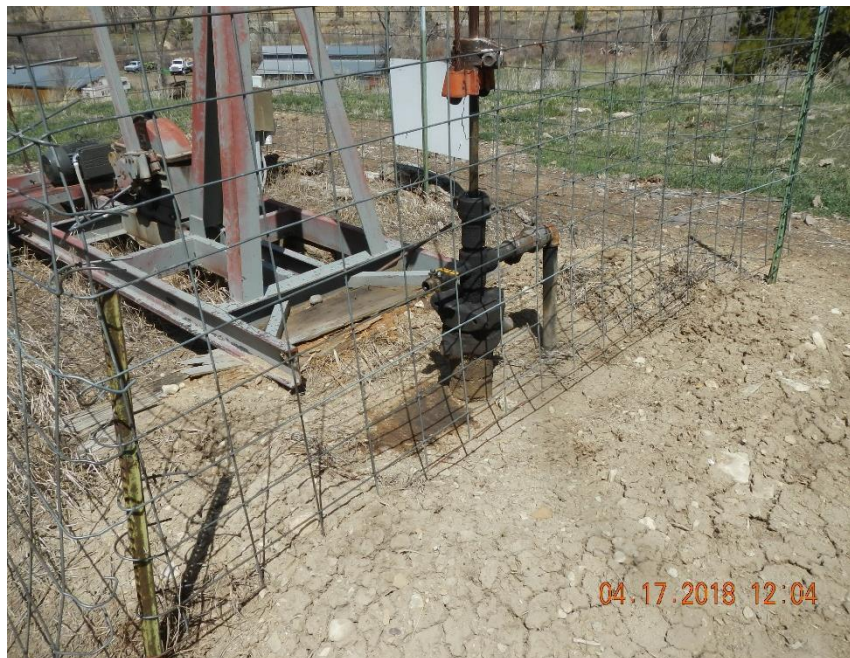
Well head and area below valve are stained.

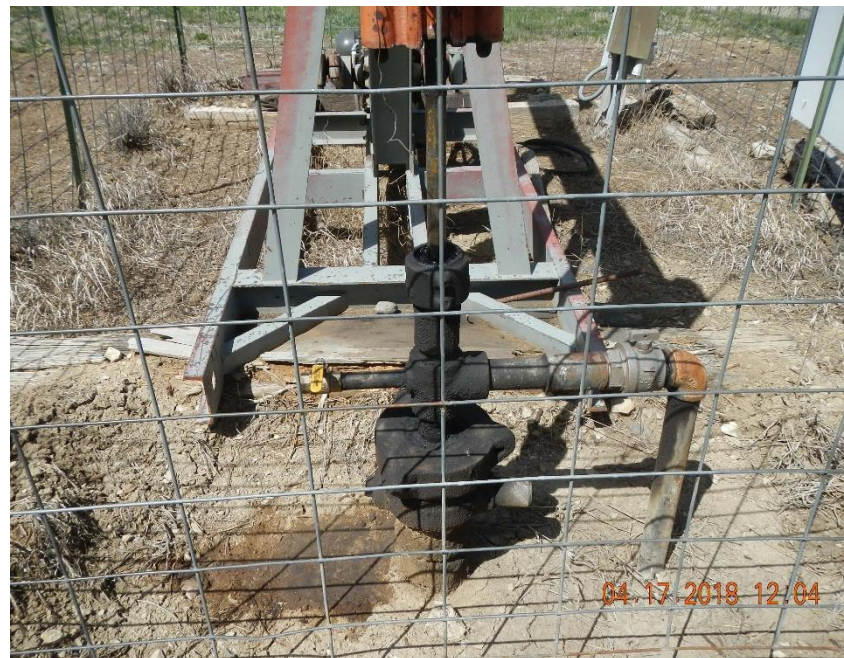
Oil stained well head and soil.
