Inspection Photos
Location Name: Albert Martinez #1
API: 05-007-06253

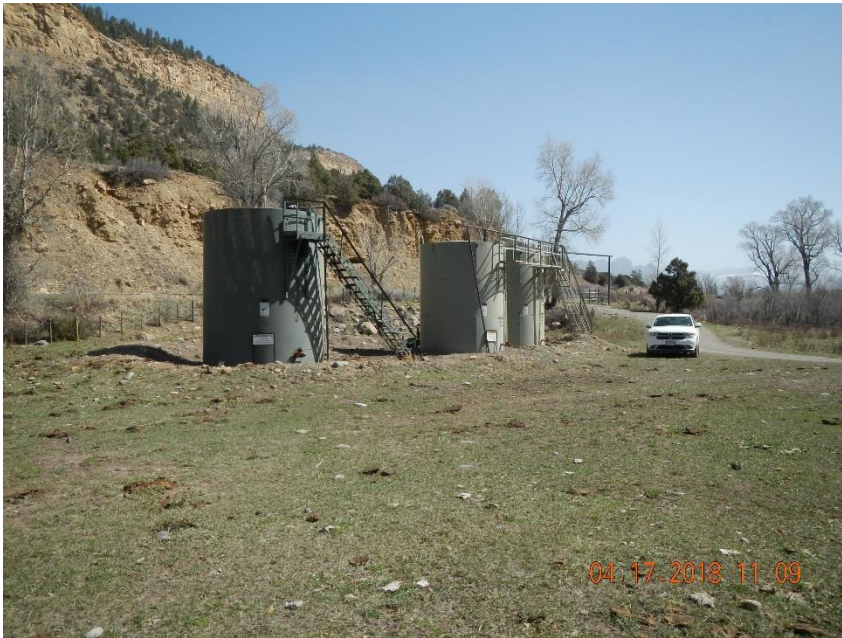
Albert Martinez #1 and Nielson #4 tank battery.

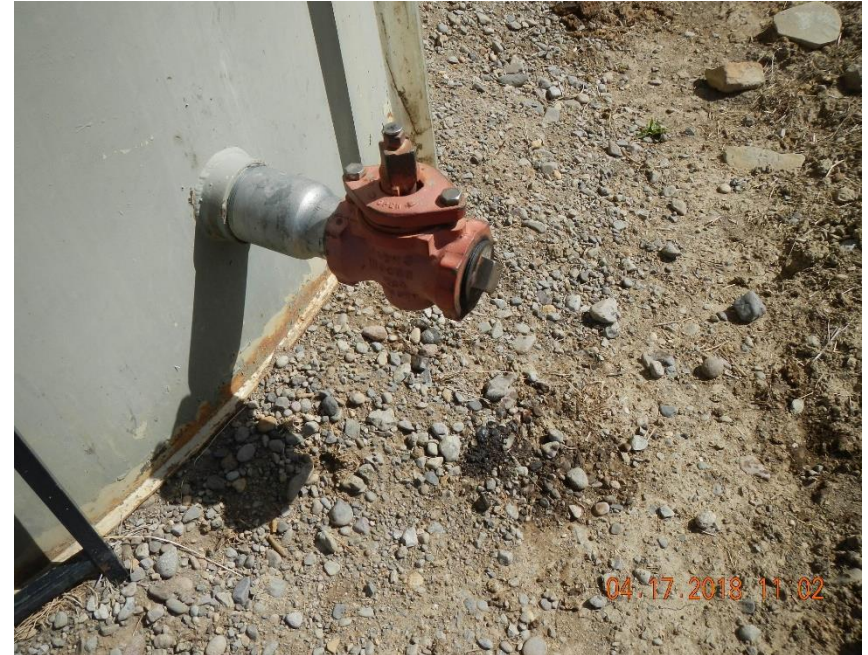
Stained soil beneath load out valve.

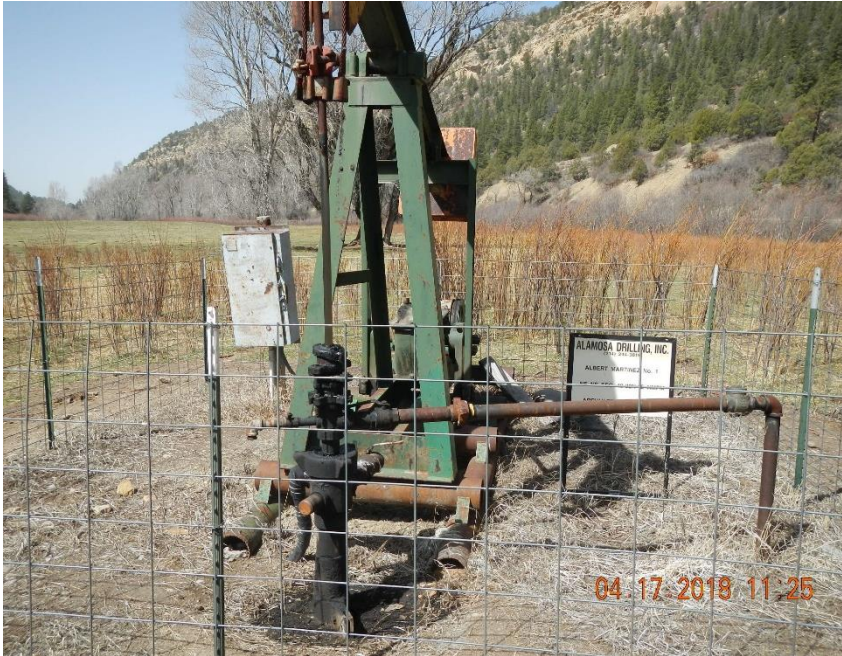
Albert Martinez #1 pump jack and well head.

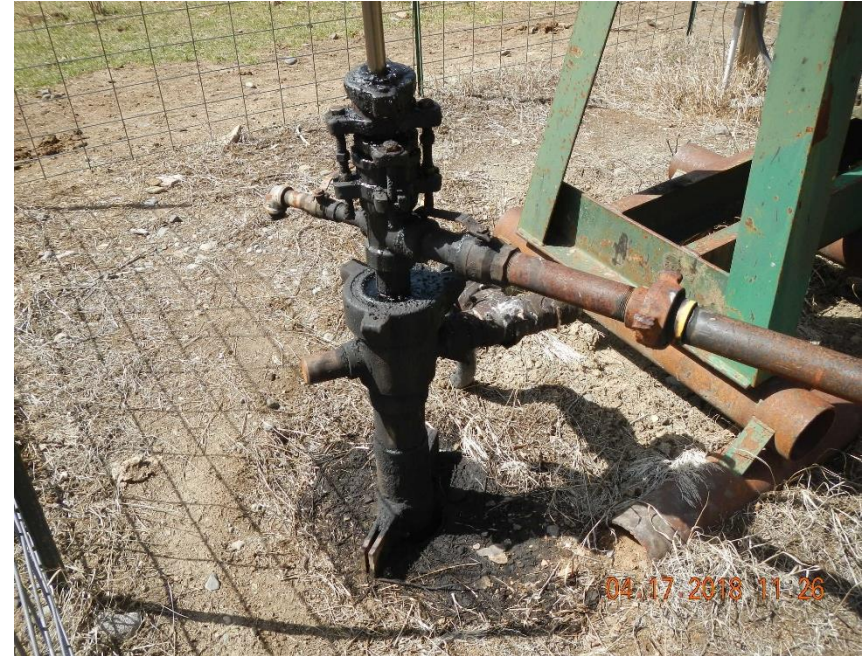
Well head and surrounding soil is stained with oil.
