# Inspection Photos

API: 05-067-07789

Operator: XTO ENERGY INC.

Inspection Date: 3/21/2018

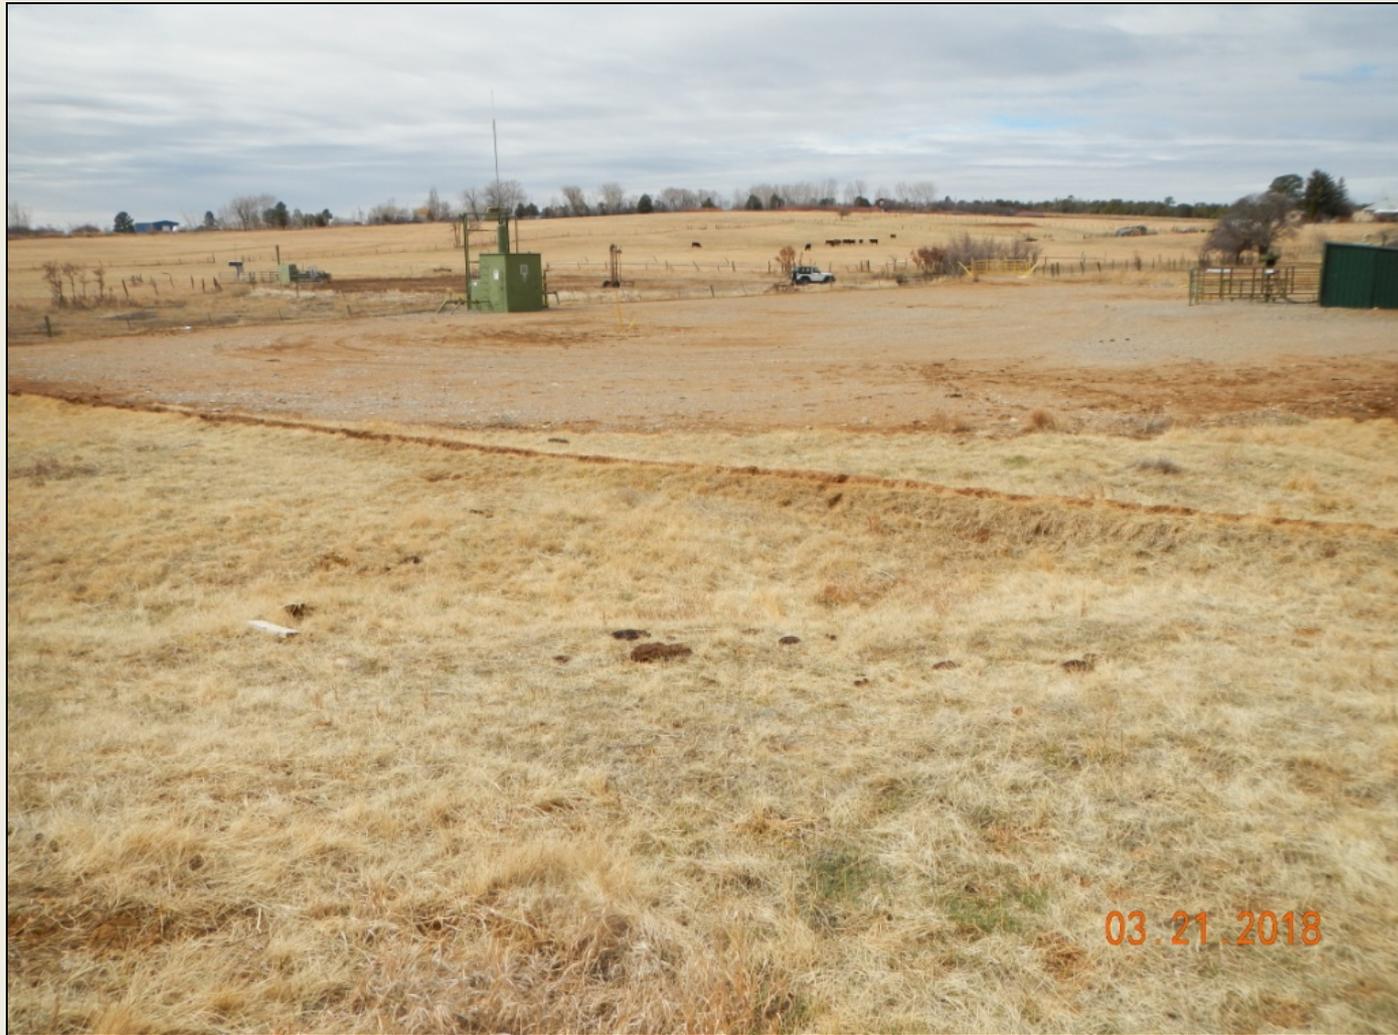
**Photo 1. View of the project area from the northeastern corner facing center.**

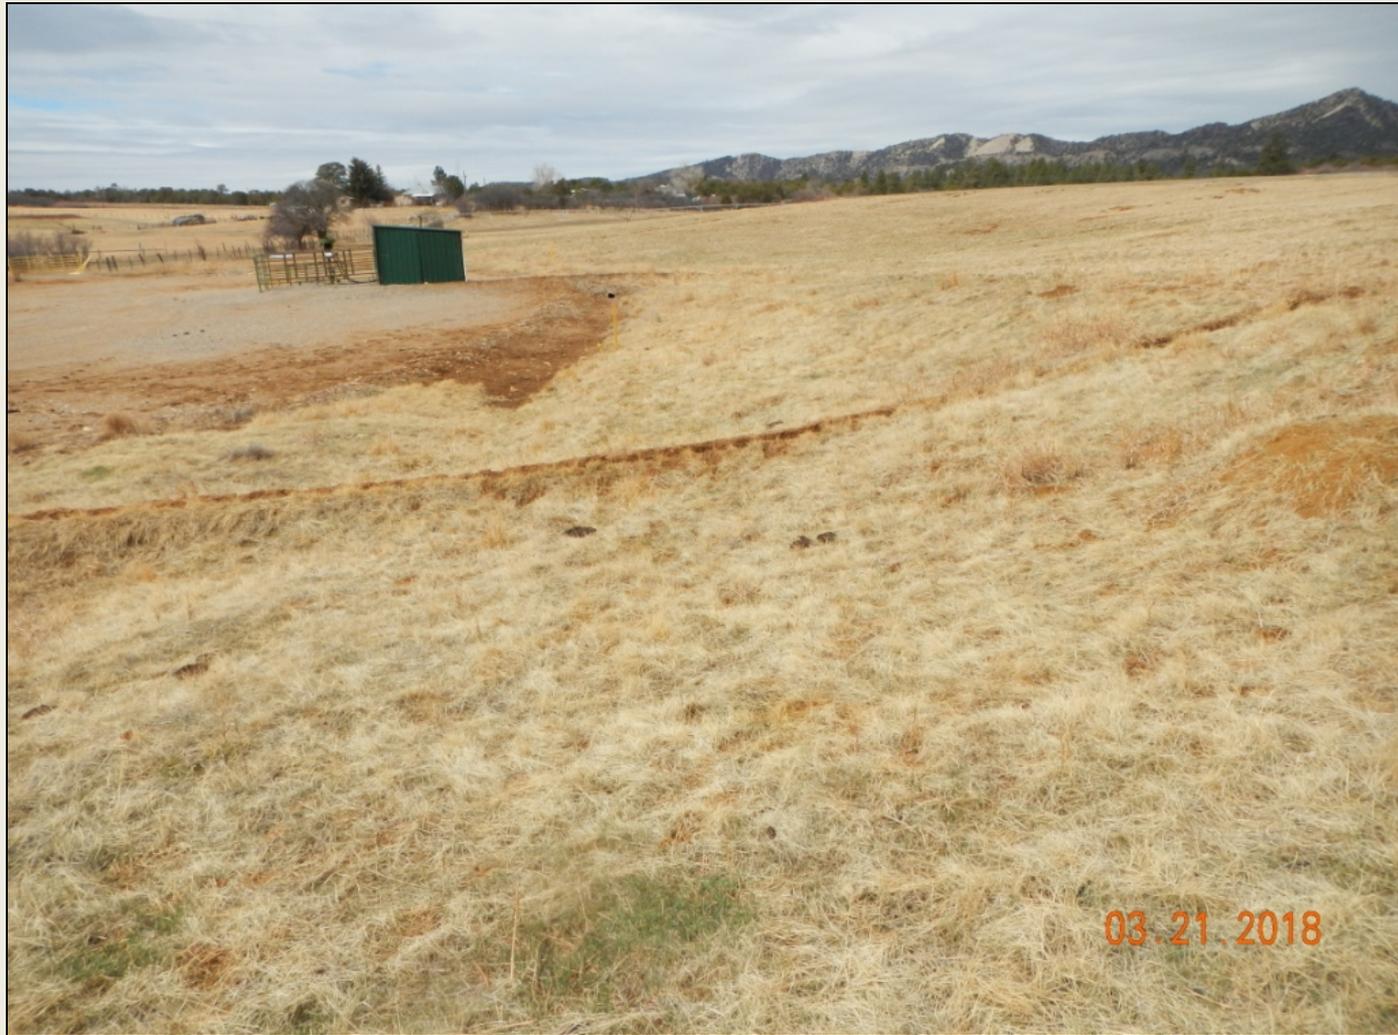
**Photo 2. View of the northern portion of the project area from the northeastern corner facing westward. Revegetation is comprised of a grasses such as smooth brome (*Bromus inermis*) and western wheatgrass (*Pascopyrum smithii*).**

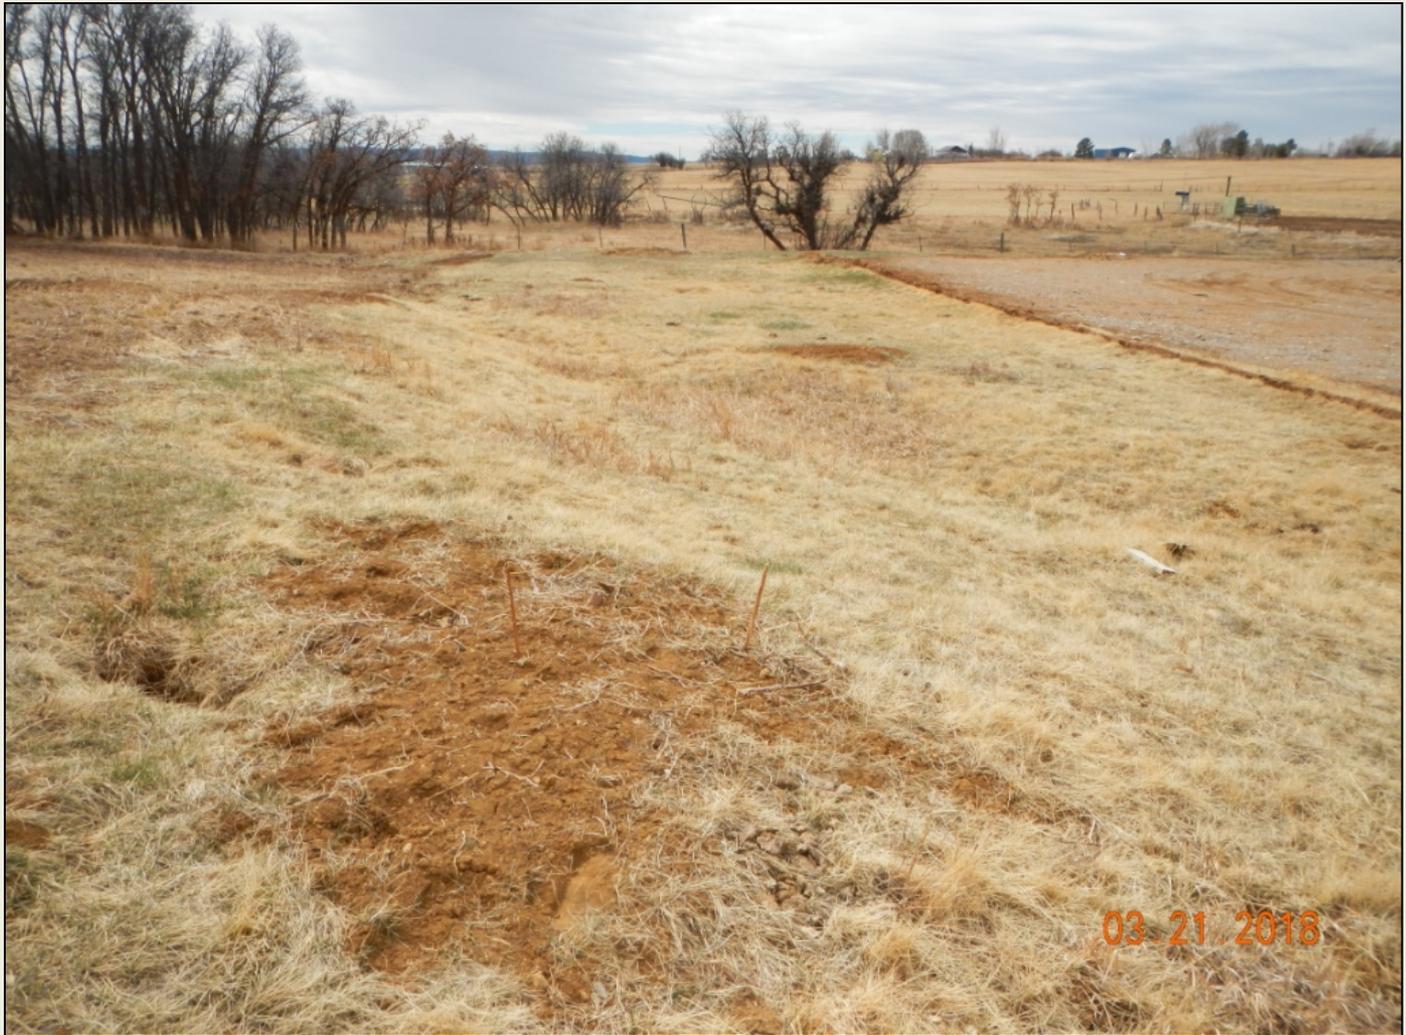
**Photo 3. View of the eastern portion of the interim reclamation area from the northeastern corner facing southward.**

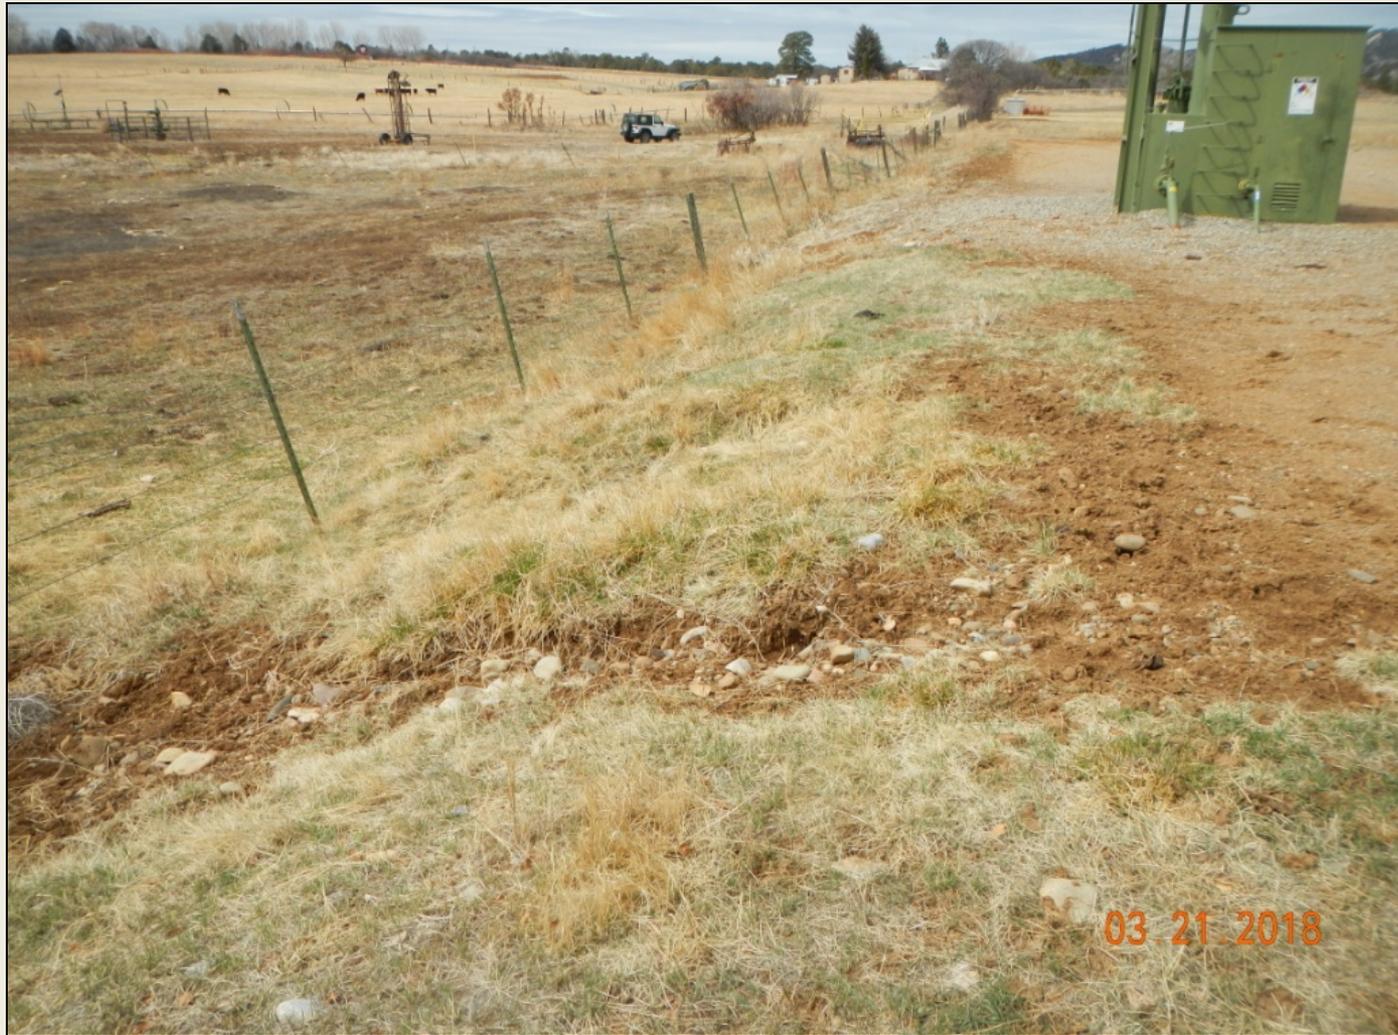
**Photo 4. View of the southern portion of the project area from the southeastern corner facing westward. Erosion is occurring in the southern project area where concentrated stormwater flows off of the well pad.**

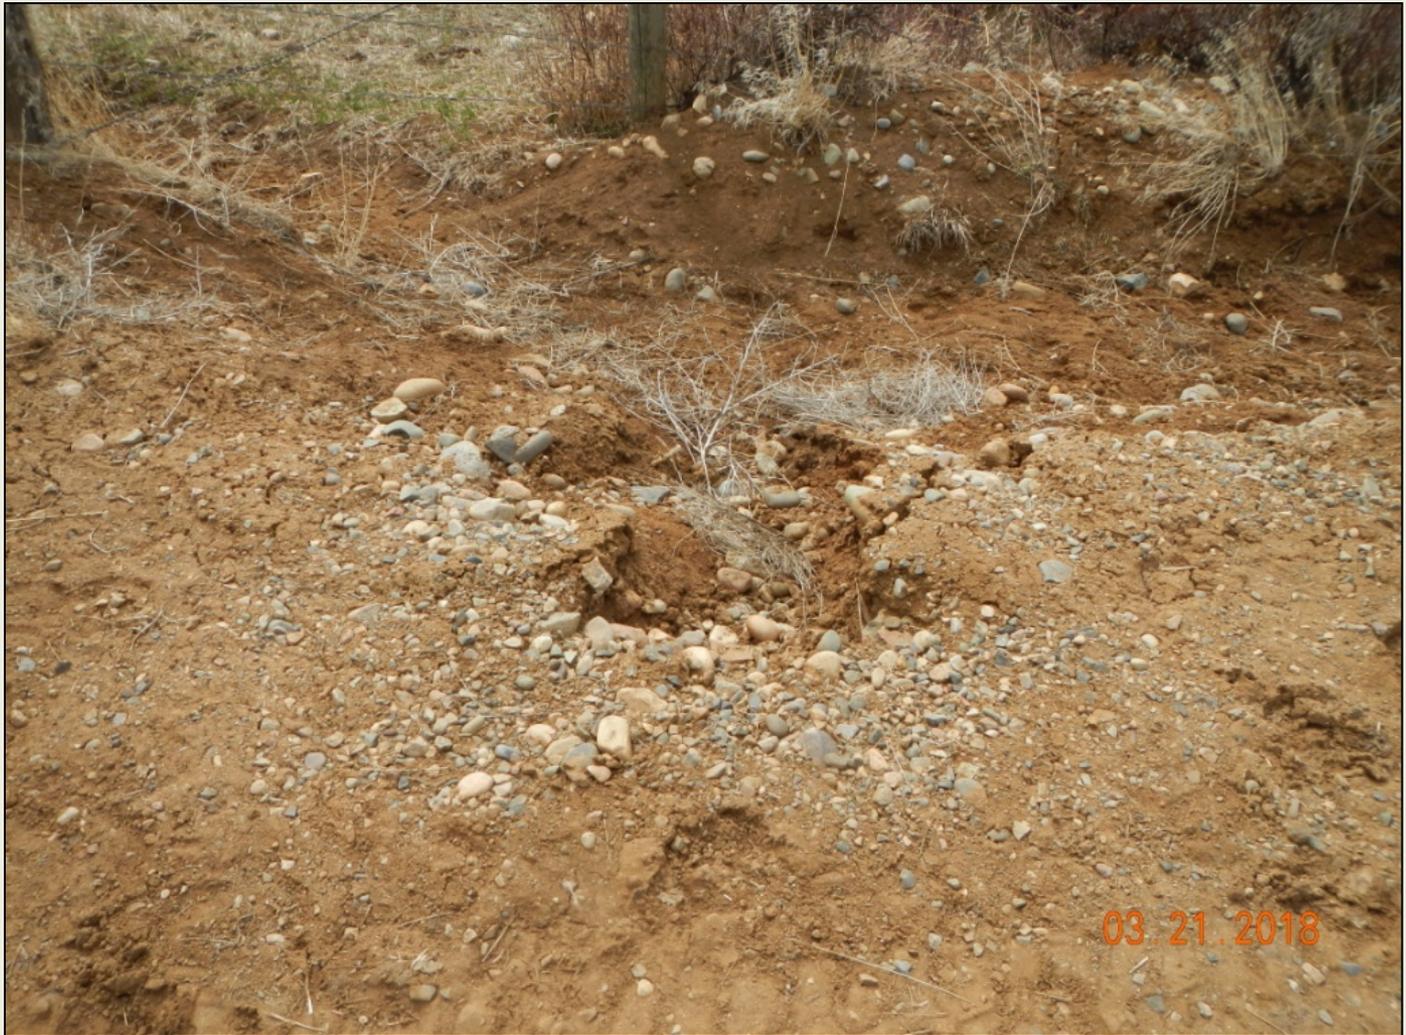
**Photo 5. View of another area in the southern project area where concentrated stormwater is eroding fill slopes.**
