Inspection Photos

API: 05-067-08408

Operator: BP AMERICA PRODUCTION
COMPANY

Inspection Date: 4/12/2018

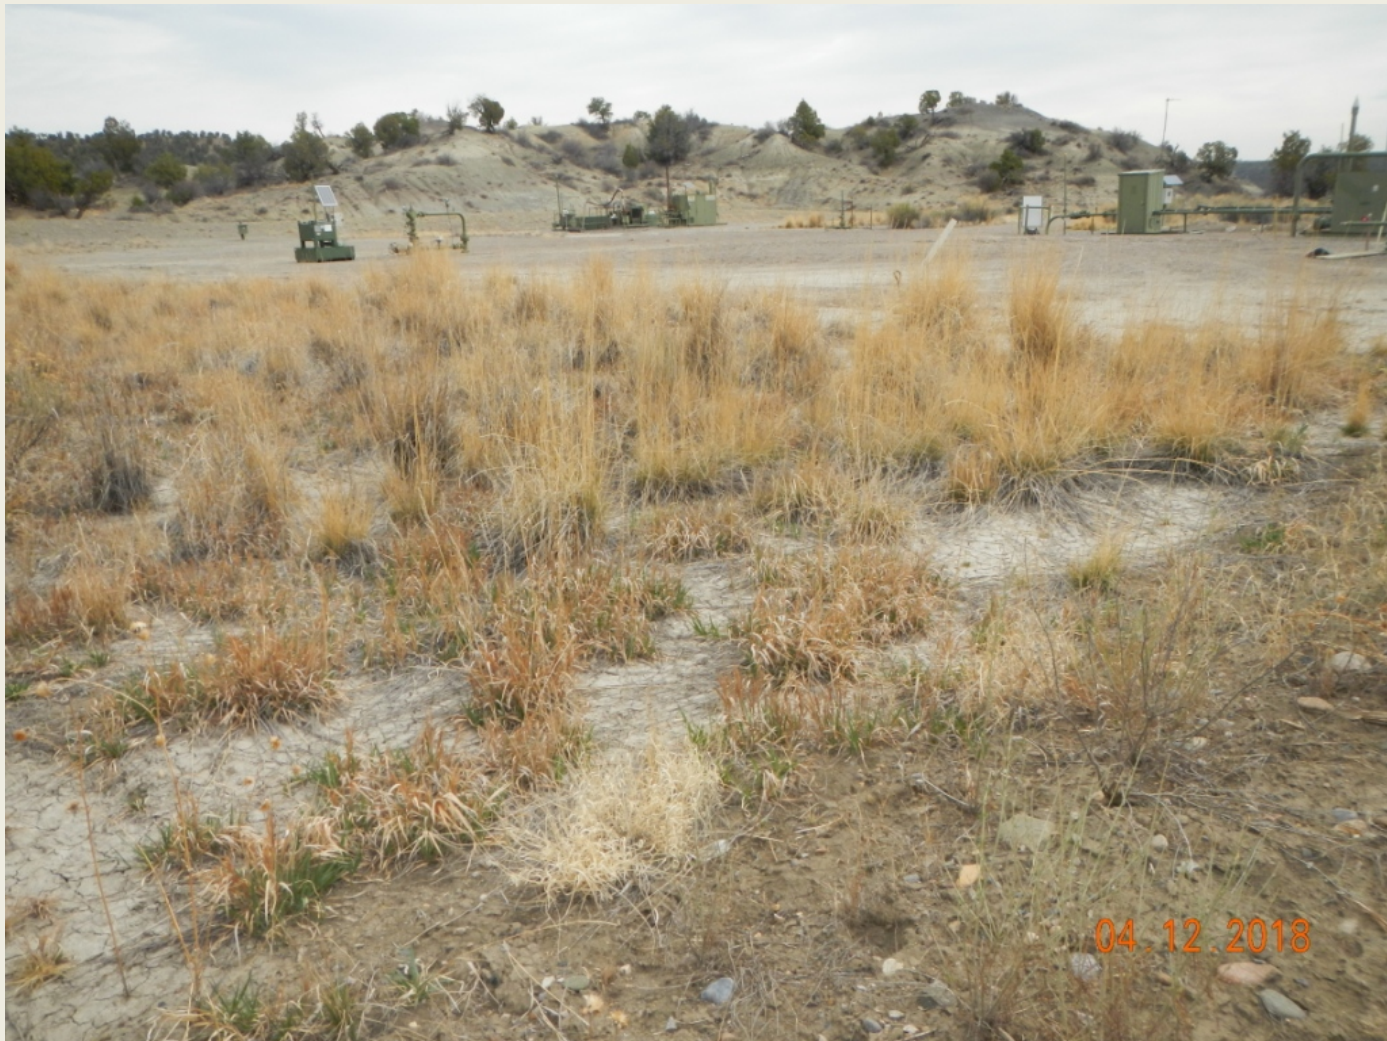
Photo 1. View of the project area from the southwestern corner facing center.

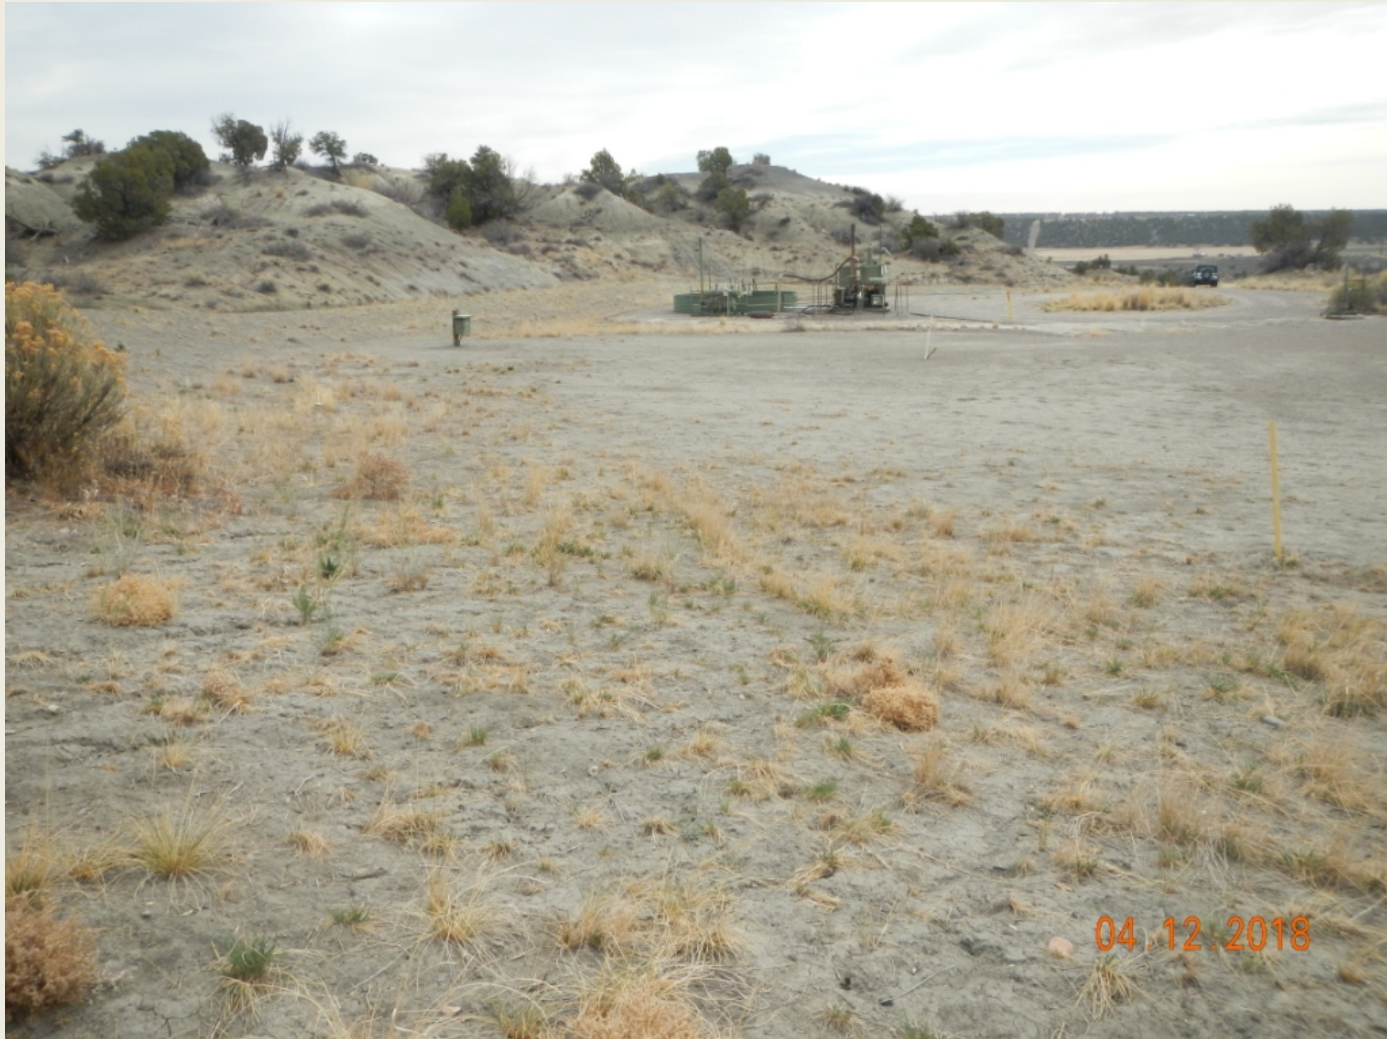
Photo 2. View of the northern project area from the western edge facing eastward. Area in the mid-ground of photo does not appear needed for production operations and needs revegetation. It is the responsibility of the two operators that share the well pad to determine revegetation responsibility.

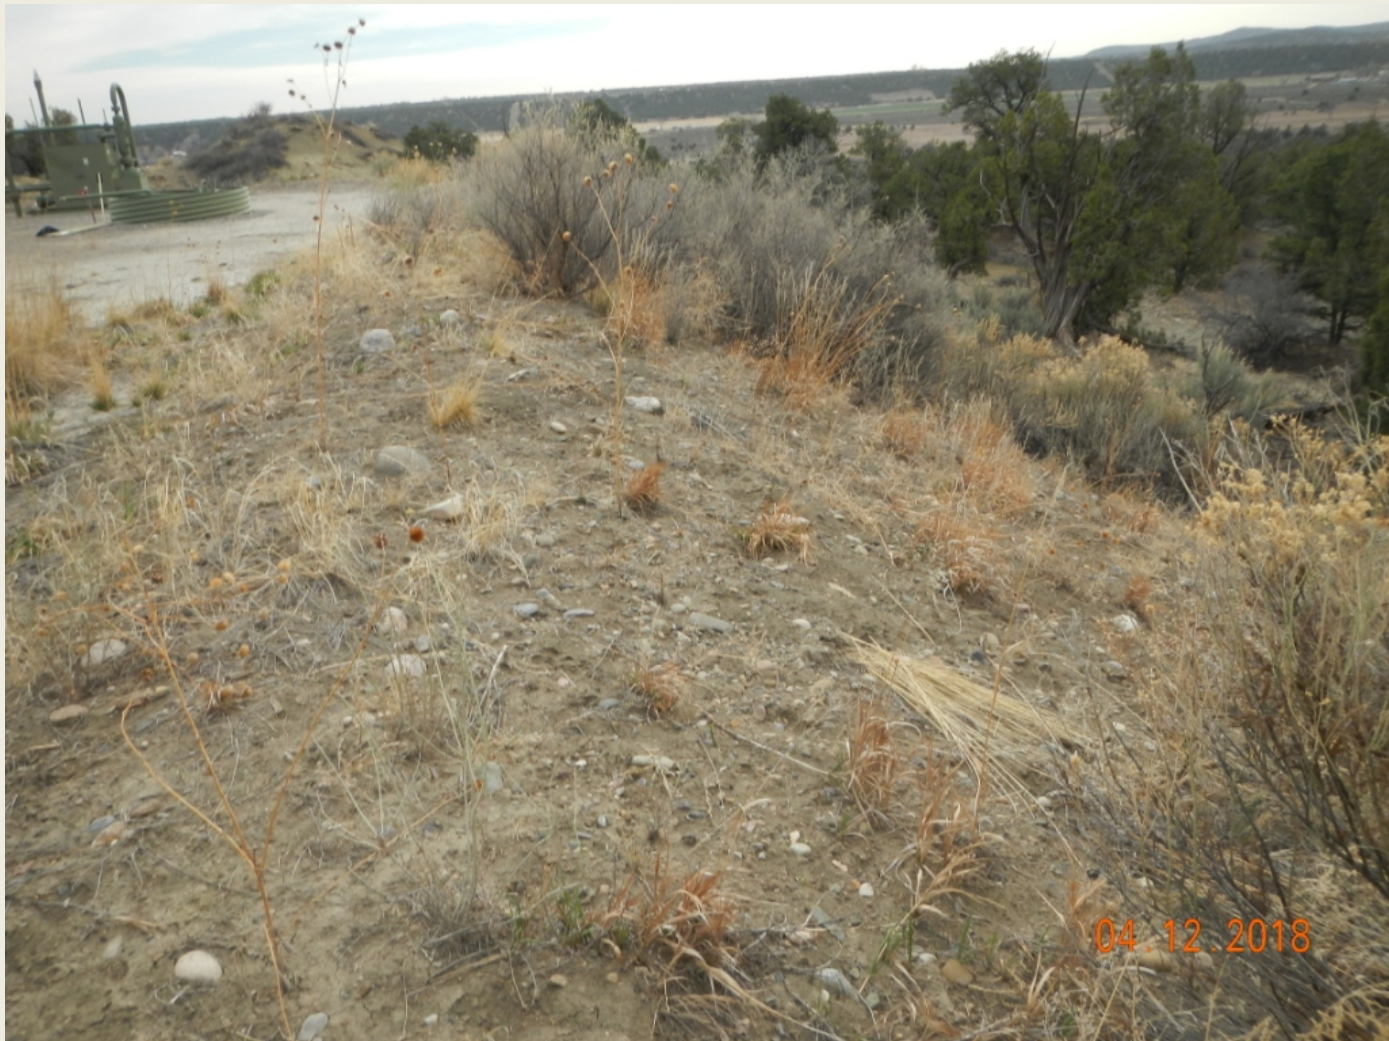
Photo 3. View of the southern portion of the project area from the southwestern corner facing eastward. Revegetation is progressing with smooth brome (*Bromus inermis*), western wheatgrass (*Pascopyrum smithii*), and Intermediate wheatgrass (*Thinopyron intermedium*), as well as rubber rabbitbrush (*Chrysothamnus nauseosus*).

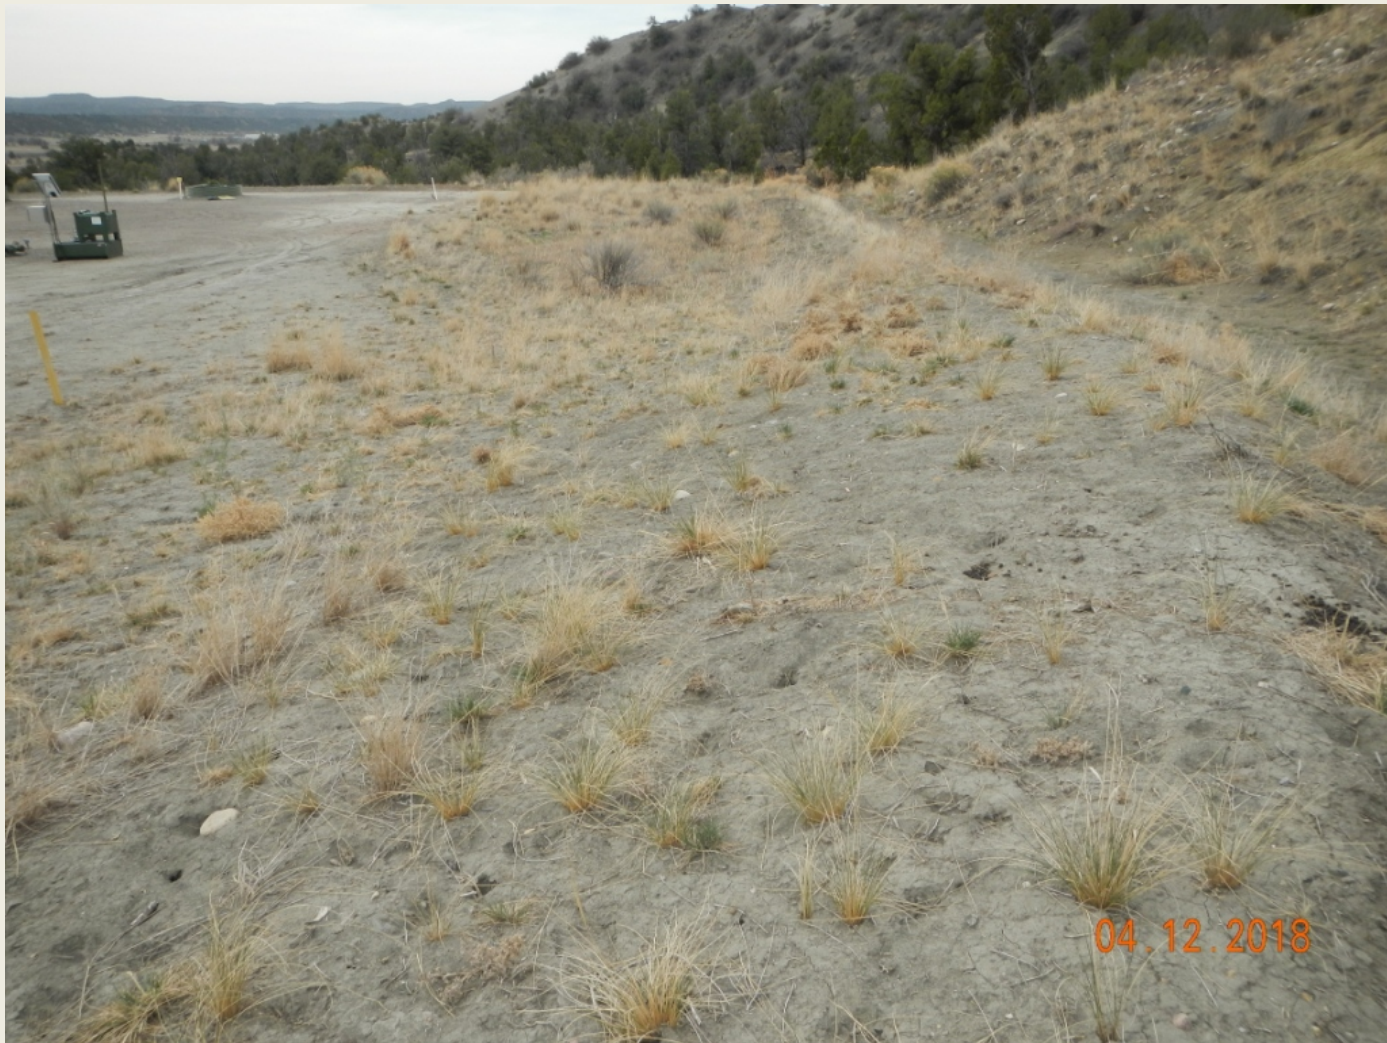
Photo 4. View of the western portion of the interim reclamation area from the northwestern edge facing southward.

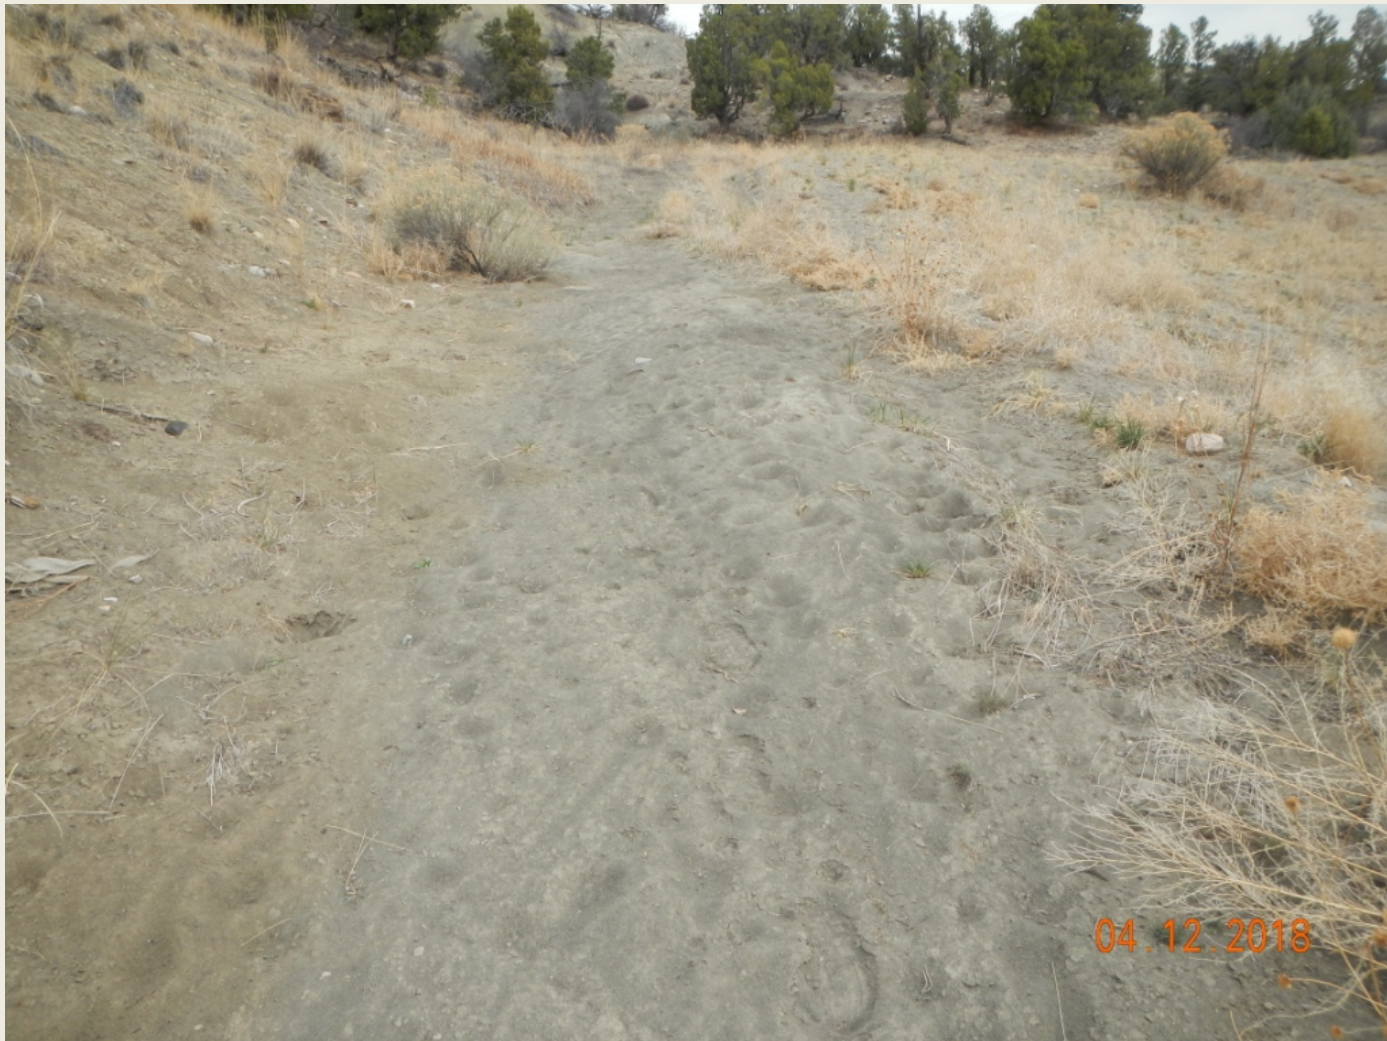
Photo 5. View of western diversion that is filled with sediment and needs maintenance.

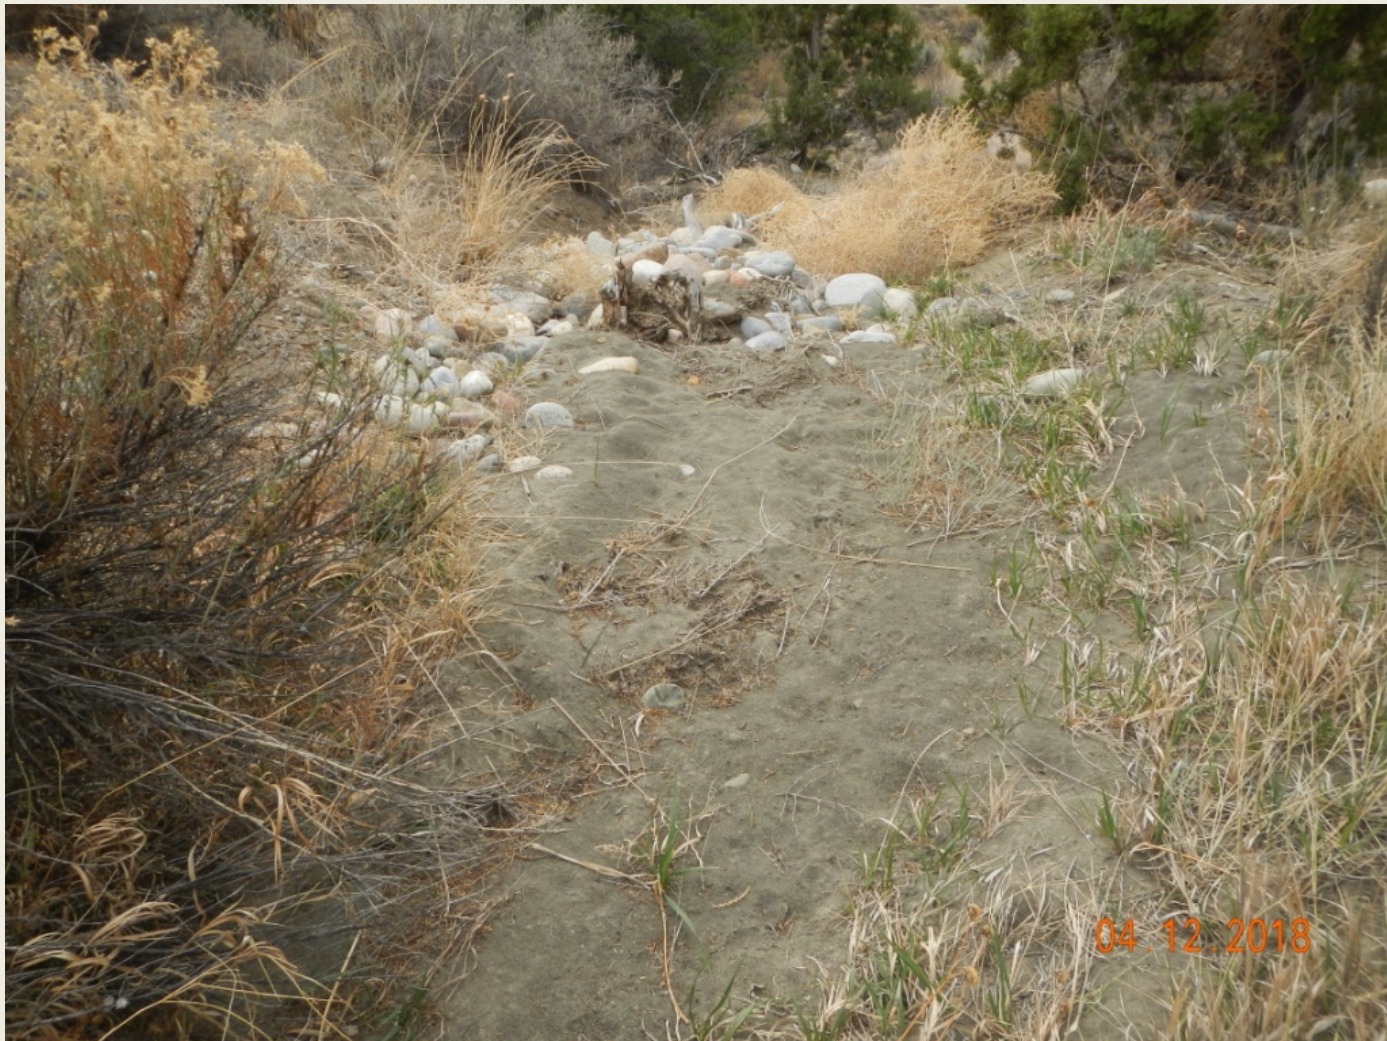
Photo 6. View of cobble run-down that is full of sediment and needs maintenance. Does not appear sufficient for sediment control.

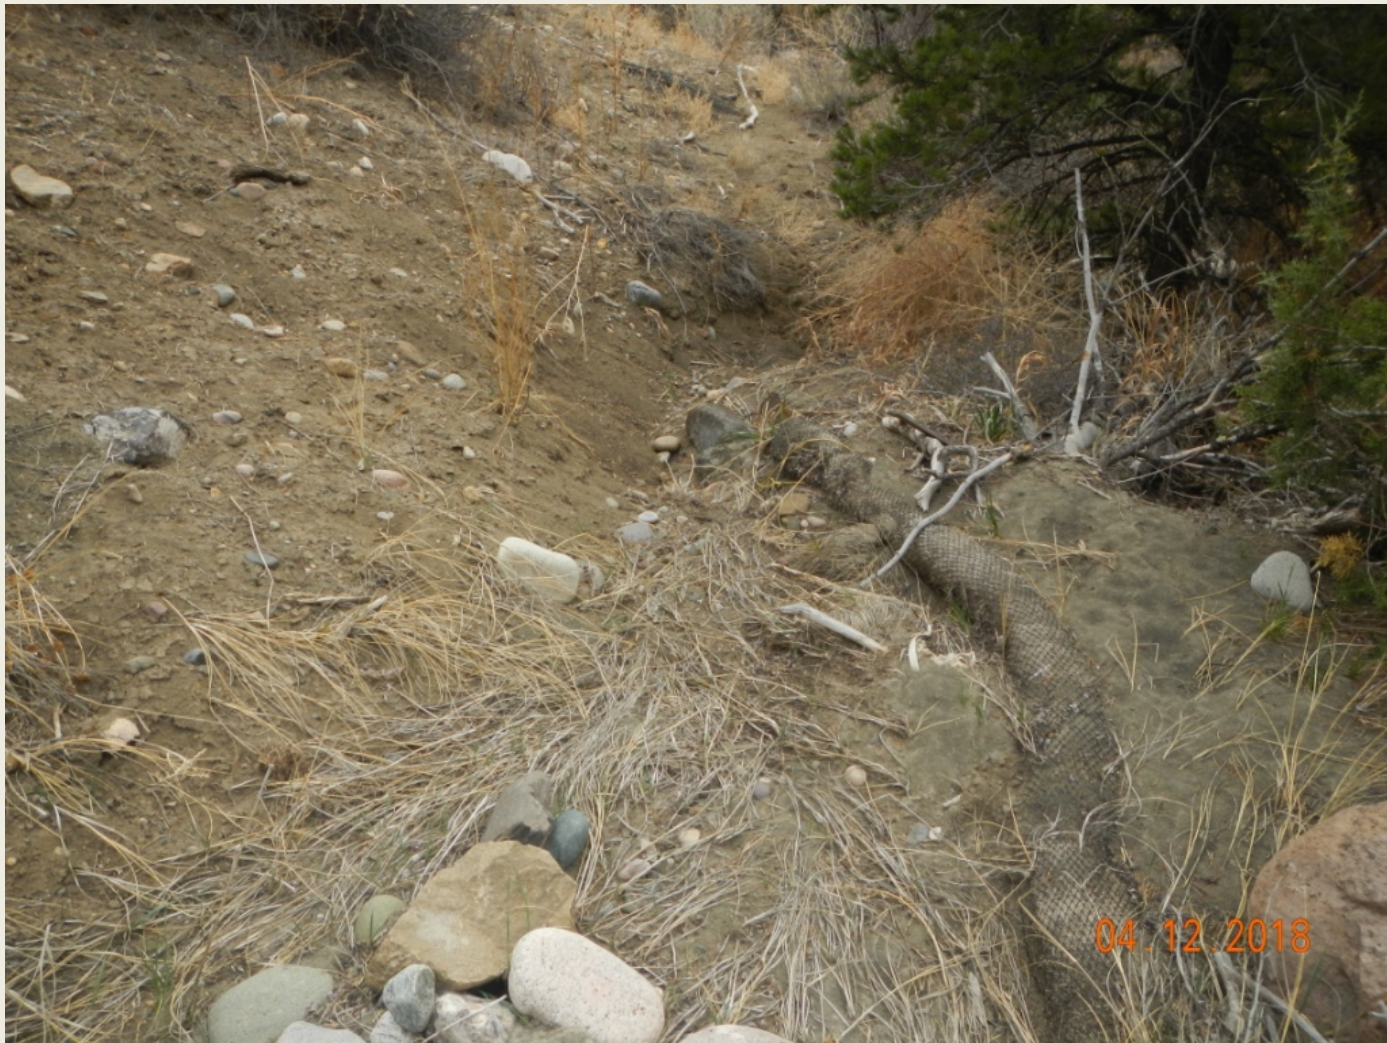
Photo 7. View of wattle failure and erosion occurring in the southwestern portion of the project area.

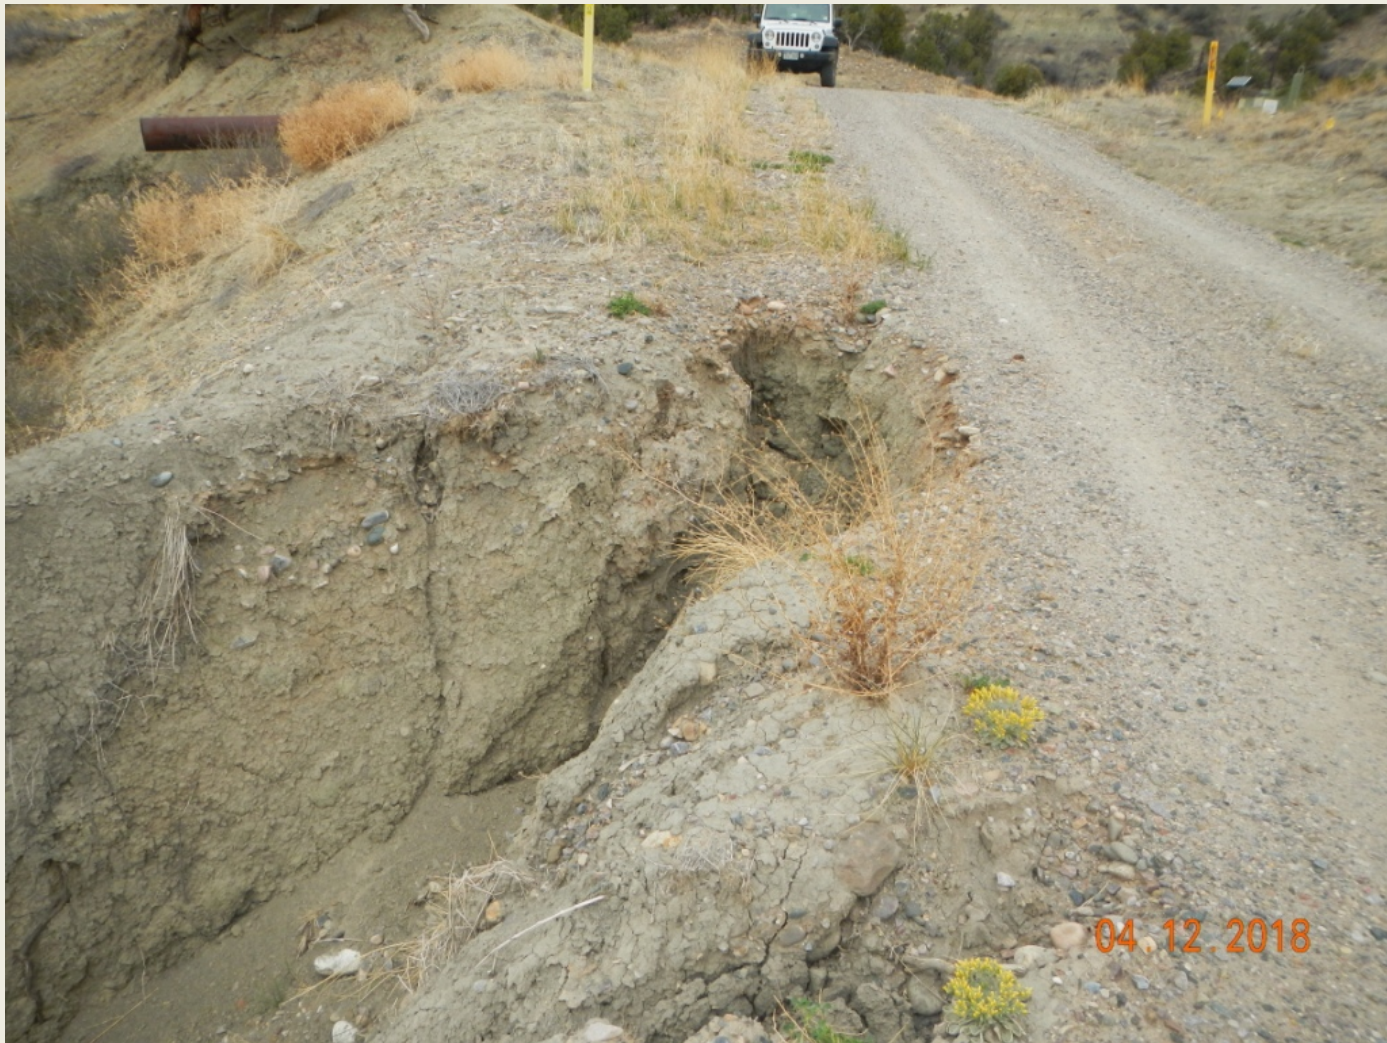
Photo 8. View of erosion occurring on the access road near the well pad entrance.

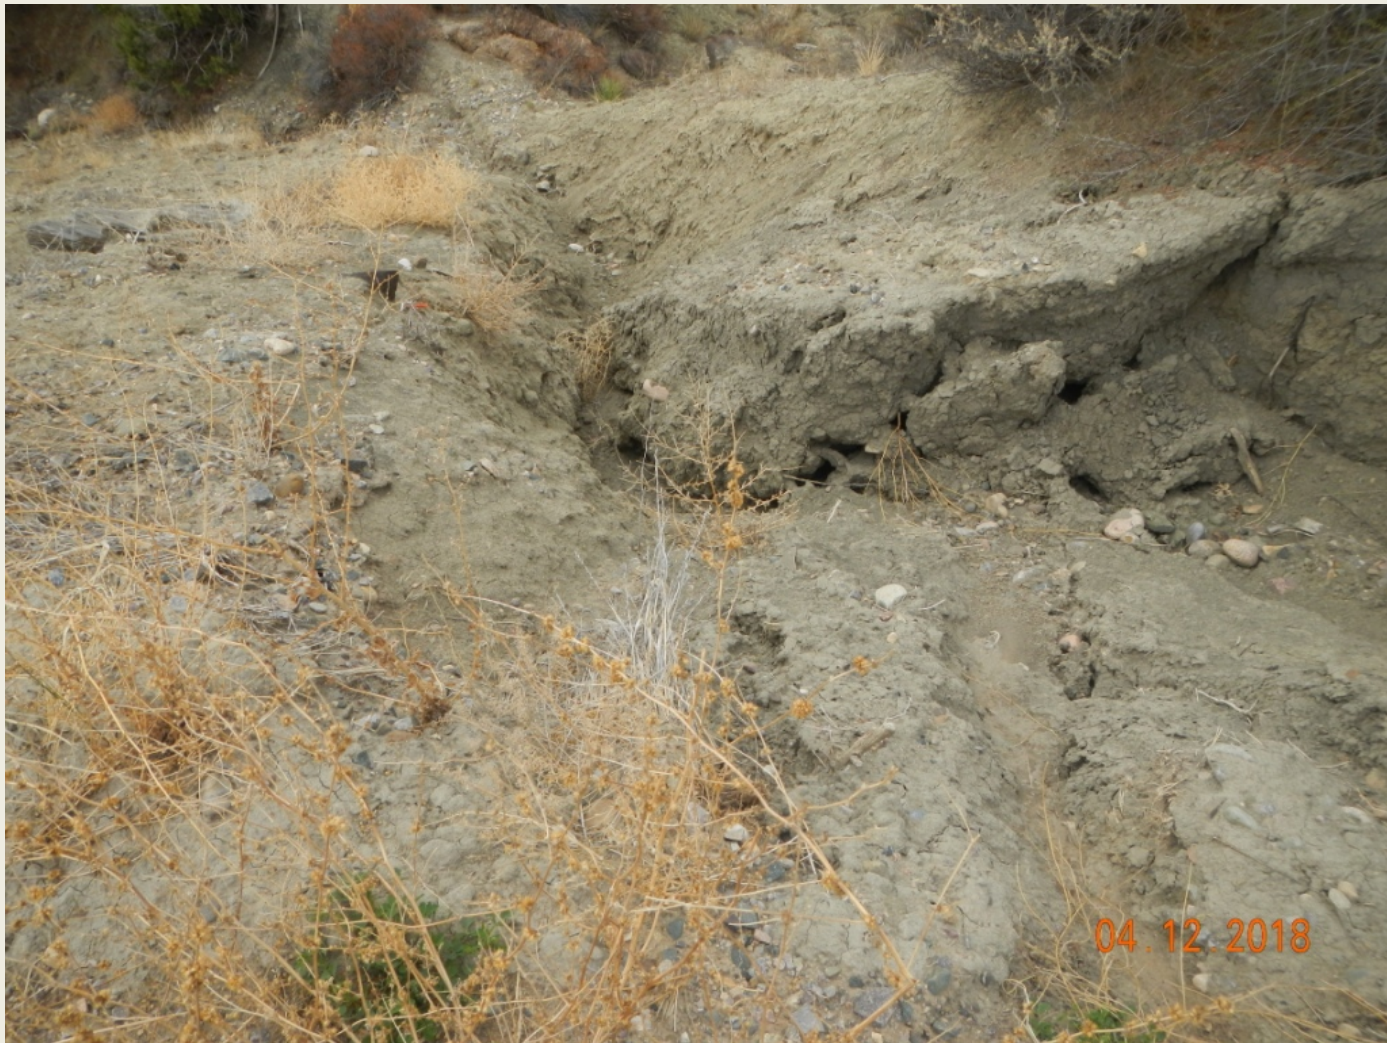
Photo 9. View of an erosional channel up to approximately 3 feet deep along the access road, facing down-slope.

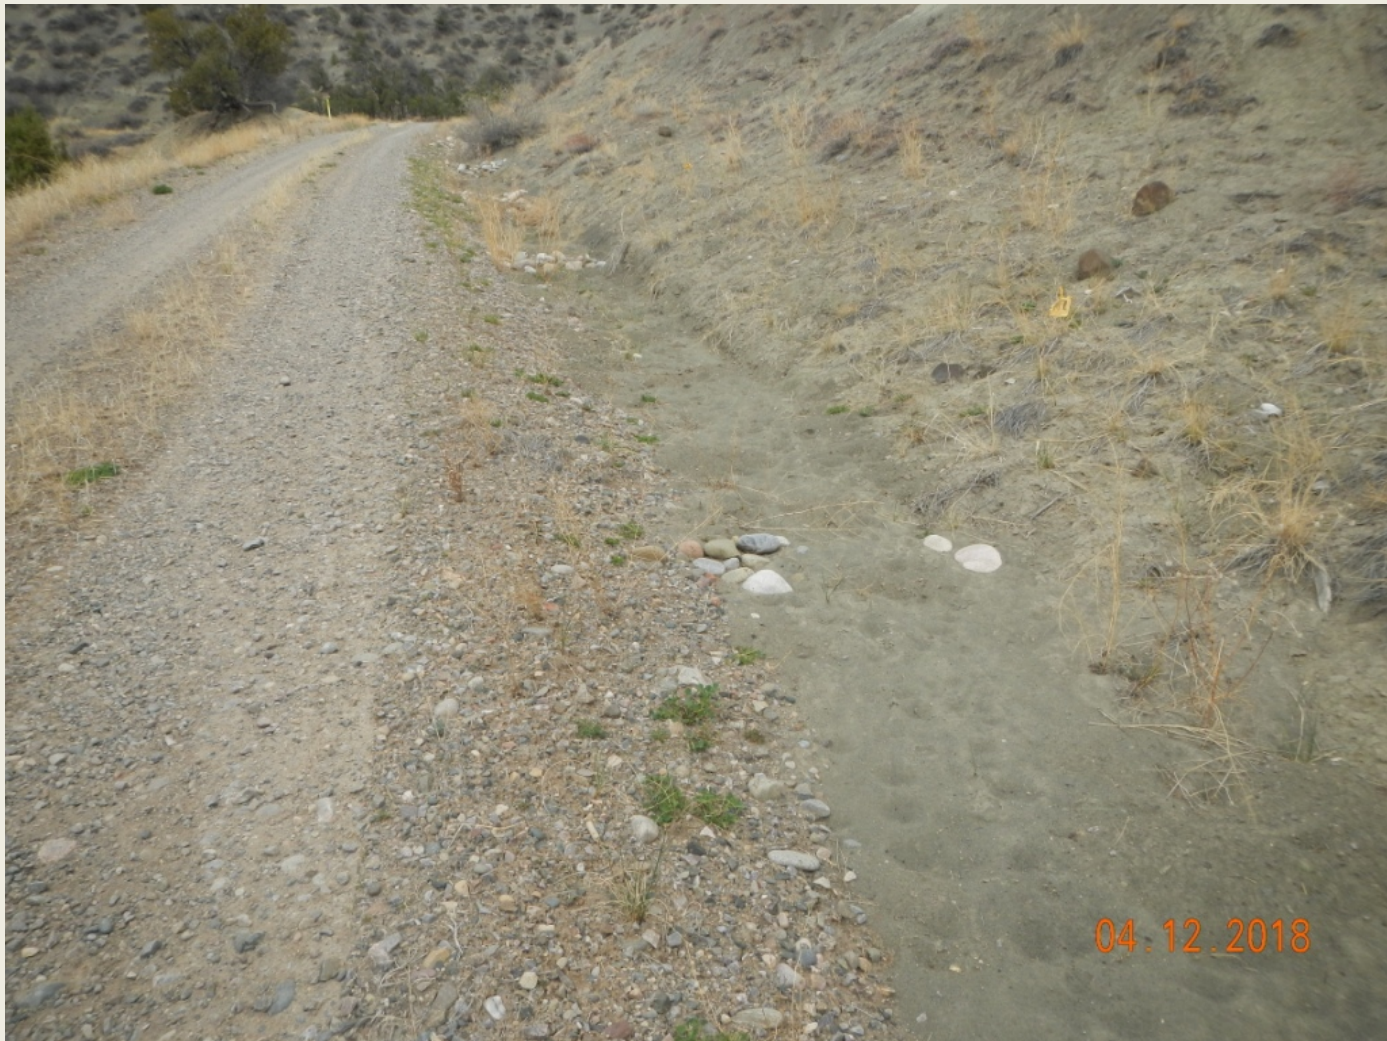
Photo 10. View of cobble check dams along the access road, full of sediment needing maintenance/repair.

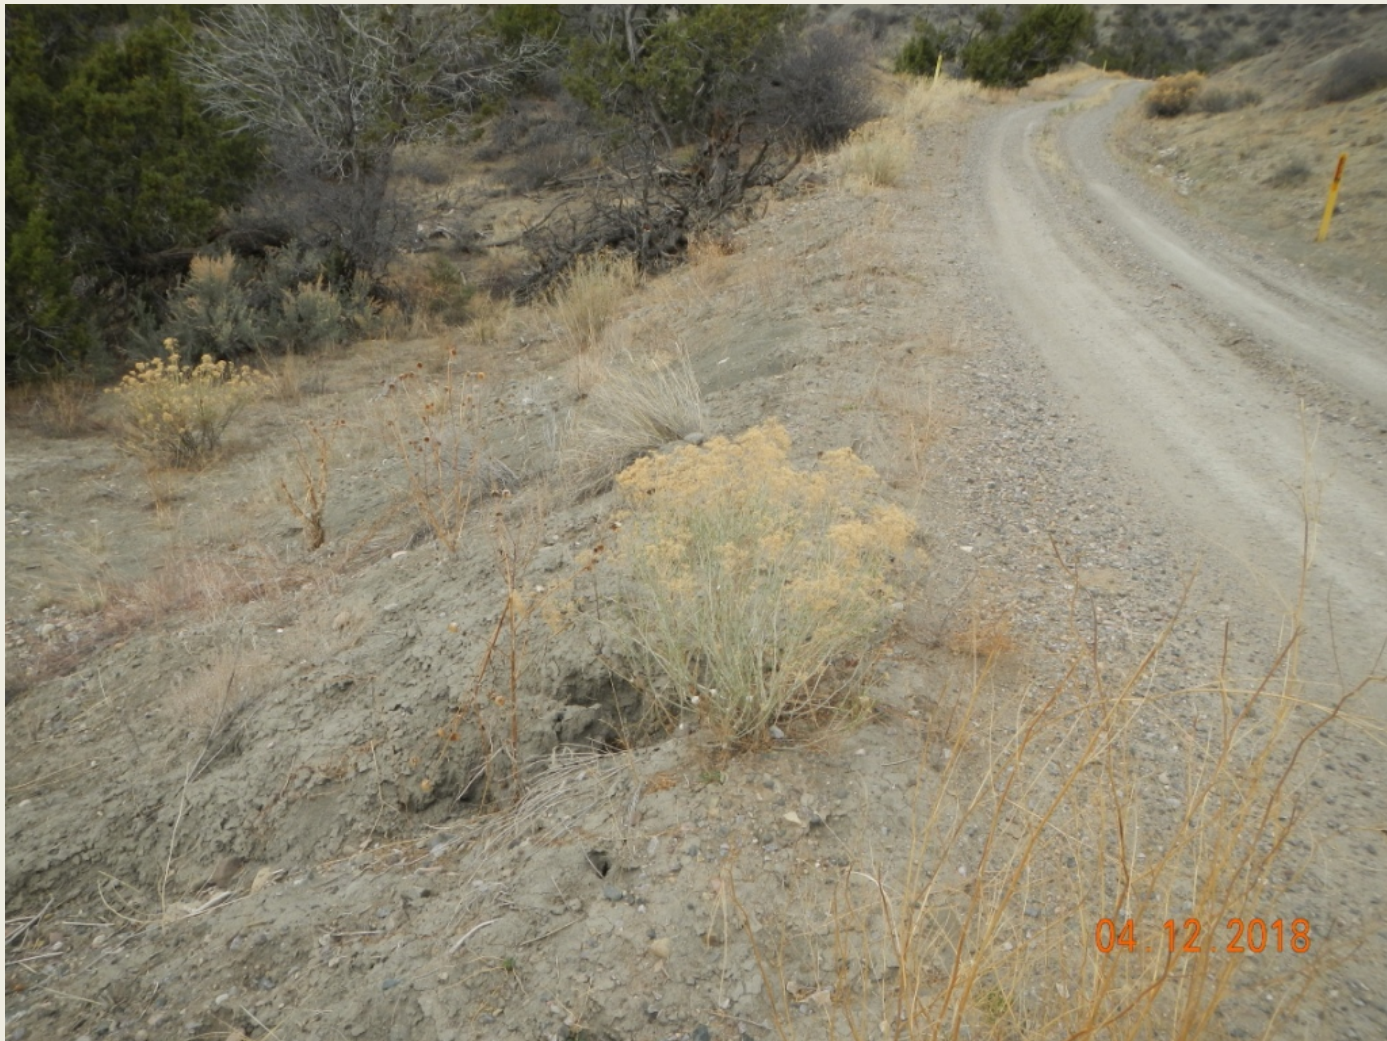
Photo 11. View of erosional rilling along the access road, needs stabilization.
