Inspection Photos

API: 05-067-06439

Operator: HILCORP ENERGY COMPANY

Inspection Date: 4/12/2018

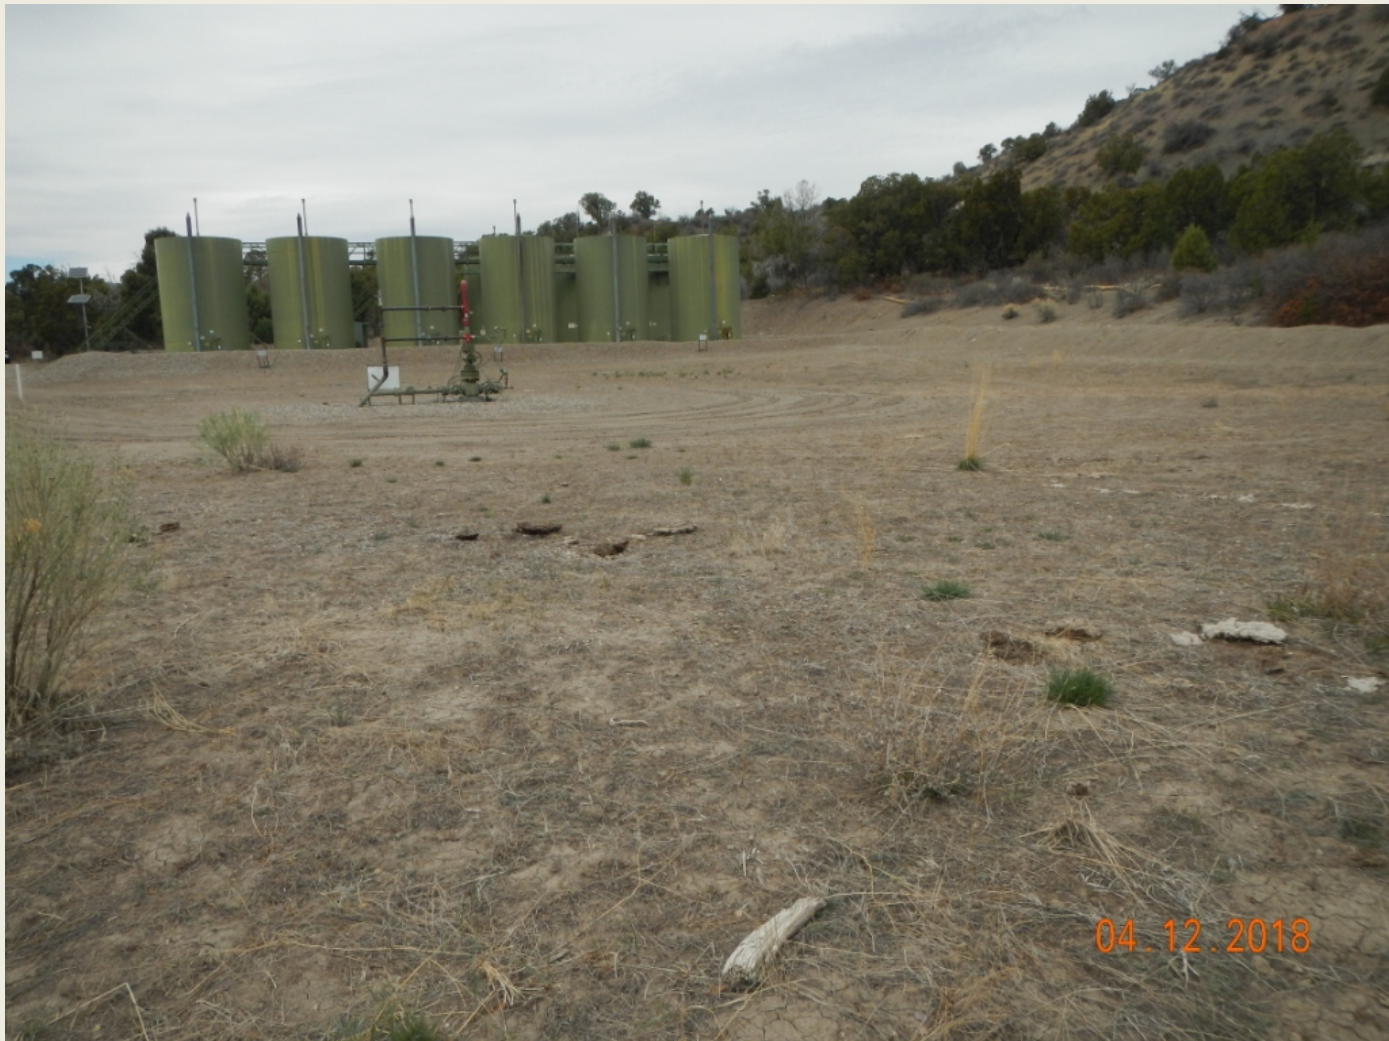
Photo 1. View of the southern portion of the project area from the northeastern corner facing center. Revegetation is sparse on flat well pad areas and needs to be monitored during the 2018 growing season and re-seeded as needed.

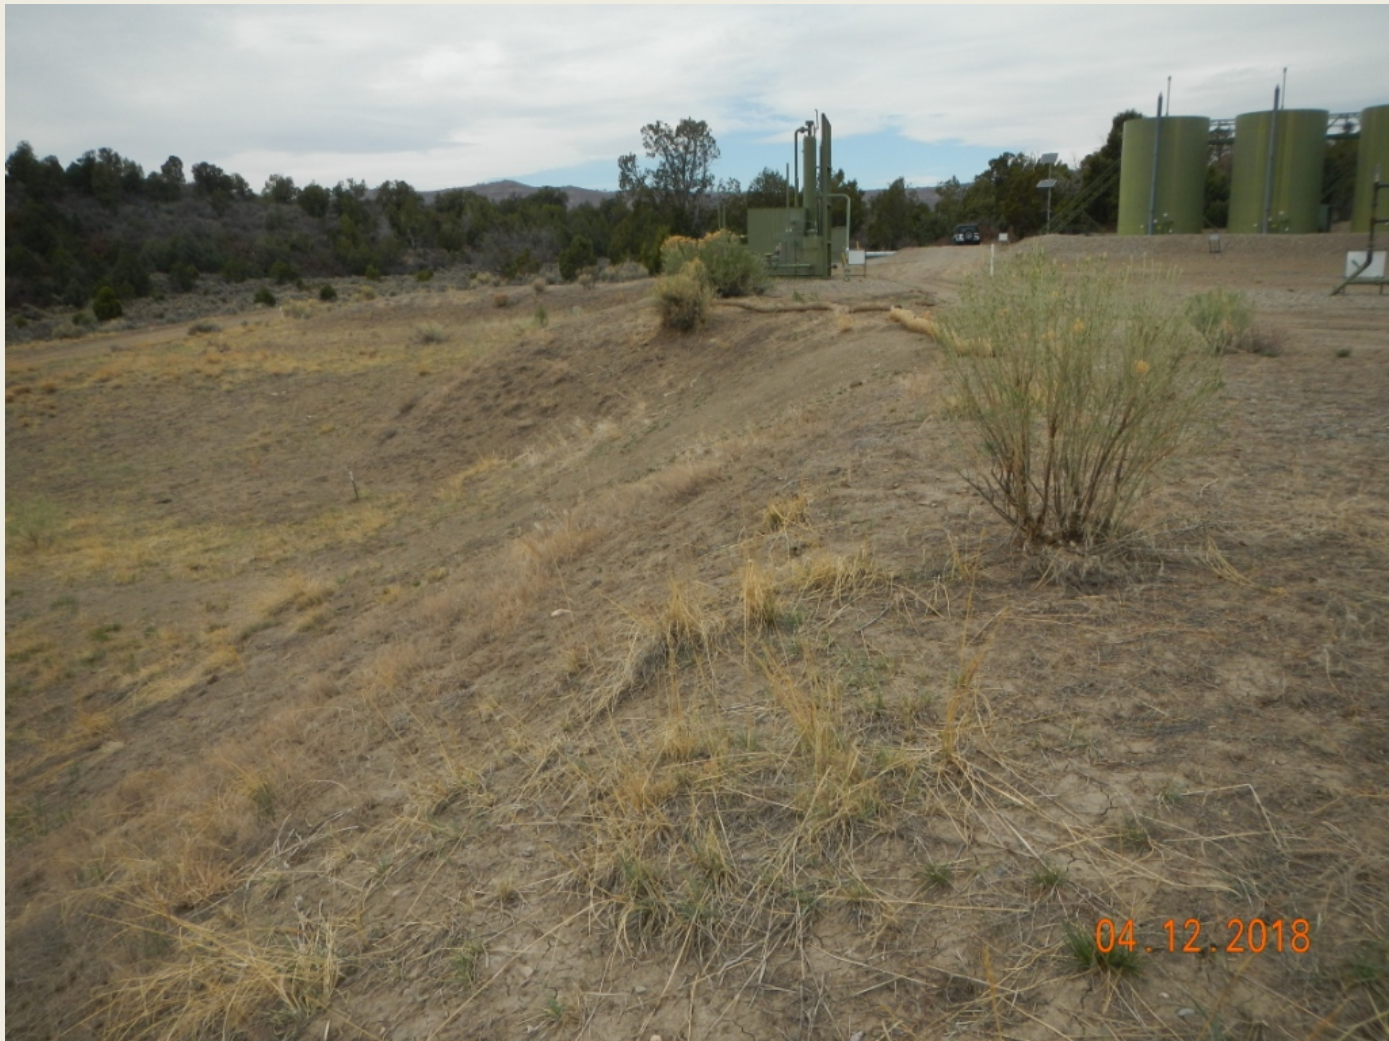
Photo 2. View of the southern portion of the project area from the southeastern corner facing westward. Temporary stormwater controls are installed along the southern edge of the working surface. This will need careful monitoring and maintenance or more permanent stormwater controls if erosion is occurring.

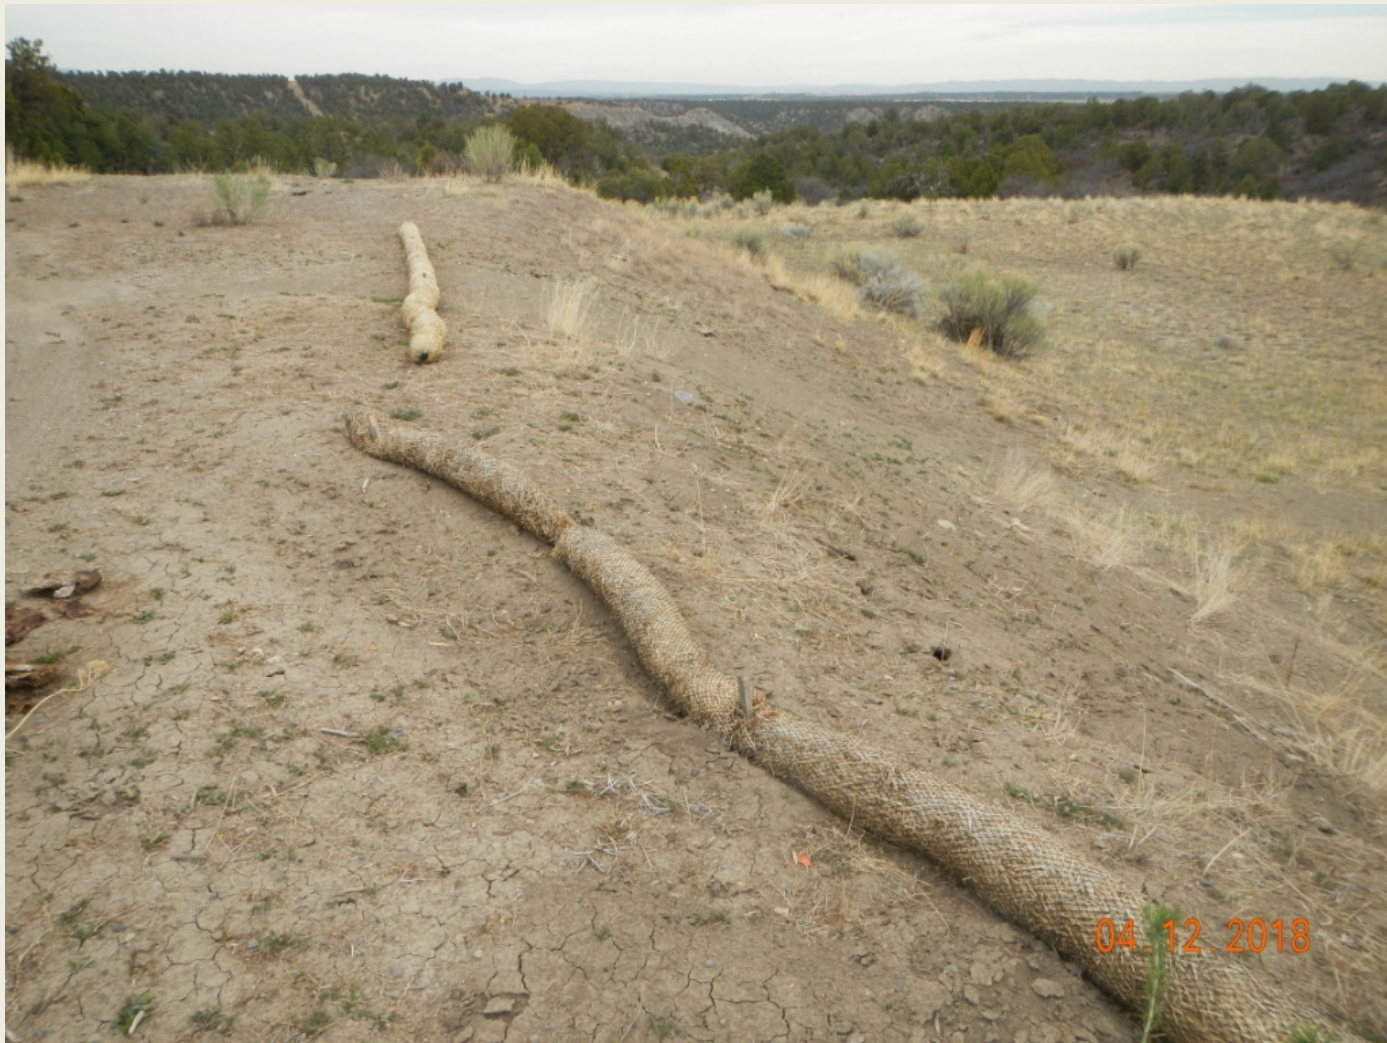
Photo 3. Close-up view of wattles and recently repaired erosional channel in the southern project area.

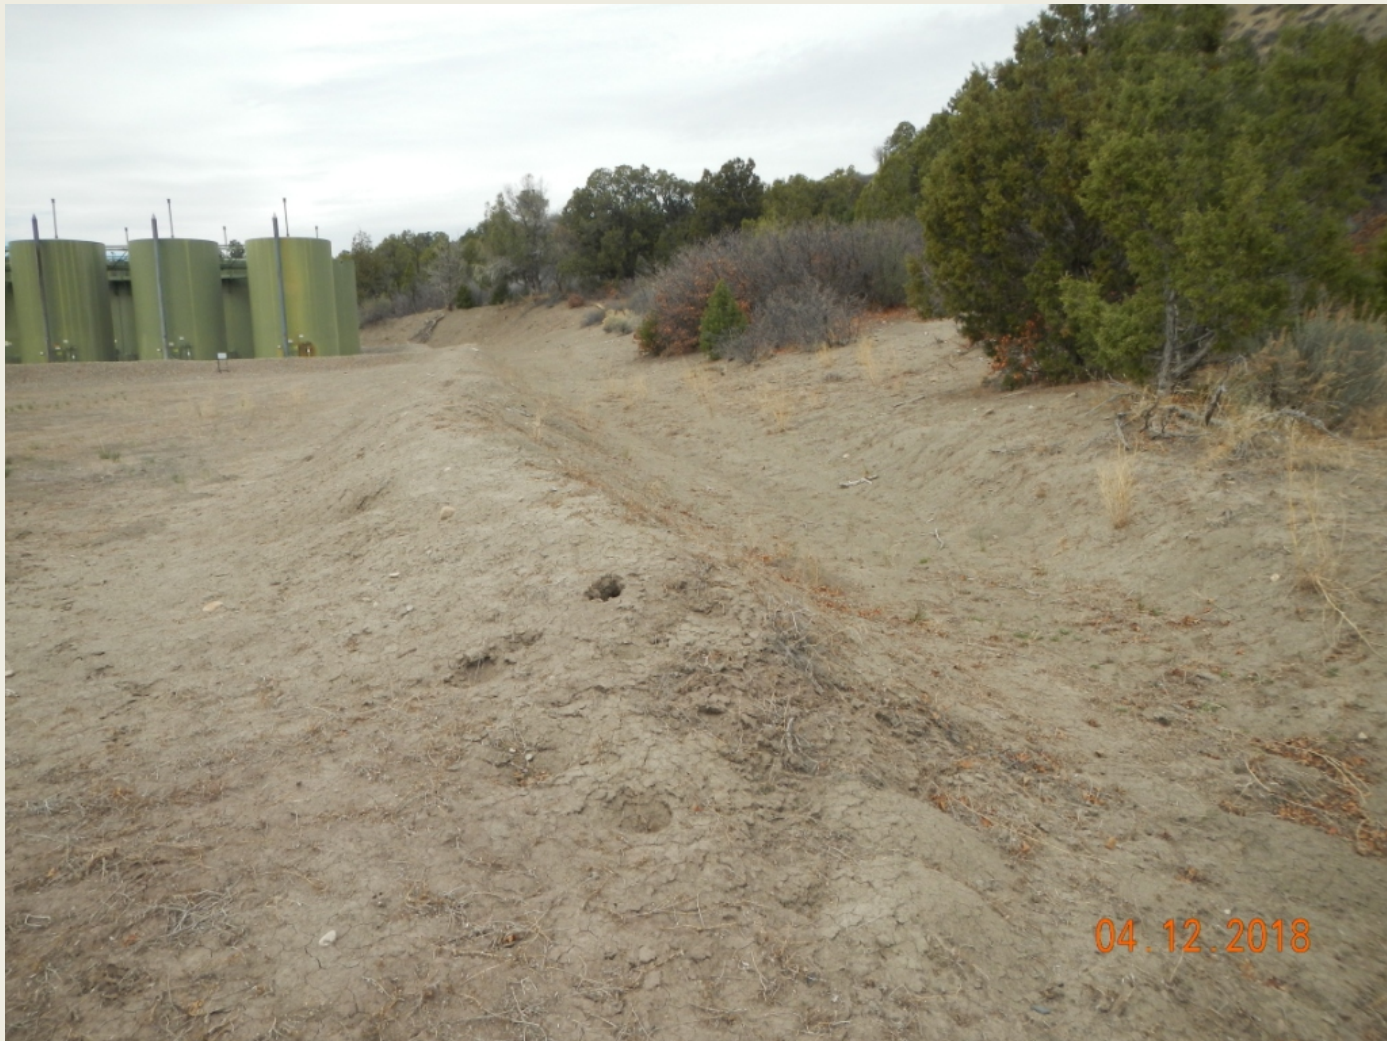
Photo 4. View of the northern project area from the northeastern corner facing westward. Berms do not appear properly stabilized and diversion channel is full of sediment.

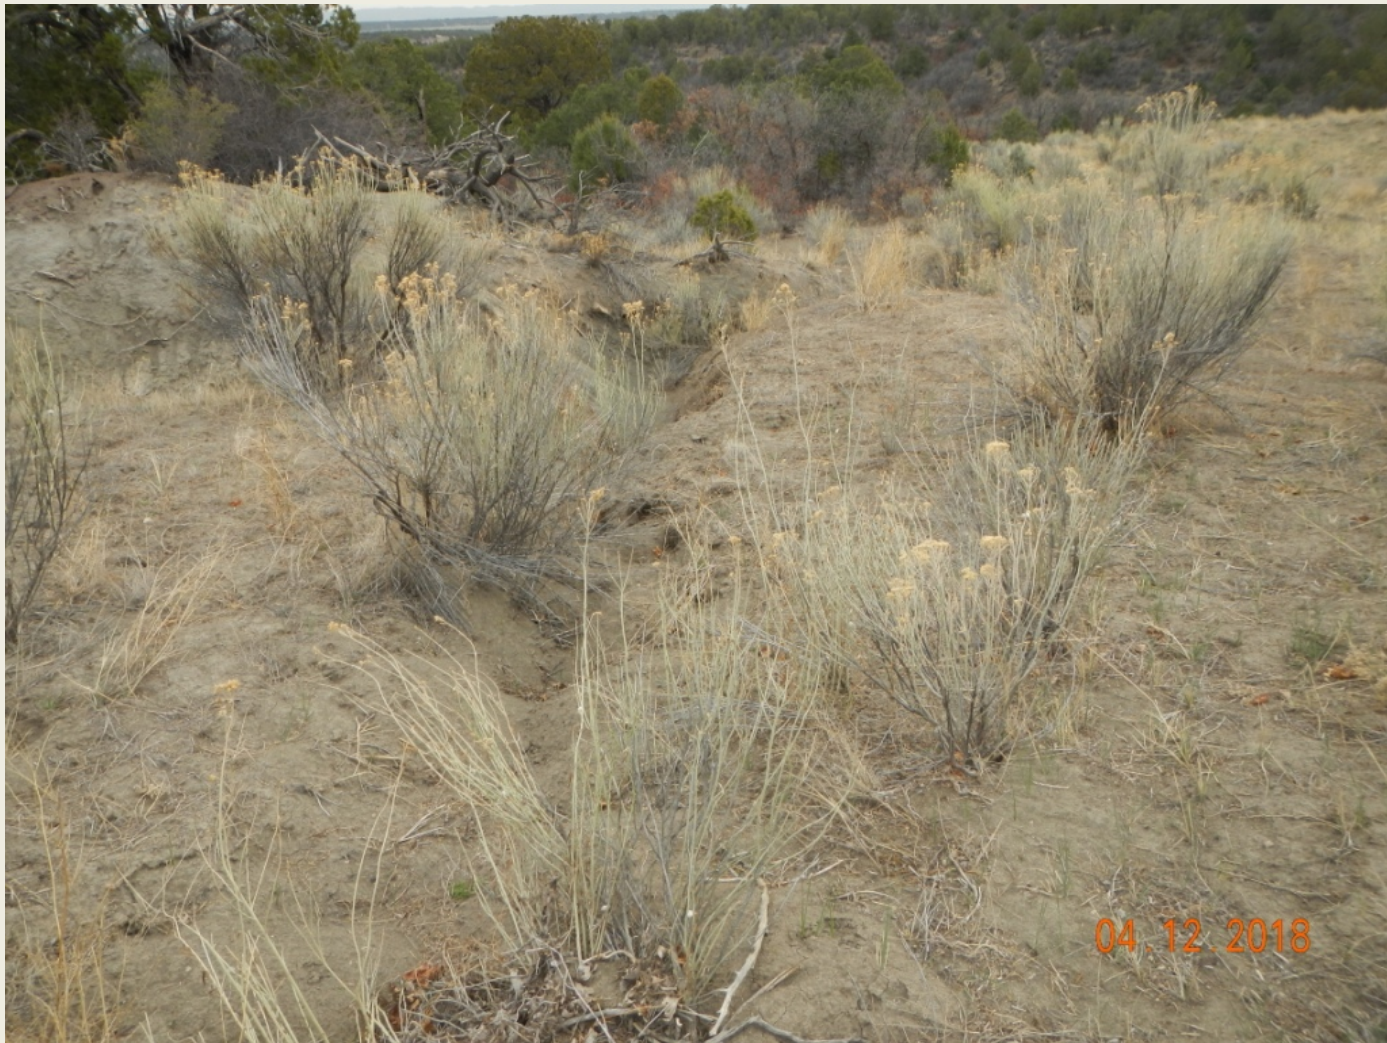
Photo 5. View of erosional channel where concentrated stormwater from well pad diversion erodes the northeastern corner of the project area. Stormwater controls are needed to de-energize flows and contain sediment.

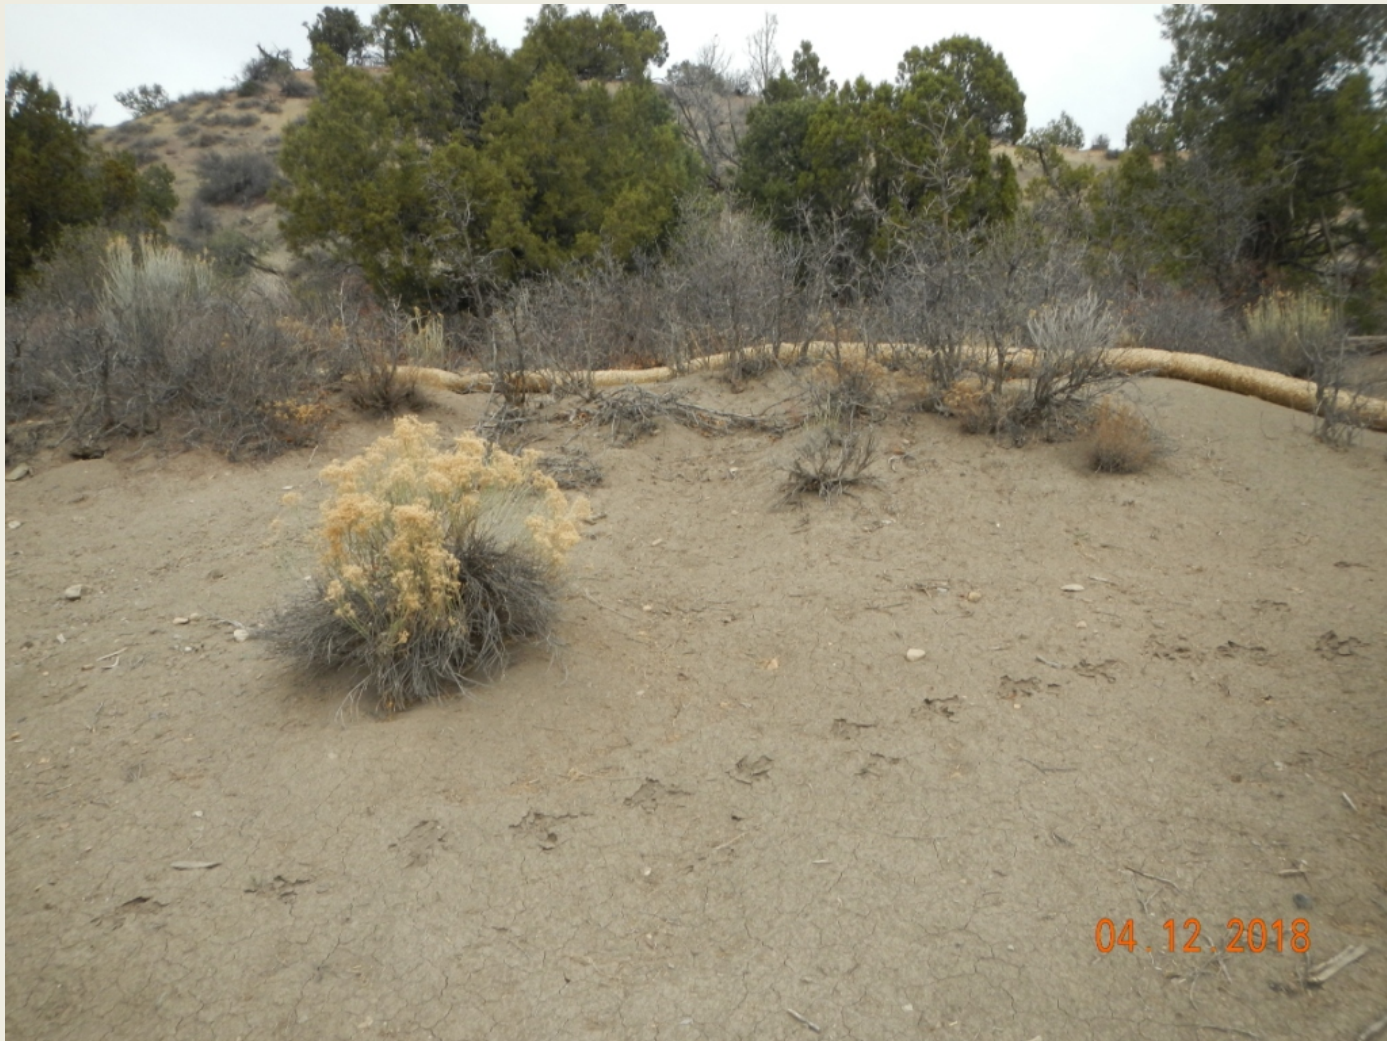
Photo 6. View of run-on controls installed in the northern portion of the project area. Cut-slope (downstream of wattles) is not stabilized.

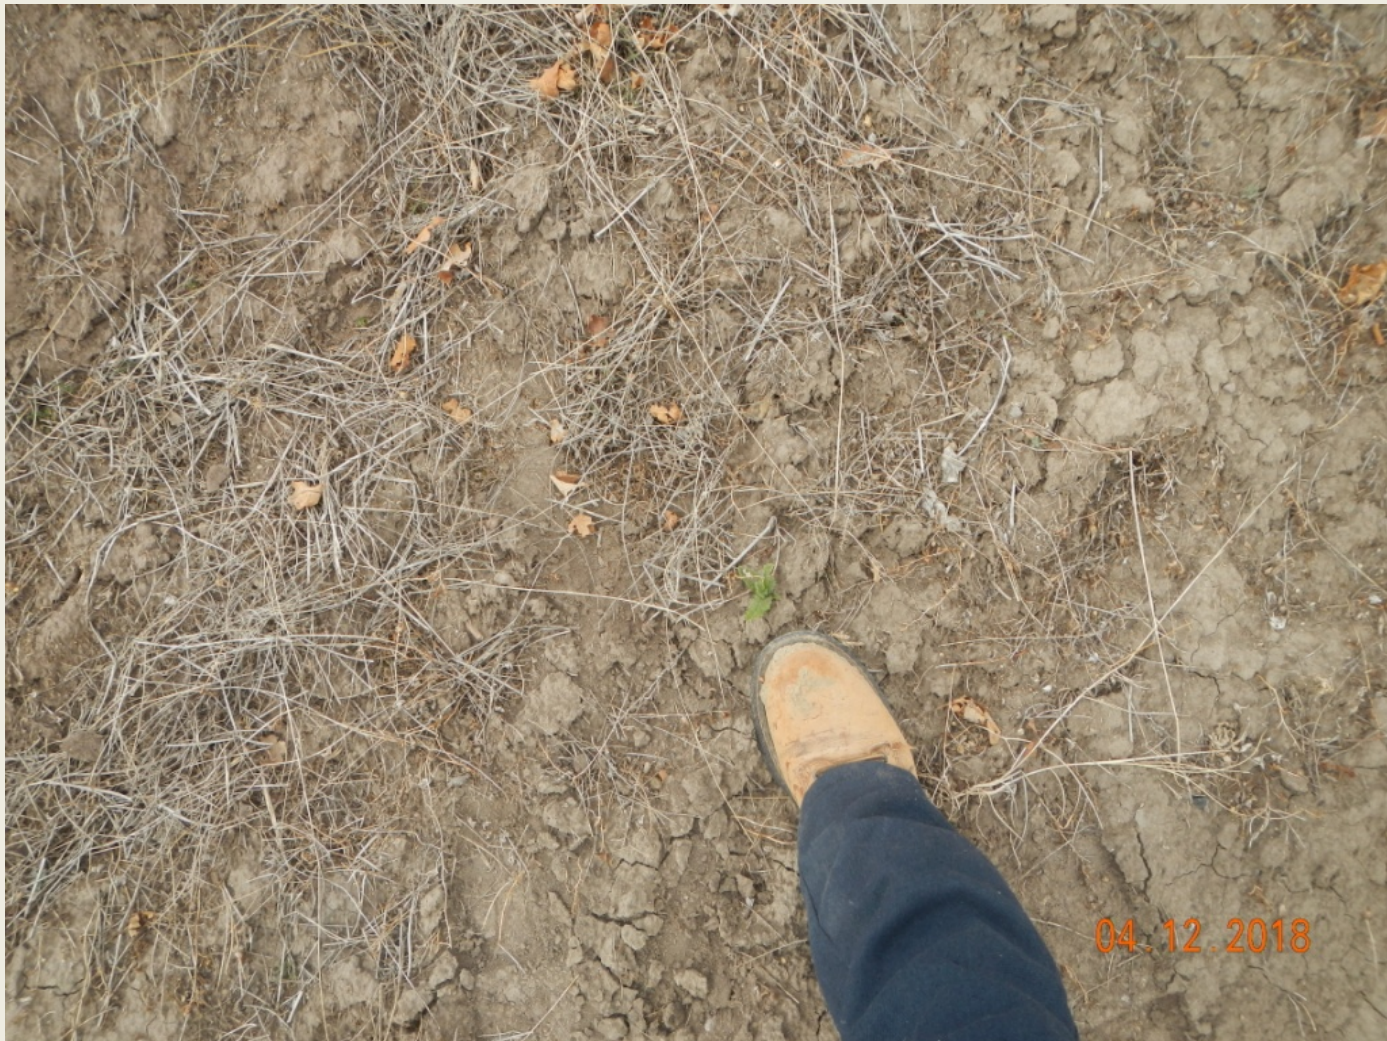
Photo 7. View of young Canada thistle (*Cirsium arvense*) in the northeastern portion of the project area.
