# Final Reclamation and Stormwater Inspection

April 20, 2018

Operator: PETROSHARE CORPORATION- 10454

API: 05-039-06428

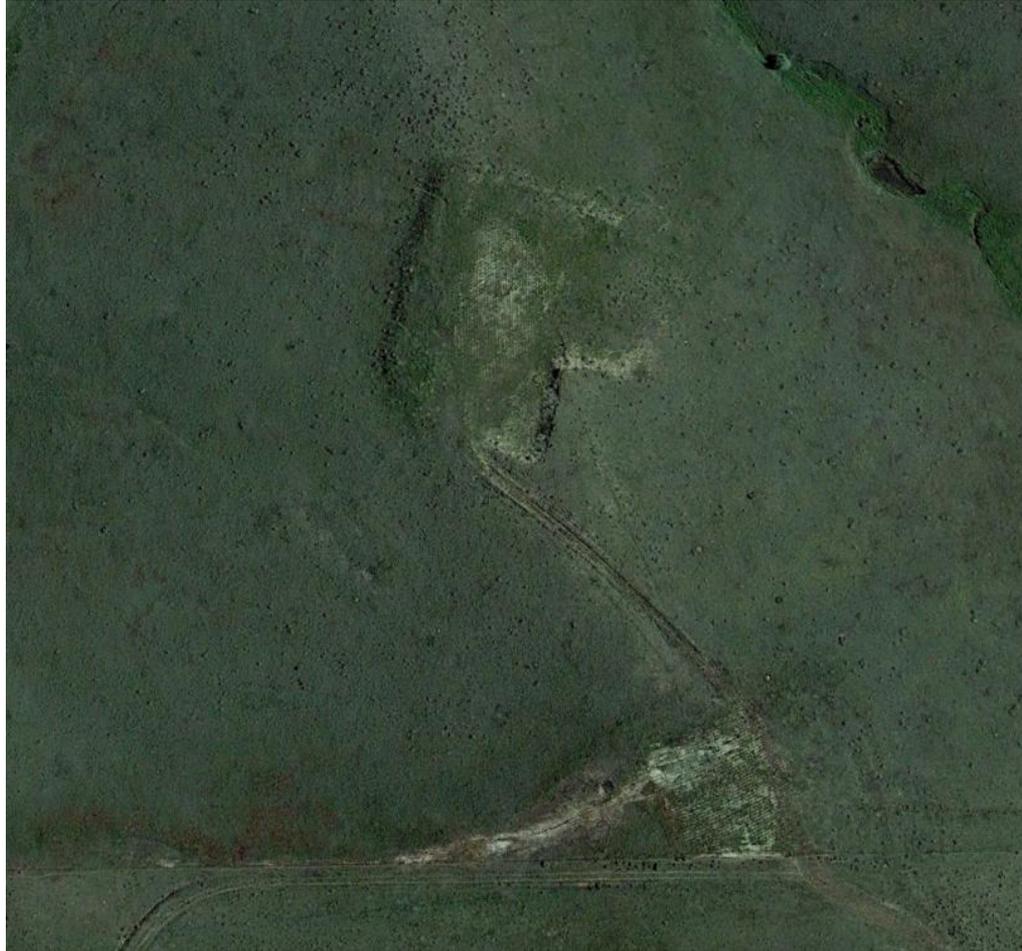
Google Earth aerial imagery taken 6/15/2010 illustrating well and battery location after the location was plugged in 2003. Both the well and battery locations do not meet Rule 1004 standards.

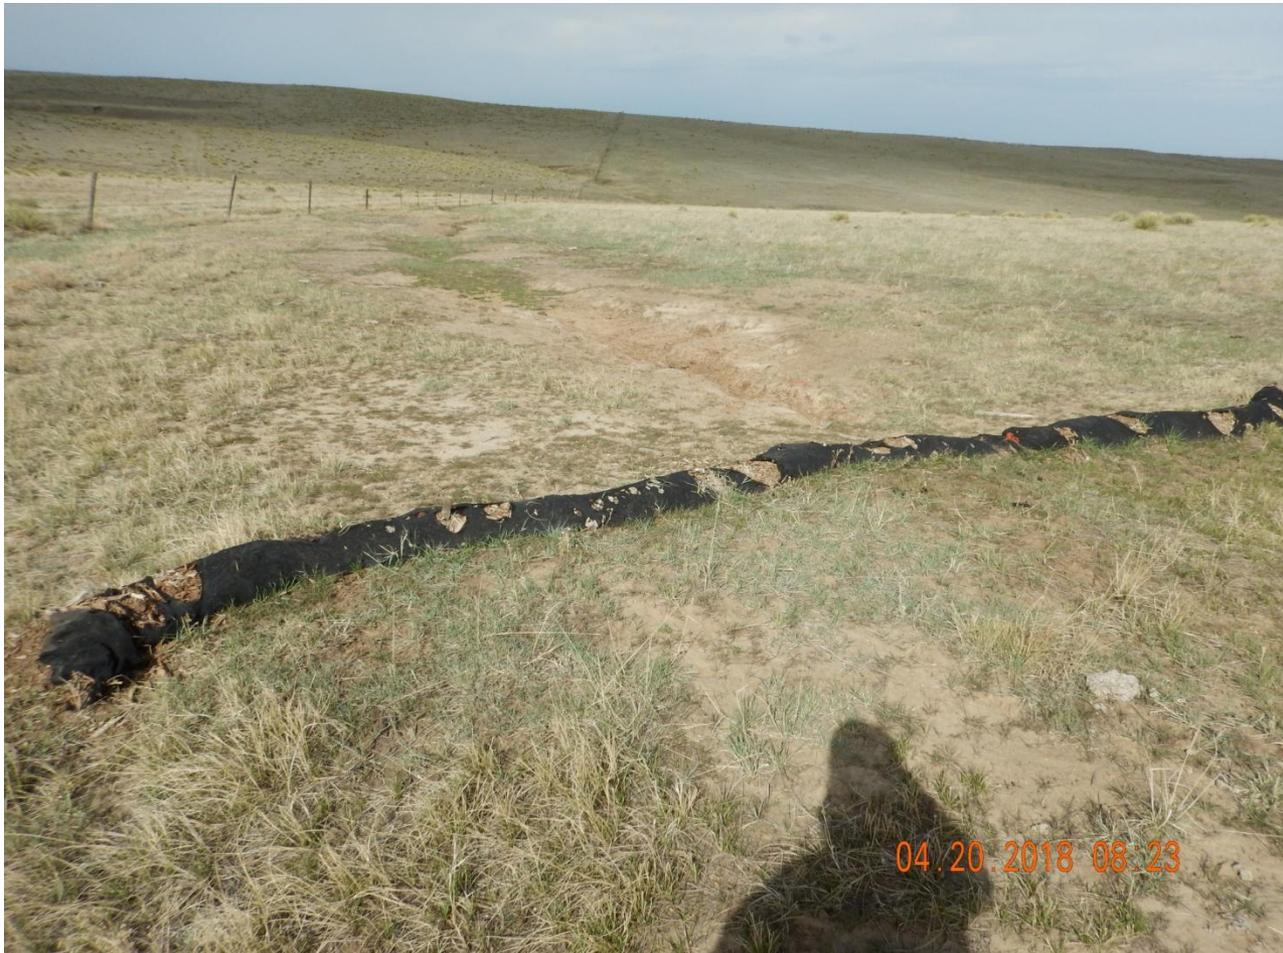
**Photo 1.** Photo taken from the western battery location, facing West. Gully erosion is evident and BMP is in disrepair. Operator has failed to complete final reclamation activities.

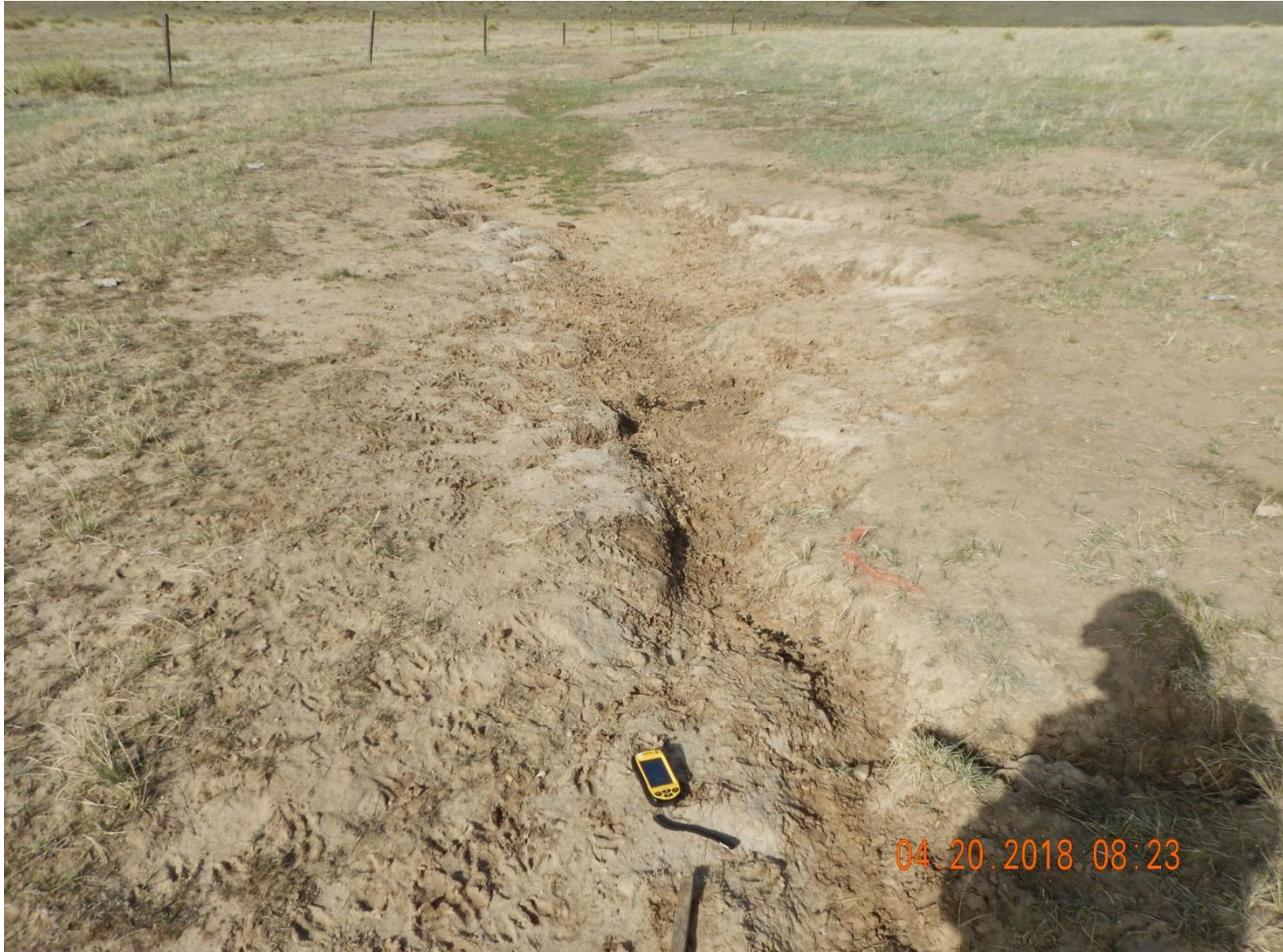
**Photo 2.** Photo taken from the gully erosion along the western battery location, facing West. Erosion continues west, off location.

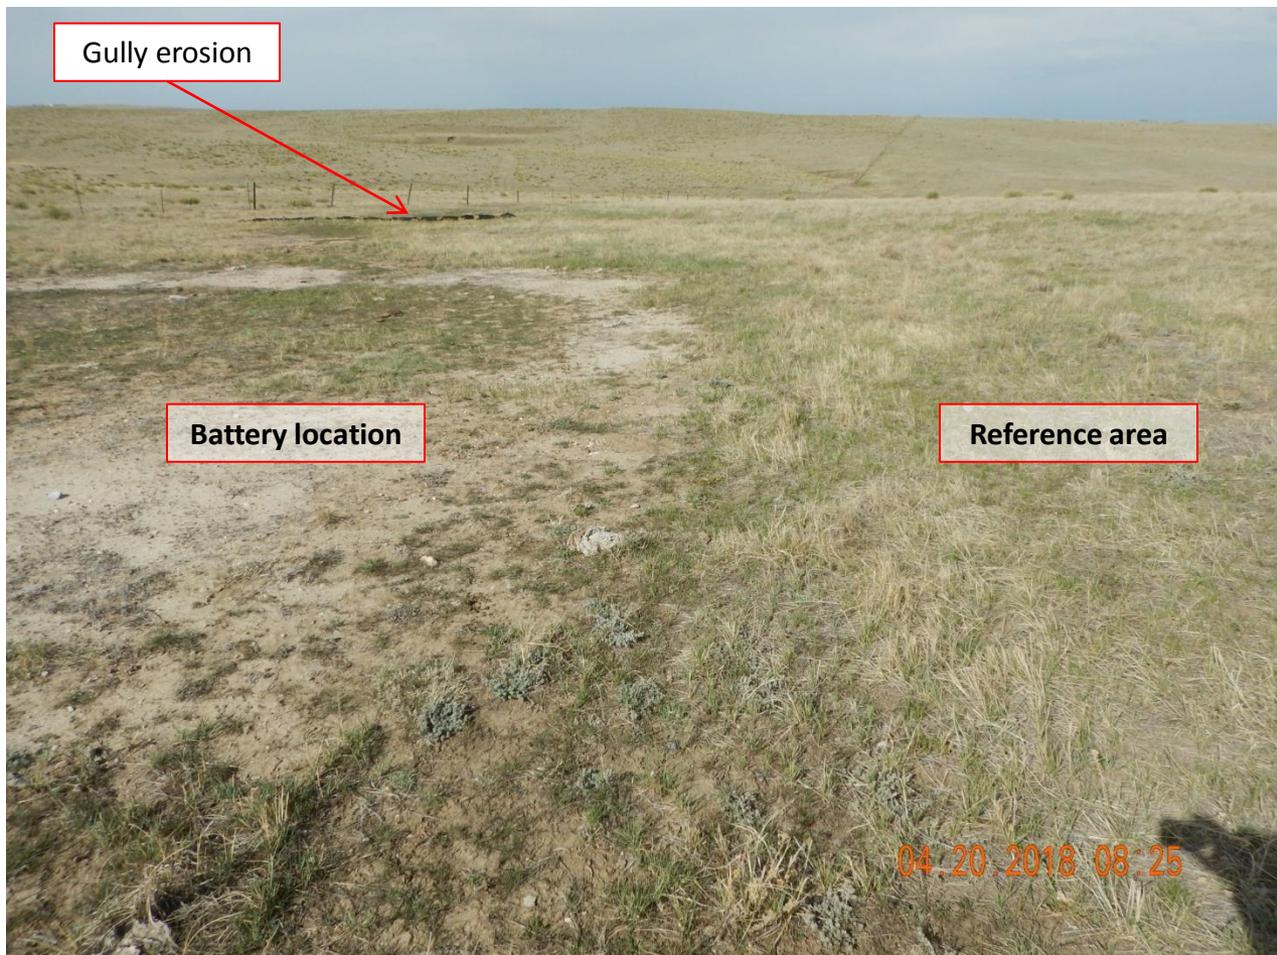
**Photo 3.** Photo taken from the western battery location, facing East. Vegetation at the battery location is not reflective of reference area vegetative level and does not meet Rule 1004 standards. Operator has failed to complete final reclamation activities.

**Photo 4.** Photo taken from the northern battery location, facing West. See comments under Photo 3.

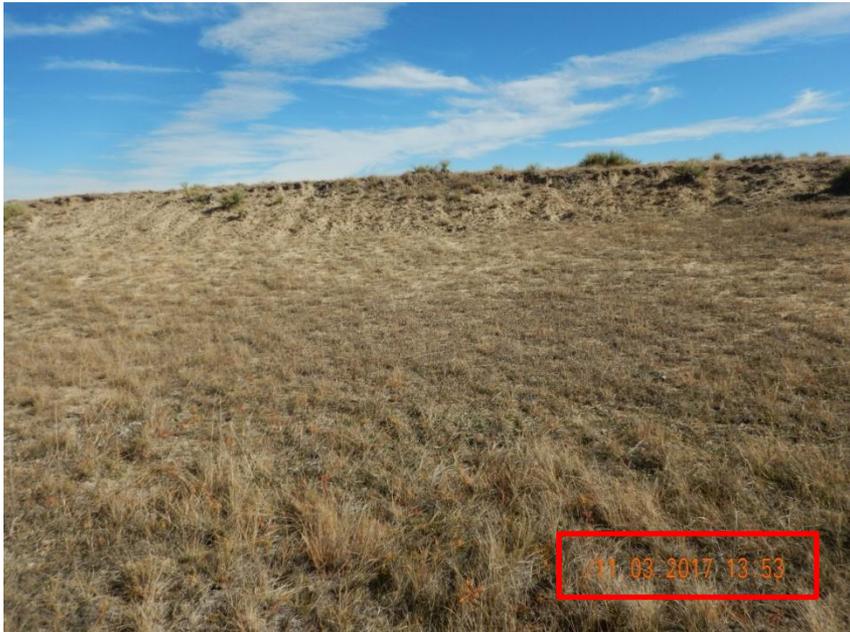
**Photo 5.** Photo taken of the eastern well location on November 3, 2017, facing East. Operator has not reclaimed the location per Rule 1004 standards. The location has not been contoured to match the surrounding landscape. Rill erosion evident along the eastern cut slope.

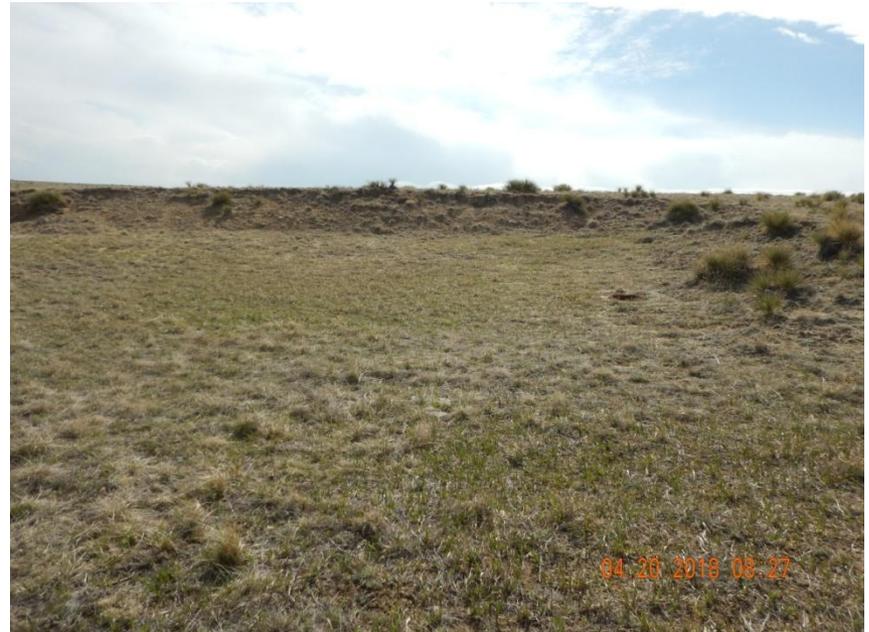
**Photo 6.** Photo taken of the eastern well location on April 20, 2018, facing East. Operator has failed to complete final reclamation activities.

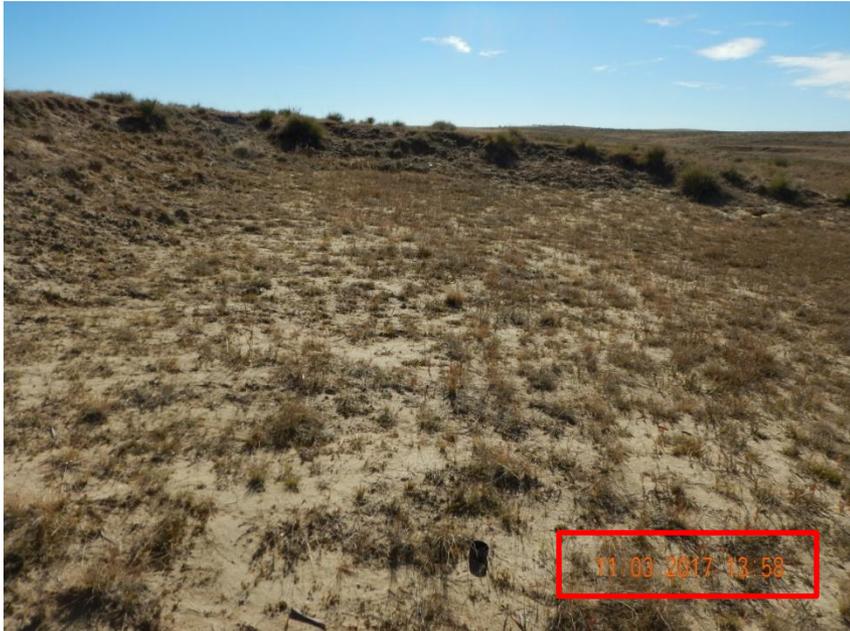
**Photo 7.** Photo taken from the eastern well location on November 3, 2017, facing South. See comments under Photo 6.

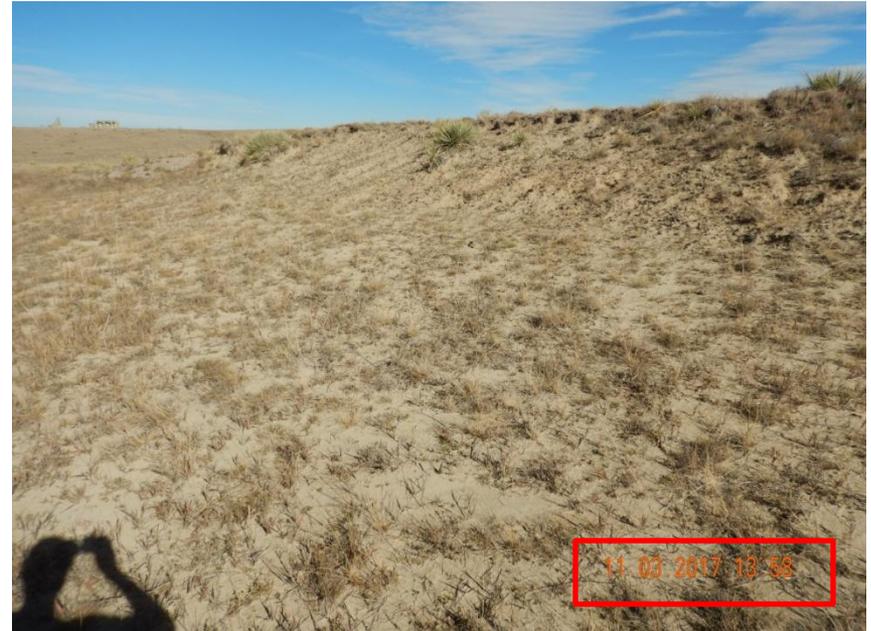
**Photo 8.** Photo taken from the eastern well location on November 3, 2017, facing North. See comments under Photo 6.
