Stormwater Inspection

April 20, 2018

Operator: PETROSHARE CORPORATION- 10454

Inspection Photos
Location Name: NORDMAN TRUST #41-20
API: 05-039-06553

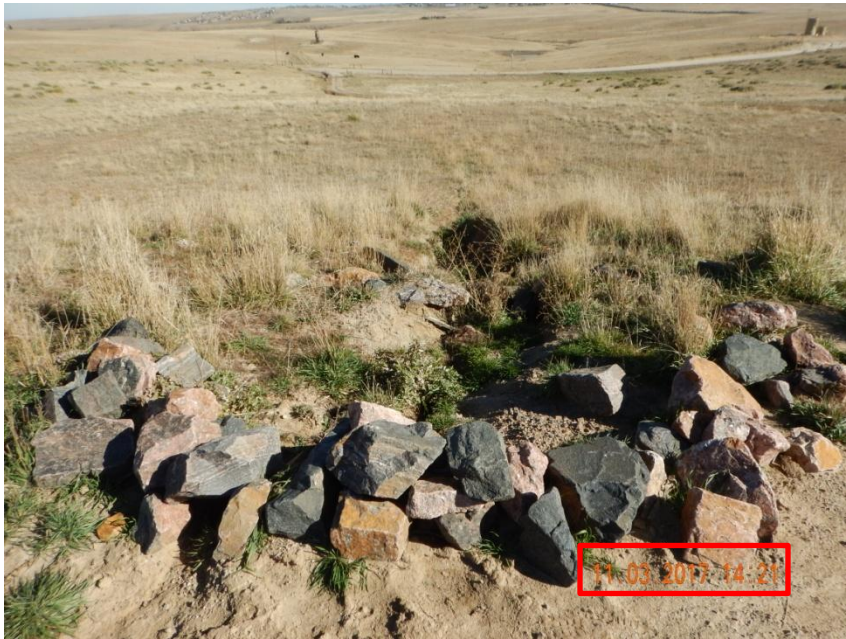
Photo 1. Photo taken from the northeast well pad on November 3, 2017, facing East. Rip-rap has been installed but does not appear to be a sufficient BMP as active gully erosion is evident. Operator needs to repair gully erosion and install sufficient BMPs.

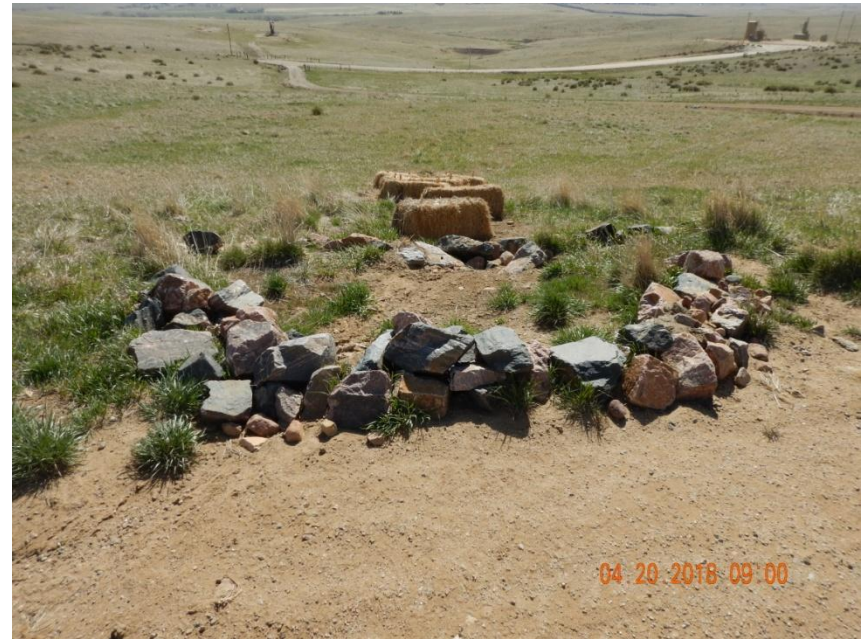
Photo 2. Photo taken from the northeast well pad on April 20, 2018, facing East. Operator made repairs to the gully erosion and installed additional BMPs (i.e., more rip-rap and straw bales).

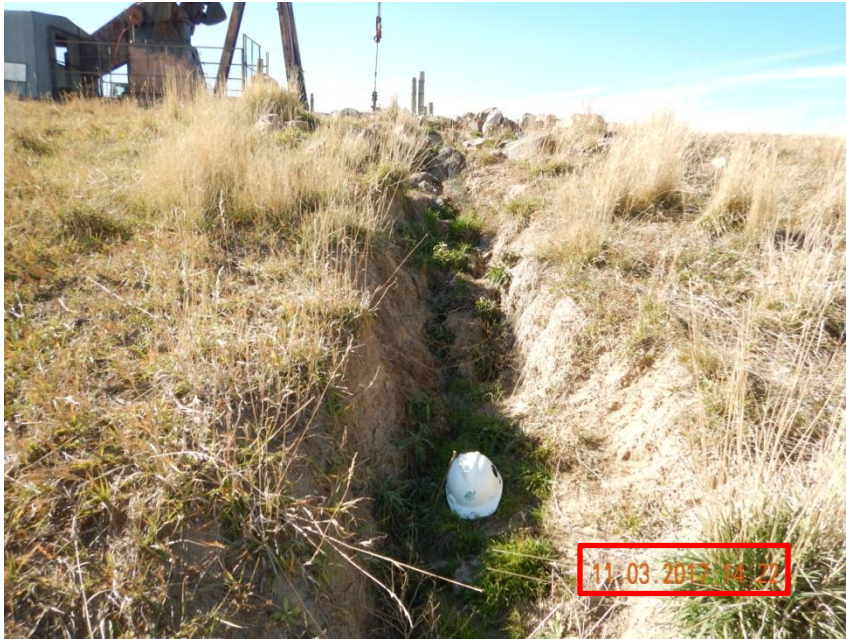
Photo 3. Photo taken downgradient from the gully erosion on November 3, 2017, facing West. See comments under Photo 1.

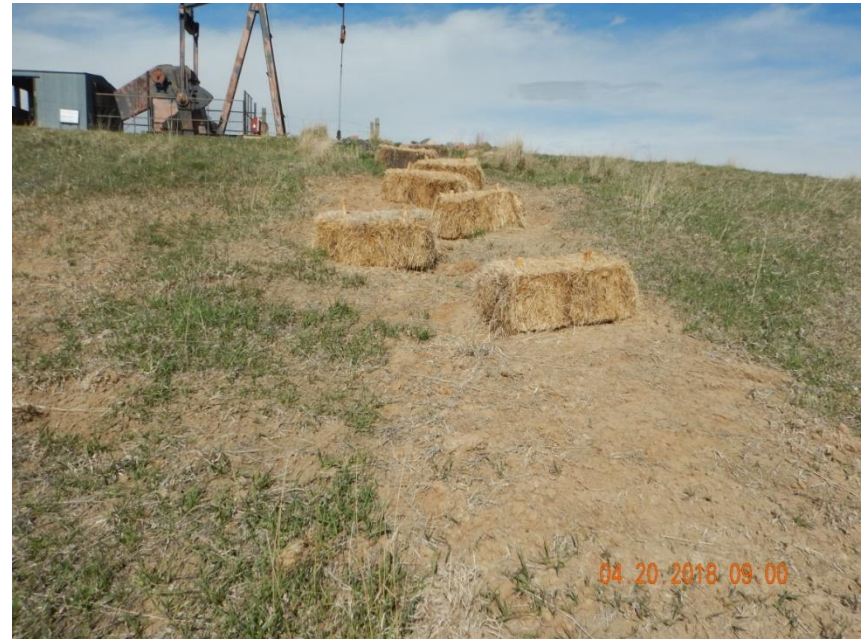
Photo 4. Photo taken downgradient from the gully erosion on April 20, 2018, facing West. See comments under Photo 2.

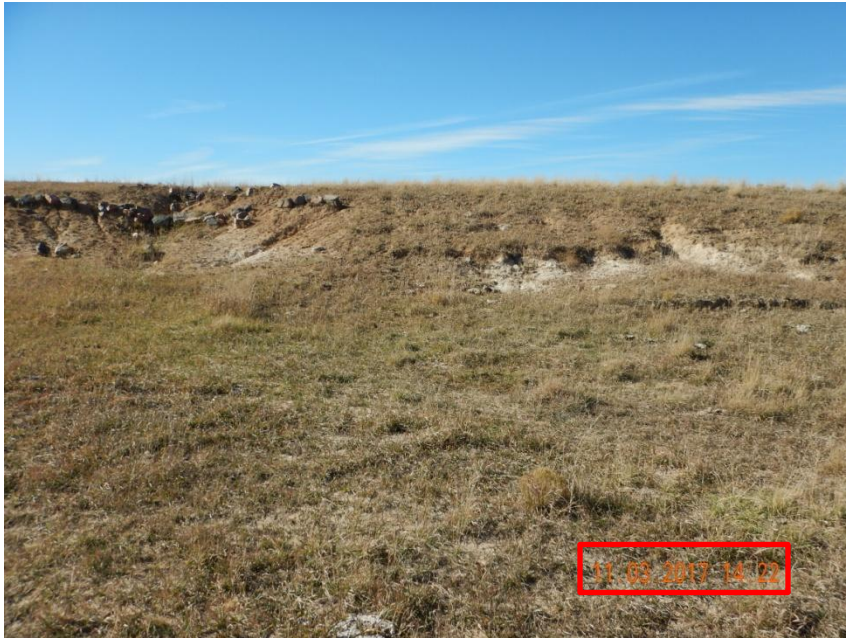
Photo 5. Photo taken from the western well pad location on November 3, 2017, facing West. Appears stormwater run-on onto the location is causing gully erosion along the western cut slope which is causing degradation to the location. Operator needs to repair gully erosion and install sufficient BMPs.

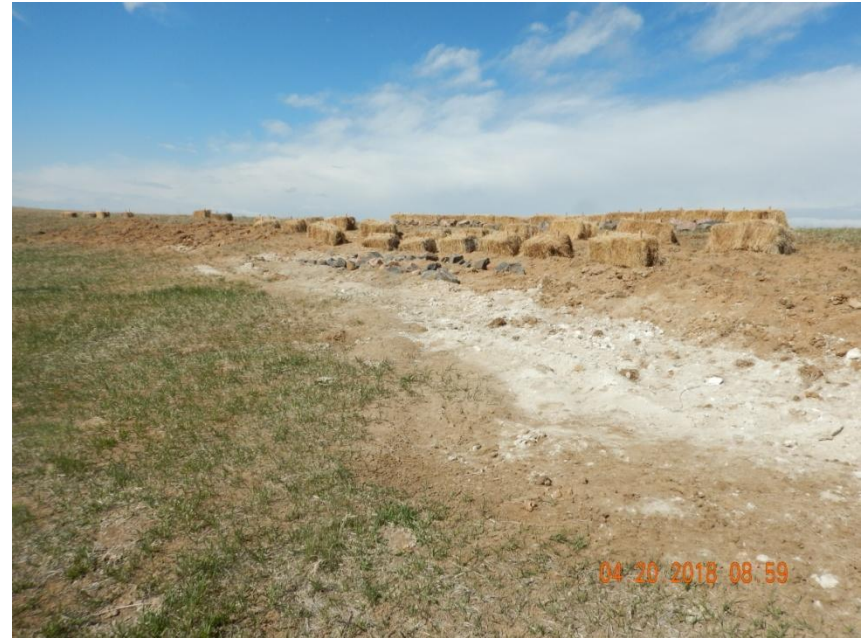
Photo 6. Photo taken from the western well pad location on April 20, 2018, facing West. Operator made repairs to the gully erosion and installed additional BMPs (i.e, more rip-rap, straw bales and surface roughening).

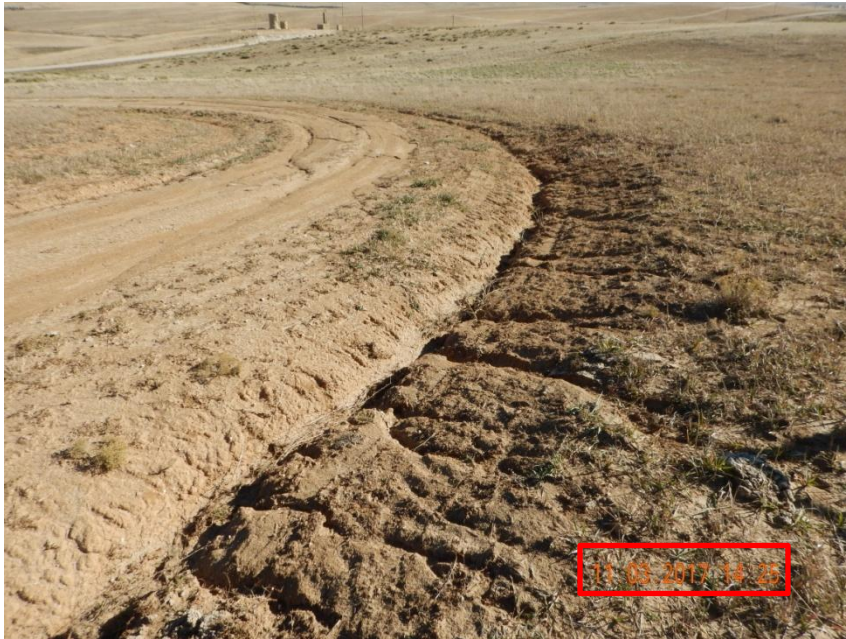
Photo 7. Photo taken from a portion of the access road on November 3, 2017, facing South. Rill erosion forming into gully erosion is evident along the access road. Operator needs to repair erosion and install sufficient BMPs.

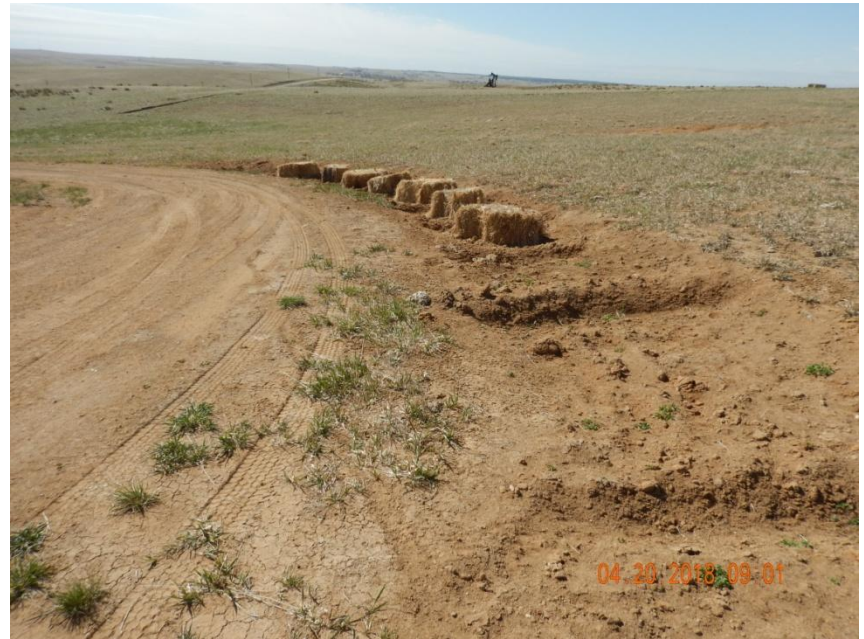
Photo 8. Photo taken from a portion of the access road on April 20, 2018, facing South. Operator made repairs and installed BMPs (i.e, straw bales and surface roughening).
