DOE PM-2-31
Api# -045-045-07036
Inspection # 689701292

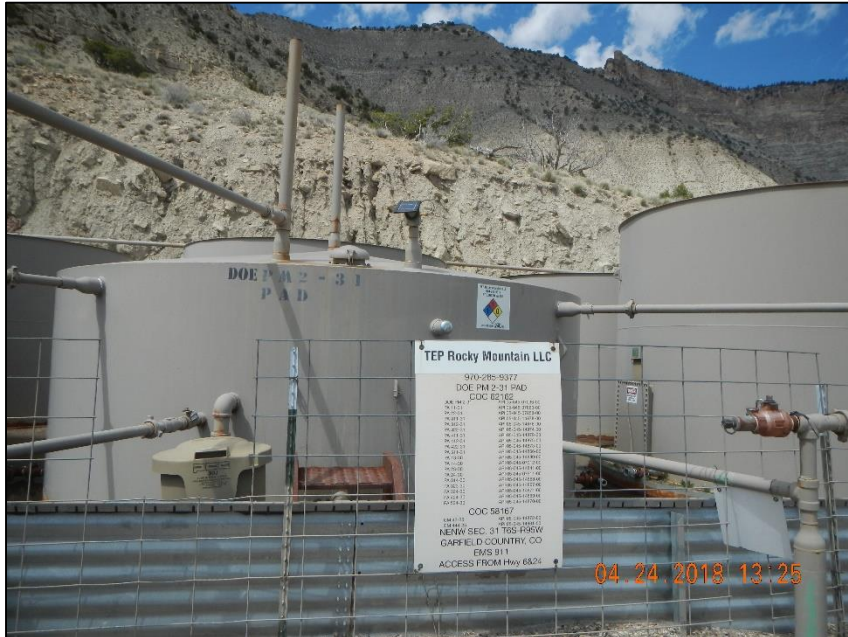
Battery sign

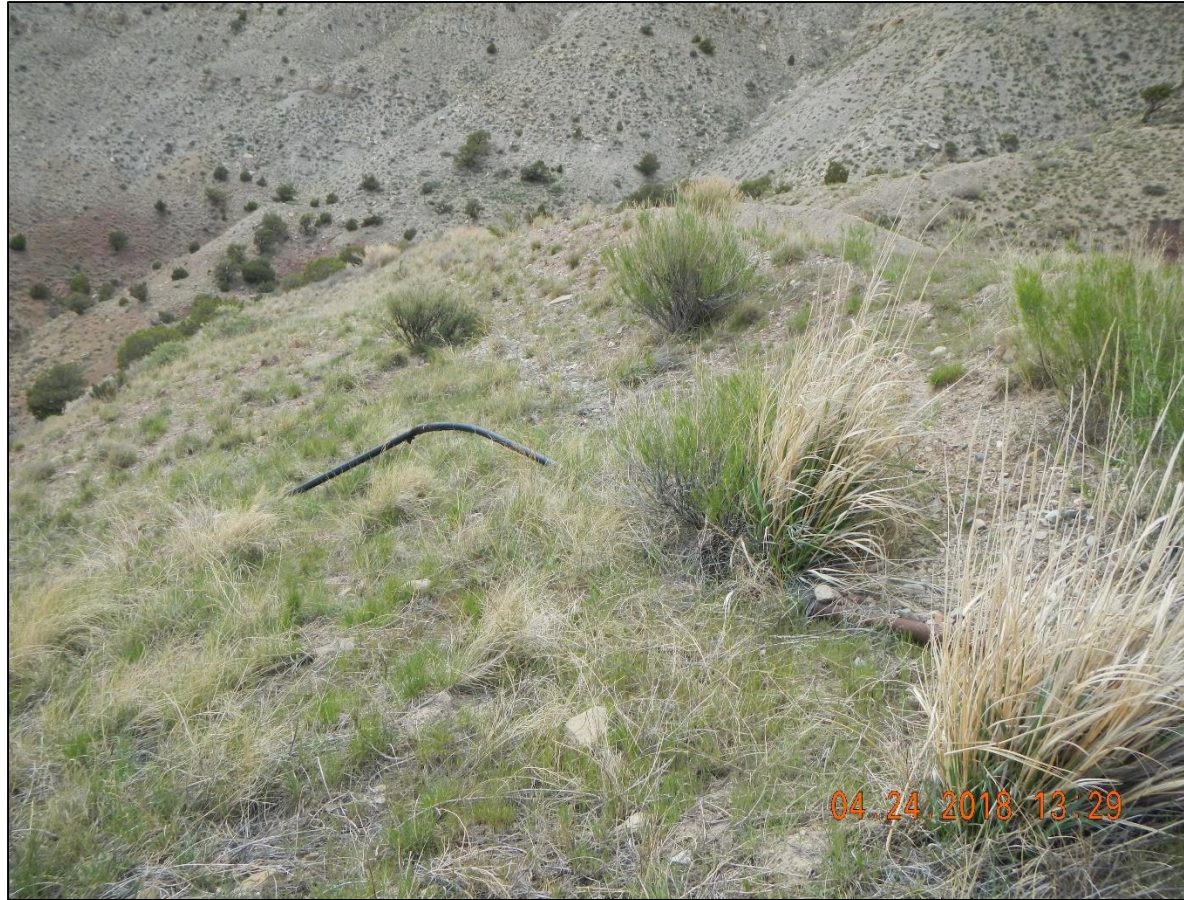
Tubing off the edge of location. 39.48637 108.04253

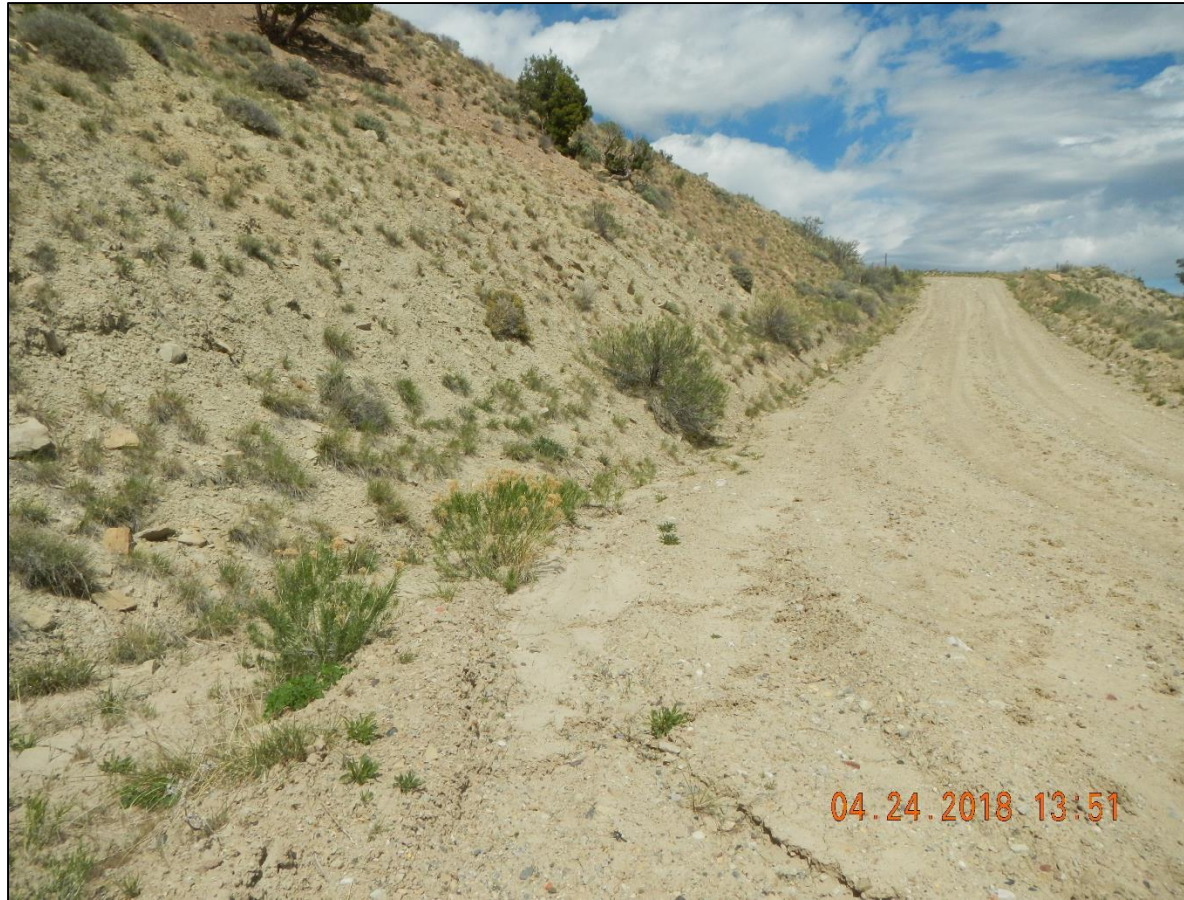
**Ruts are creating erosion riling at top switch back. Sediment build up in ditch.
(39.48567 108.04314)**

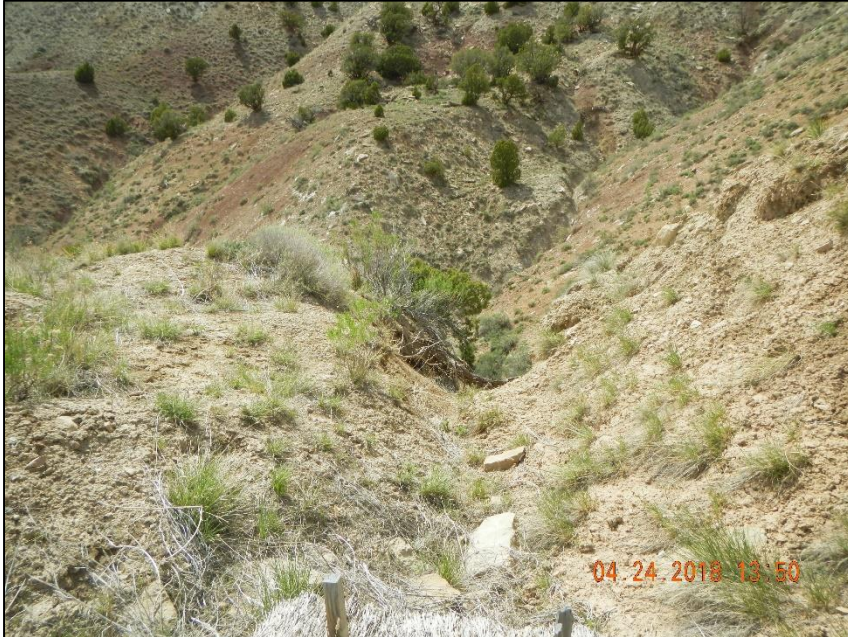
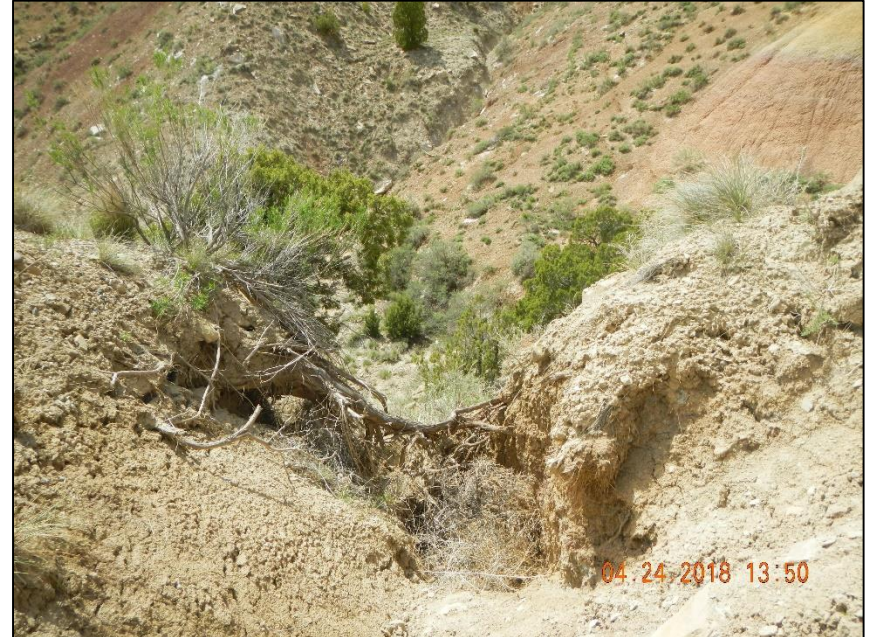
Erosion of hillside from ditch run off at top switch back.
(39.48567 108.04314)

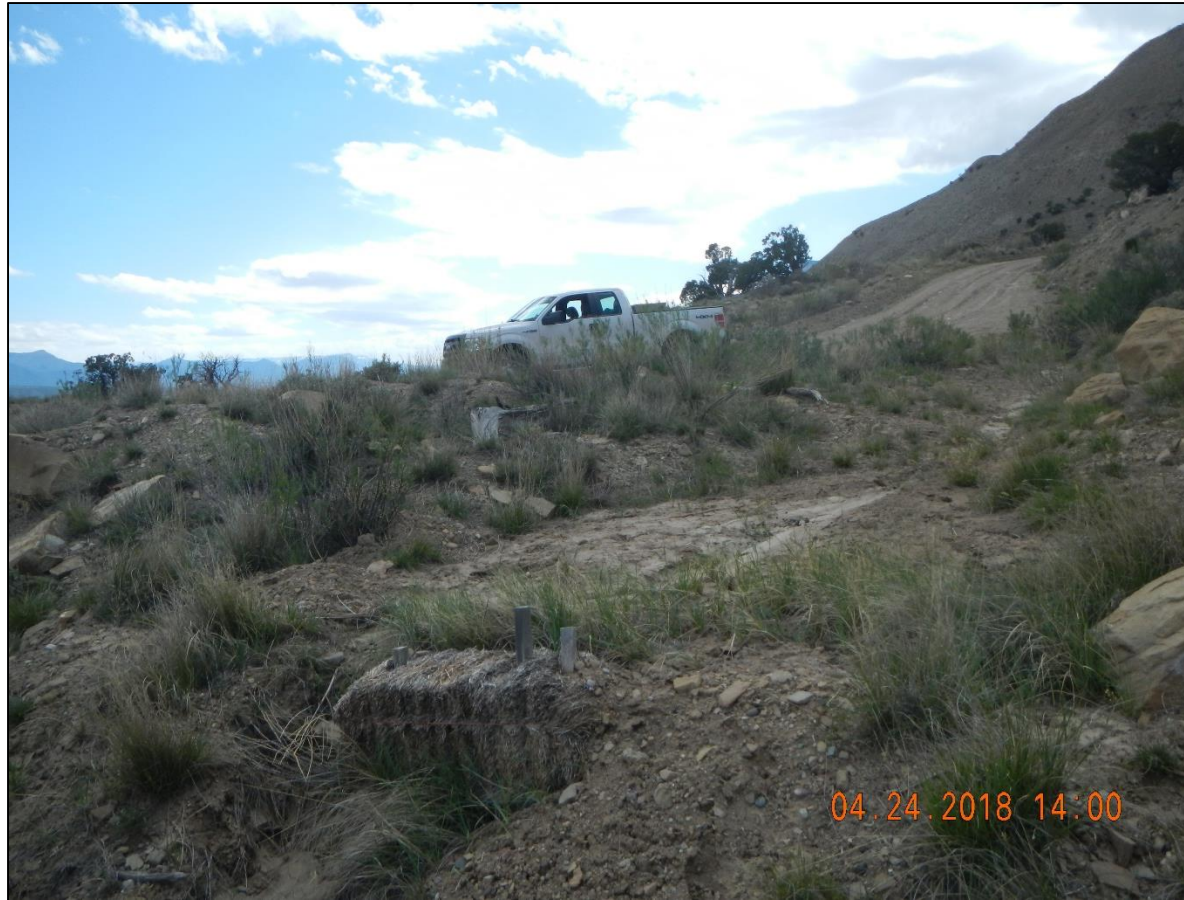
**Sediment build up over straw bales used for check dams @ Switch back
(39.48597 108.04075)**

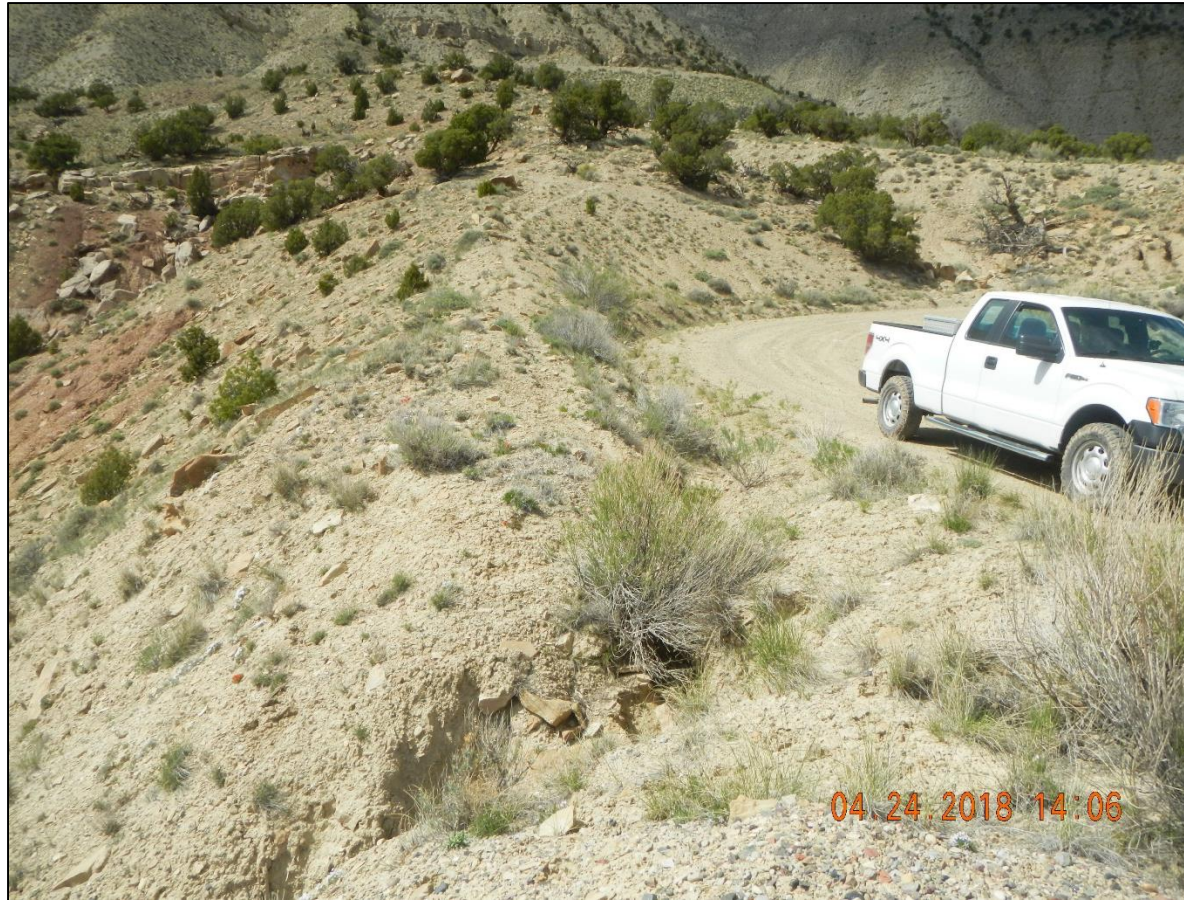
**Erosion of hillside from ditch run off and rilling of roadside @ (39.48523
108.04113)**

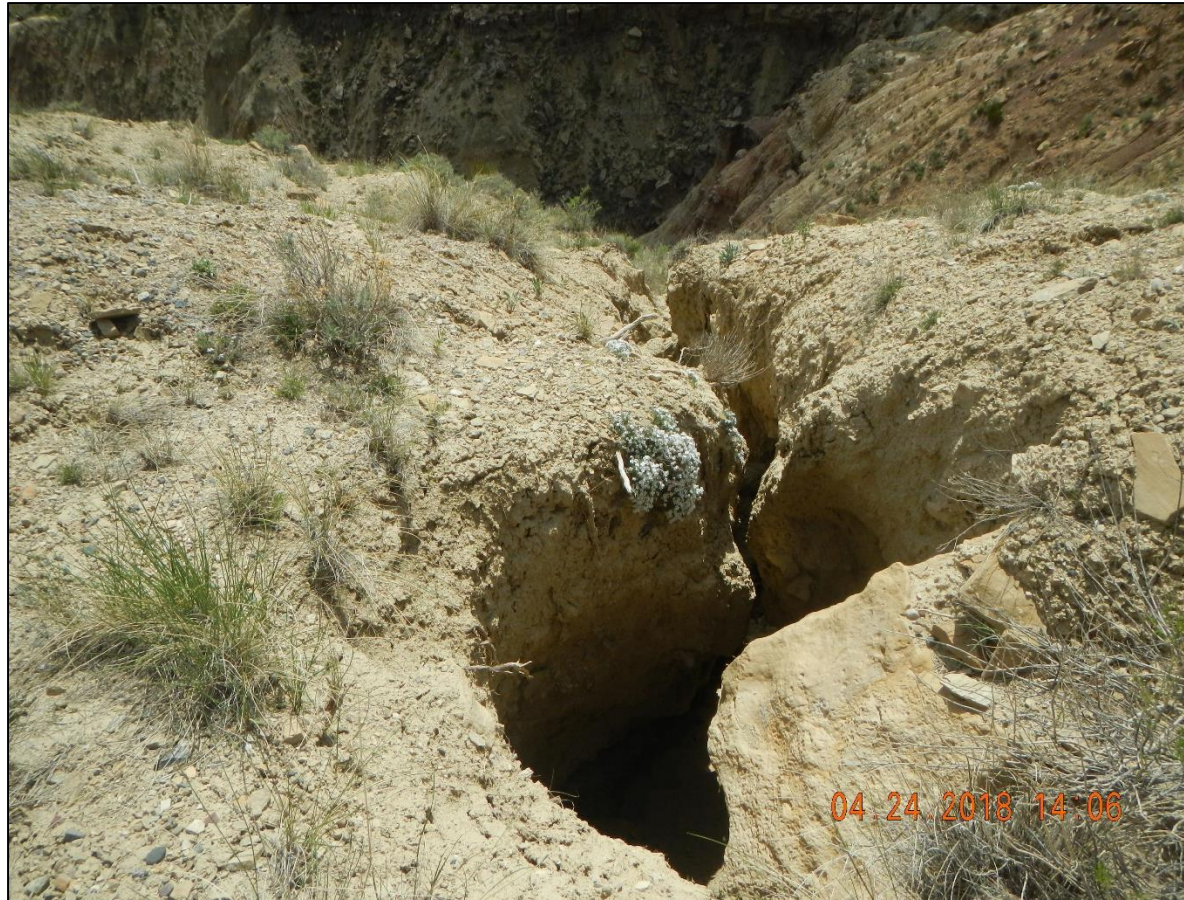
**Erosion of hillside from ditch run off and rilling of roadside @ (39.48523
108.04113)**

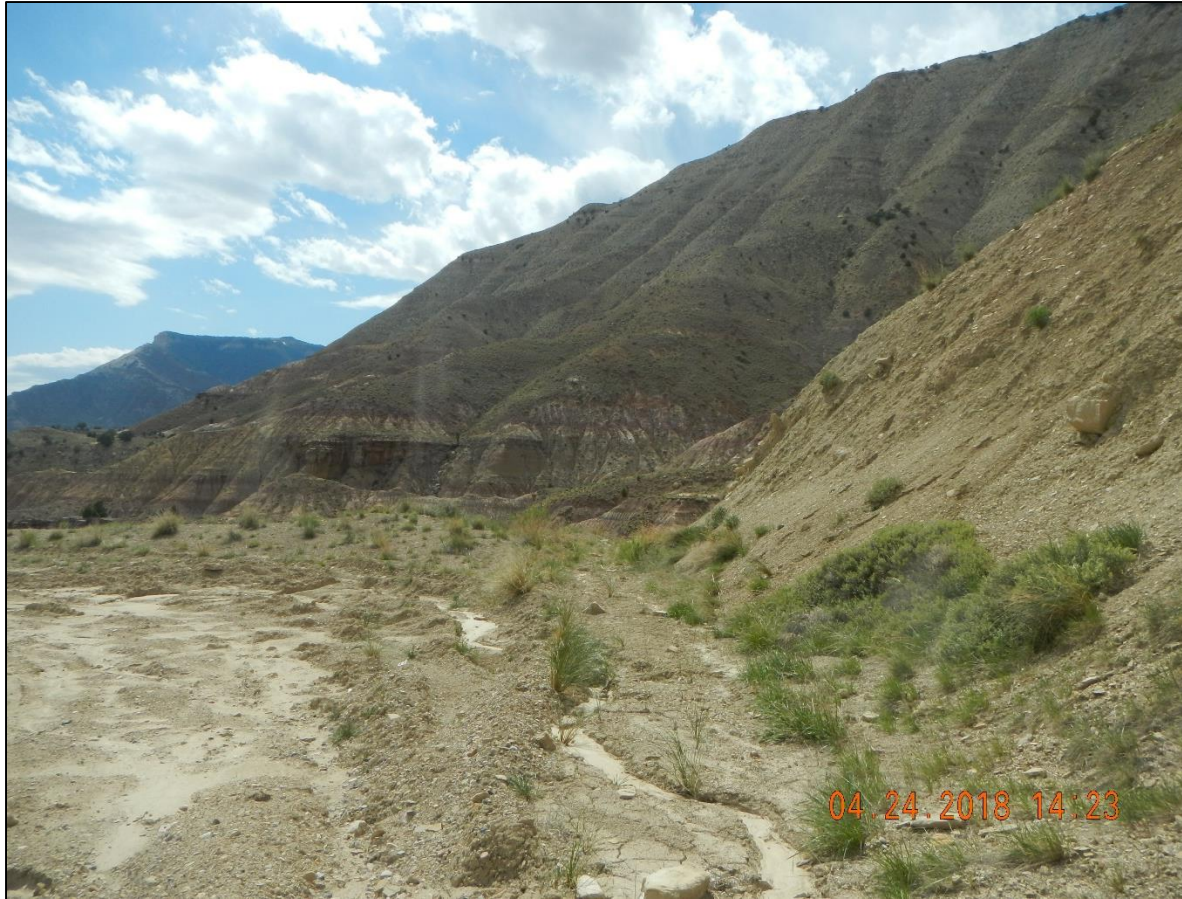
Sediment build up in ditch @ (39.48382 108.04018)

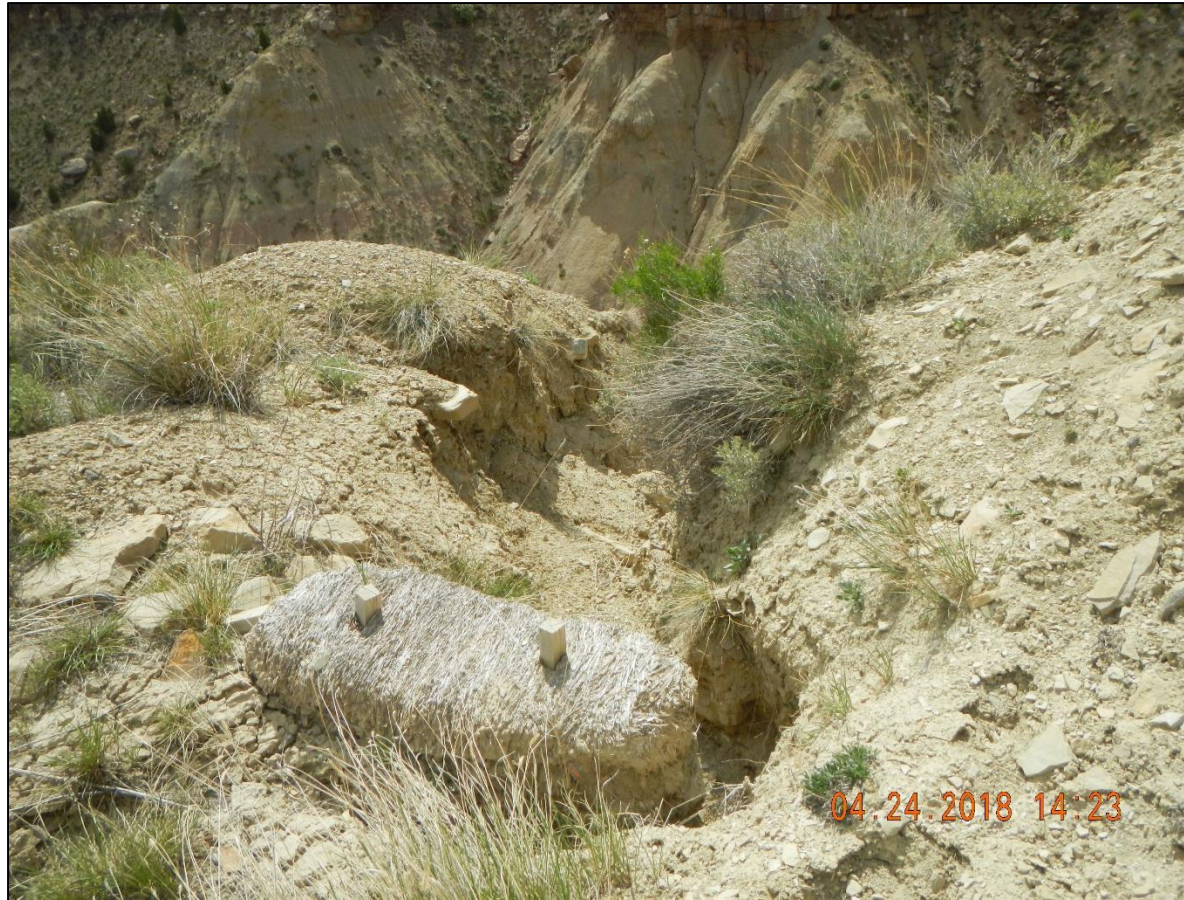
Erosion of hillside from ditch run off @ (39.48382 108.04018)
