# Inspection Photos

API: 05-067-09374

Operator: HILCORP ENERGY COMPANY

Inspection Date: 4/12/2018

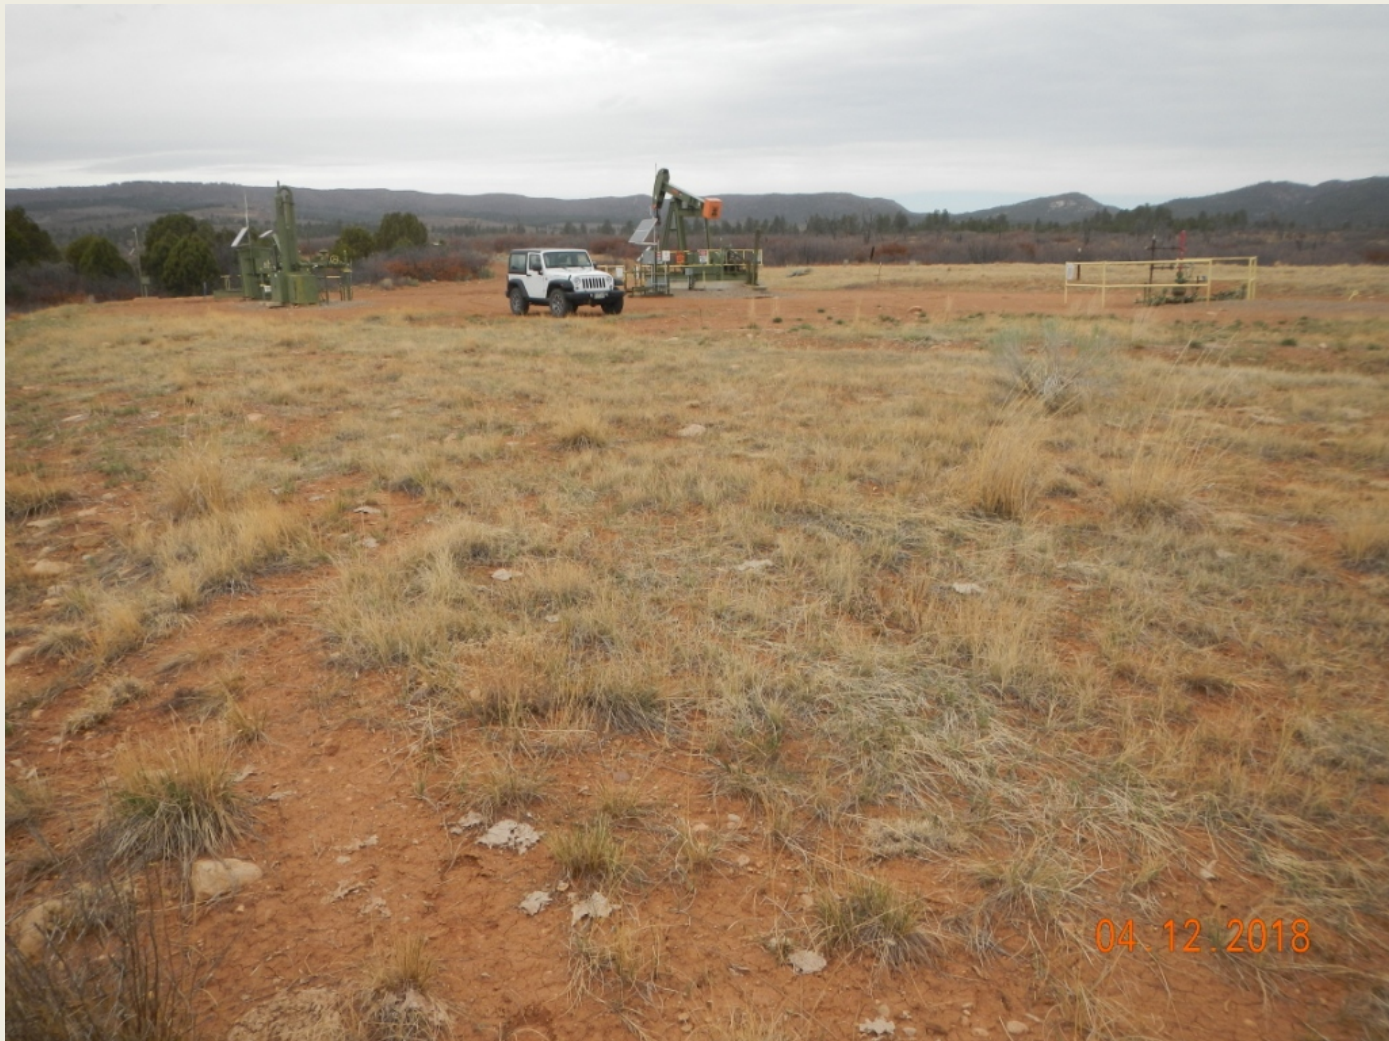
**Photo 1. View of the project area from the southeastern corner facing center.**

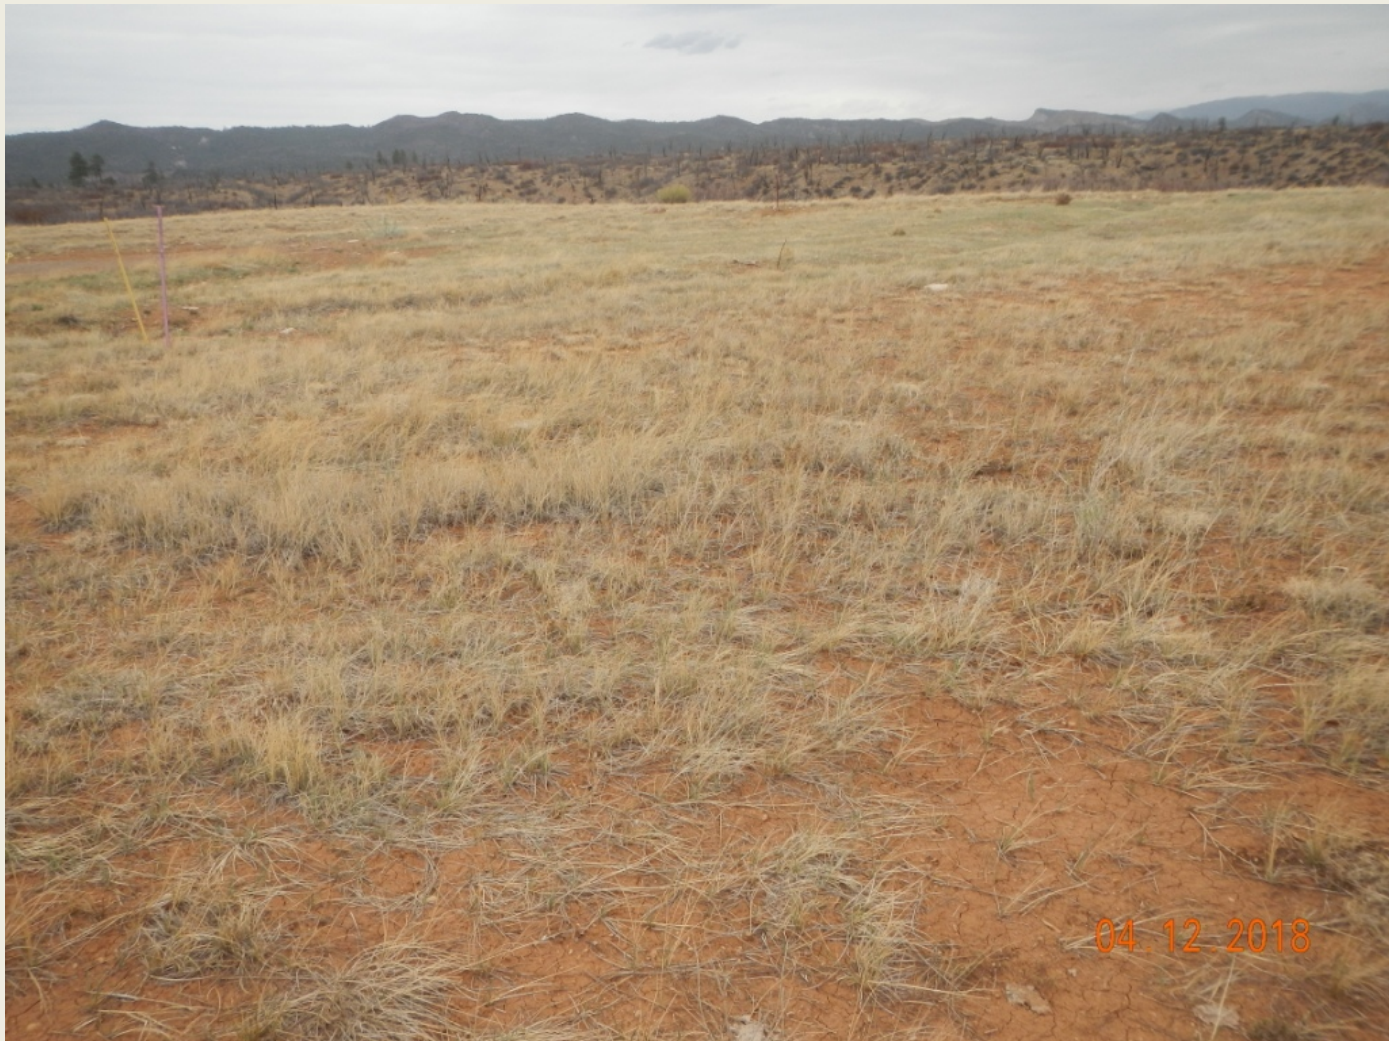
**Photo 2. View of the eastern portion of the project area from the southeastern corner facing northward. Revegetation is progressing, largely with western wheatgrass (*Pascopyrum smithii*).**

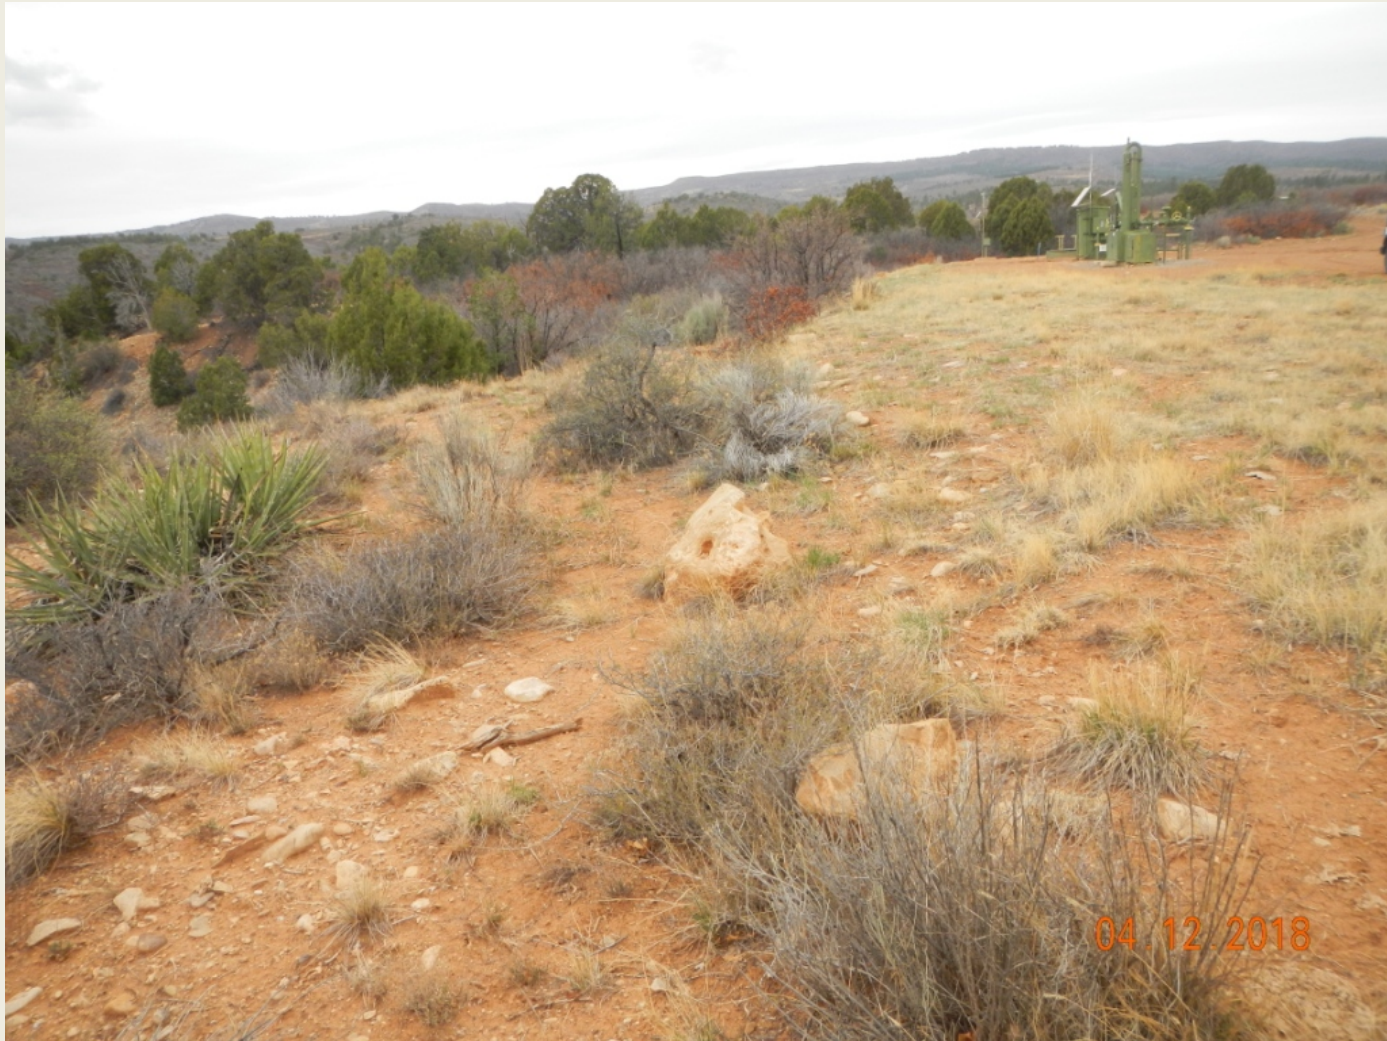
**Photo 3. View of the southern portion of the project area from the southeastern corner facing westward.**

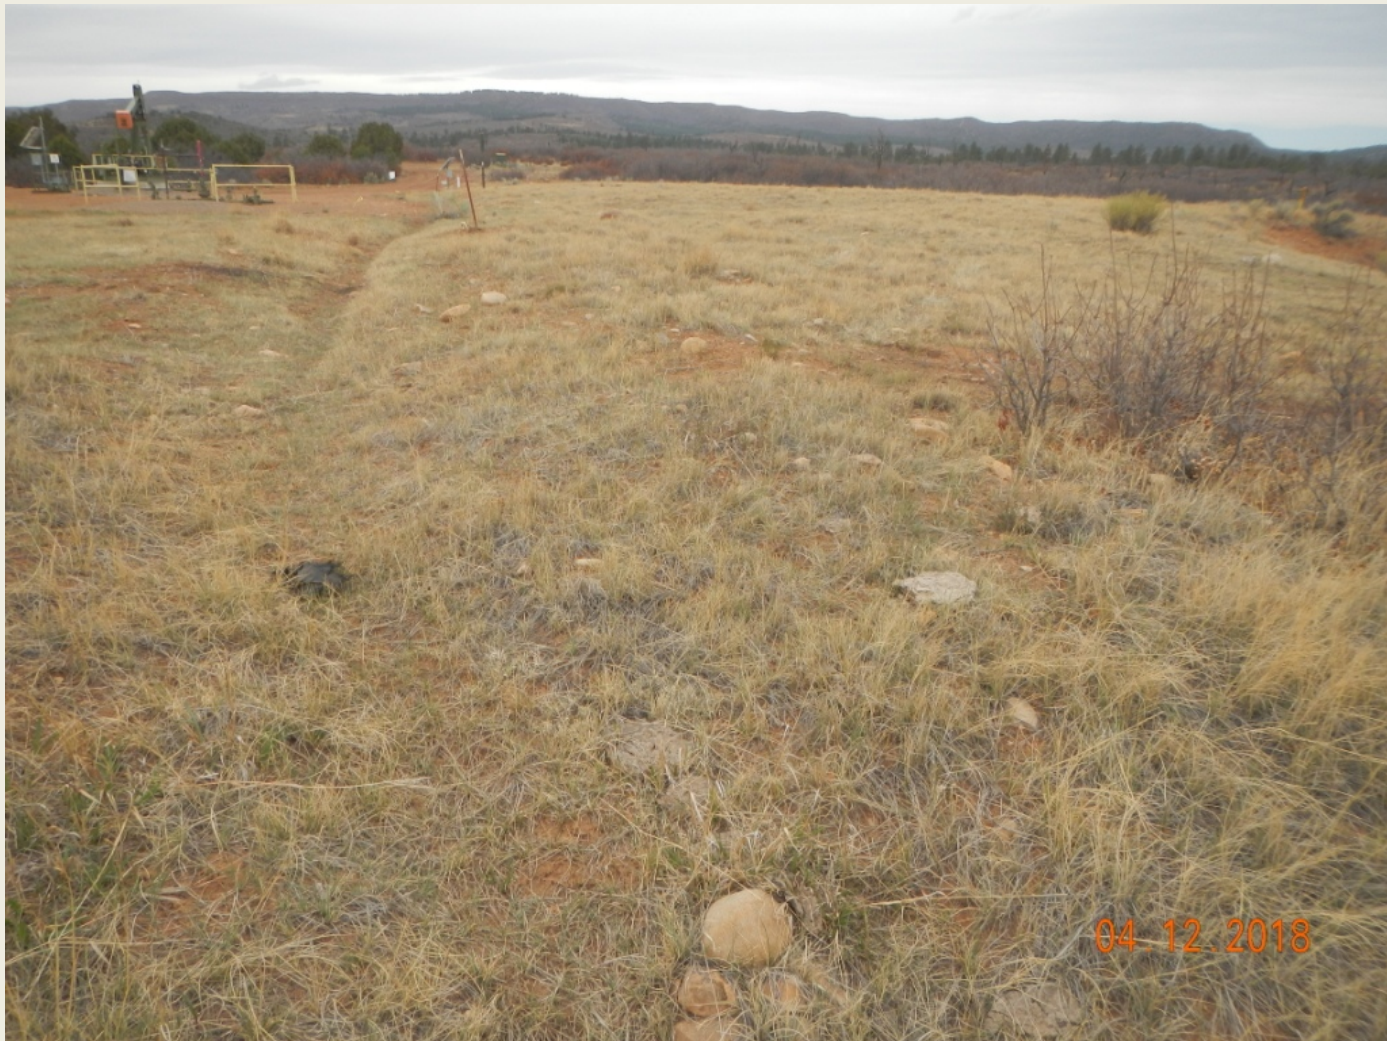
**Photo 4. View of the northern project area from the northeastern corner facing westward. Stormwater diversion appears to flow to the northeastern corner.**

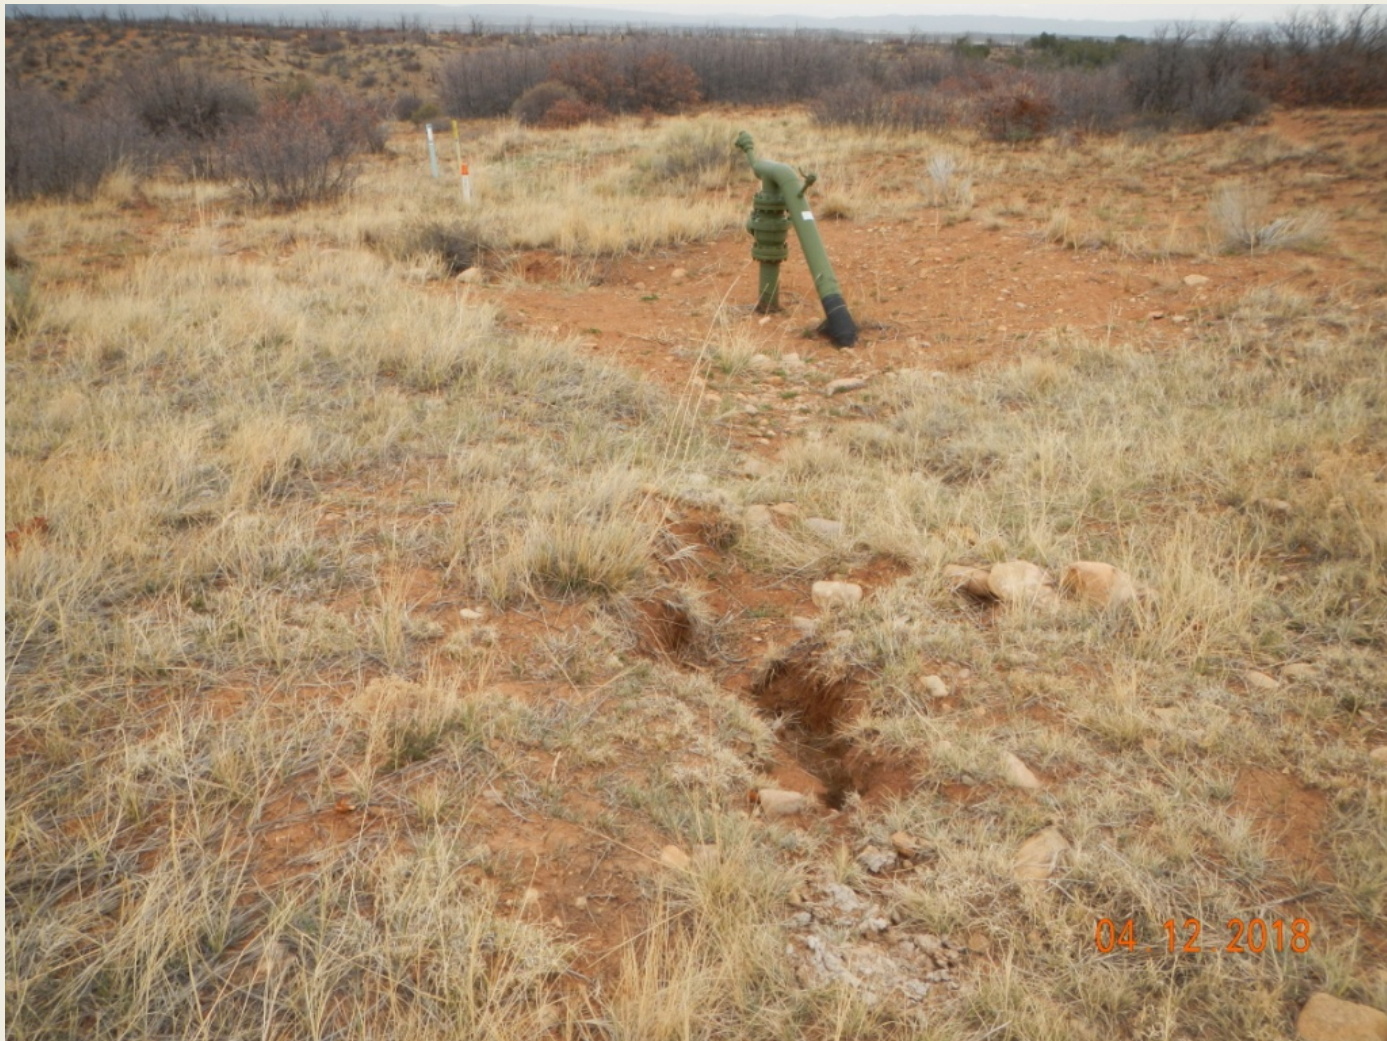
**Photo 5. View of erosional channel where concentrated stormwater from well pad diversion erodes the northeastern corner of the project area. Stormwater controls are needed to de-energize flows and contain sediment.**

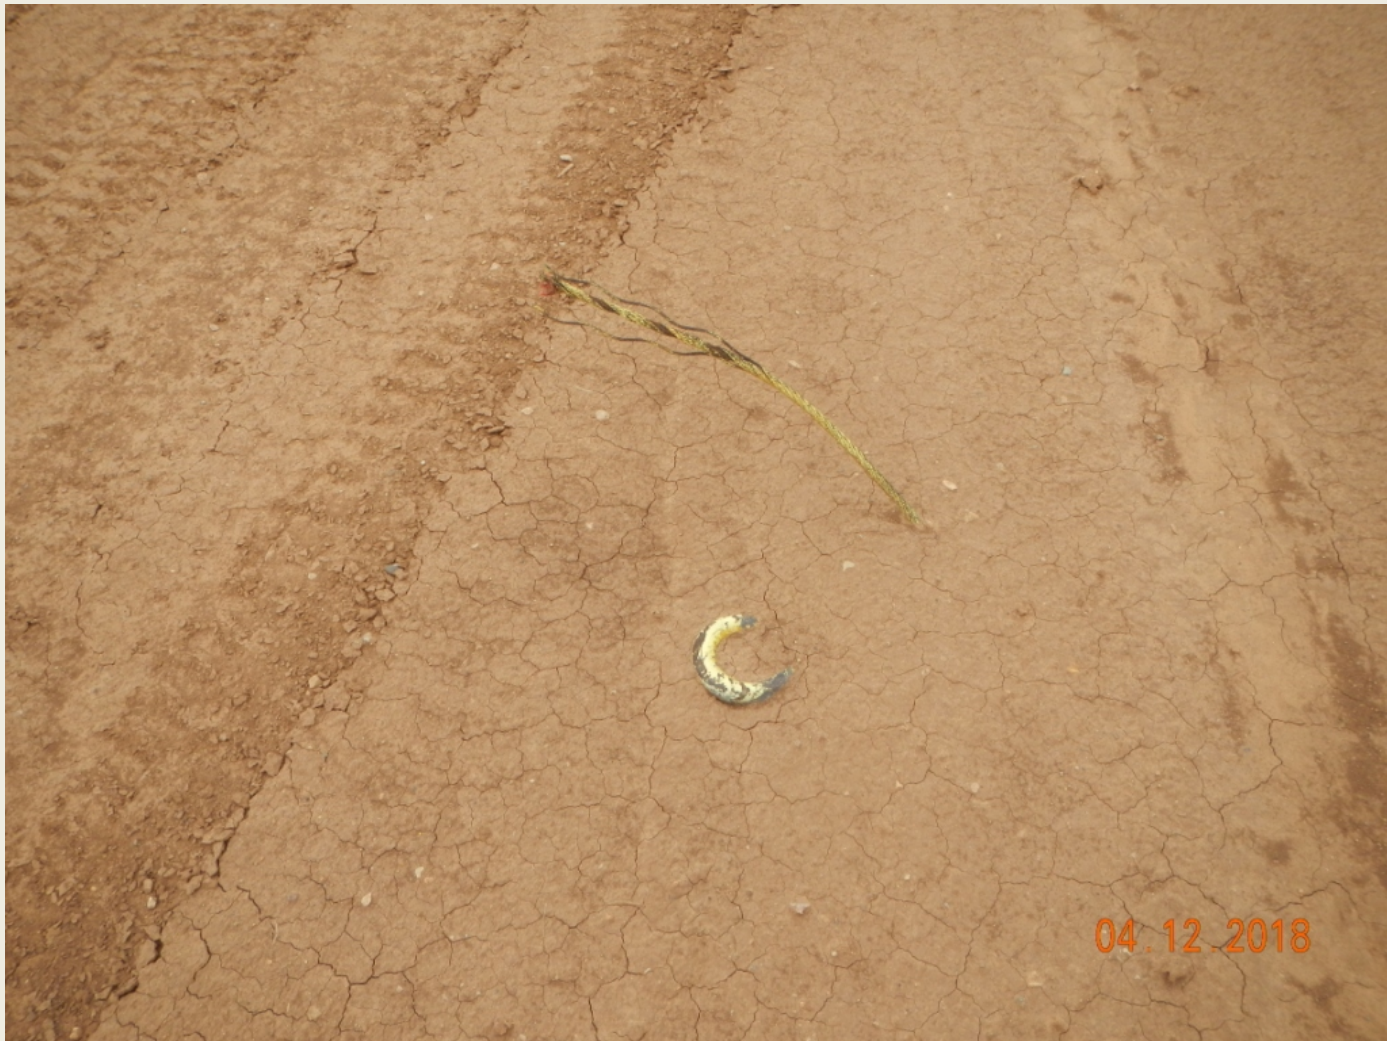
**Photo 6. Guy line anchor not marked.**
