# **Inspection Photos**

API: 05-067-09069

Operator: HILCORP ENERGY COMPANY

Inspection Date: 4/12/2018

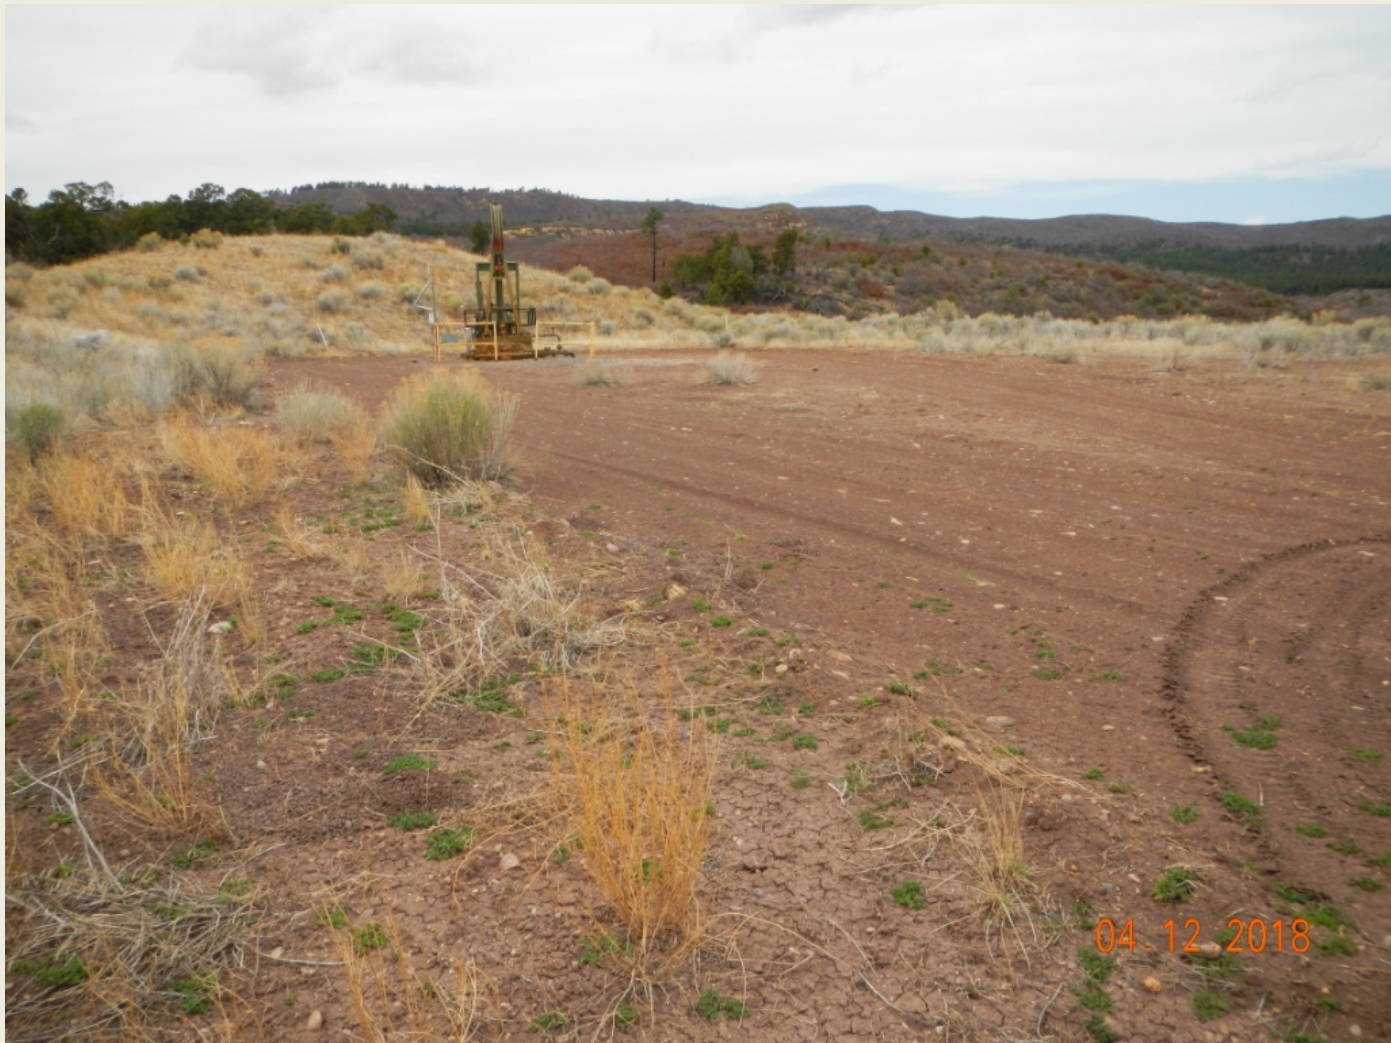
**Photo 1. View of the project area from the southeastern corner of the working area facing center.**

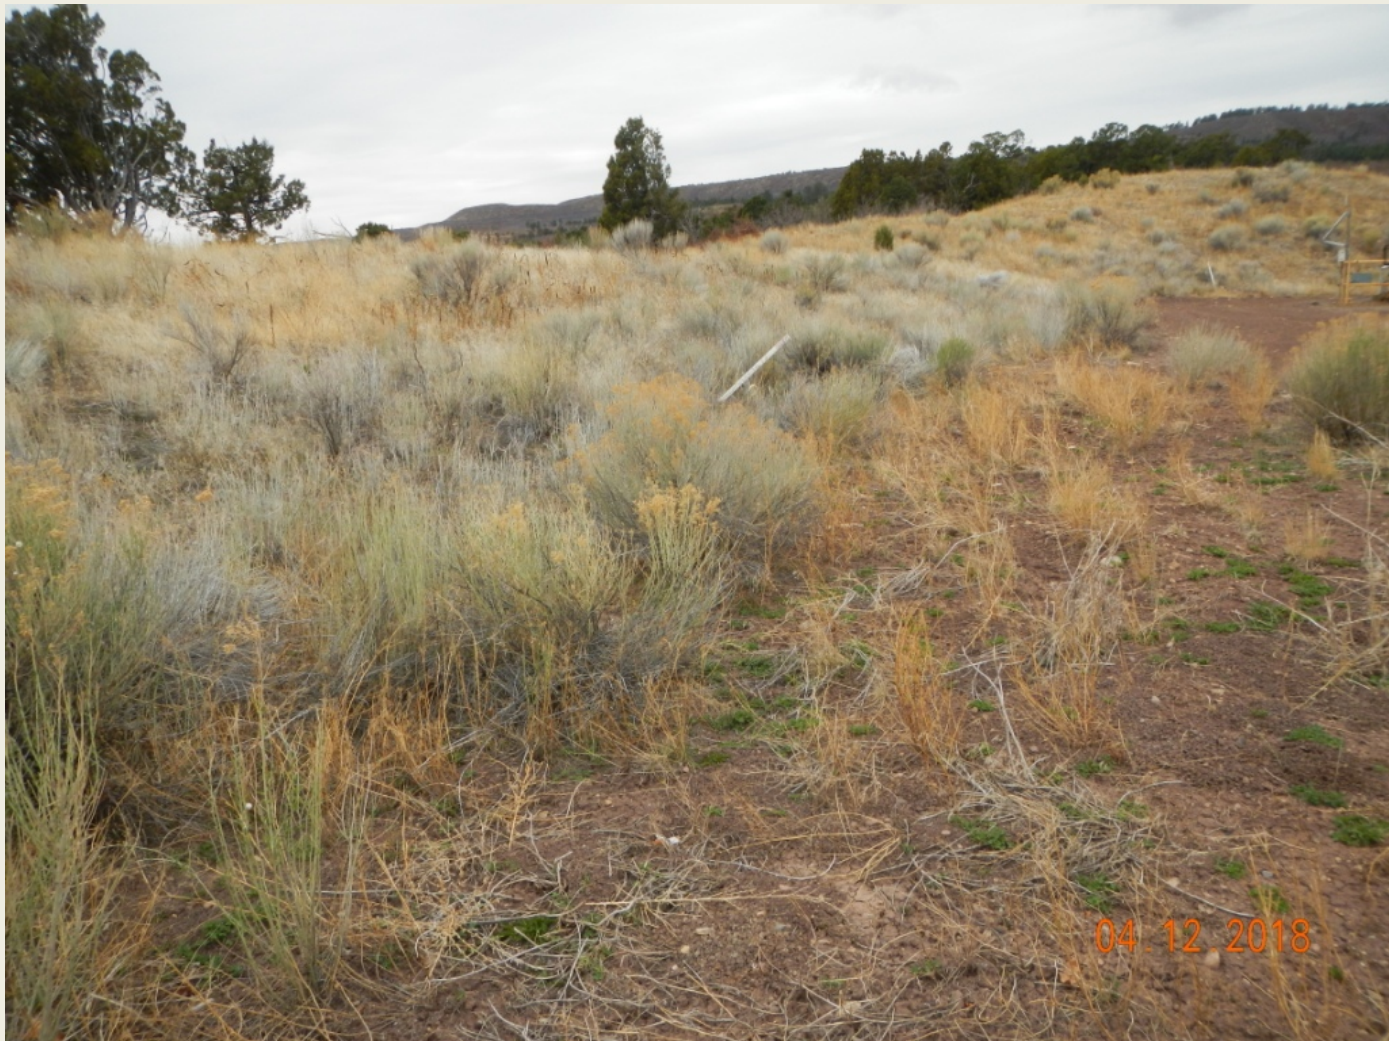
**Photo 2. View of the southern portion of the project area from the southeastern corner facing westward. Revegetation is progressing, largely with western wheatgrass (*Pascopyrum smithii*), crested wheatgrass (*Agropyron cristatum*), and rubber rabbitbrush (*Chrysothamnus nauseosus*).**

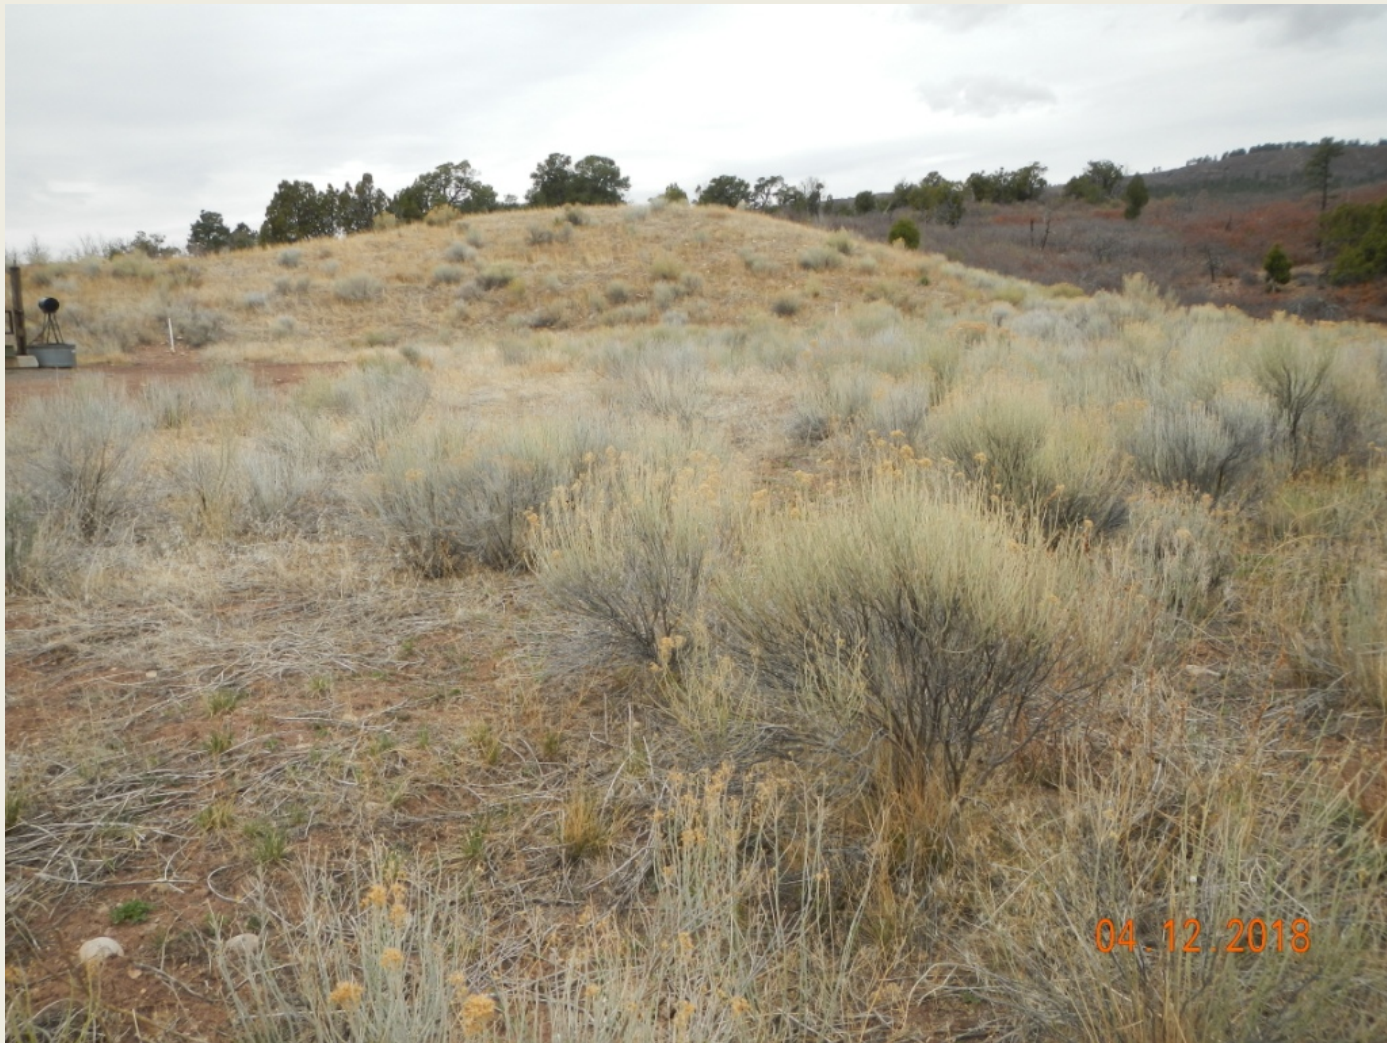
**Photo 3. View of the northern portion of the project area from the northeastern portion facing westward.**

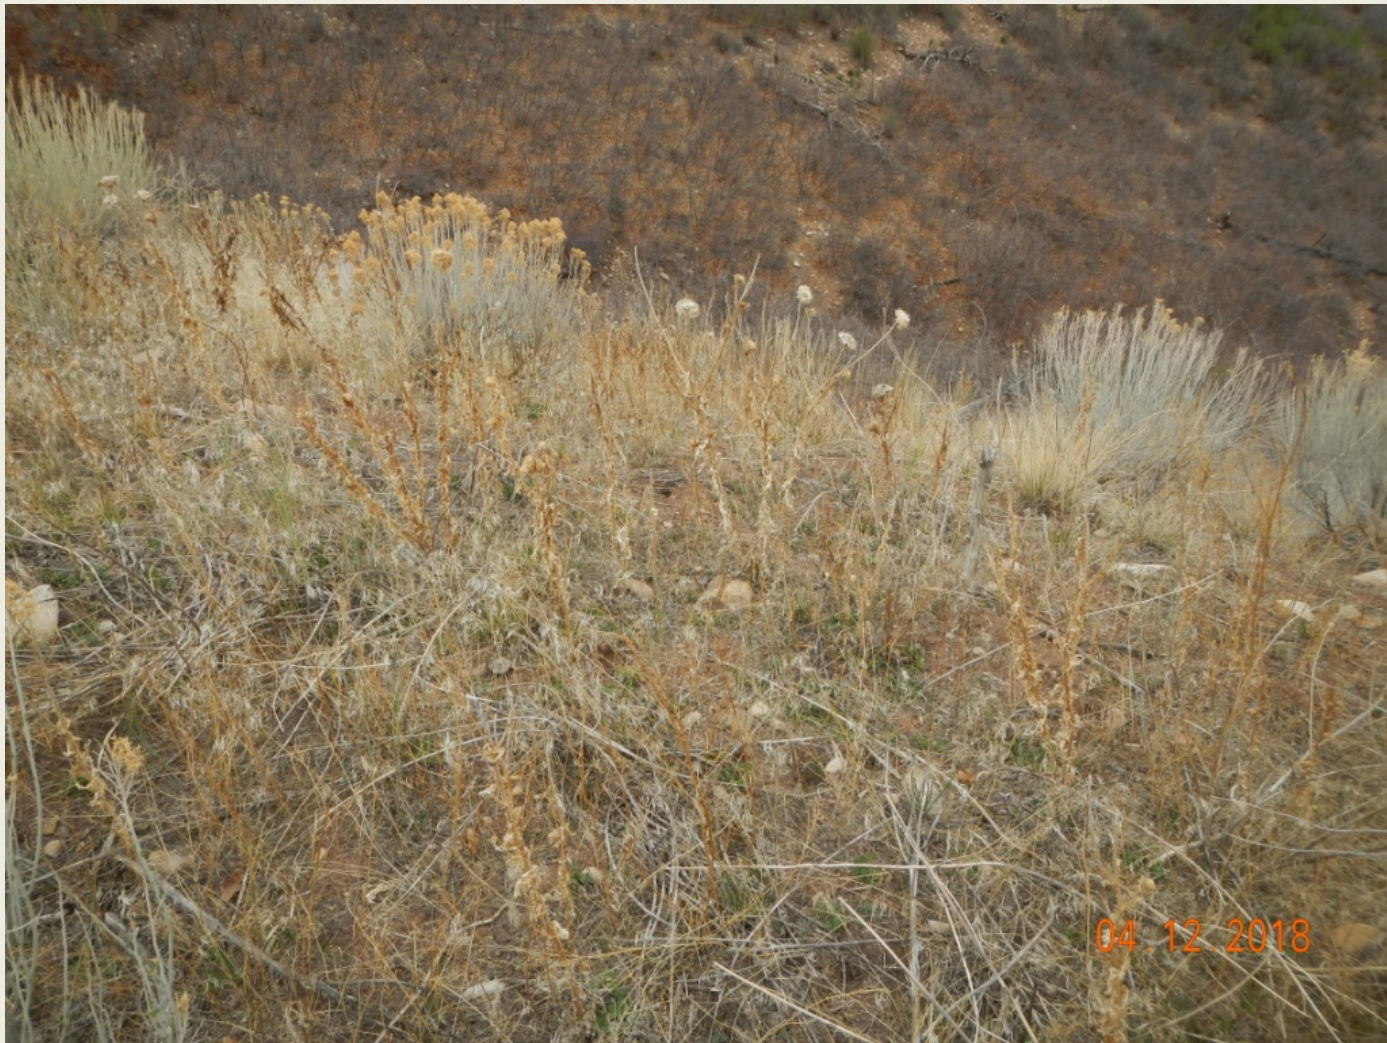
**Photo 4. View of musk thistles (*Carduus nutans*) within the northwestern portion of the project area.**

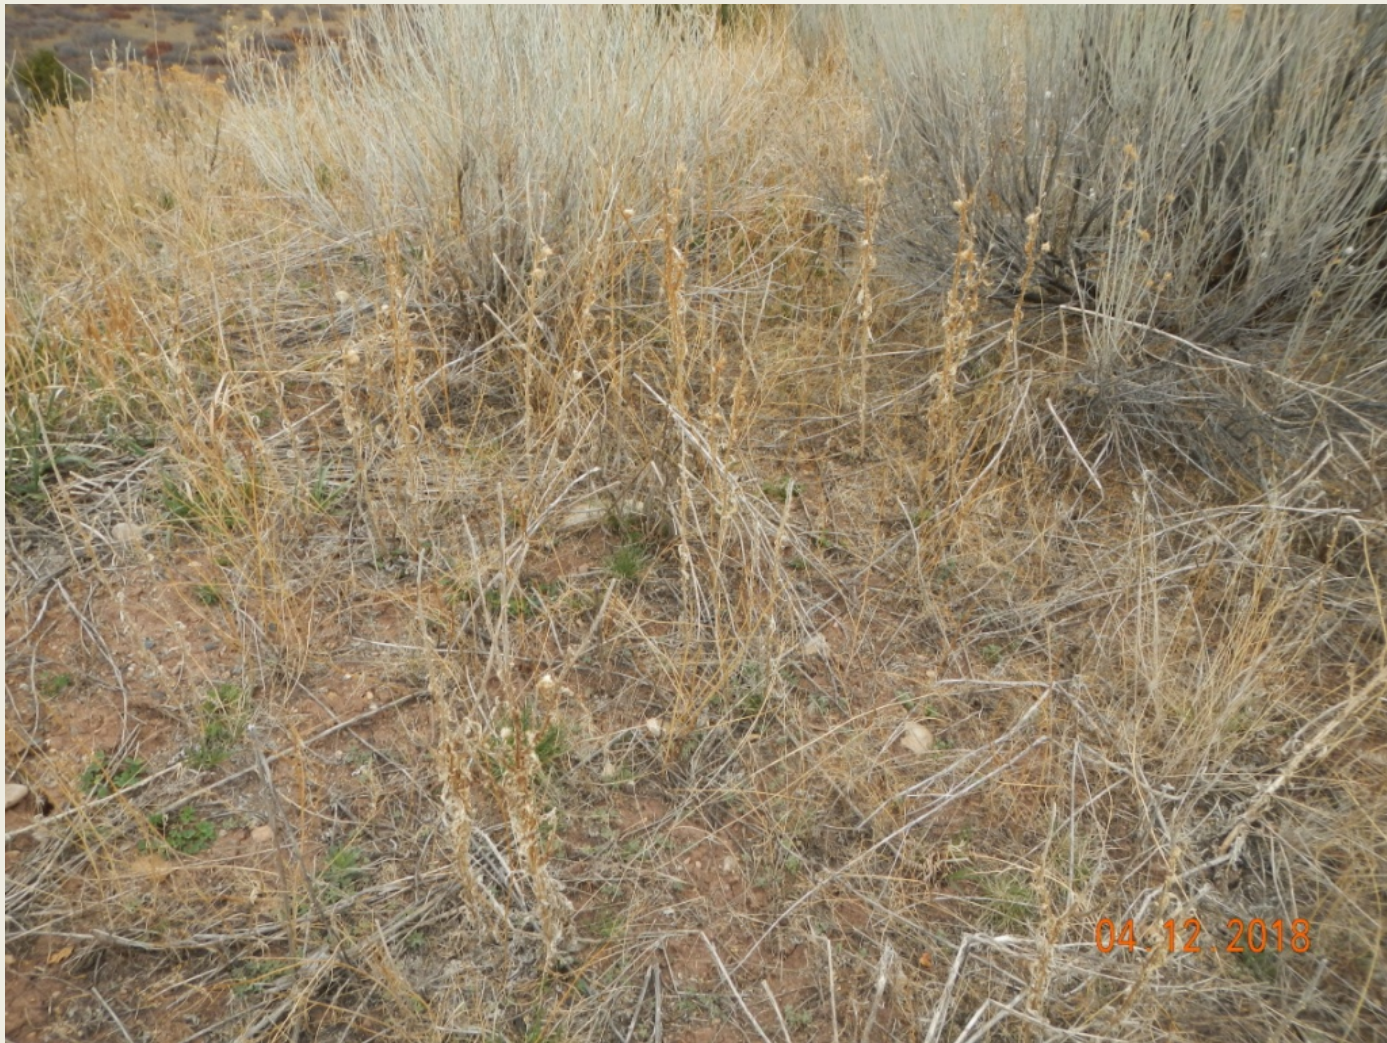
**Photo 5. View of more musk thistles in the northern interim reclamation area.**

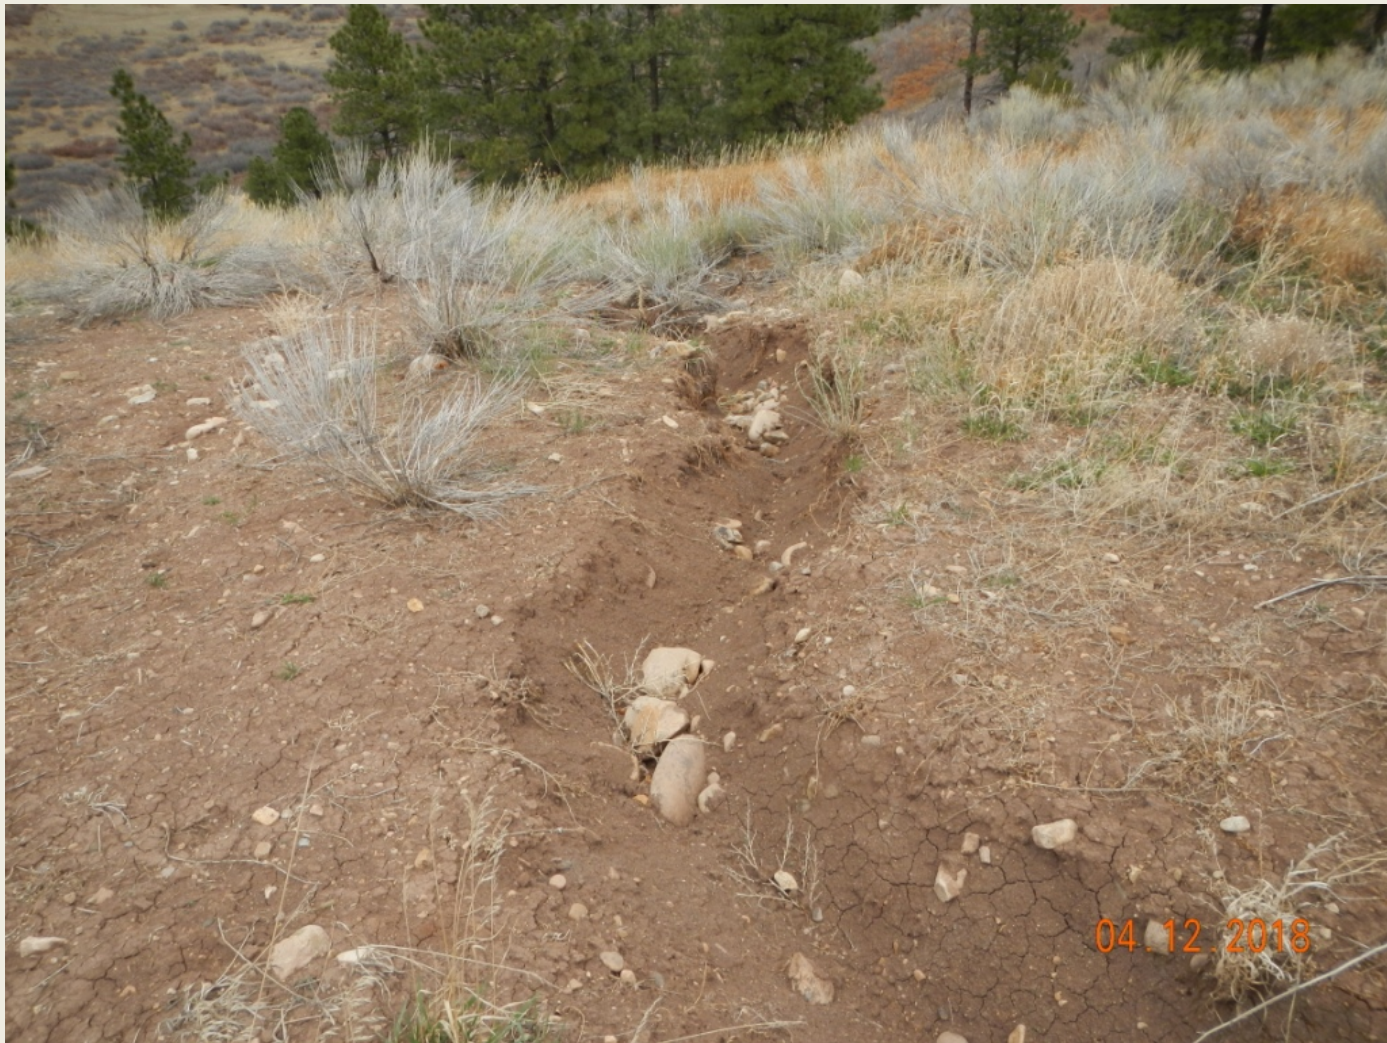
**Photo 6. View of erosional channel approximately 1.5 feet wide and deep in the northeastern portion of the project area.**

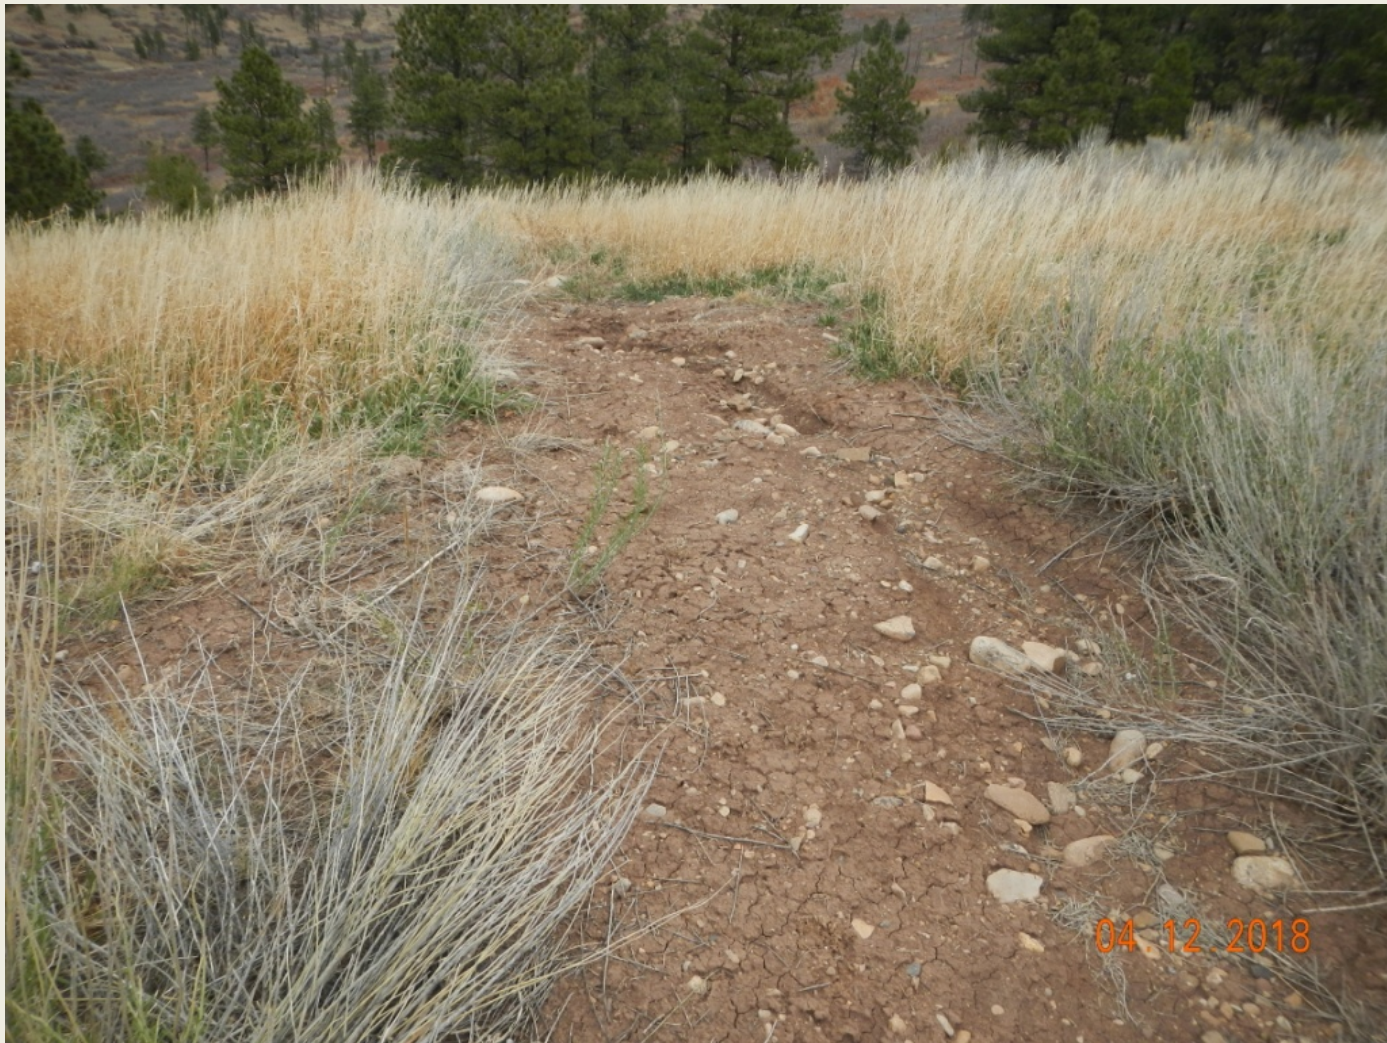
**Photo 7. View of another erosional channel forming in the northeastern portion of the project area.**
