Inspection Photos
Location Name: ROLLIE J. VINCENT A #1
Facility ID #244760

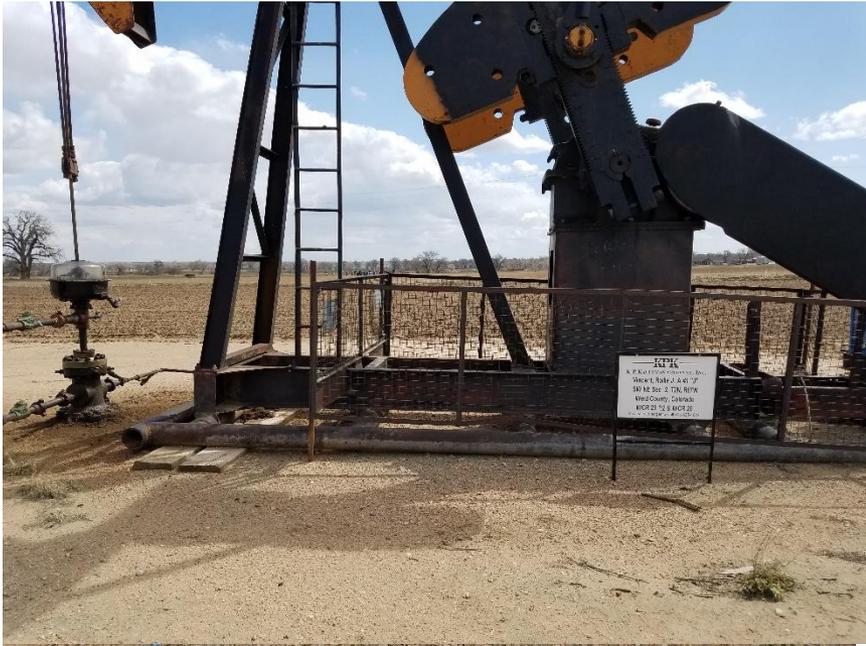
Photo 1. Wellhead

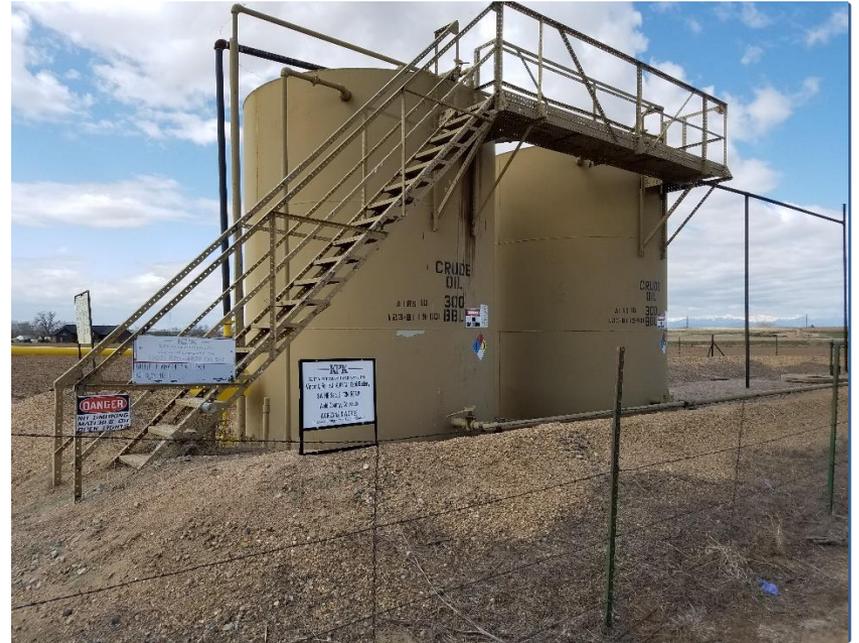
Photo 2. Tank battery

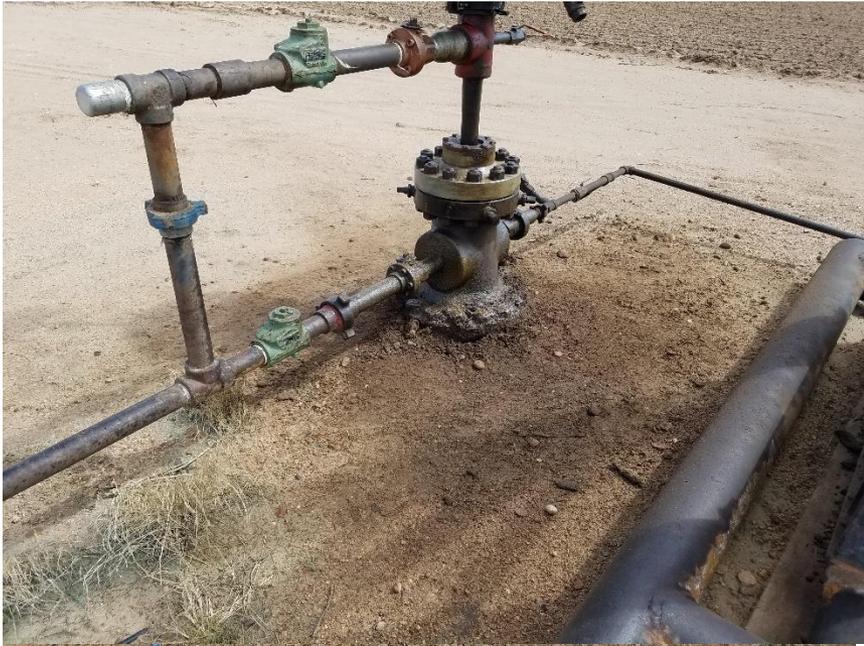
Photo 3. Stained soil around wellhead

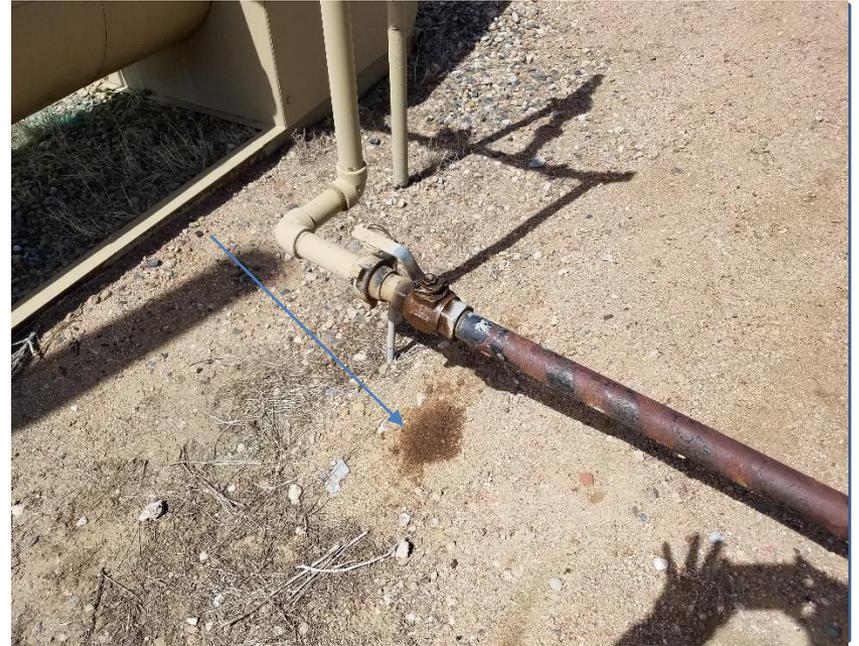
Photo 3. Stained soil near heated treater under valve
