Inspection Photos
Location Name: Fitzhugh #6, REM #10228
API: 05-007-05038

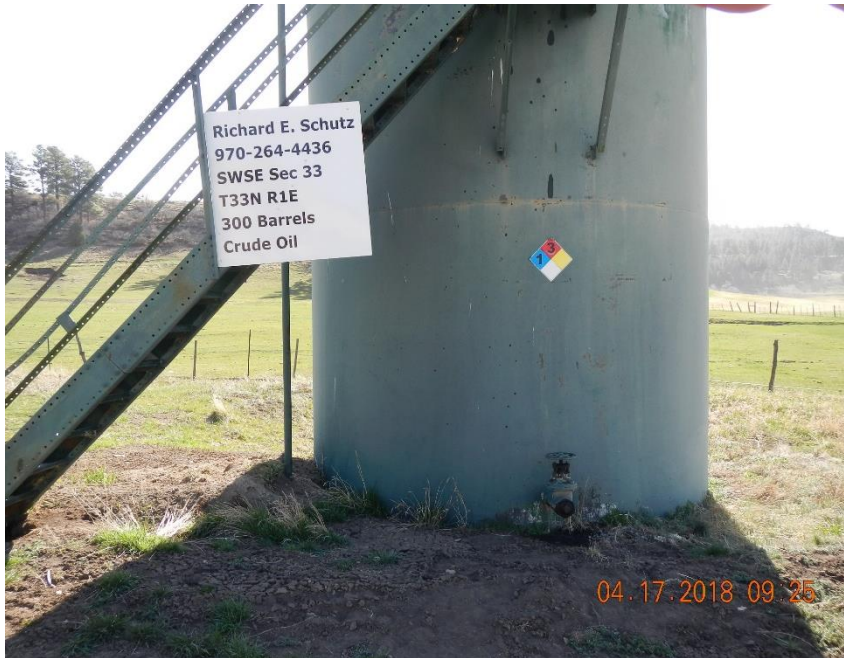
Crude oil AST without secondary containment.

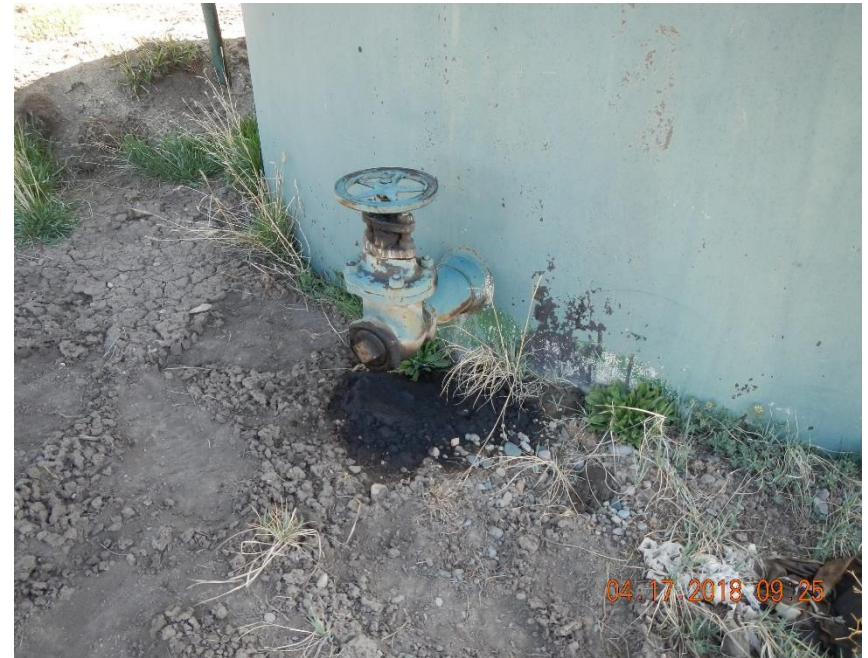
Stained soil beneath load out valve.

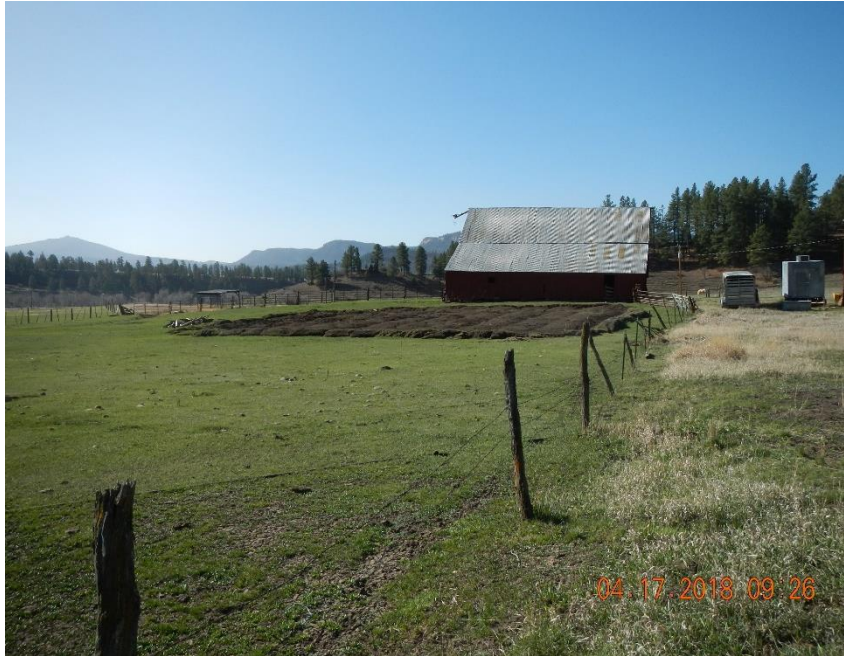
Land farm treatment area for REM #10228.

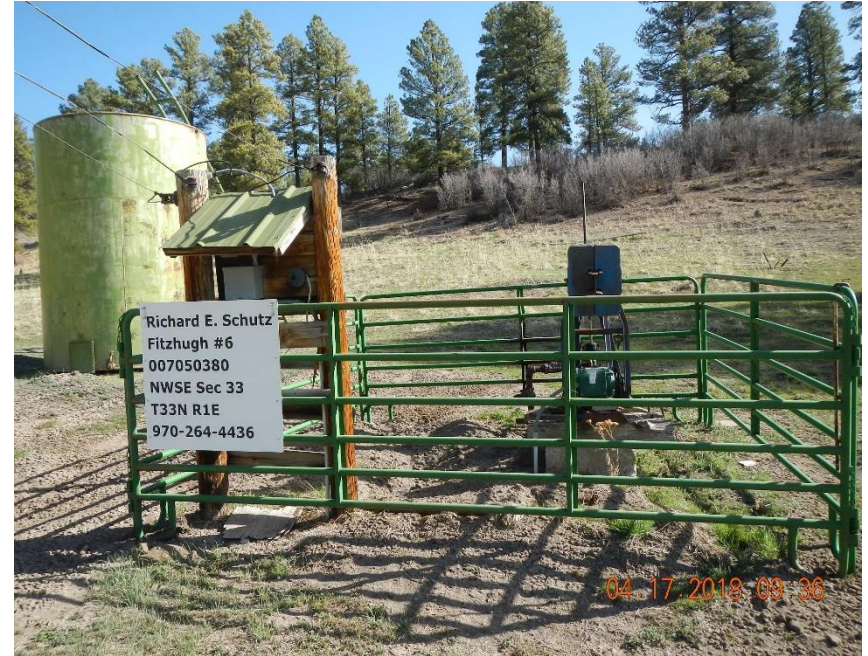
Fitzhugh #6 well head and pump jack.

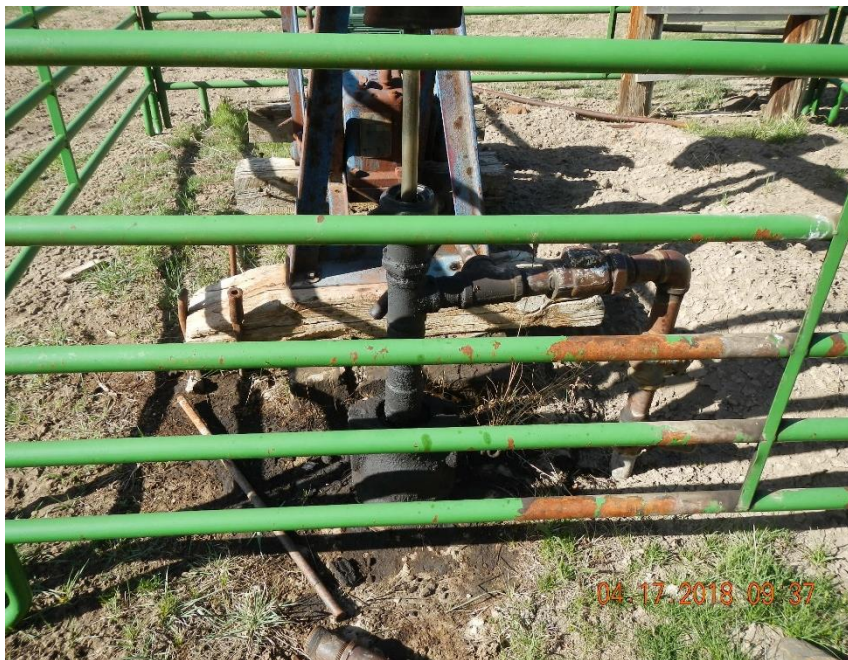
Fitzhugh #6 well head and surrounding soil are stained.

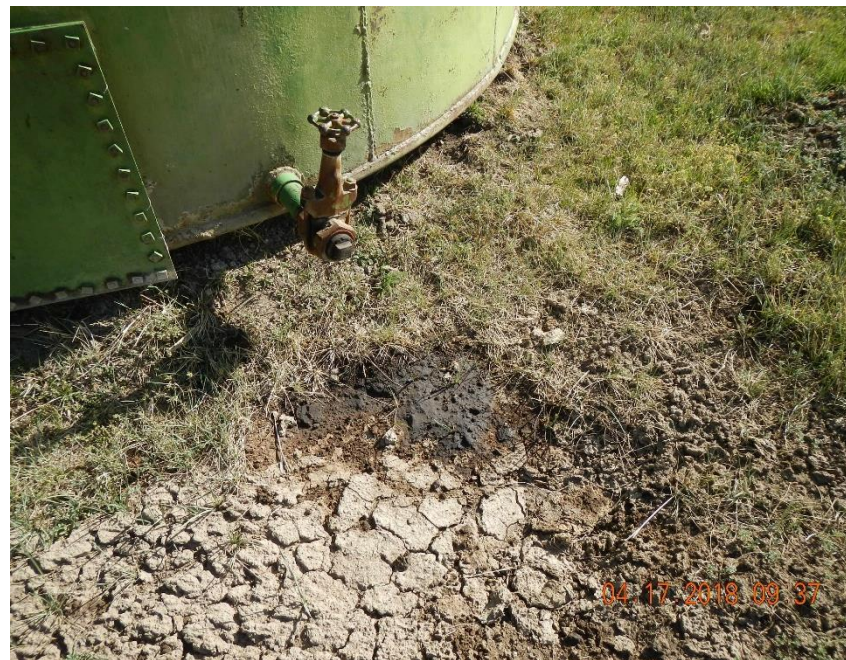
Stained soil beneath load out valve on unused AST.

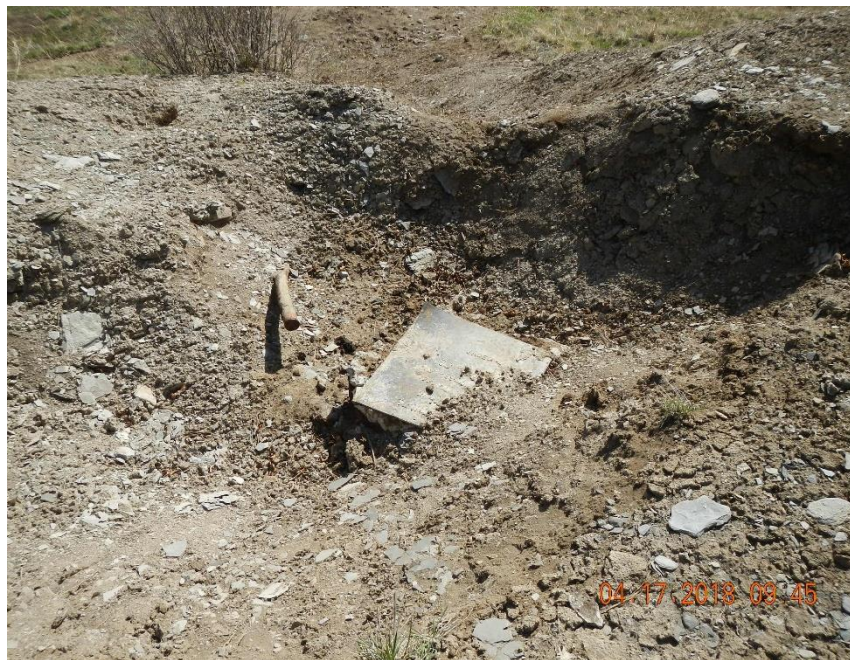
Fitzhugh #15 PA marker and abandoned flow line.

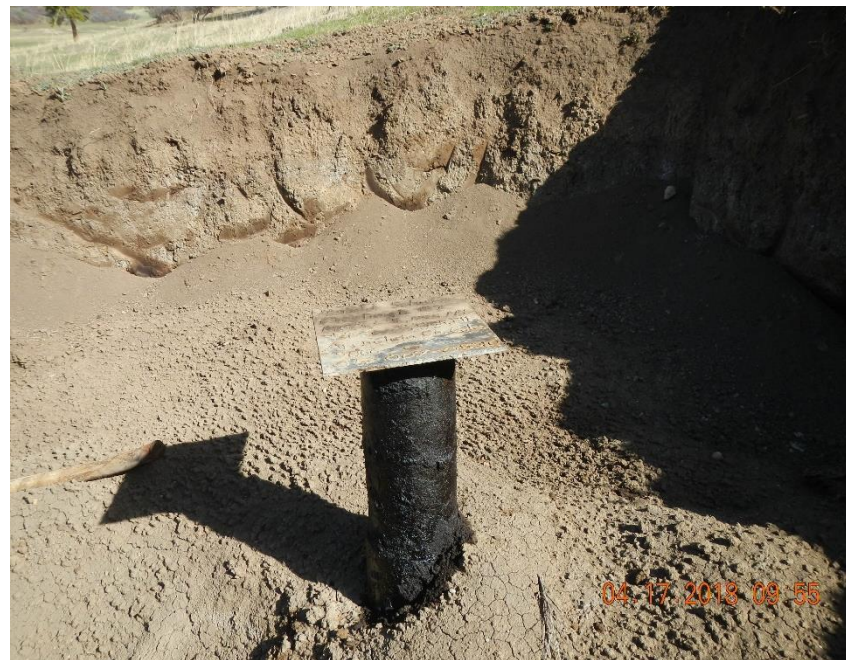
Fitzhugh #7 casing is stained with oil.

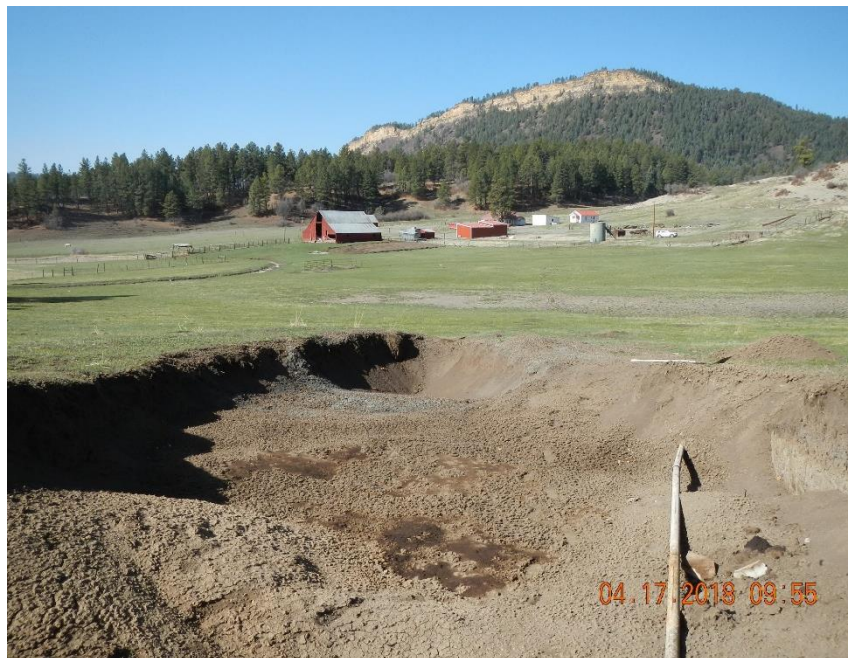
Excavation around Fitzhugh #7 well head.

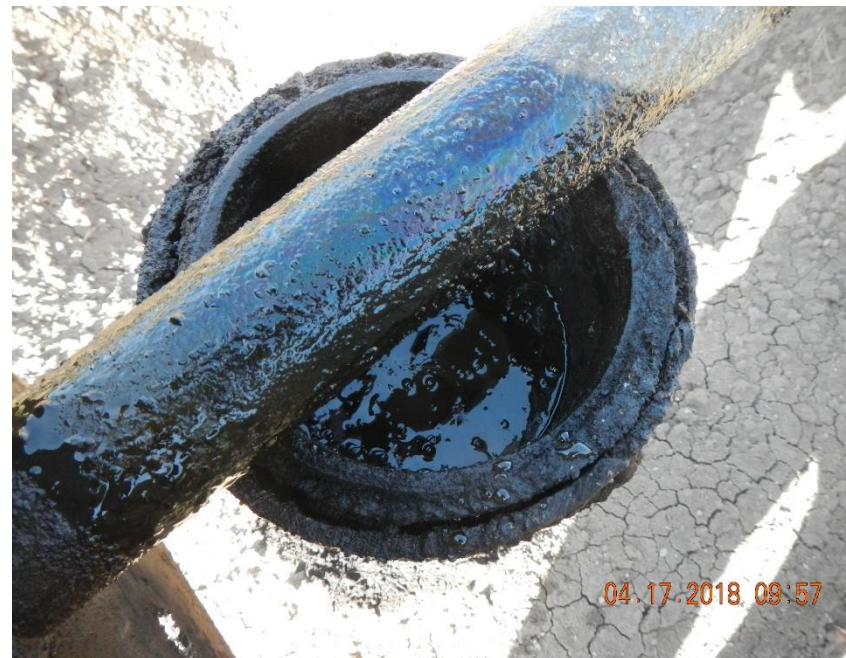
Fluids present in Fitzhugh #7 well bore. PA marker is not welded on.

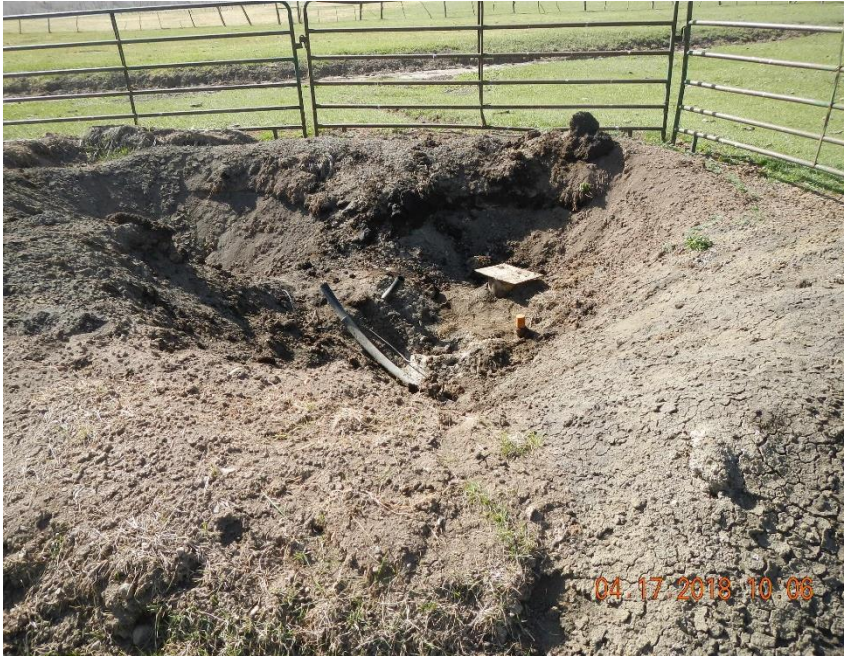
Fitzhugh #15 PA marker and abandoned flow lines.

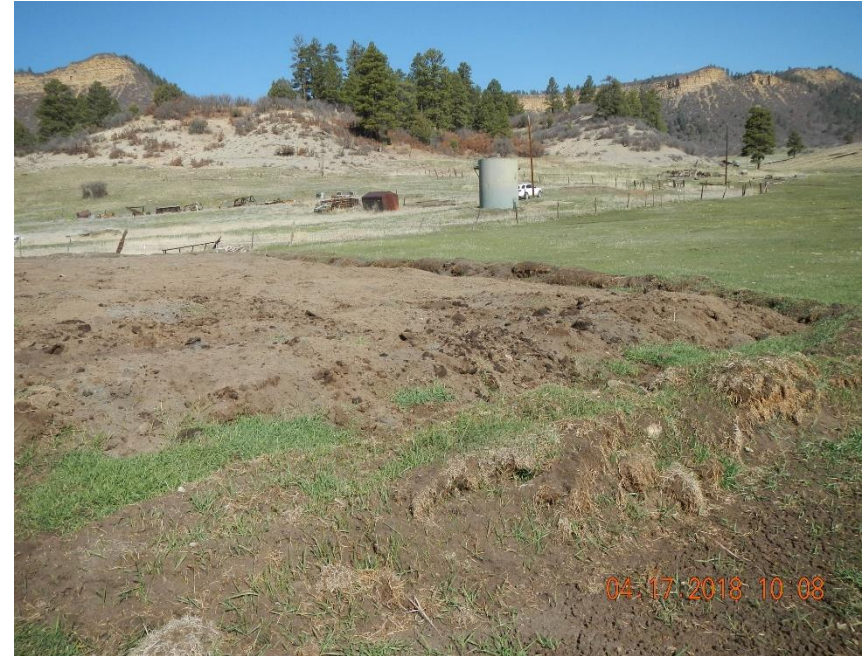
Land farm treatment cell.

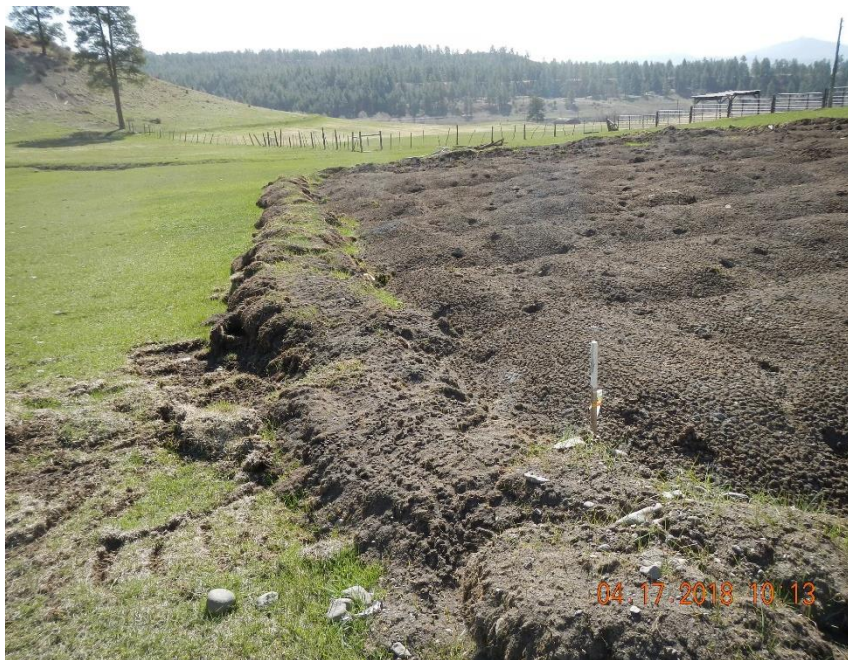
Containment berm along northern edge of land farm treatment cell.

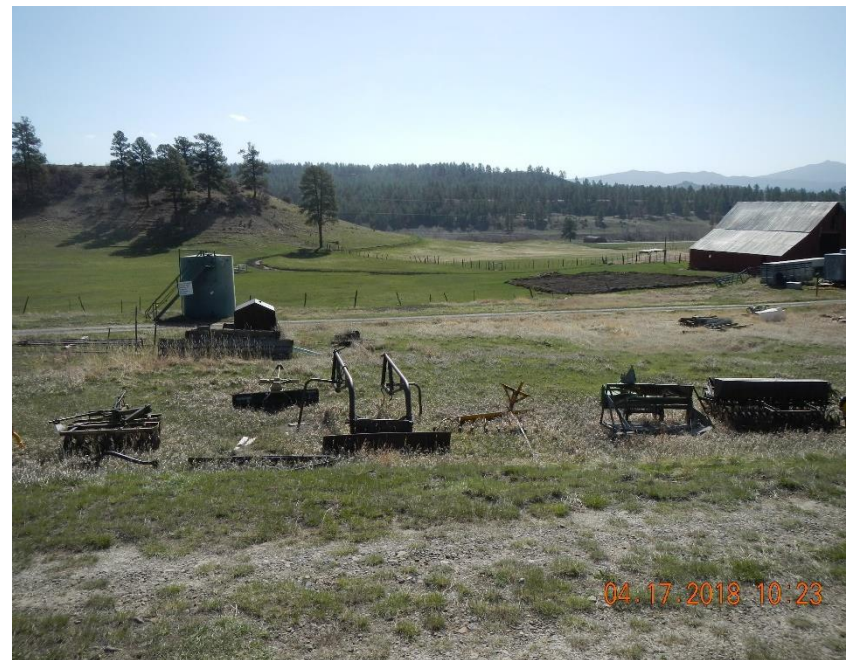
Overview photo with 300 bbl. AST and land farm treatment cell.
