Inspection Photos

Loc#449874

Operator: Laramie Energy

Inspection Number: 680102913

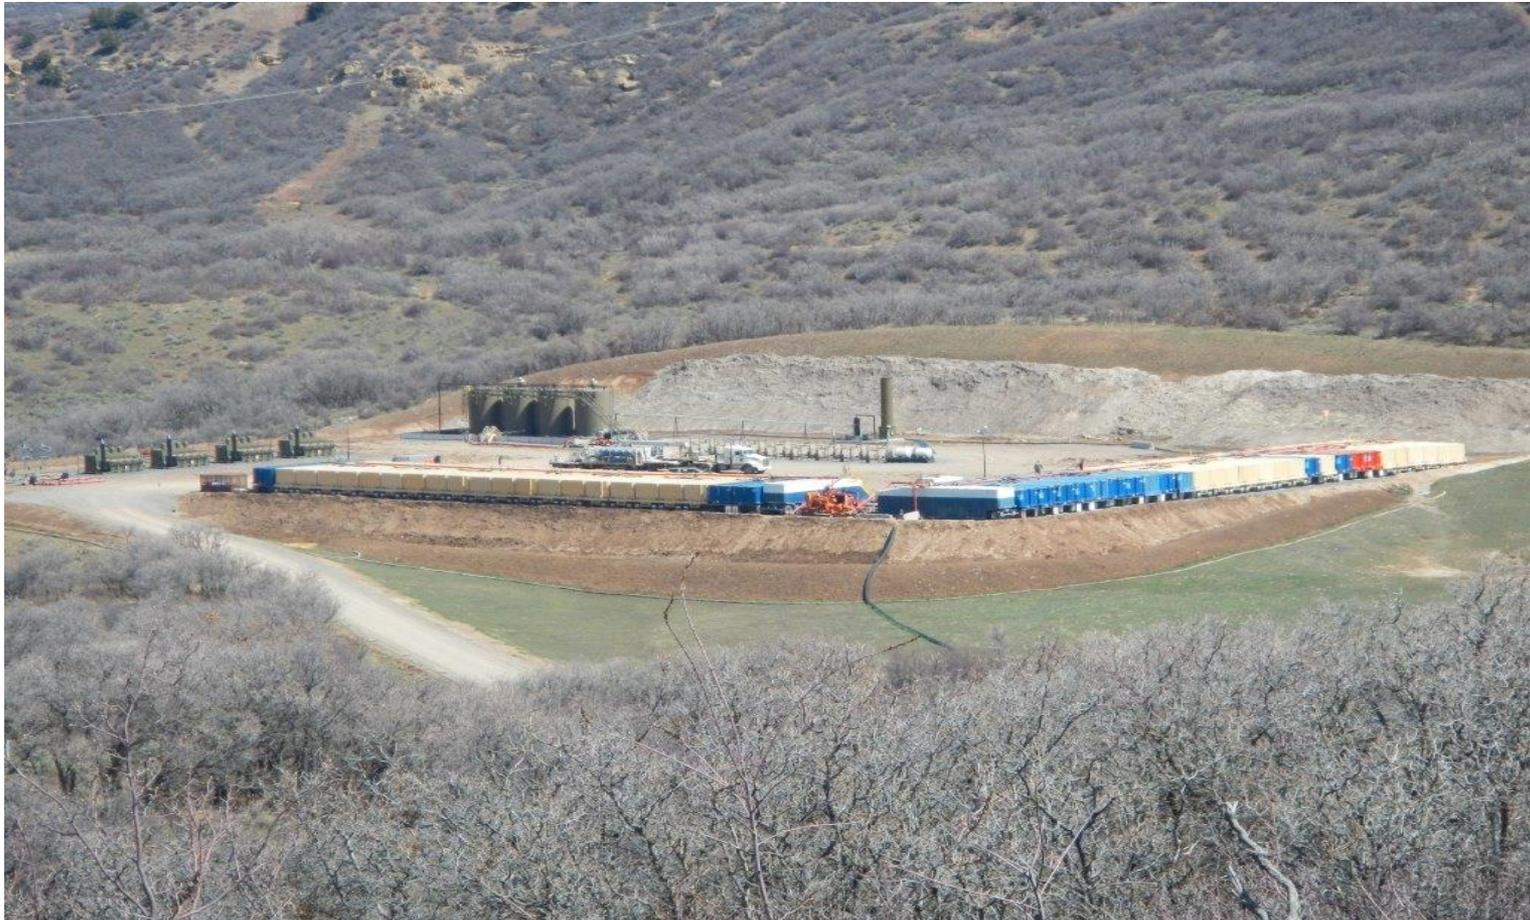
Photo#1:
Overview of Location to Northeast.

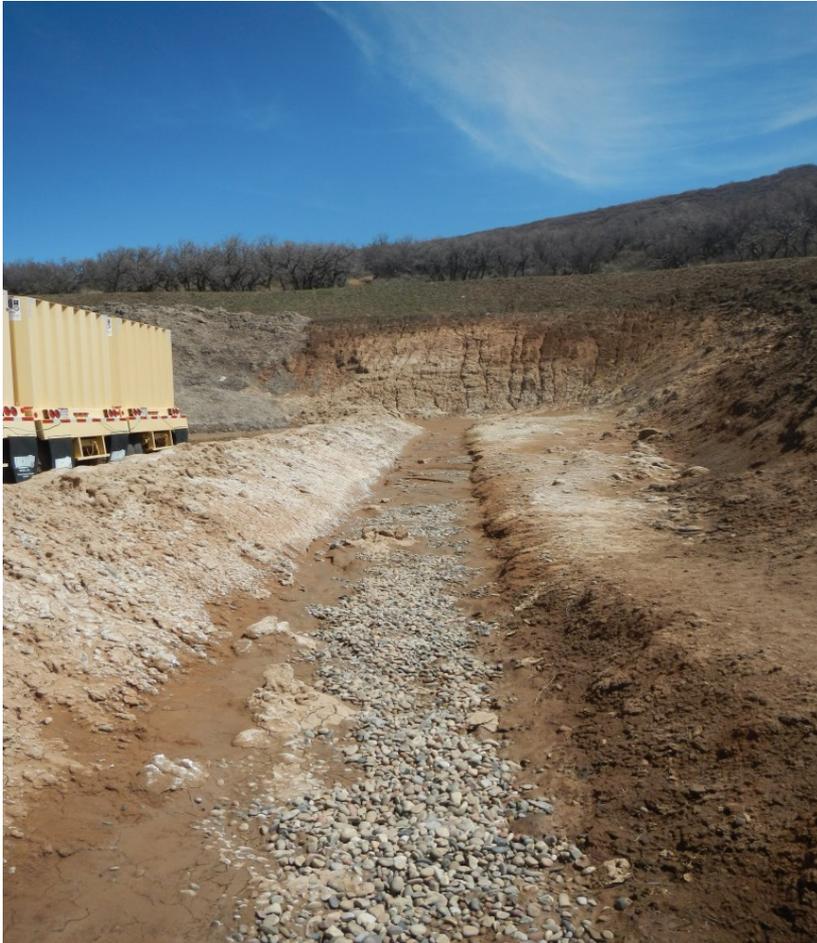
Photo#2:
View to NE of eroding cut slope.

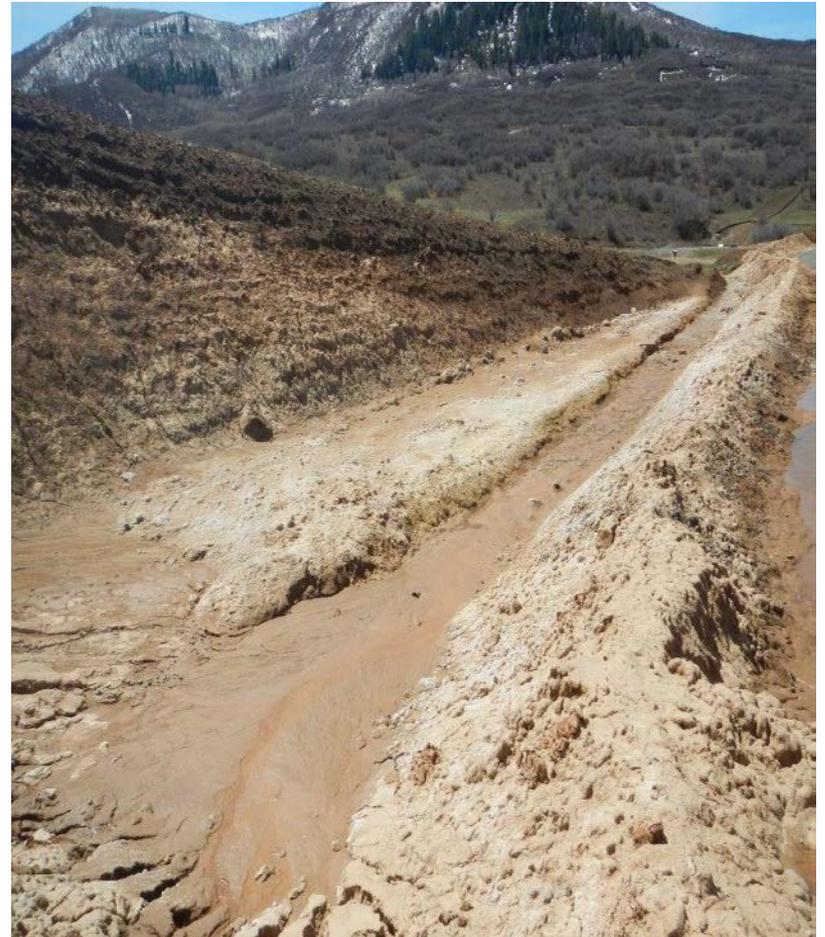
Photo #3:
View SW of sediment migrating from base of cut slope.

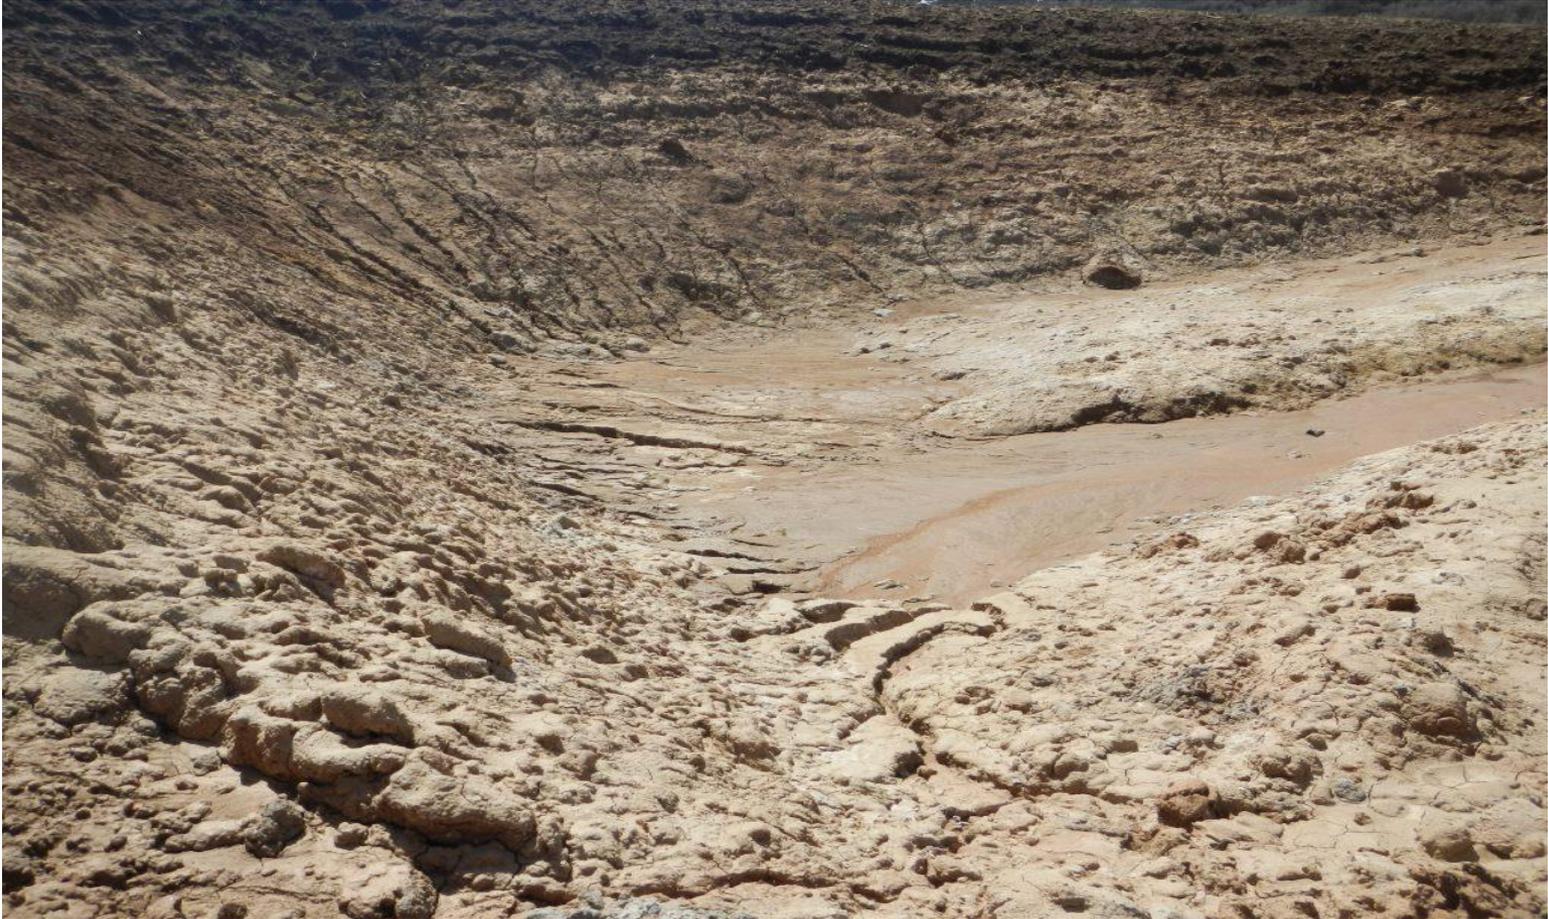
Photo#4:
Close up view of sediment retention area and drain ditch at base of cut slope.

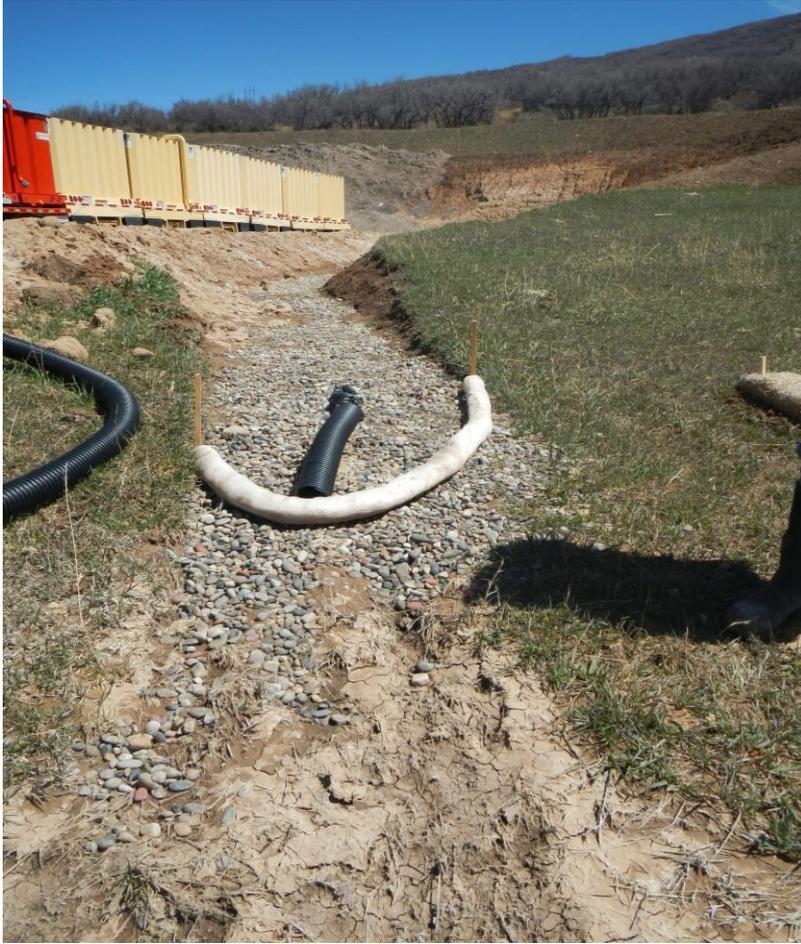
Photo#5:
BMP outlet / discharge leading from eroding cut slope, showing sediment migration..

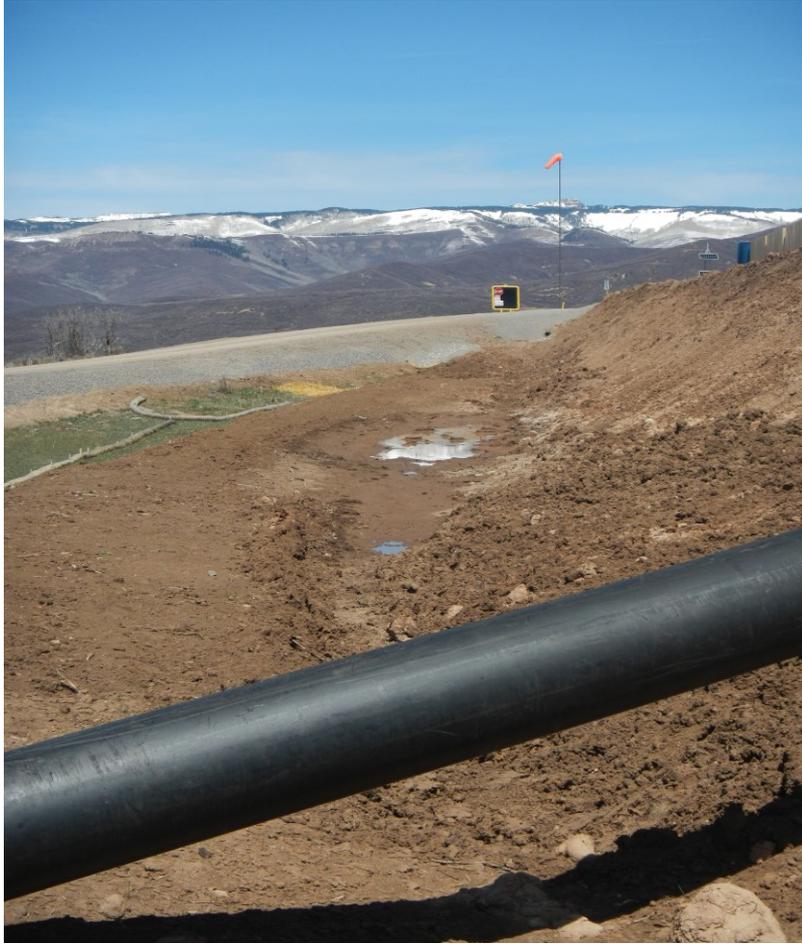
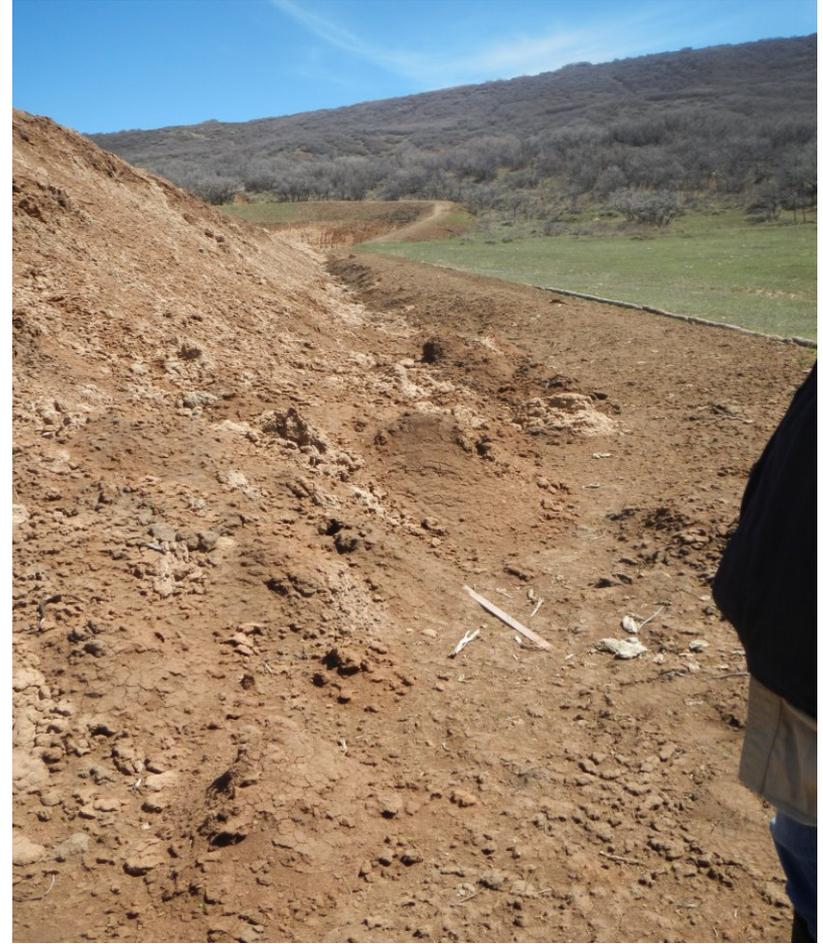
Topsoil is not stabilized, has the potential for degradation due to mixing with subsoil and wind/water erosion.

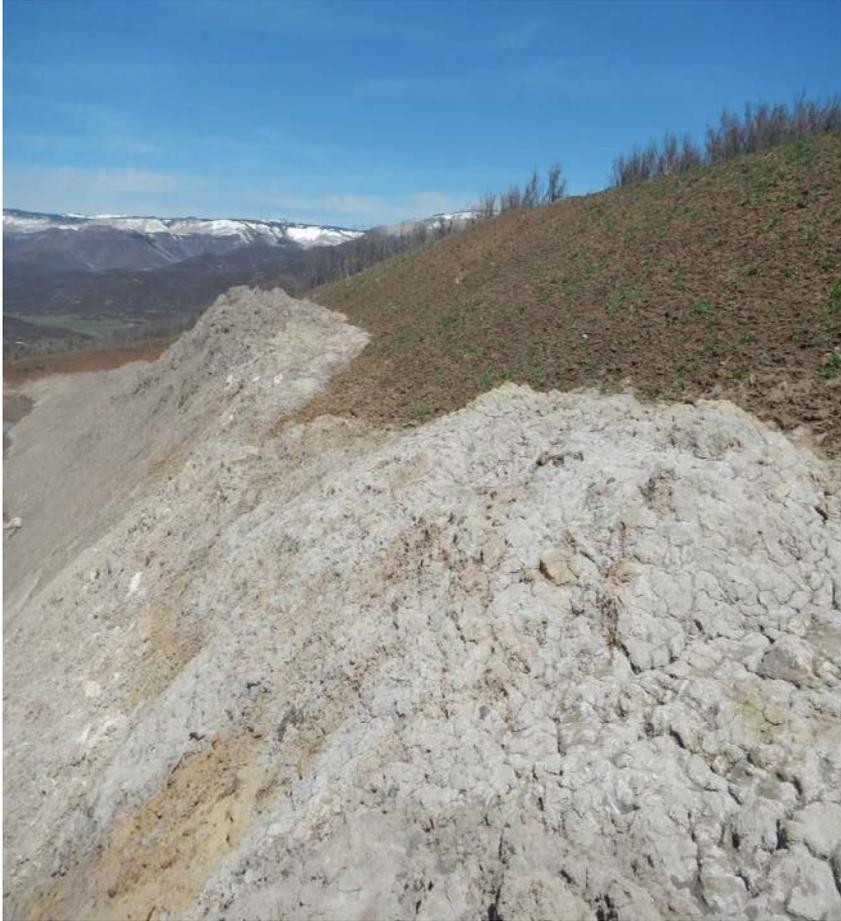
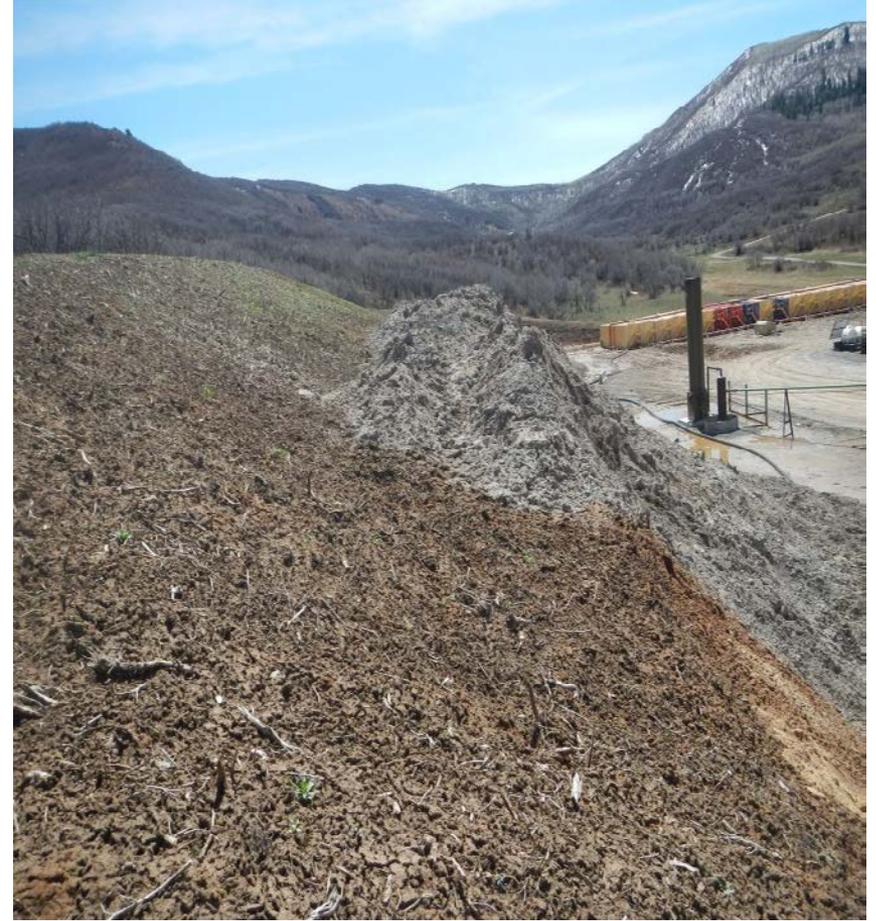
Area at top of cut slope where cuttings have been piled & are mixing with topsoil.
