Inspection Photos
Location Name: Boxer 25, 29, & 26 Tank Battery
Facility ID: 439100
Inspection Date: April 27, 2018

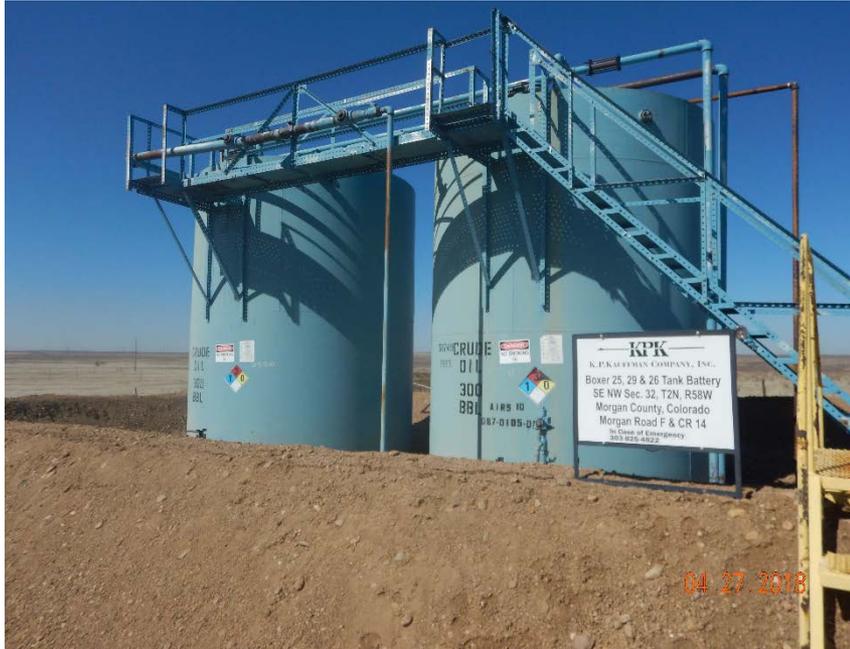
Photo #1 – Crude oil tank battery with battery sign.

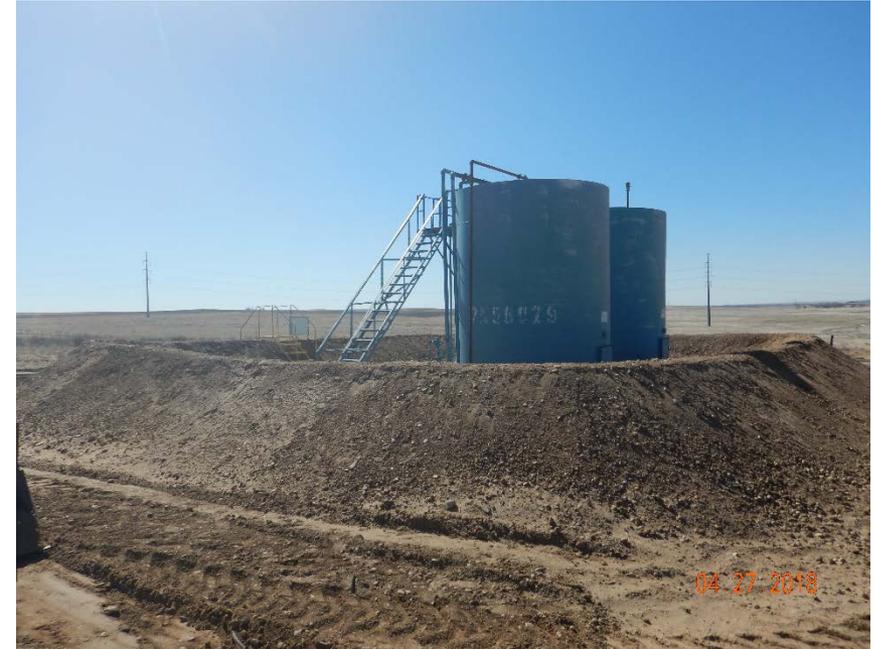
Photo #2 – View from NW of tank battery documents that operator has improved berms on location.

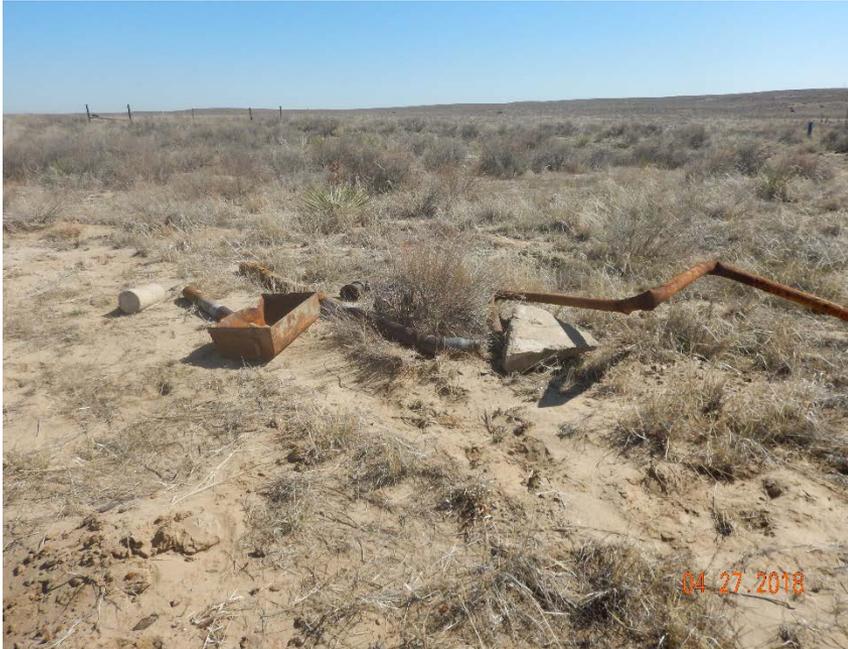
Photo #3 – Unused junk at NE corner of facility.

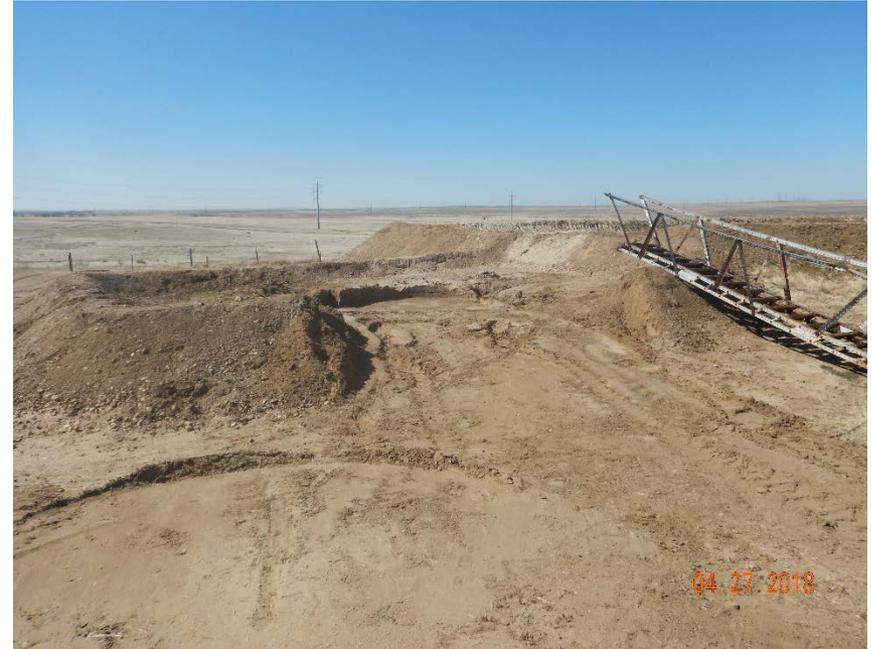
Photo #4 – 300 bbl produced water AST has been removed, additional work required to remove unused equipment and to reclaim former earthen berm.

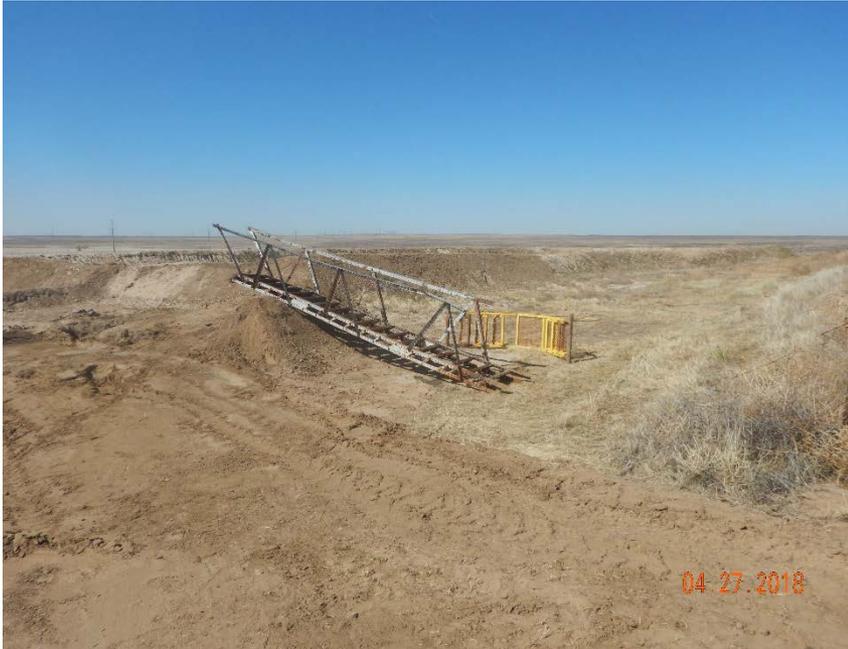
Photo #5 – Unused stairs remaining at NE corner of evaporation pit.

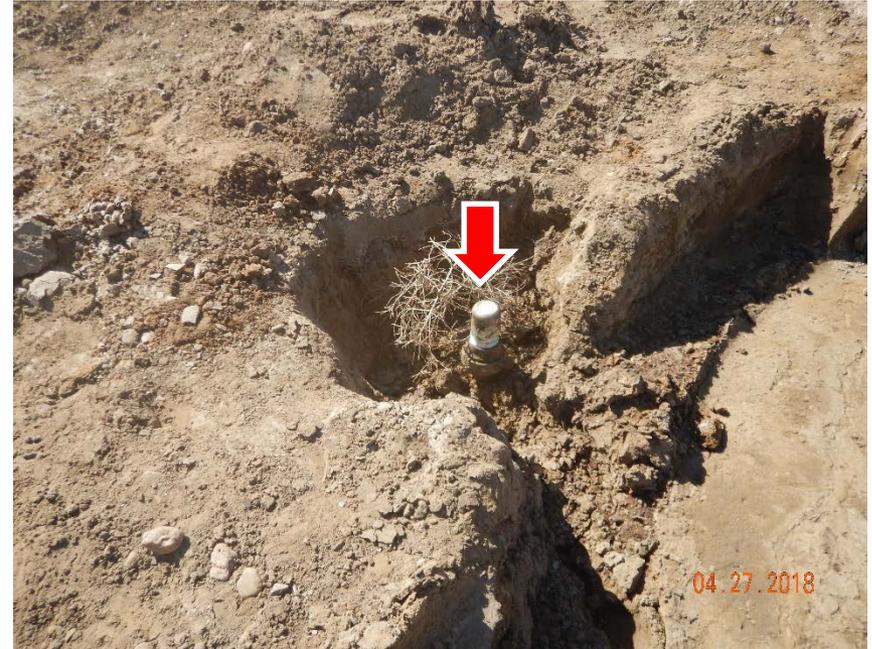
Photo #6 – Flowline riser at SE corner of former produced water AST location.

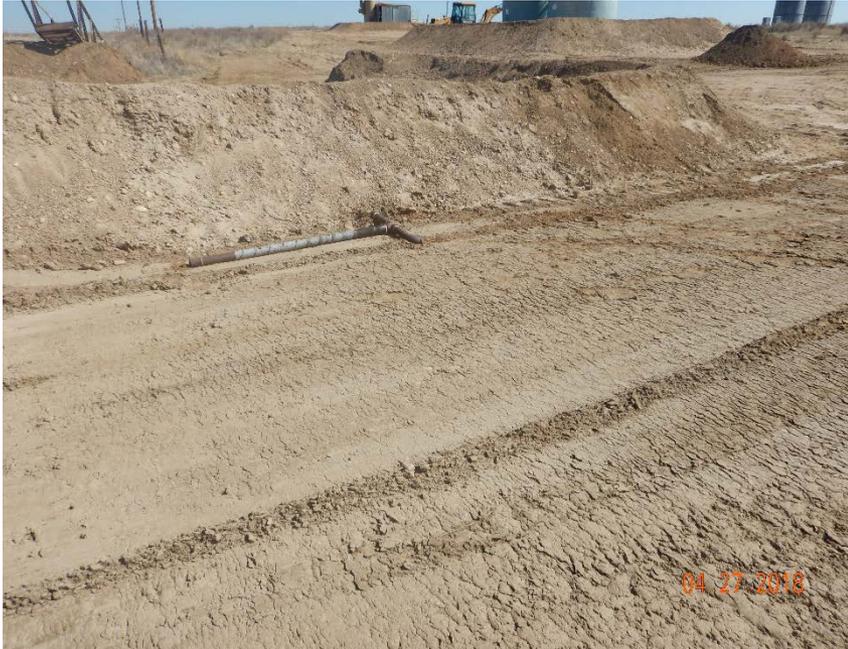
Photo #7 – Unused pipe on south side of former produced water AST berm.

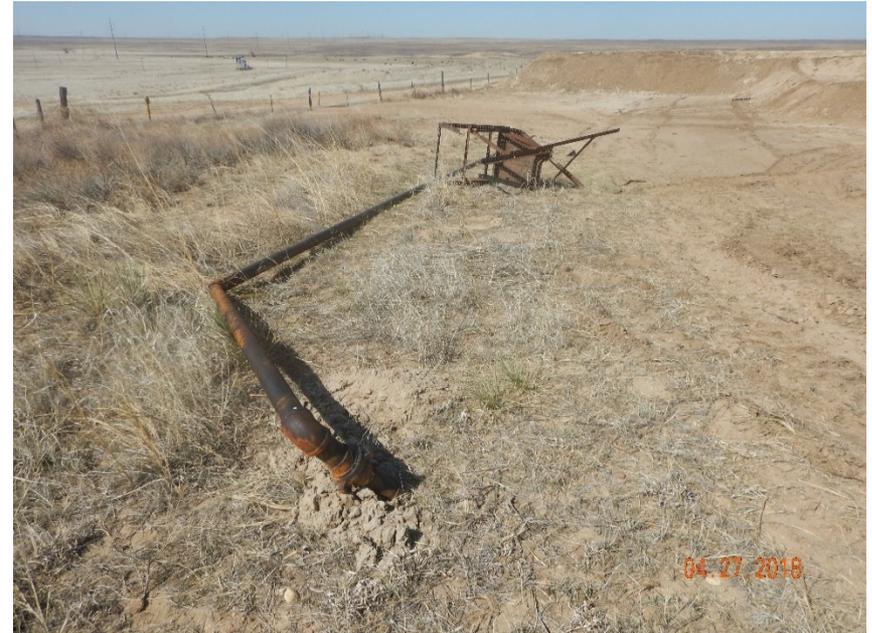
Photo #8 – Unused pipe and stairway on south side of facility.

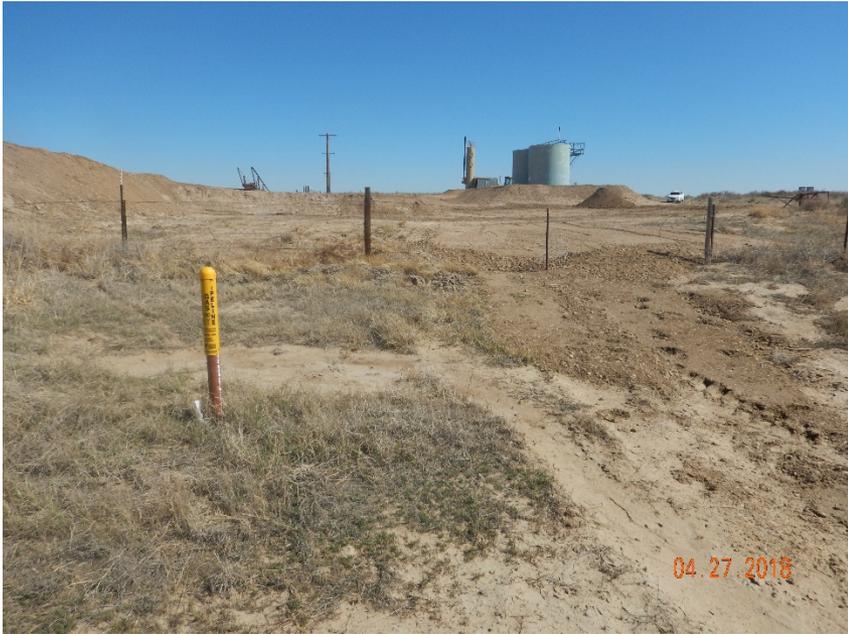
Photo #9 – View of facility from south side of fence demonstrates surface grading and erosion control efforts made by operator.

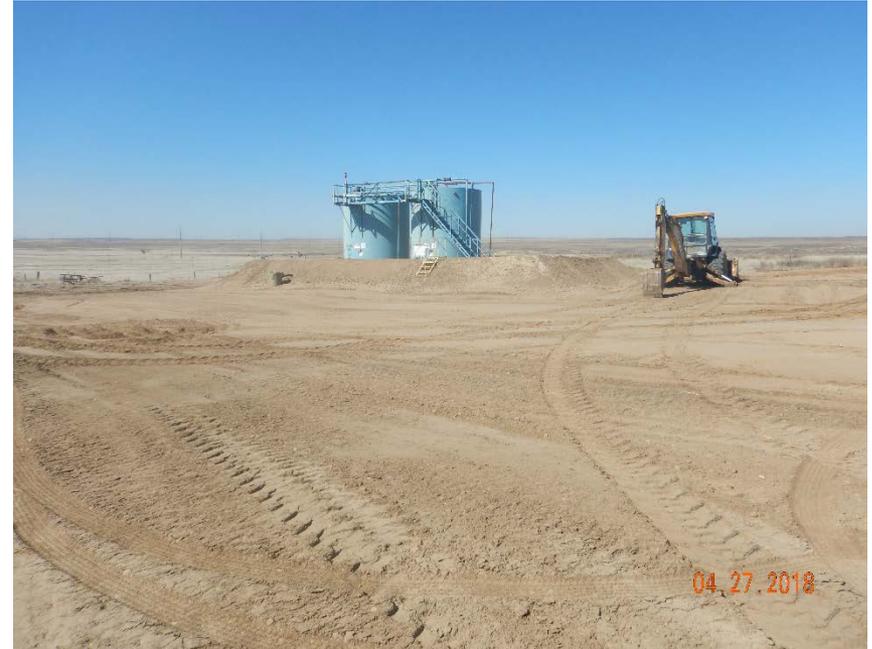
Photo #10 – View from NE corner of facility demonstrates ongoing surface grading efforts made by operator.

Refer to Remediation Project #1551 for documentation of ongoing site investigation and remediation efforts in this area.

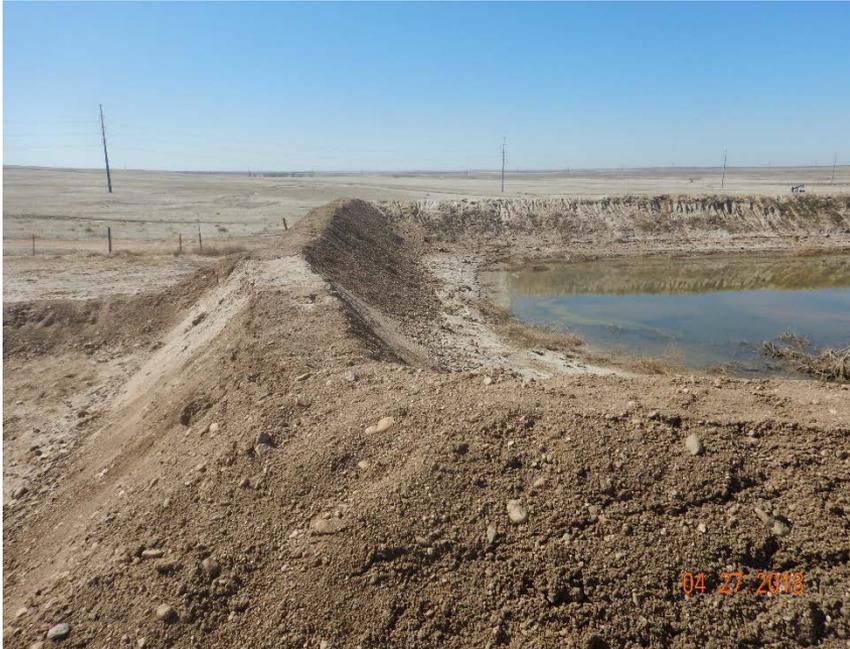
Photo #11 – View of NE corner of repaired pit berm.

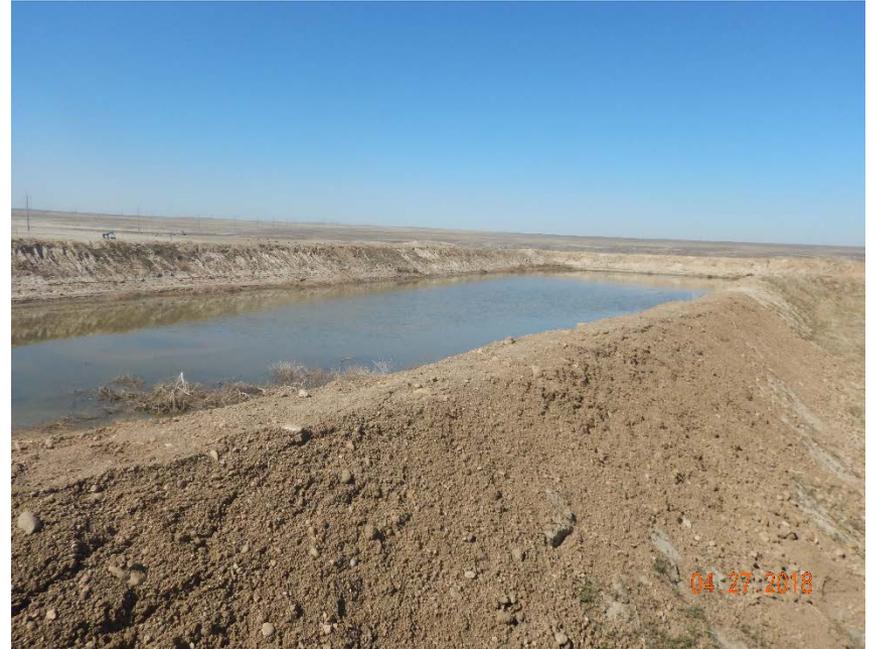
Photo #12 – View looking SW over evaporation pit documents berm repair and weed control efforts.

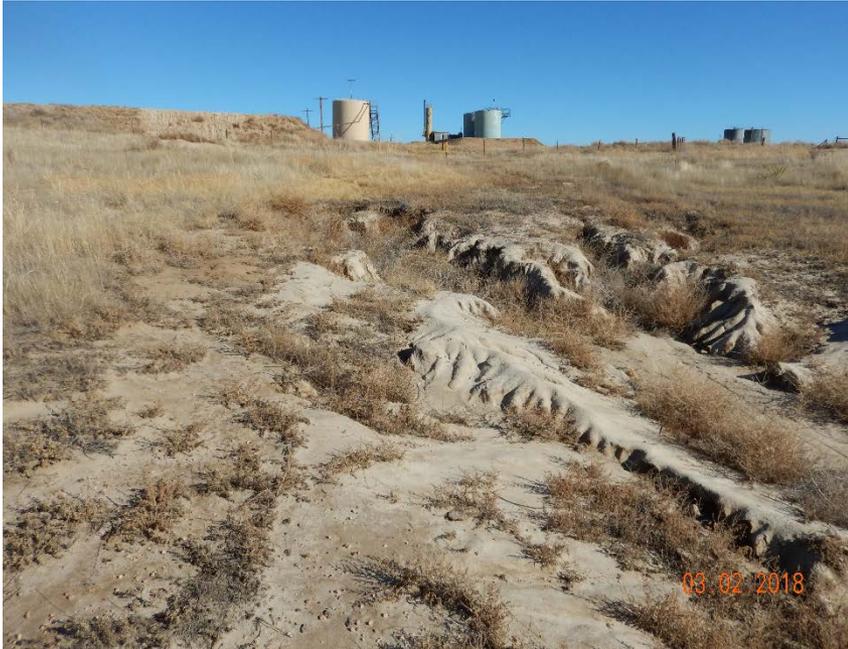
Photo #13 – Photo from previous FIR (dated 3/2/2018) shows conditions of eroded area south of location, looking north.

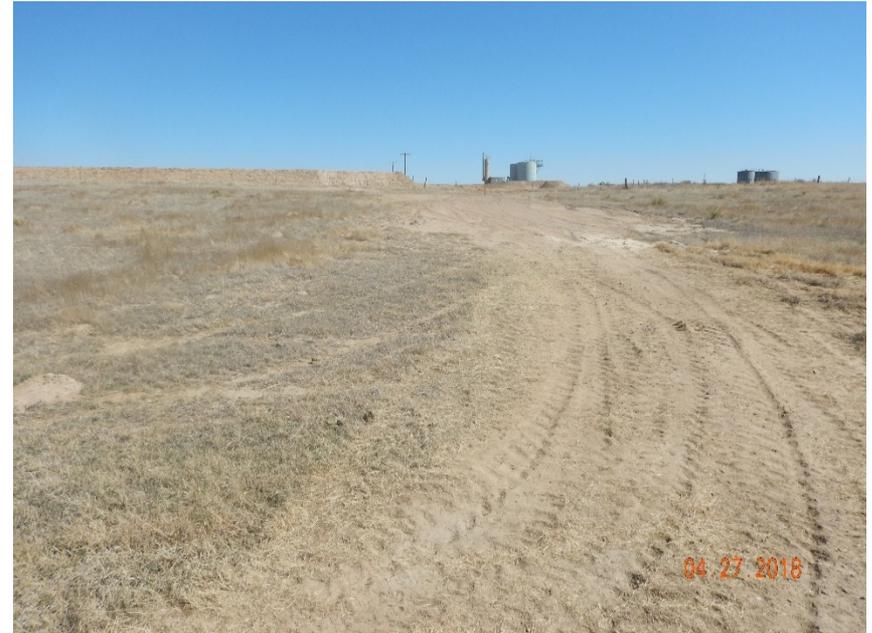
Photo #14 – Photo from inspection date shows that area from previous photo has been graded by operator.

Refer to Remediation Project #9362 for ongoing site investigation and remediation efforts in this area.
