**Inspection Photos**  
**Location Name: State CF #1**  
**API: 05-067-07927**

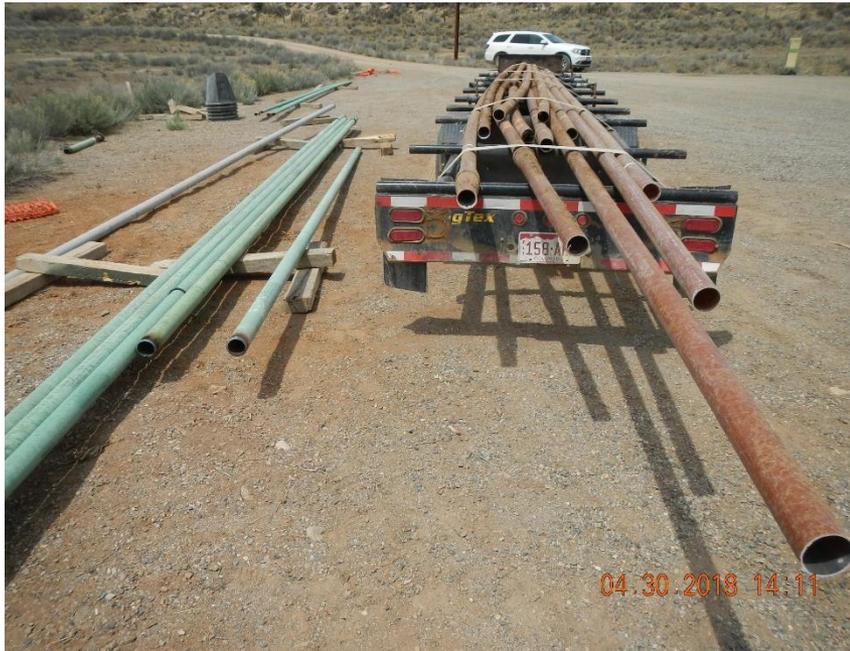
**Sections of 3" fiberglass pipe being replaced with steel pipe.**

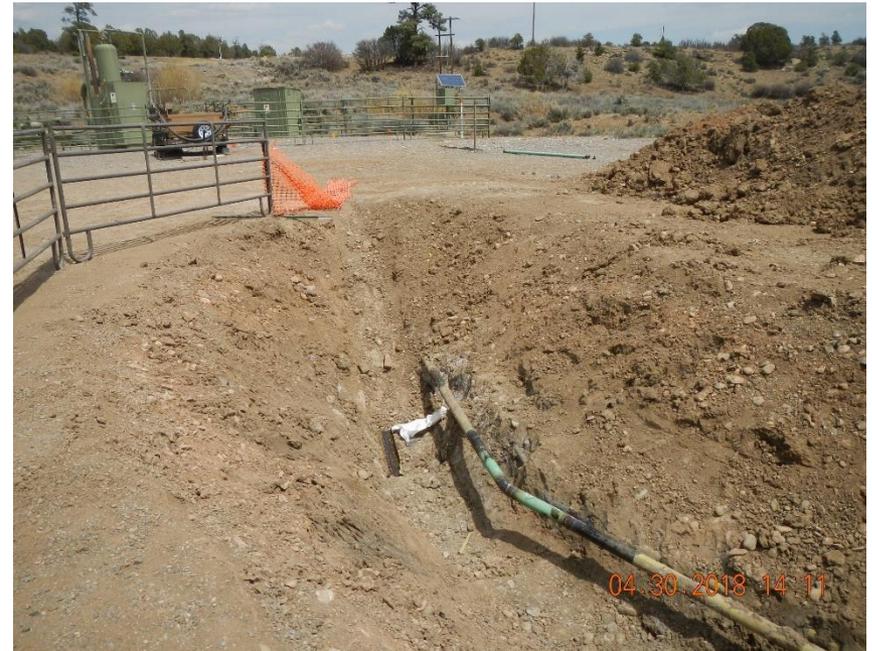
**Repaired section of transfer line on location.**

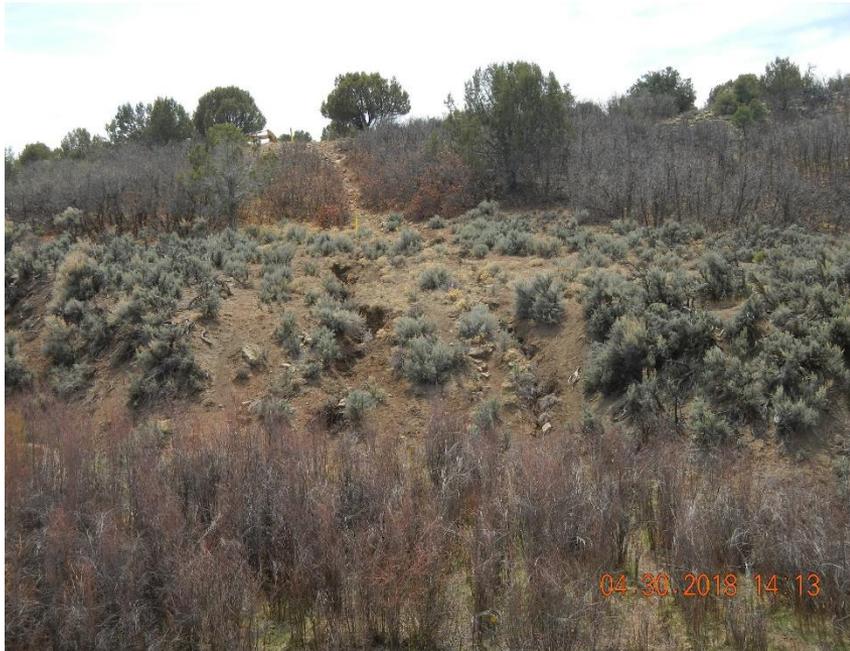
**Pipe line route south of the State CF #1 location.**

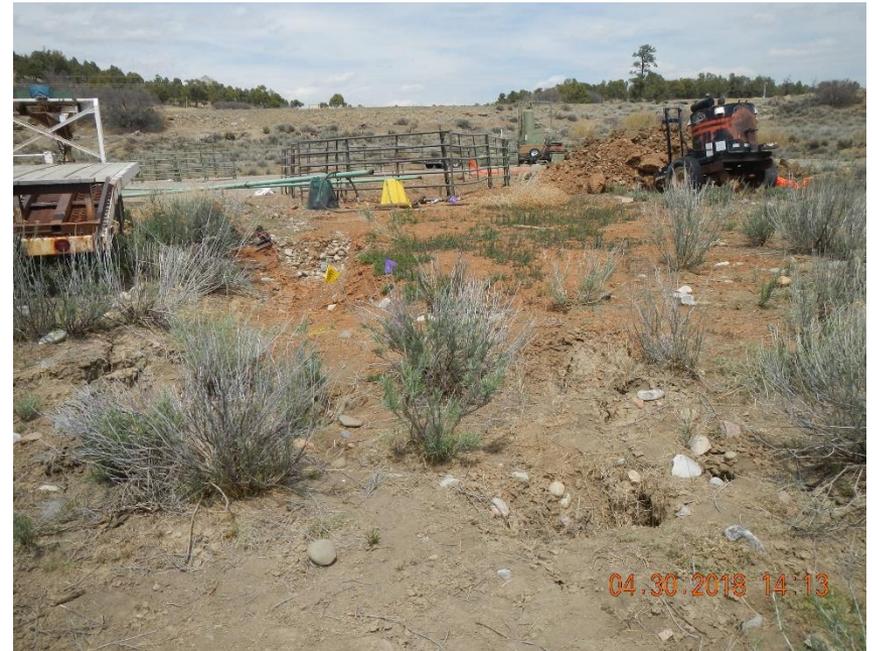
**Subsidence along pipe line route on location.**

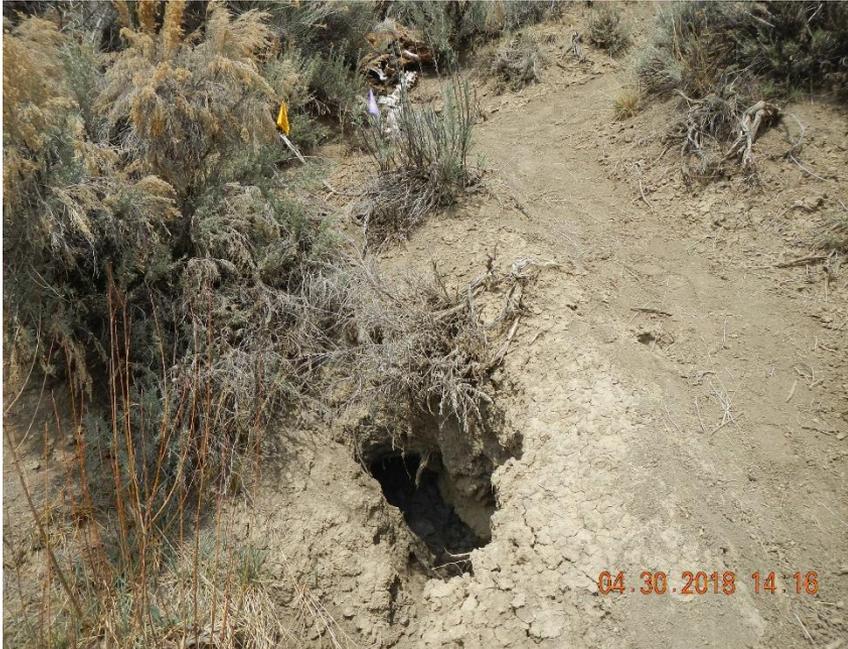
**Southern edge of location along pipe line route.**

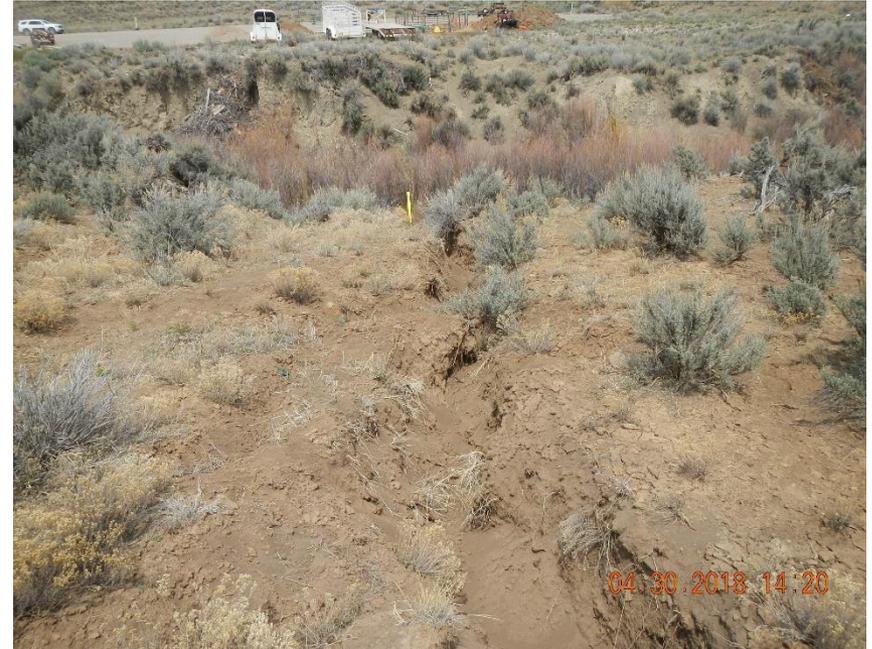
**Erosion along pipe line right of way.**

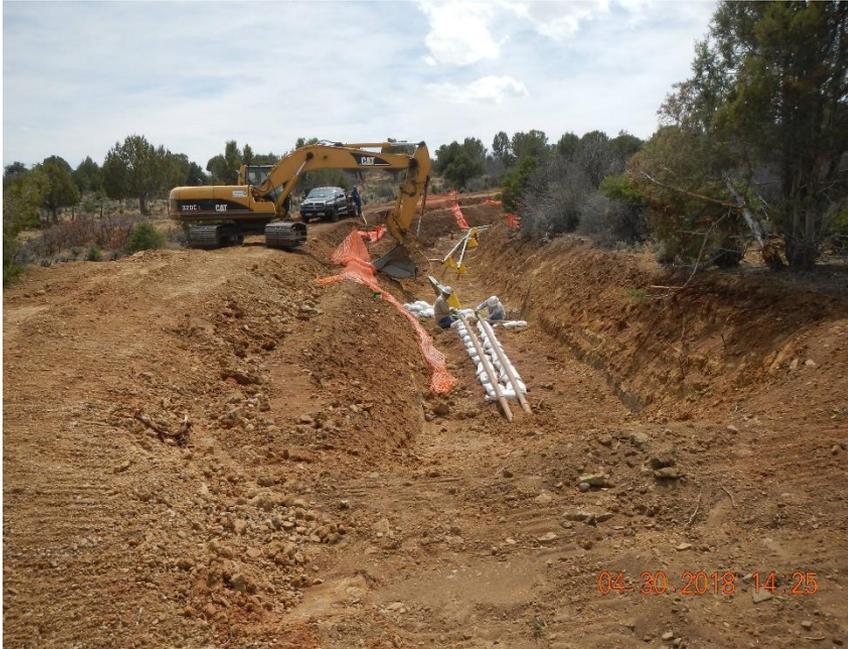
**New sections of steel pipe being installed.**

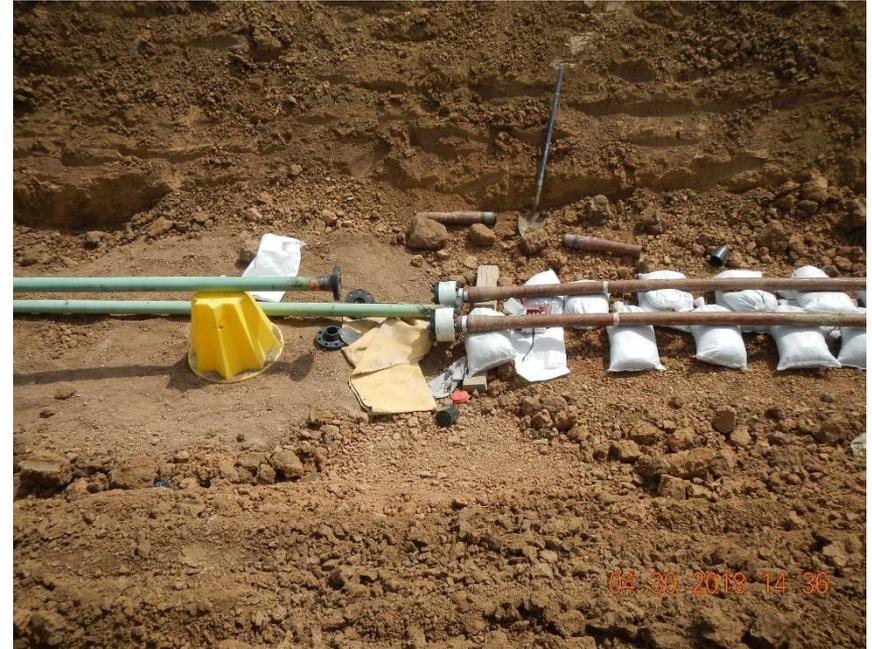
**Transition from fiberglass pipe to new steel pipe.**

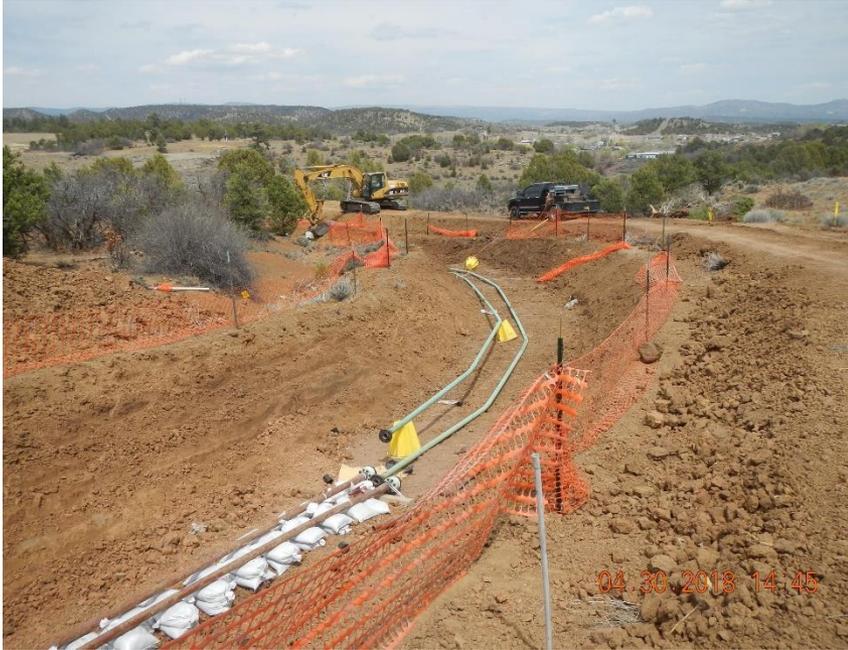
**New section of steel pipe in area where failure occurred.**

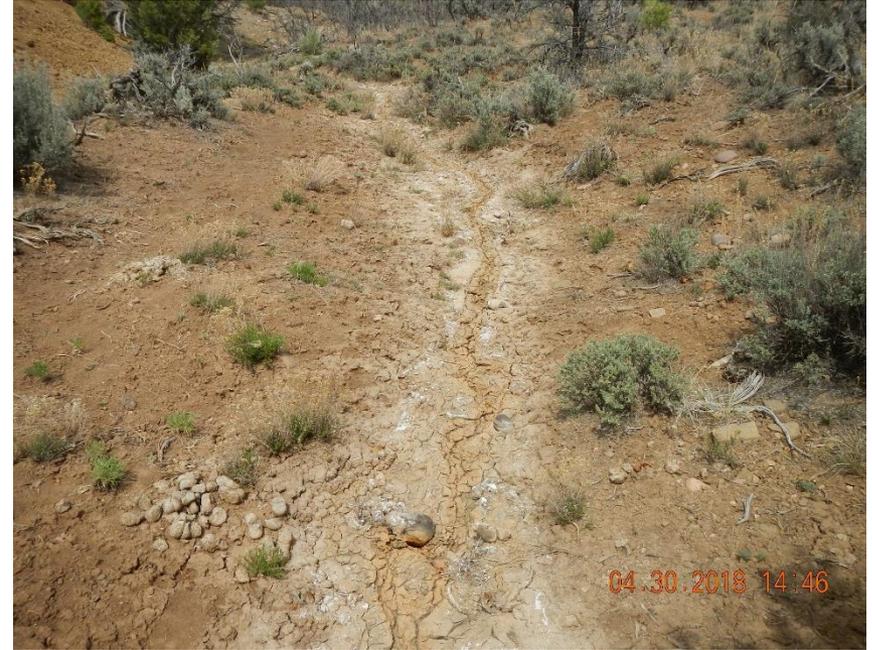
**Stained soil along flow path of release.**
