Inspection Photos

Operator: WIEPKING-FULLERTON ENERGY LLC -
96340

Location ID: 436744

Inspection Doc. Number: 682503289
Lincoln County, CO

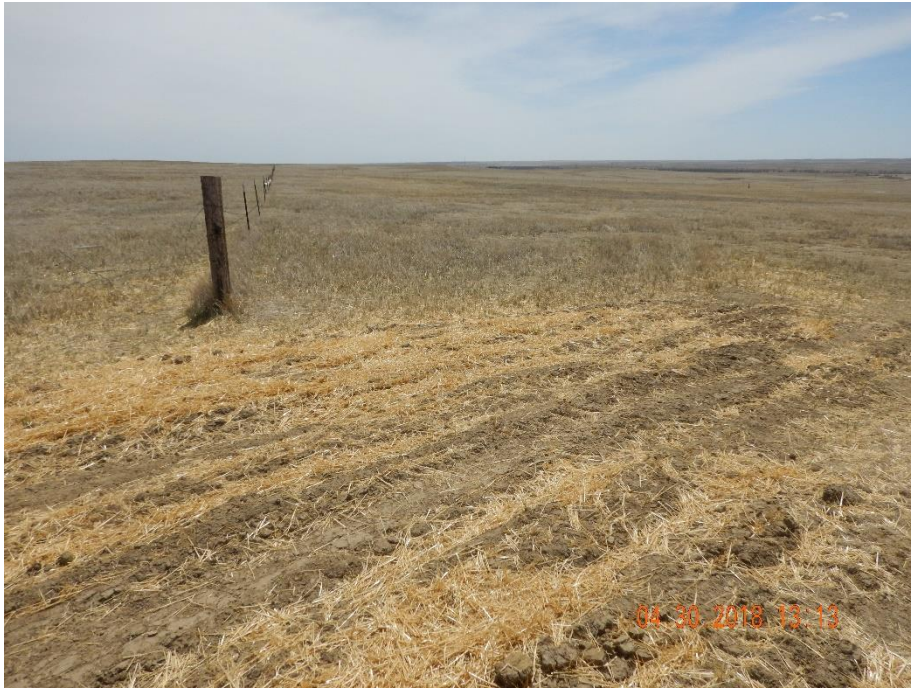
Photo 1: Photo taken from the north end of the location, facing southeast. Photo shows overview of the location

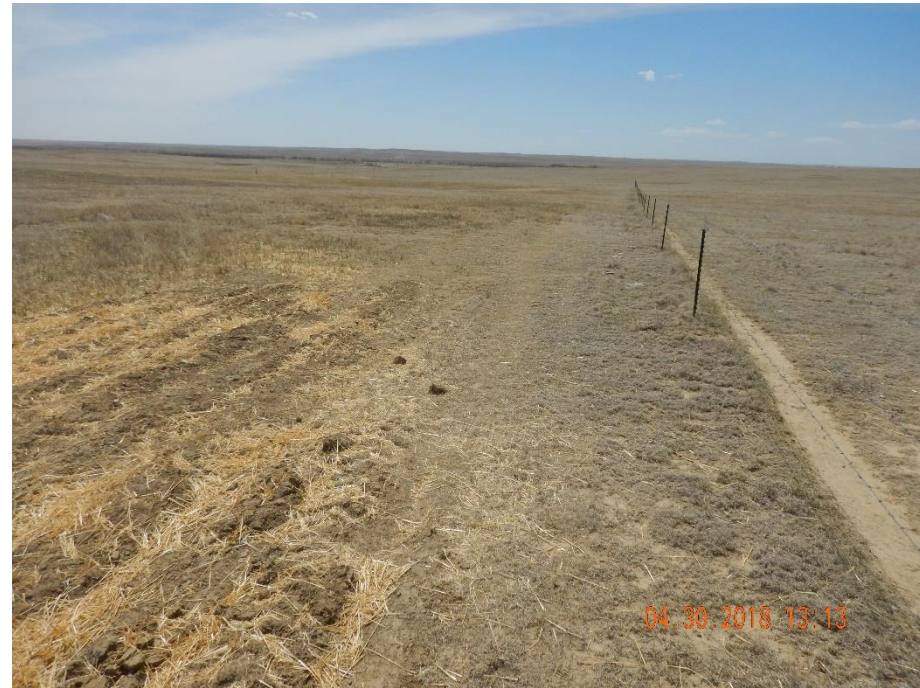
Photo 2: Photo taken from the north end of the location, facing southwest. Photo shows overview of the location

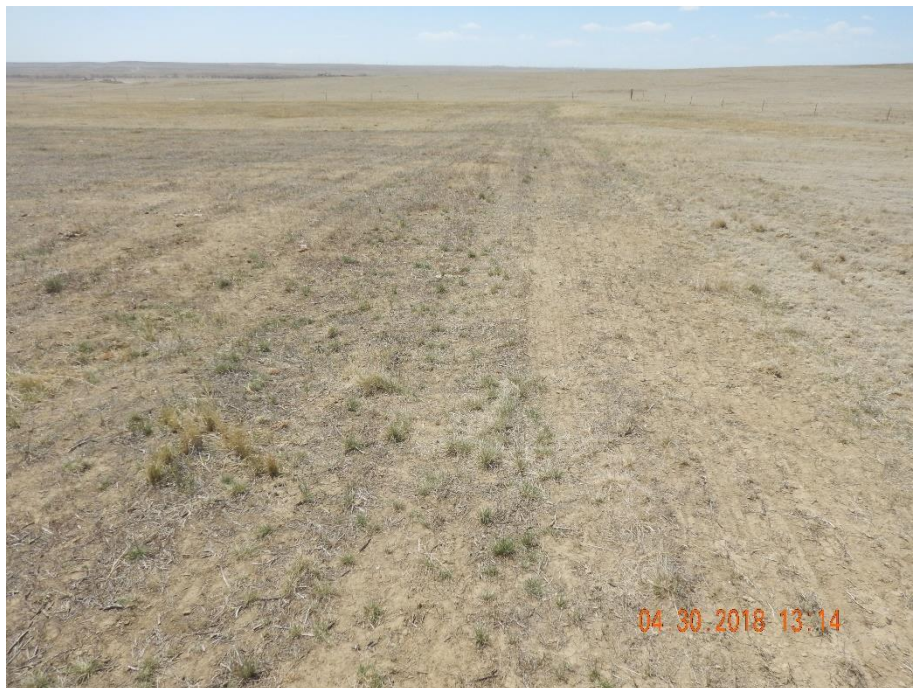
Photo 3: Photo taken from the location, facing west. Photo shows striations in the soil surface, suggesting area was reseeded was conducted, possibly using a no-till seed drill.

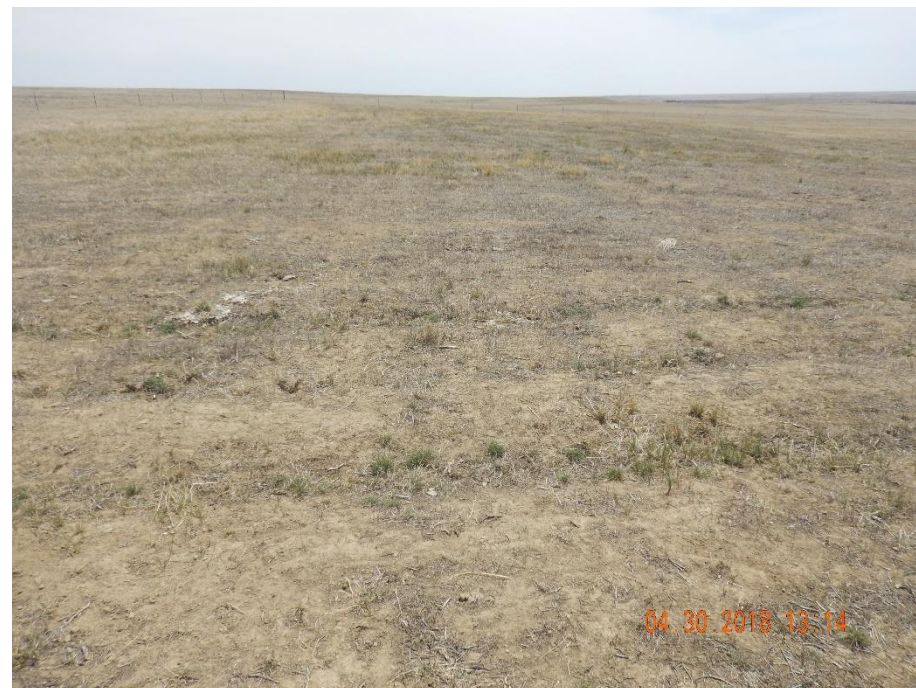
Photo 4: Photo taken from the location, facing south. Photo shows striations in the soil surface, suggesting area was reseeded was conducted, possibly using a no-till seed drill.

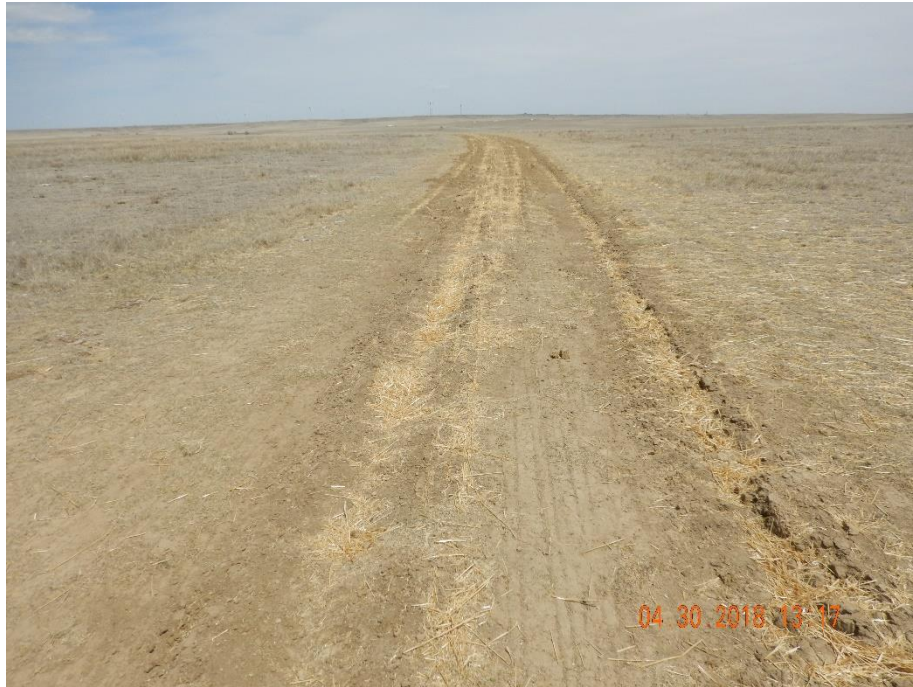
Photo 5: Photo taken from the access road entrance, facing northeast. Photo shows additional work appears to have been conducted, however, it also appears a two-pronged ripper only cut through areas of the ruts within the road. Compaction alleviation does not appear to have conducted in accordance to reclamation requirements. Compaction concerns remain on access road.

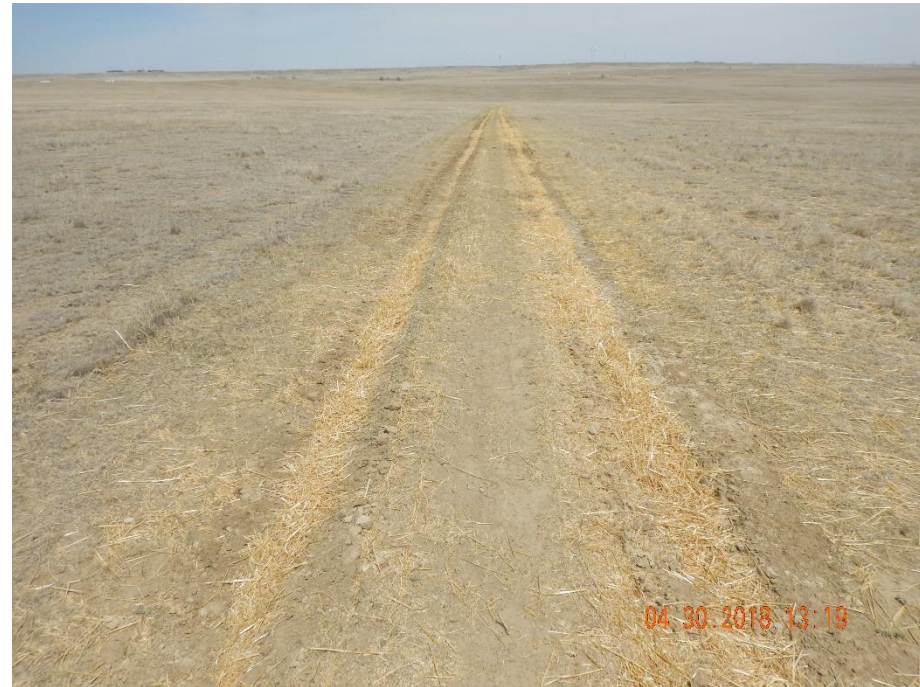
Photo 6: Photo taken from the access road entrance, facing northeast. See comments under photo 5.

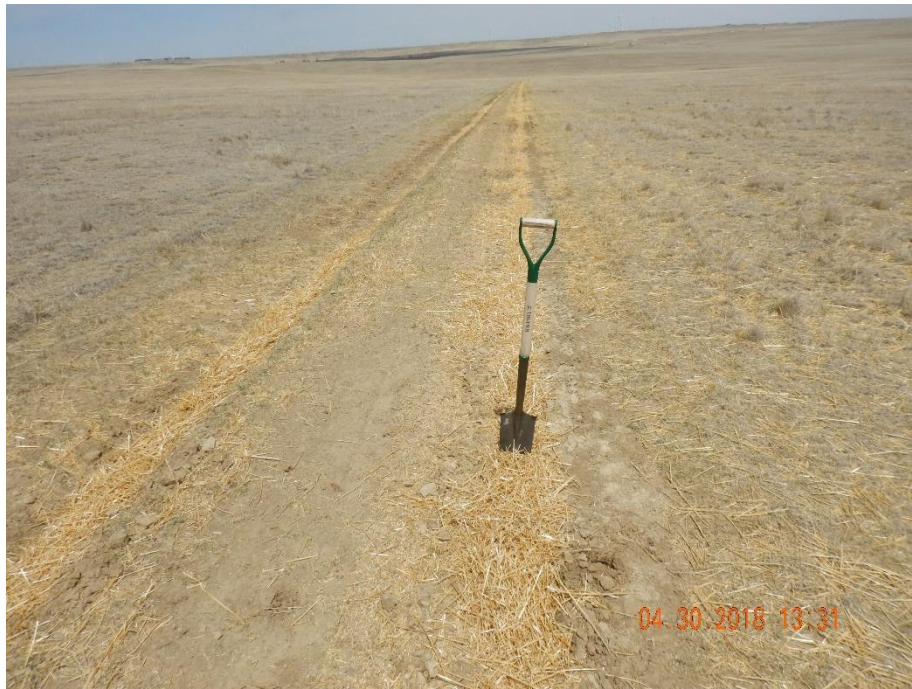
Photo 7: Photo taken from the access road, facing northeast. Photo shows inspector tested the access road for compaction concerns. Photo shows soils within the areas of the ruts, where a ripper did pass through, were easier to penetrate.

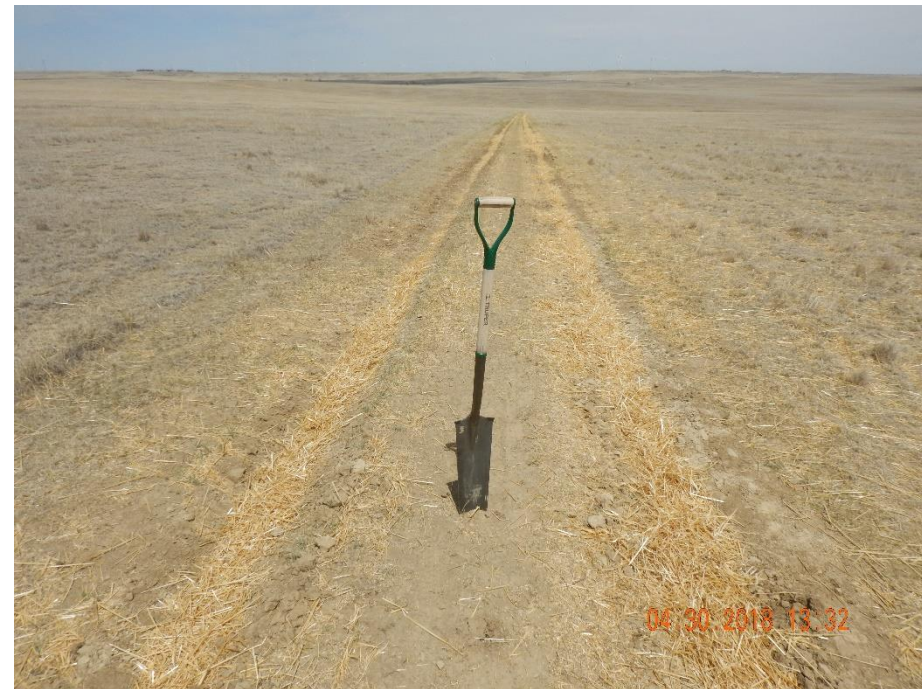
Photo 8: Photo taken from the access road, facing northeast. Photo shows inspector tested the access road for compaction concerns. Photo shows soils **OUTSIDE** the areas of the ruts, where a ripper **DID NOT** pass through, were difficult to penetrate; inspector was only able to easily penetrate to top couple inches of soil. Compaction concerns remain evident.

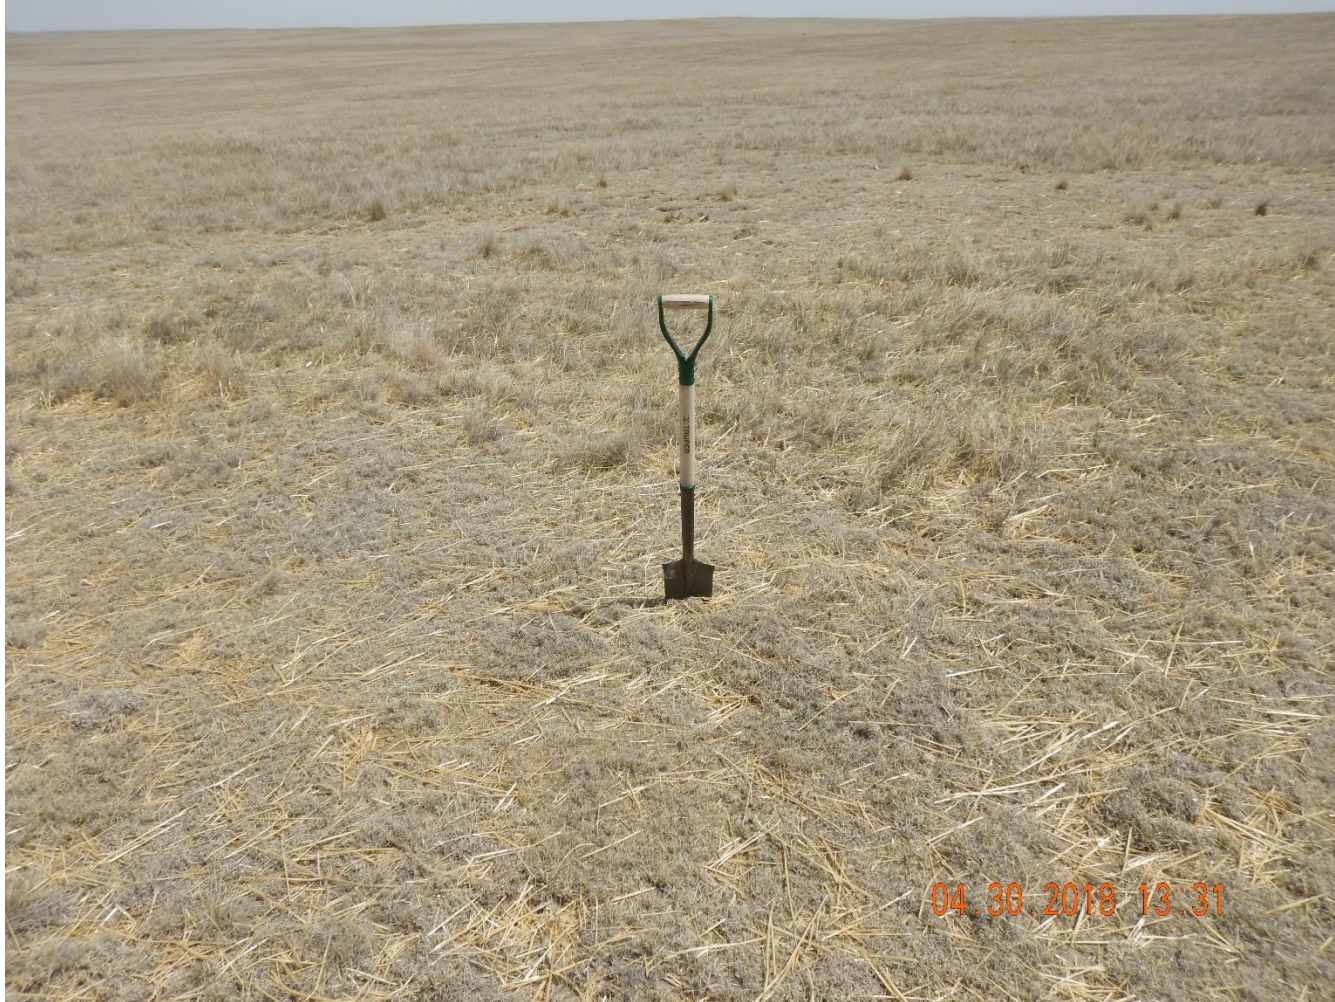
Photo 9: Photo taken from the adjacent reference area. Photo shows inspector was able to easily penetrate the soils in the reference area.

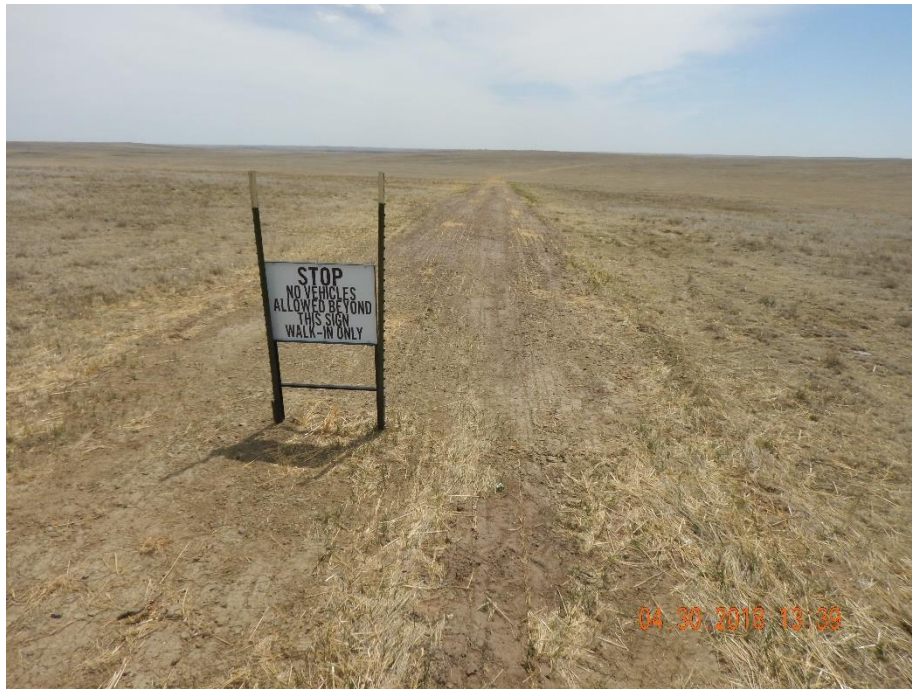
Photo 10: Photo taken from the access road to the north of the location. Photo shows sign where operator appears to have ended reclamation of the access road. Access road continues ~1/4 mile to the north. Operator remains responsible for the reclamation of these areas of access road.

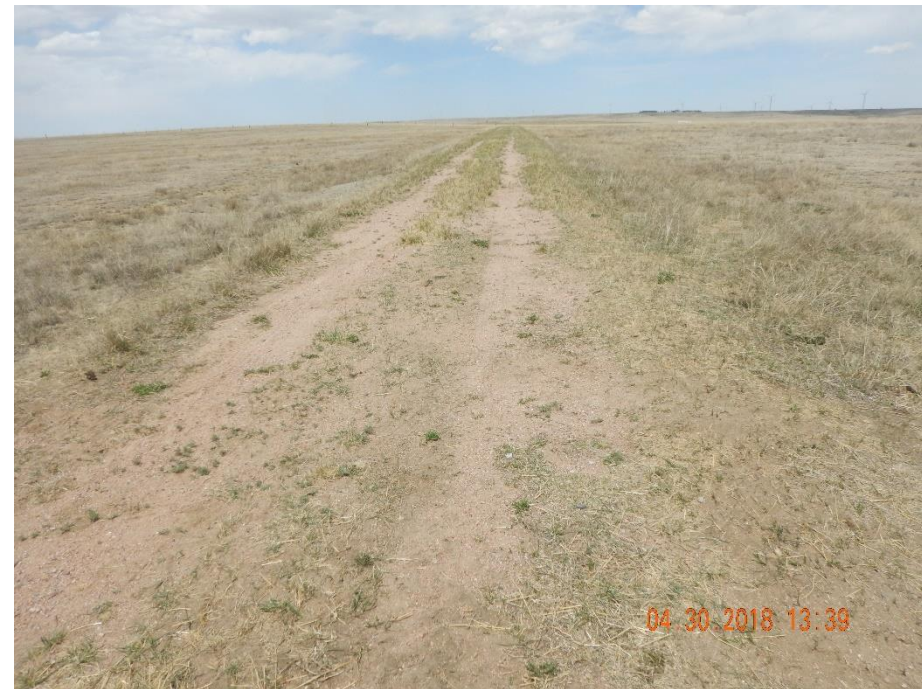
Photo 11: Photo taken from the sign seen in photo 10 within the access road. Photo shows remaining section of access road to the north. Photo shows no reclamation activities appear to have been performed; gravel remains on road, access road has not been re-contoured, re-graded or had compaction alleviation conducted. Operator remains responsible for reclamation of access road.

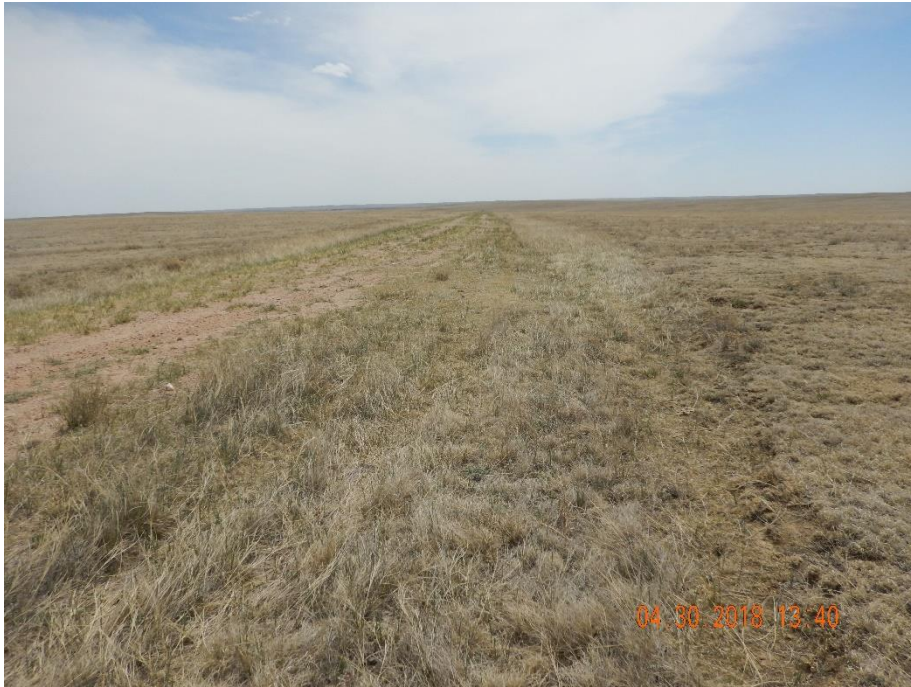
Photo 11: Photo taken from the area where the access road joins the east/west ranch road, north of the sign seen in photo 10, facing south. Photo shows remaining section of access road where no reclamation activities appear to have been performed; gravel remains on road, access road has not been re-contoured, re-graded or had compaction alleviation conducted. Operator remains responsible for reclamation of access road.

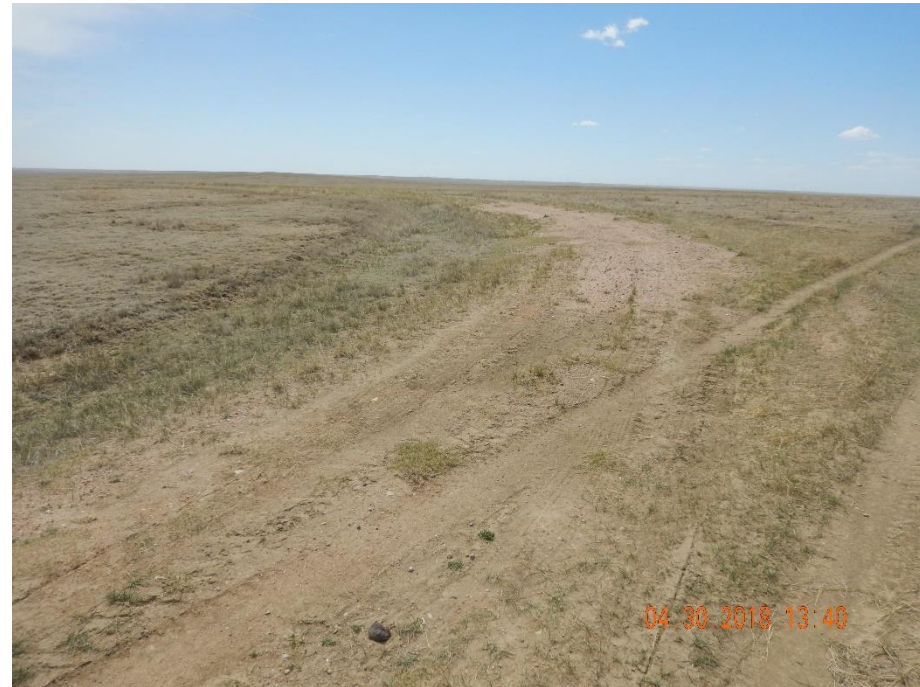
Photo 12: Photo taken from the area where the access road joins the east/west ranch road, north of the sign seen in photo 10, facing southwest. Photo shows remaining section of access road where no reclamation activities appear to have been performed; gravel remains on road, access road has not been re-contoured, re-graded or had compaction alleviation conducted. Operator remains responsible for reclamation of access road.
