Inspection Photos

Location Name: Little Beaver Unit Injection Plant

Location ID: #451505

Inspection Date: April 27, 2018

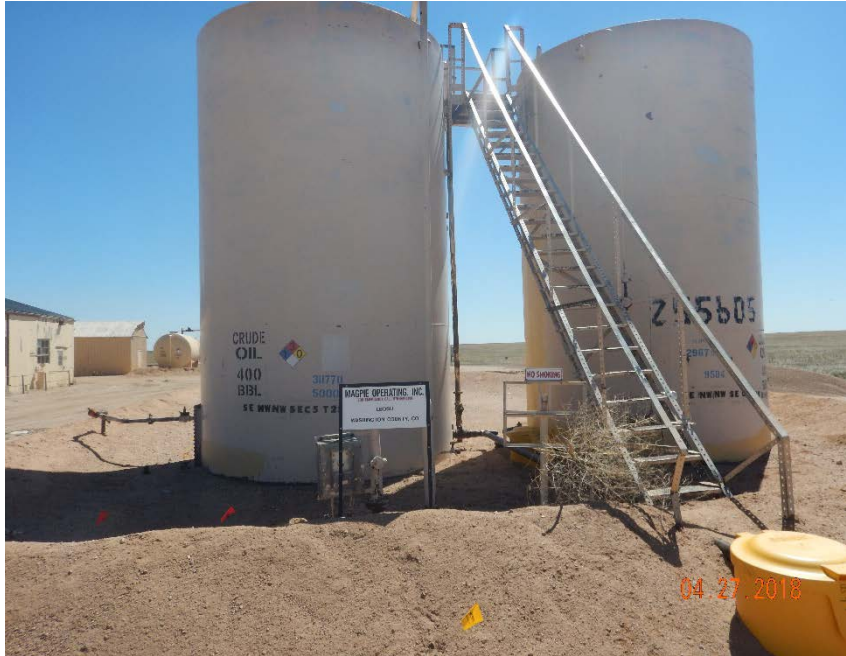
Photo #1 - Crude oil ASTs and battery sign.

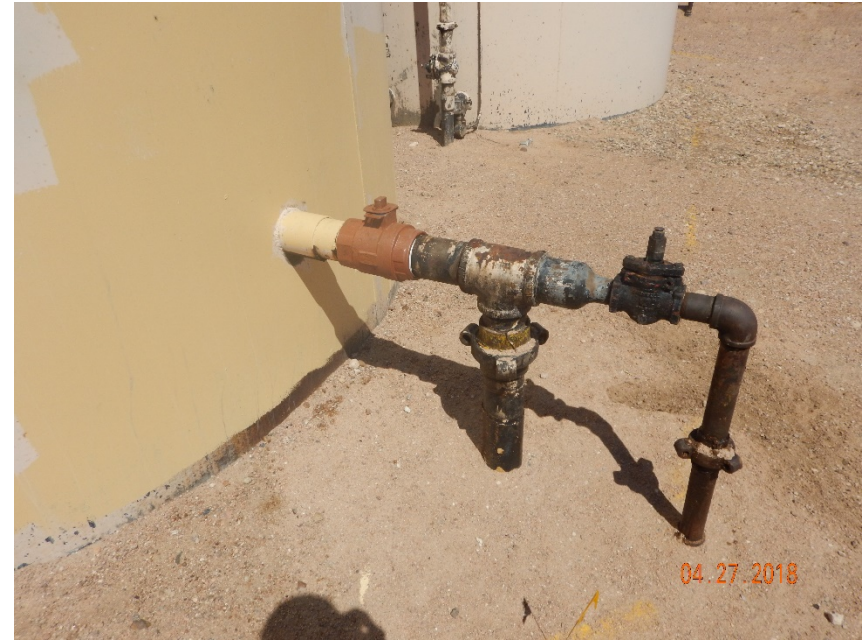
Photo #2 – Dripping valve on east side of crude oil AST that was documented in previous FIRs has been repaired.

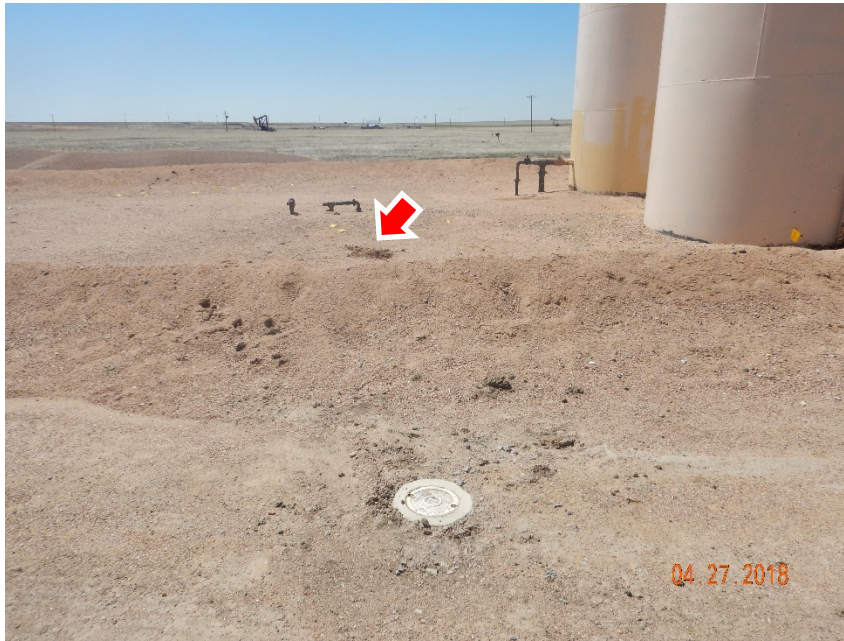
Photo #3 – Monitor wells (MW-02 pictured) have been installed throughout location, per Remediation Project #11196. Flowlines east of crude oil ASTs have been removed or marked and capped, arrow points to area depicted in Photo #4.

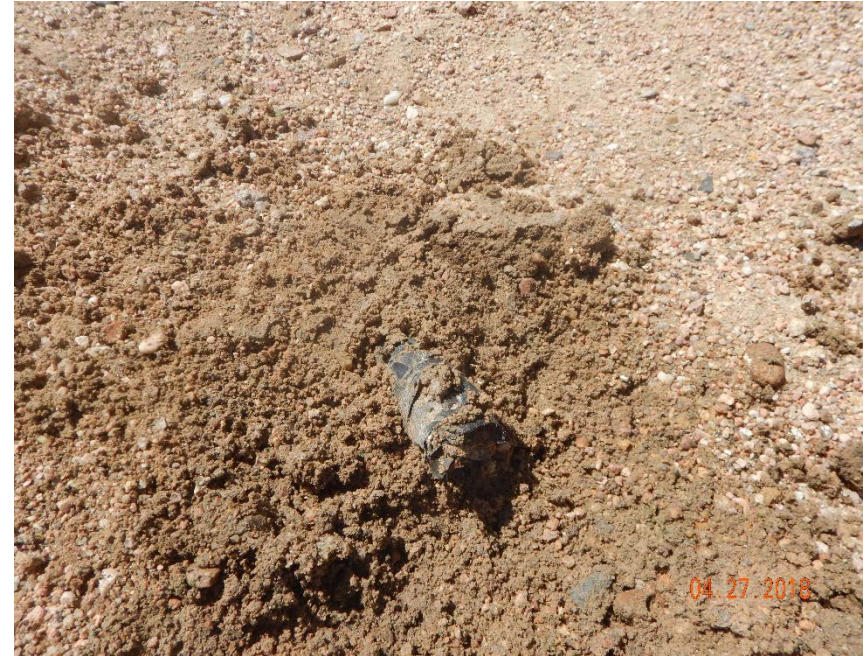
Photo #4 – Taped, uncapped apparent 1" flowline remains east of crude oil ASTs.

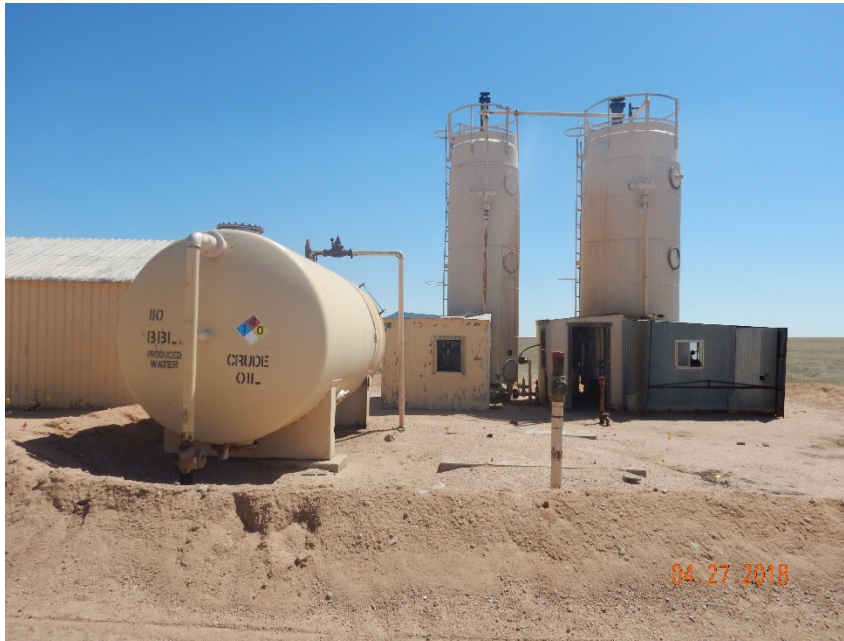
Photo #5 – NFPA placard and content/volume labels have been affixed to horizontal AST. Flowline risers inside of shared earthen berm have been removed or marked and capped.

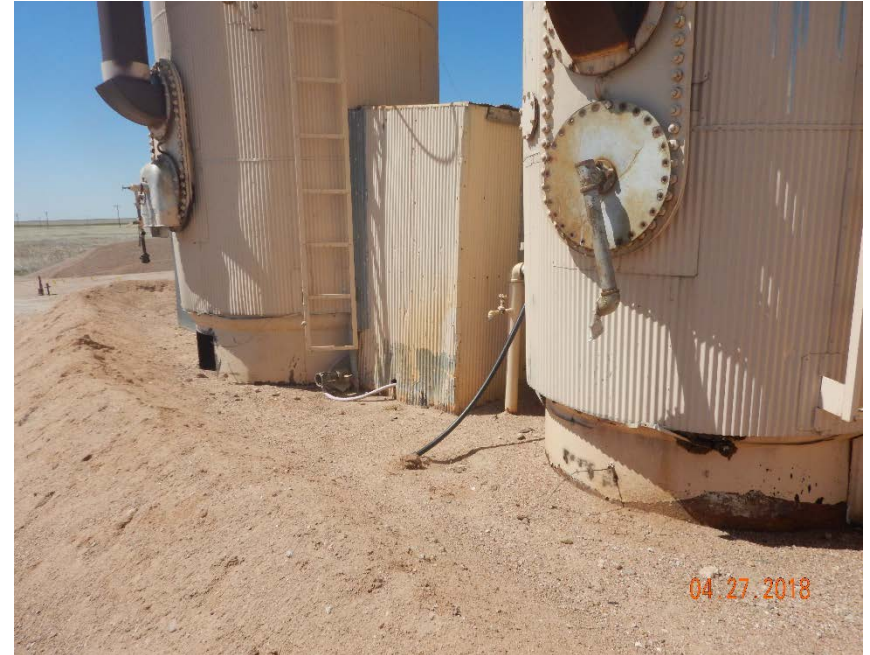
Photo #6 – Debris and flowlines east of VHT sheds have been removed in response to previous FIRs.

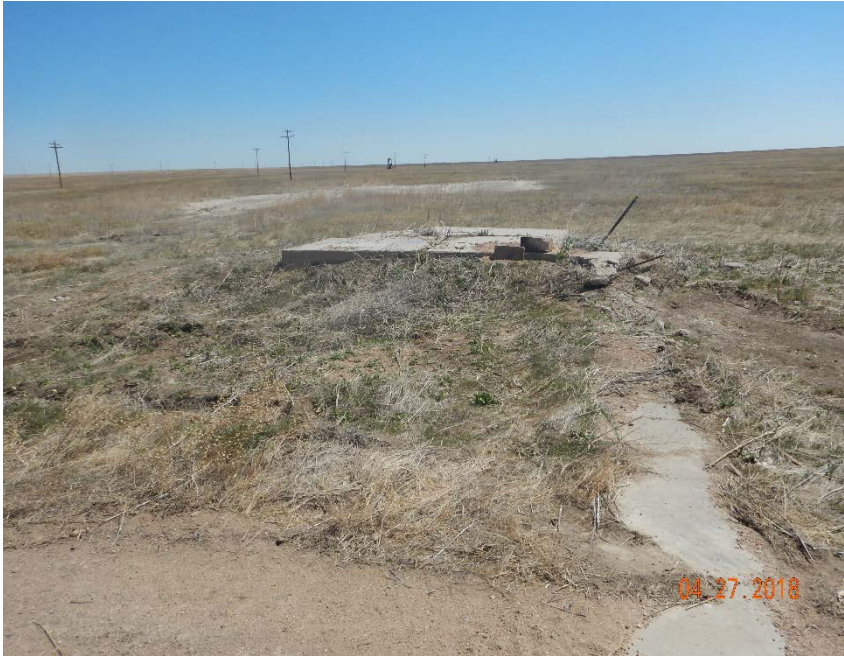
Photo #7 – Concrete slab with debris remains ~50' east of facility.

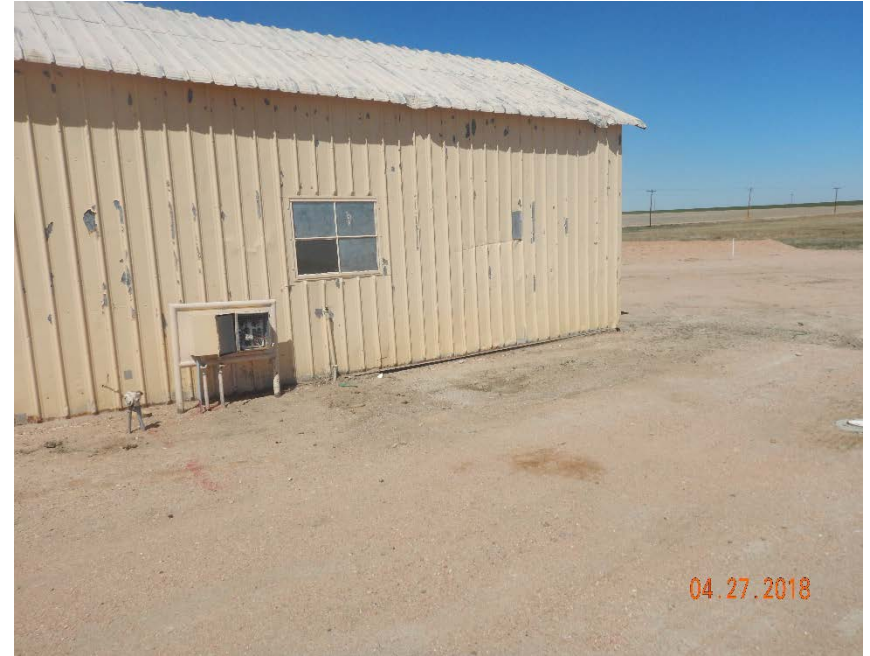
Photo #8 – Diesel AST described in previous FIRs has been removed.

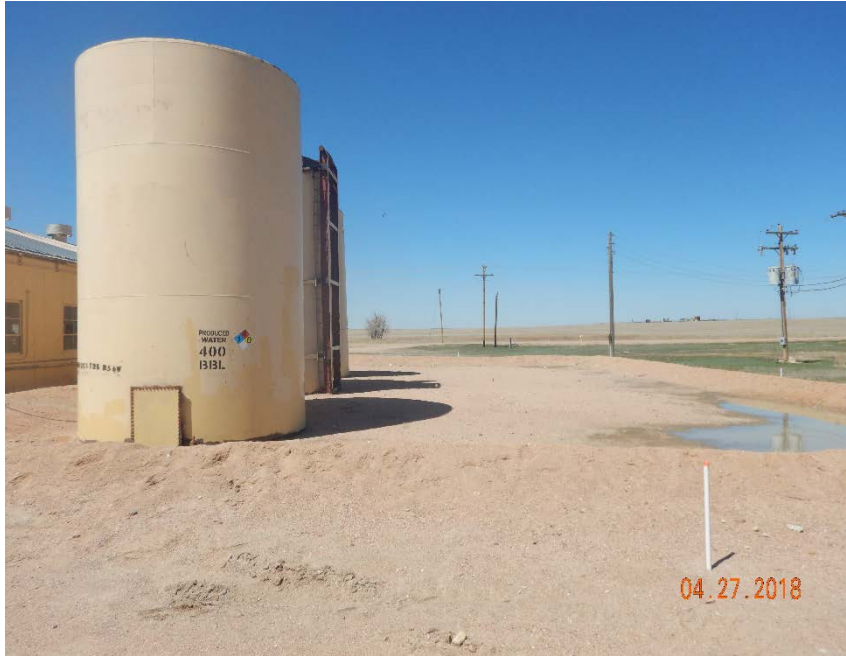
Photo #9 – Produced water tanks on north side of location have adequate NFPA placards and volume/content labels. Monitor well MW-09 visible in foreground.

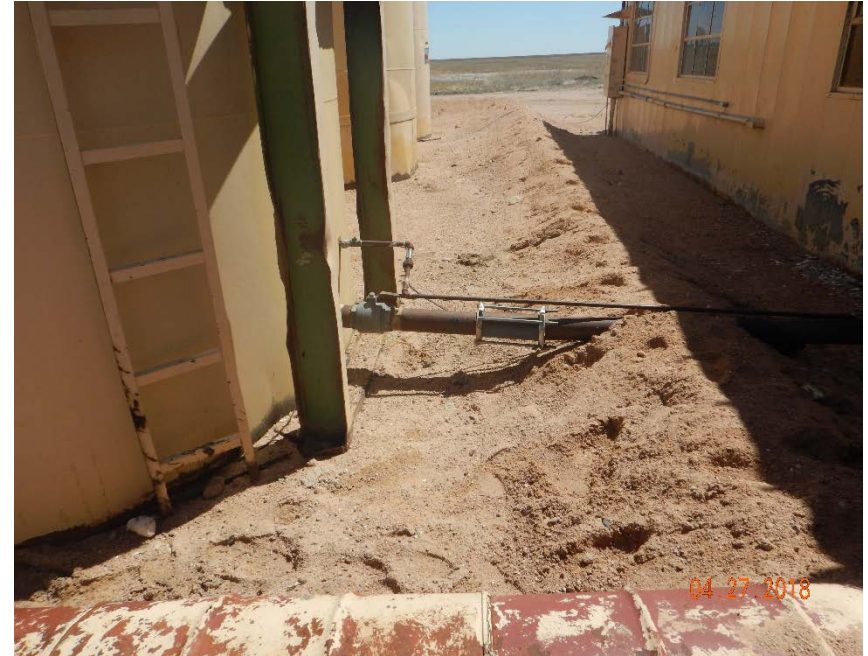
Photo #10 – Earthen berm surrounding produced water ASTs is adequate, but berm on north side is damaged & eroded.

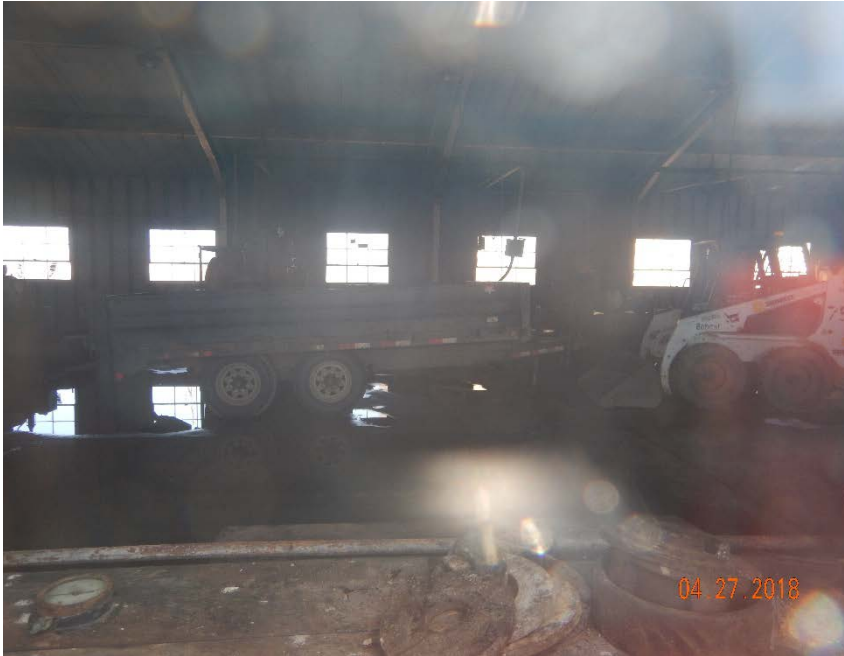
Photo #11 – Pooled fluid visible inside of main building.

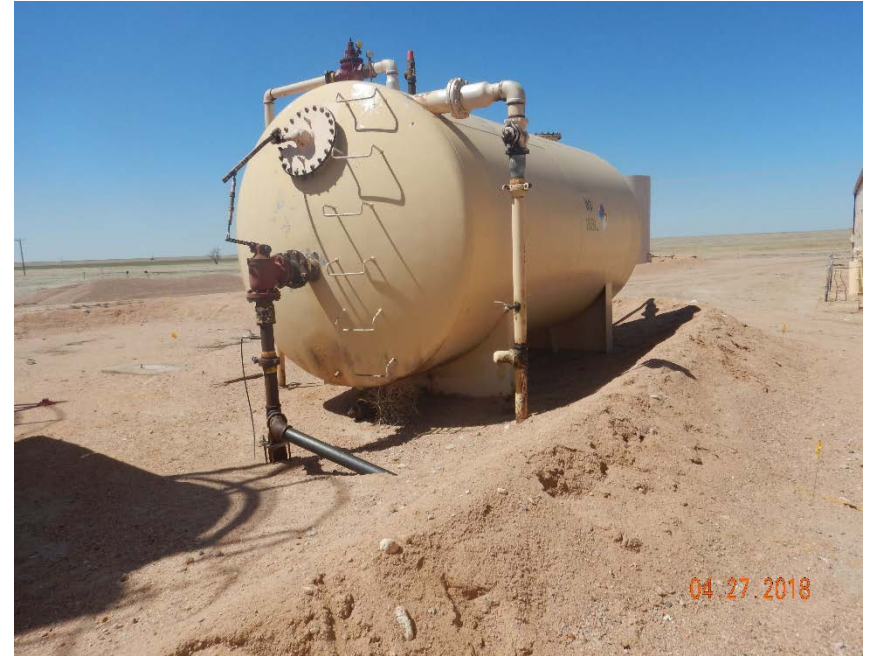
Photo #12 – Earthen berm shared by horizontal AST and VHT sheds has sufficient volume, though berms in NW corner show signs of erosion and damage.
