Inspection Photo
GGU Miller 33C-31-691
API# 045-18239
Inspection # 689301063

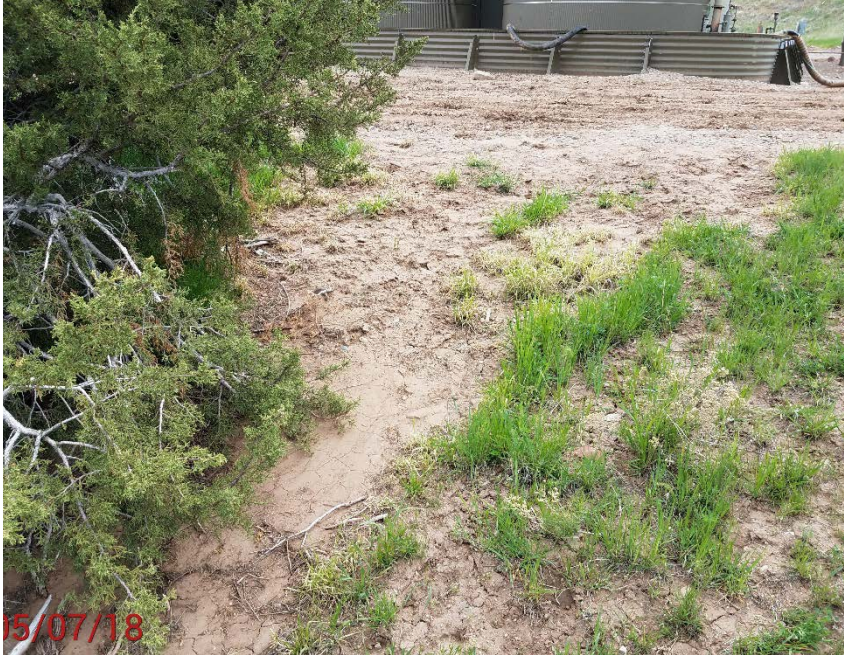
Location photo # 3 storm water Erosion

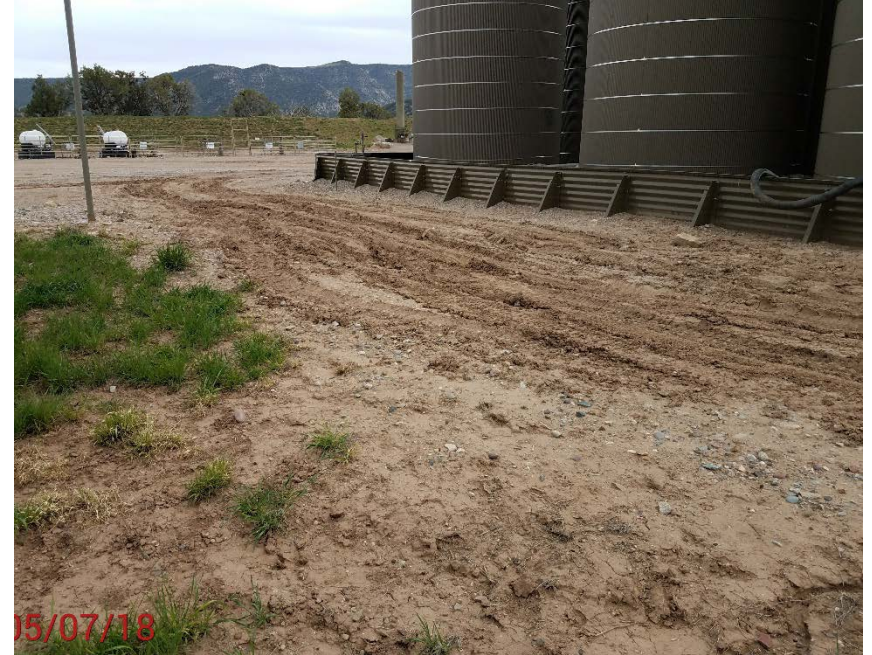
Location photo #4 Rutted location

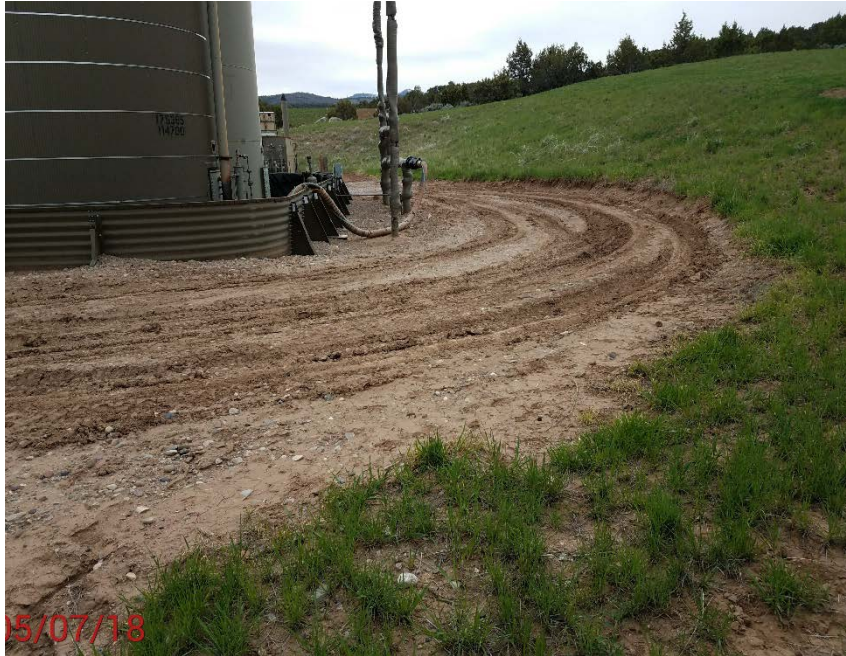
Location photo # 5 Rutted location

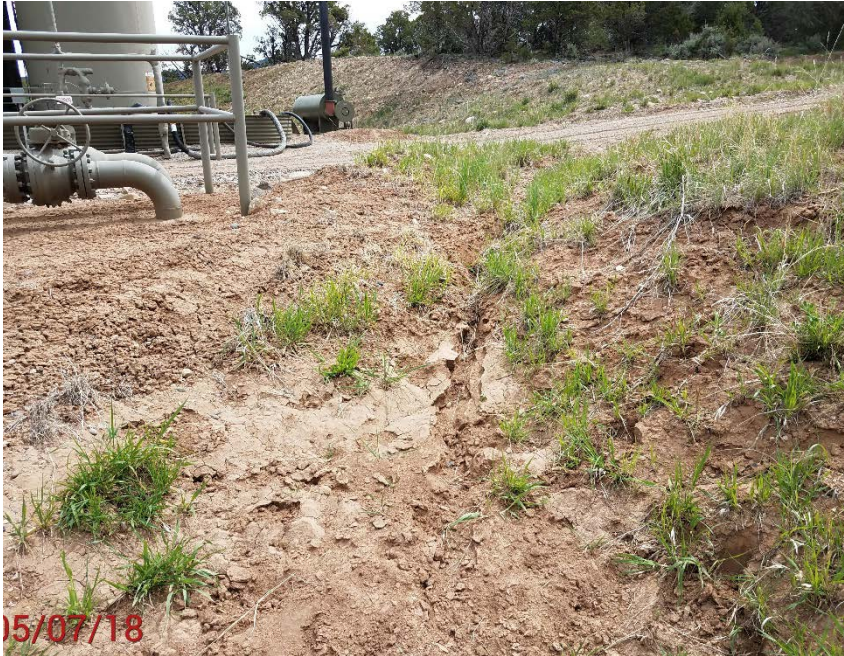
Location photo # 7 storm water erosion

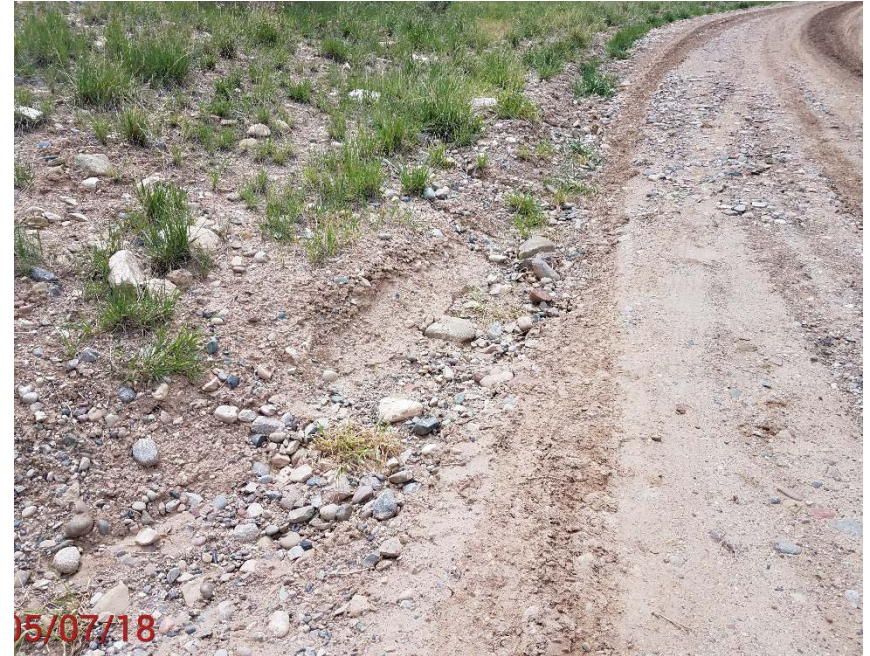
**Location photo # 8 storm water erosion
near heater treater**

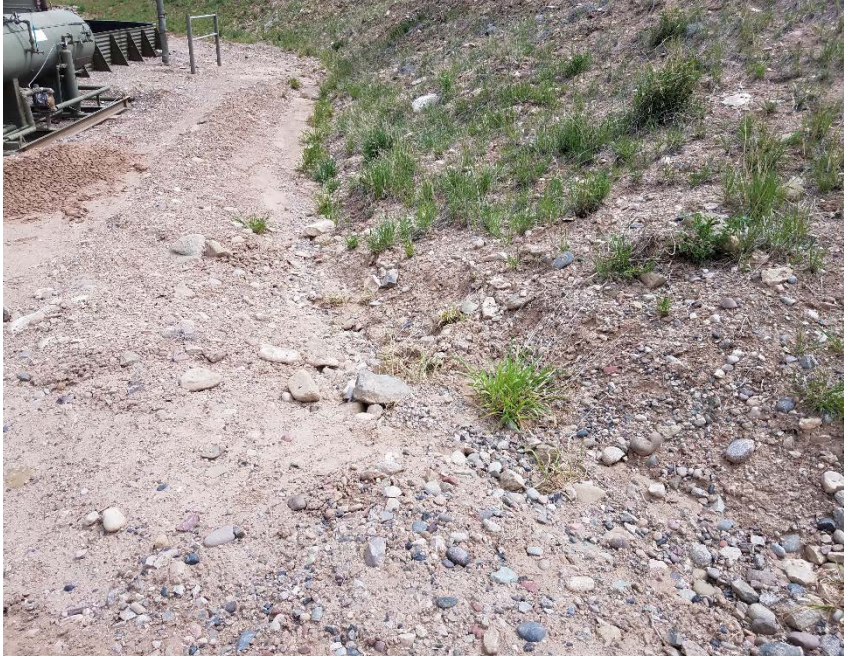
Location photo # 9 storm water erosion near heater treater

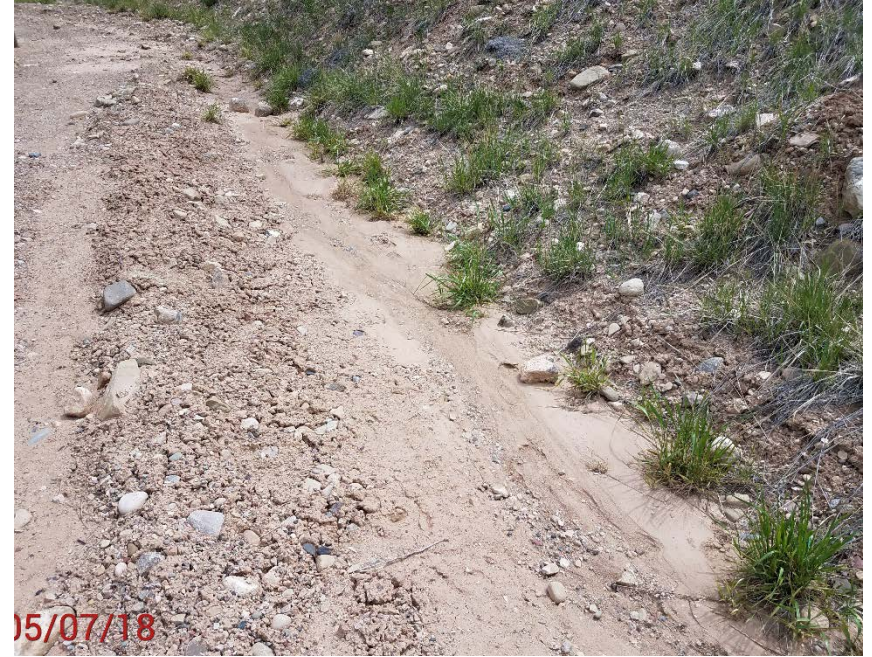
Location photo # 10 storm water erosion near heater treater

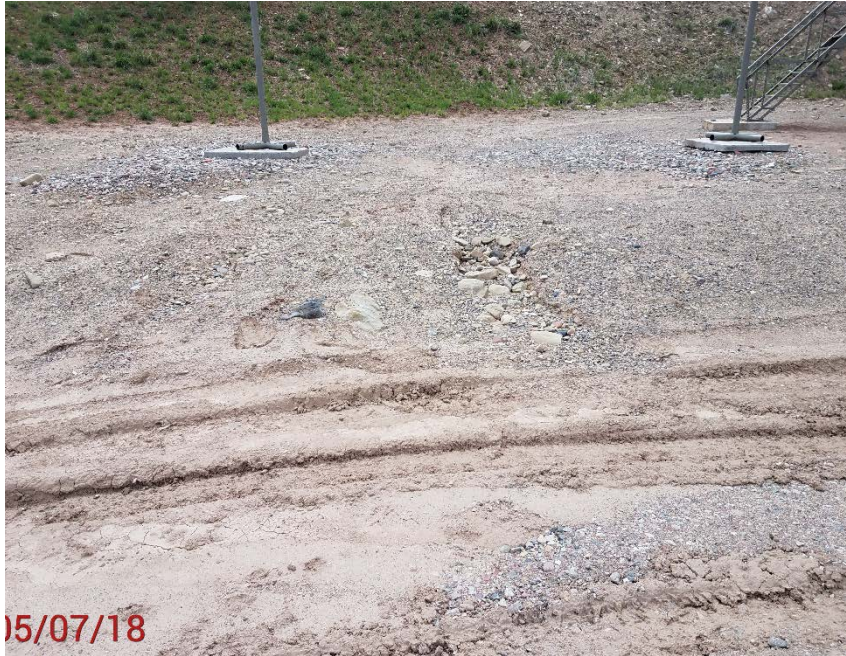
Location photo # 11 Storm water North of heater-treater

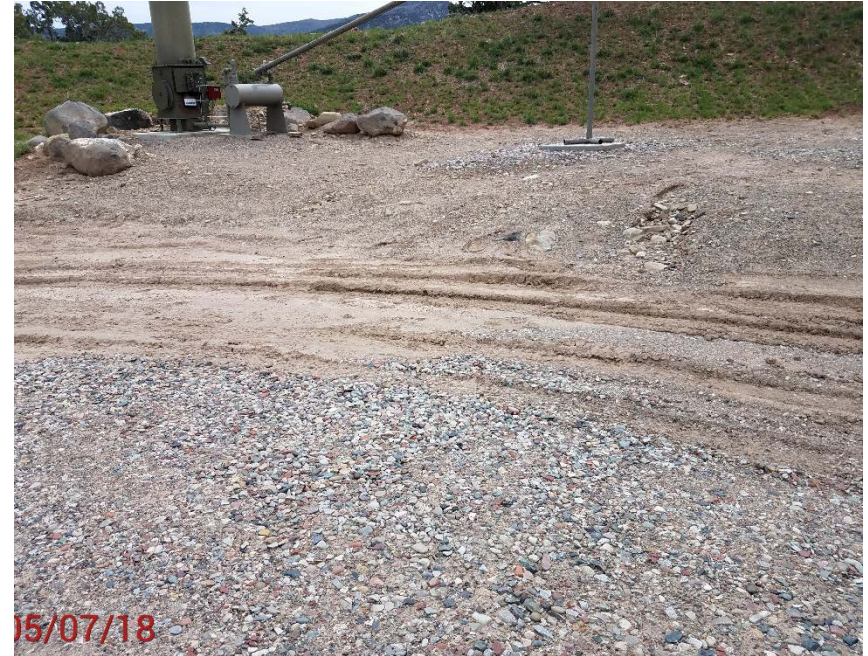
Location photo #12 Storm water North of heater-treater

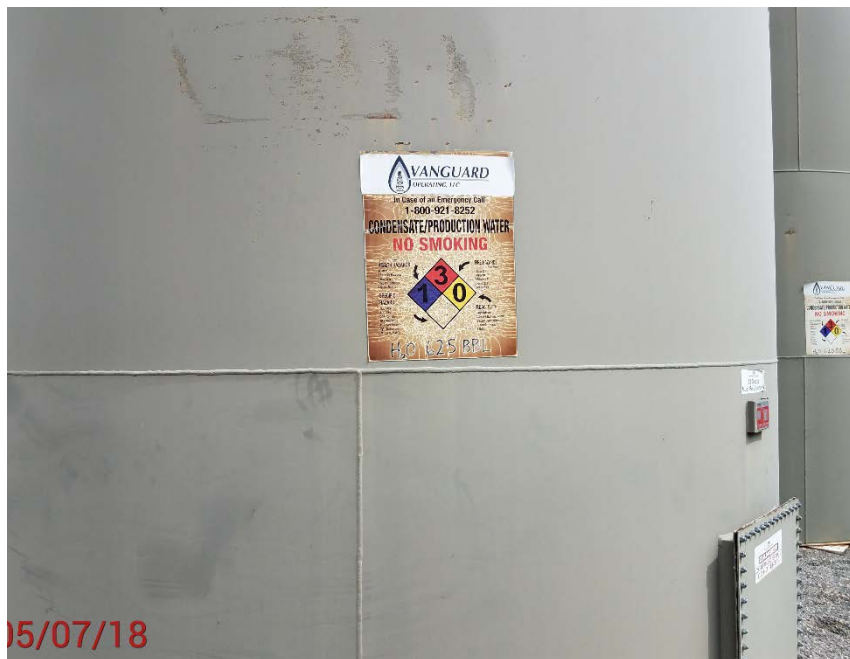
Location photo # 13, faded tank label/sign

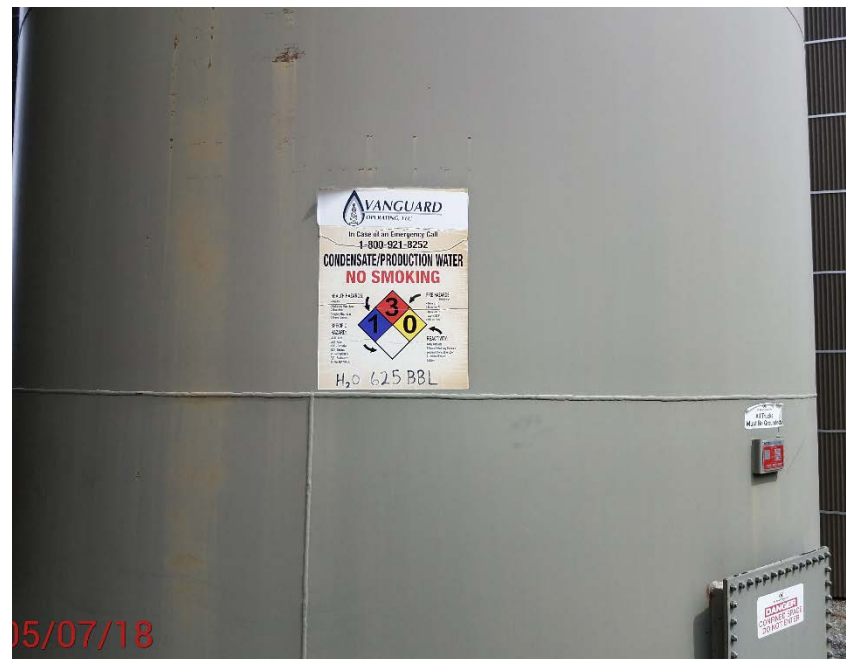
Location photo # 14 Peeling sign
