Inspection Photos

Loc#414880

Operator: Caerus

Inspection Number: 680102942

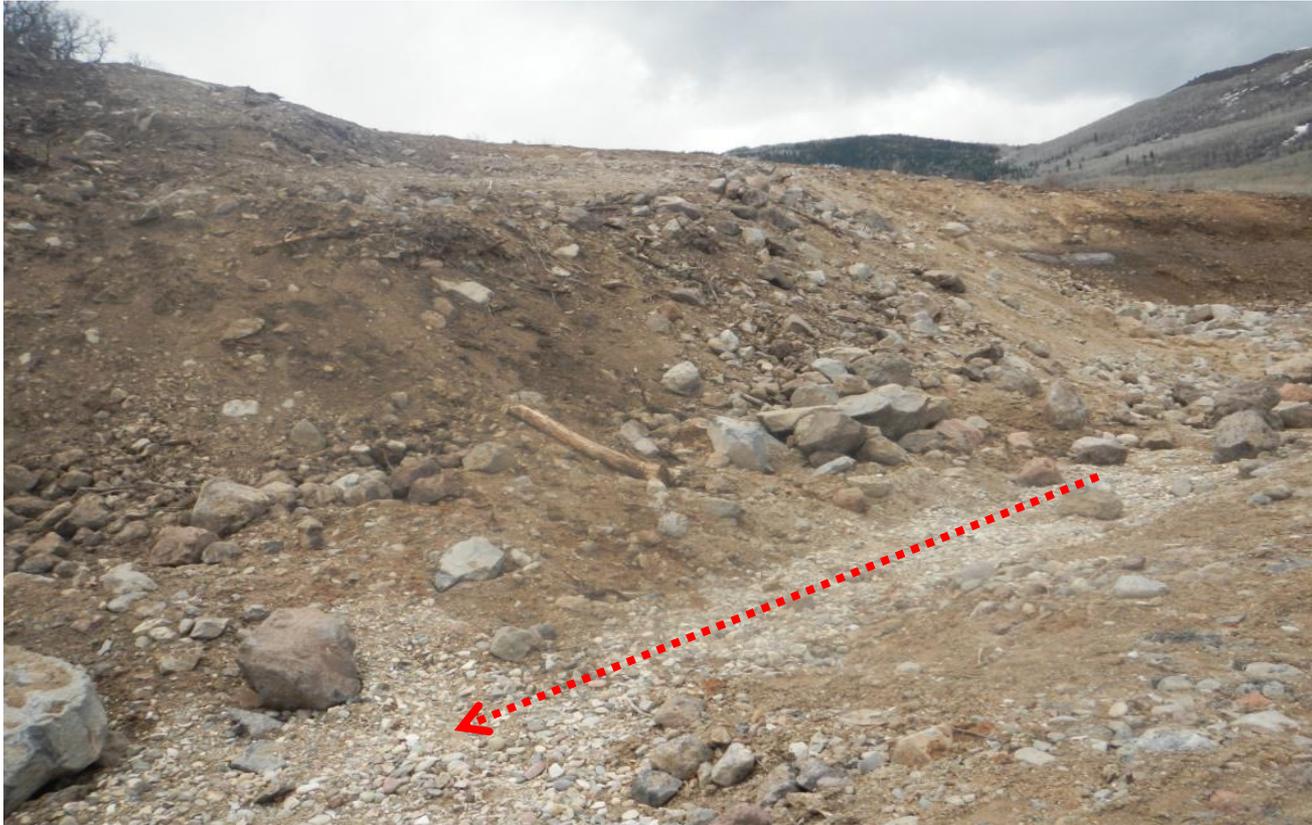
Photo#4:

Graveled strip at base of cut slope at Southeast corner of site indicates path of french drain that daylight & flows into sediment trap in photos #5 & #6.

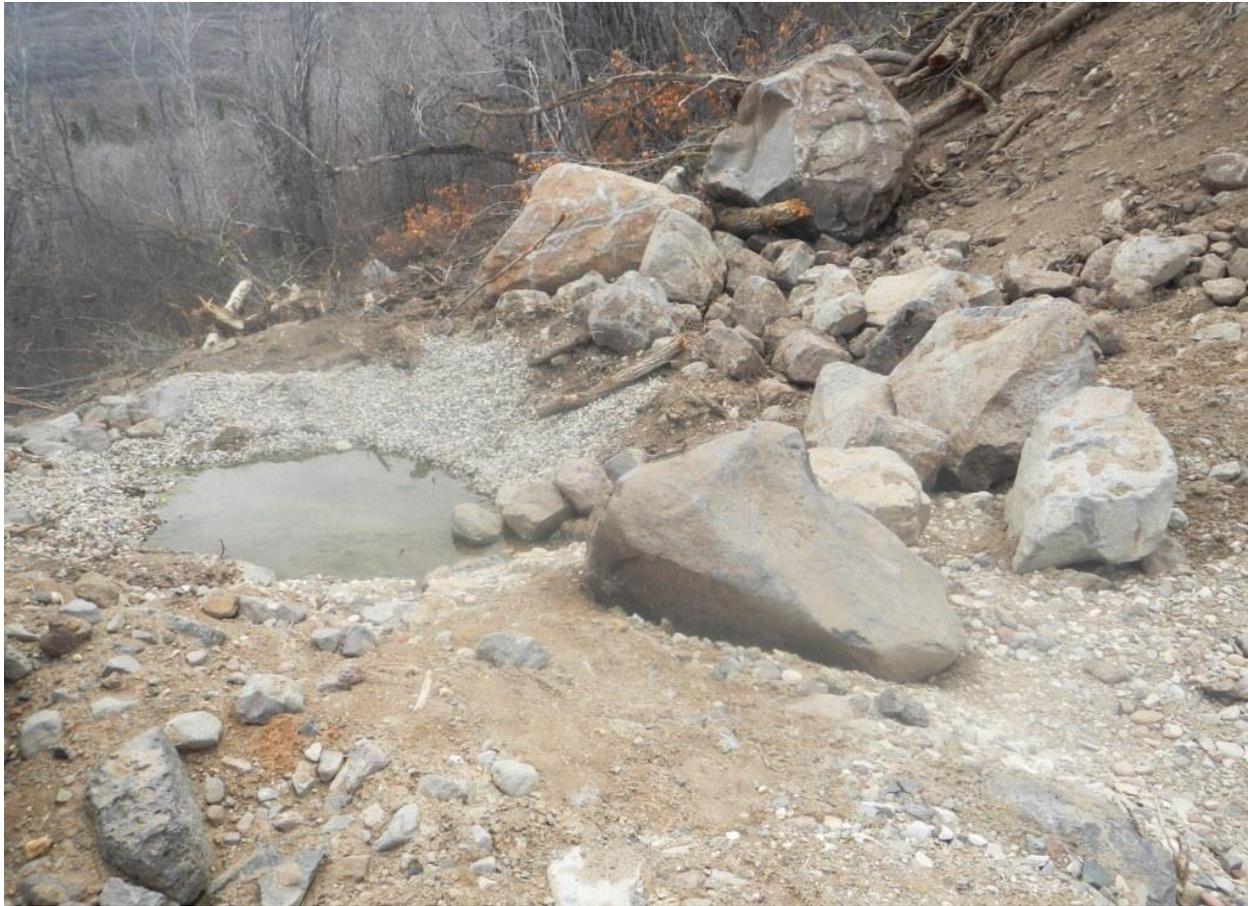
Photo#5:
Sediment trap receiving flow from french drain routing Spring water. View to East.

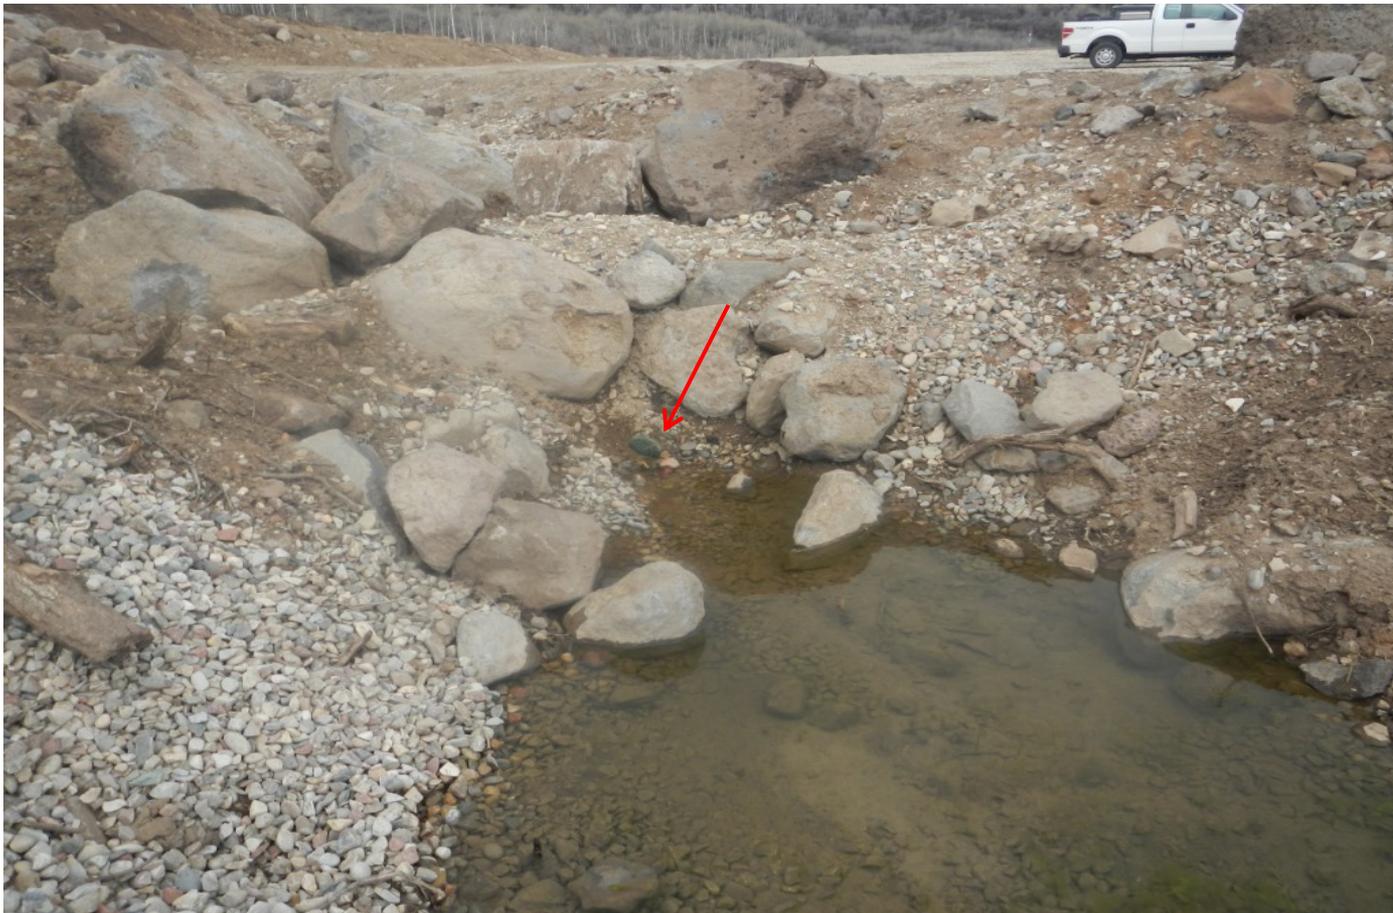
Photo#6:

View to West back over Sediment trap in Photo#5; with French Drain daylight point indicated by arrow.

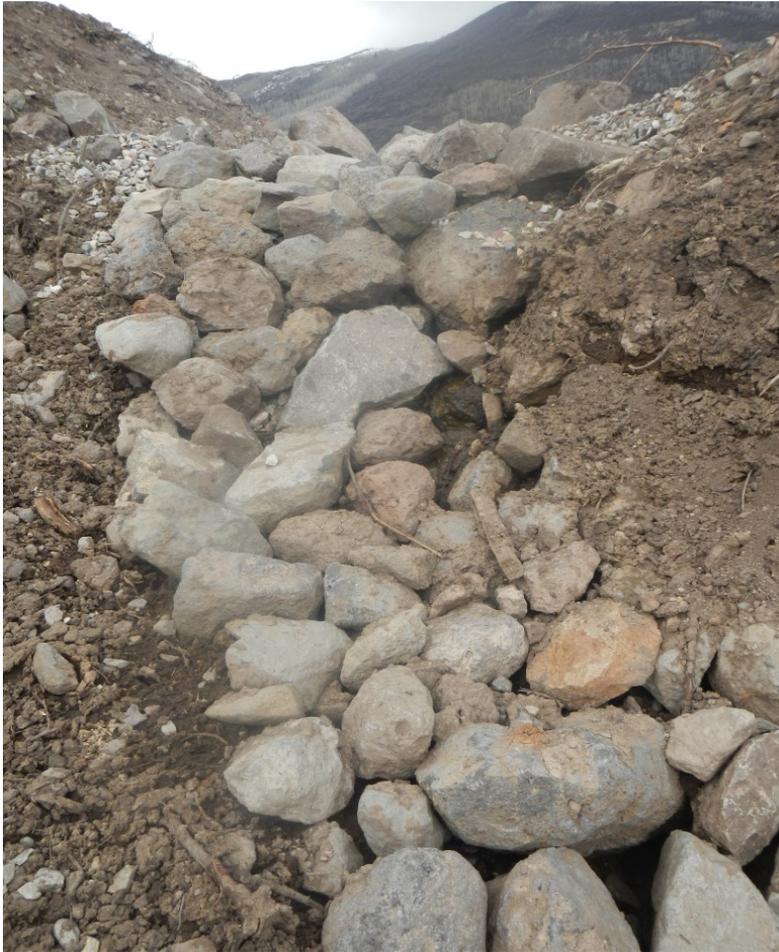
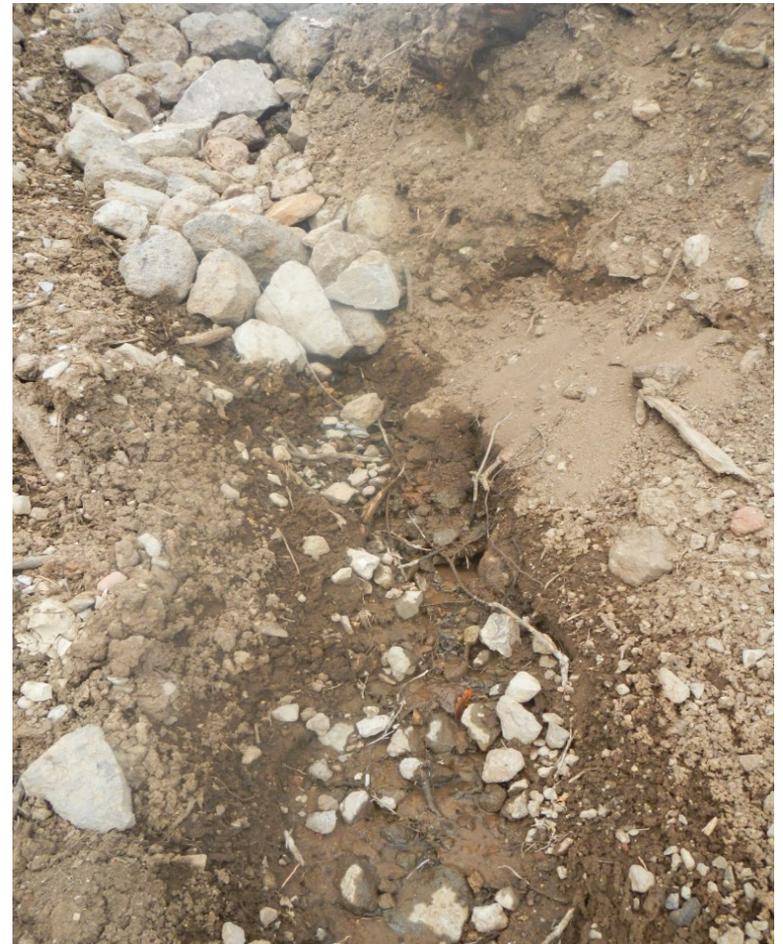
Photo#7:

Two views of Rocked Drain from Sediment Trap in Photo #6. Water flow under cuts this drain & immediately infiltrates into soil, potentially saturating soils which could further destabilize fill slopes.

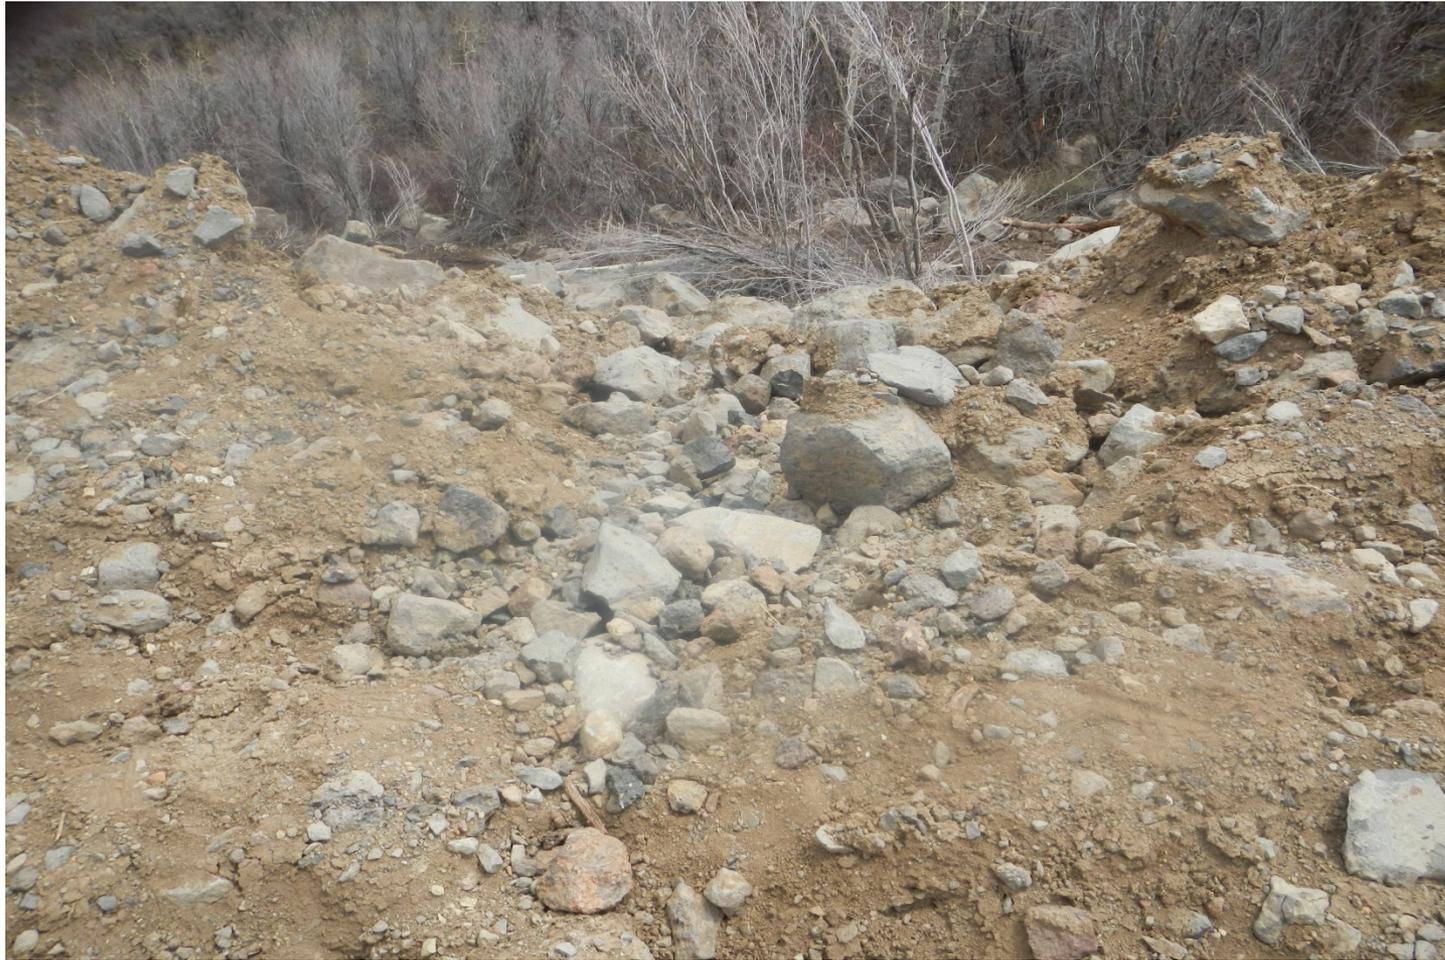
Photo#10:

Outlet point at edge of pad where Bmp drain is sloughing; this drain leads down slope in Photo #11.

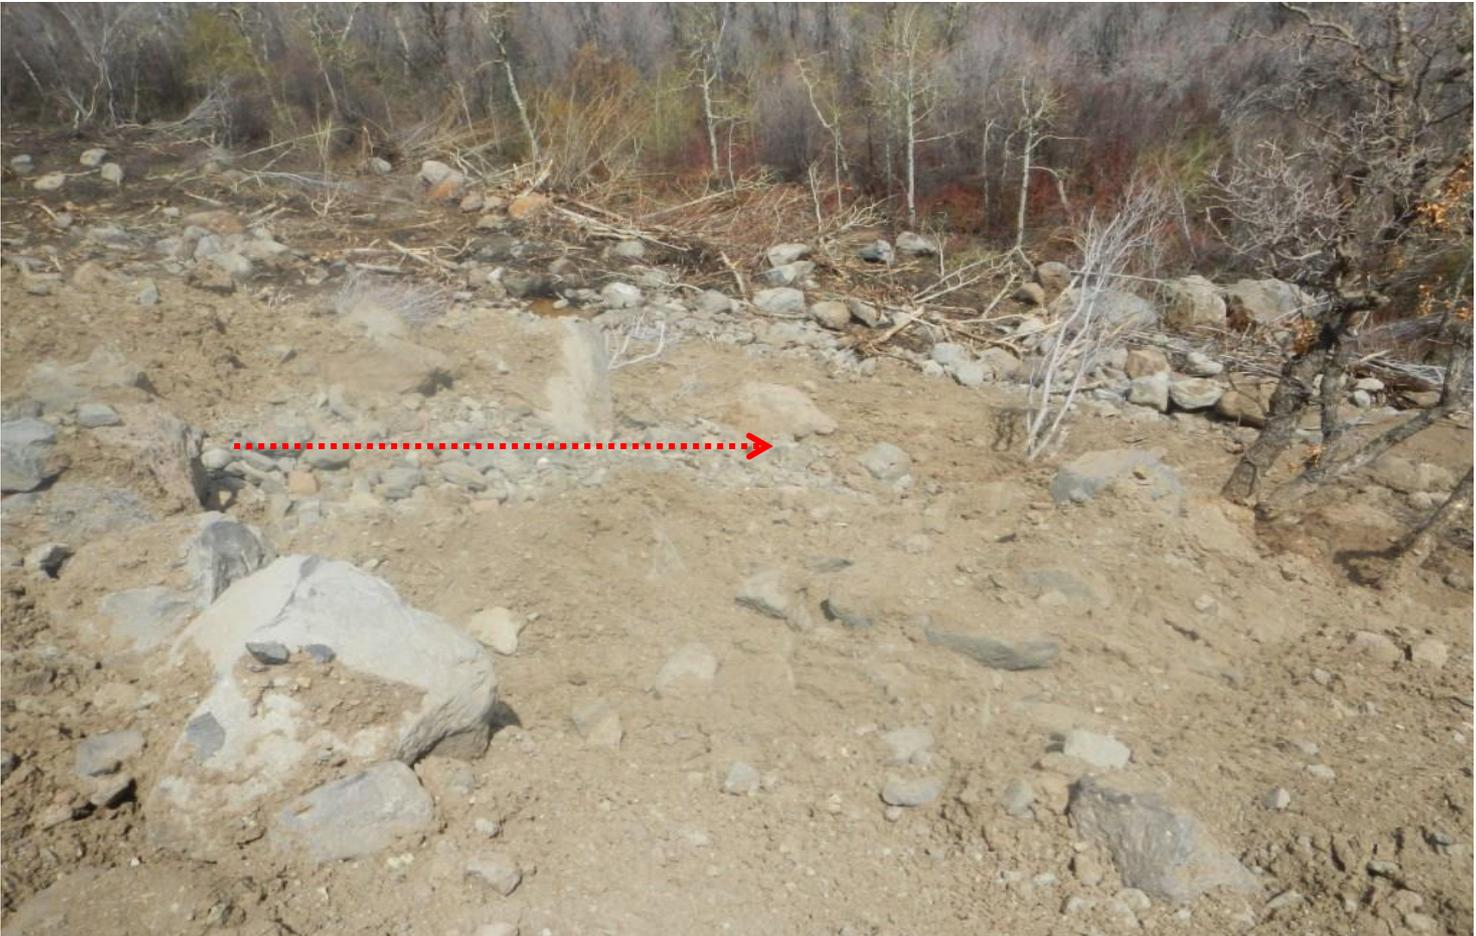
Photo#11:

View from pad edge down to base of fill slope. Rocked drain leading from outlet in Photo #10 indicated by arrow.

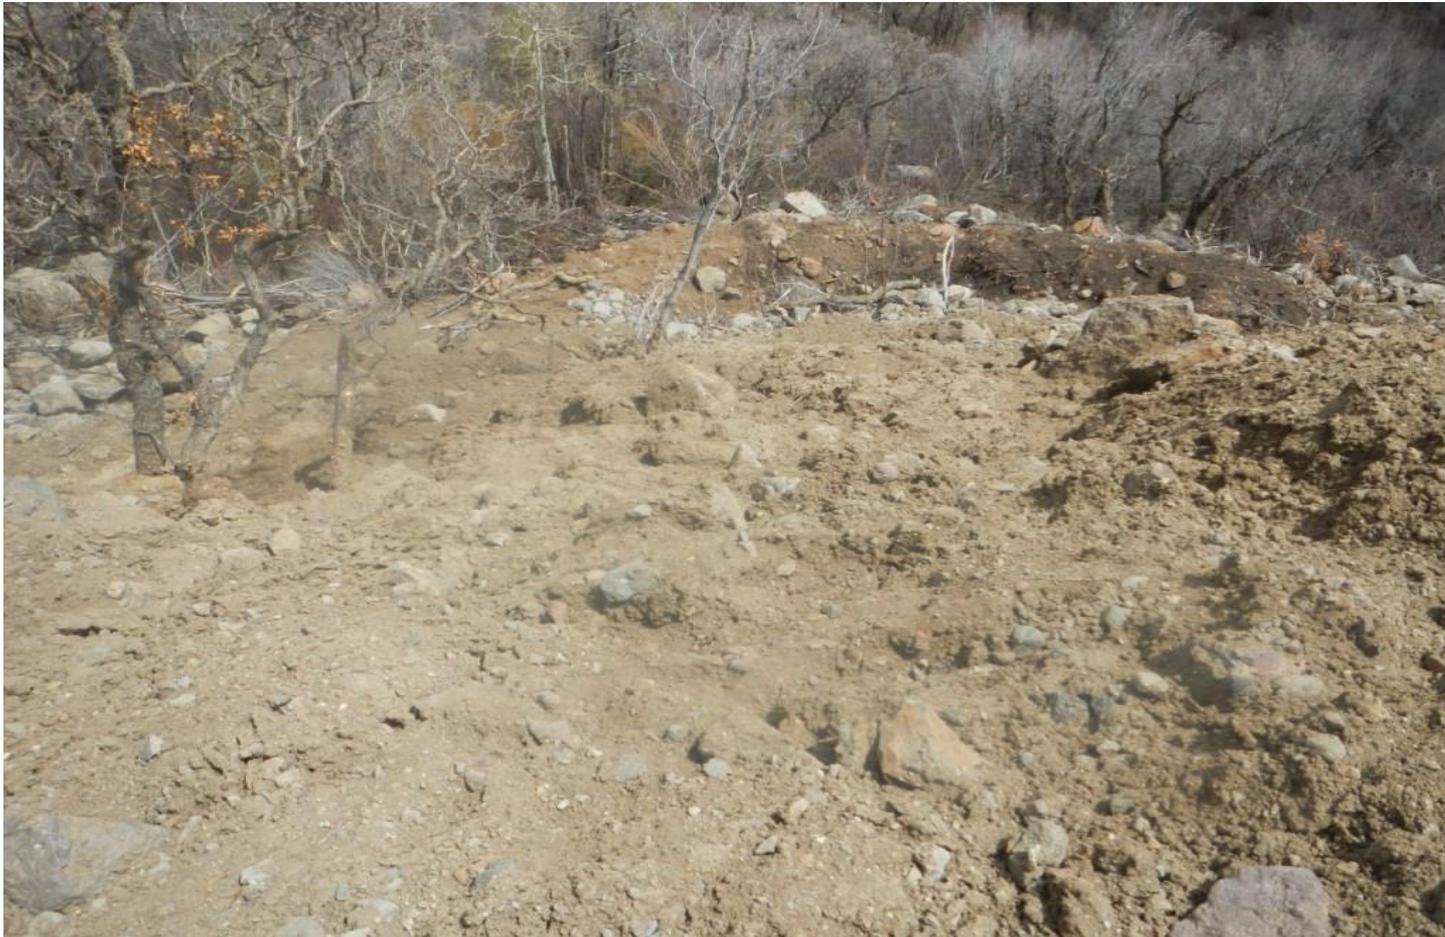
Photo#12:

View from of Pad edge down to Sediment reservoir at base of unstabilized fill slope.

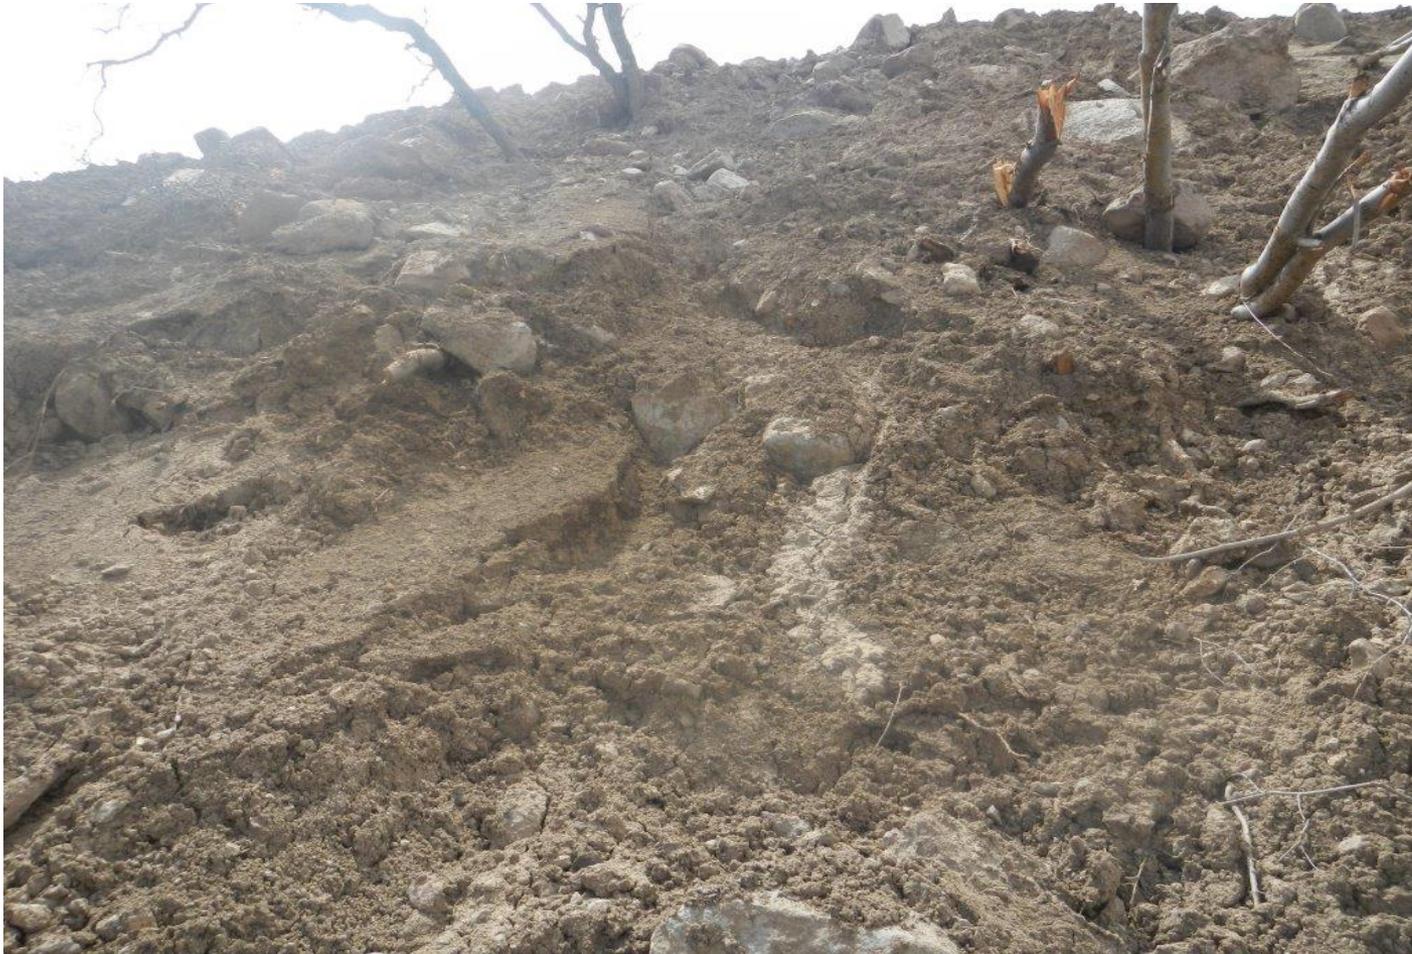
Photo#13:
View from base of Fill slope up to top of pad, showing unstable conditions.

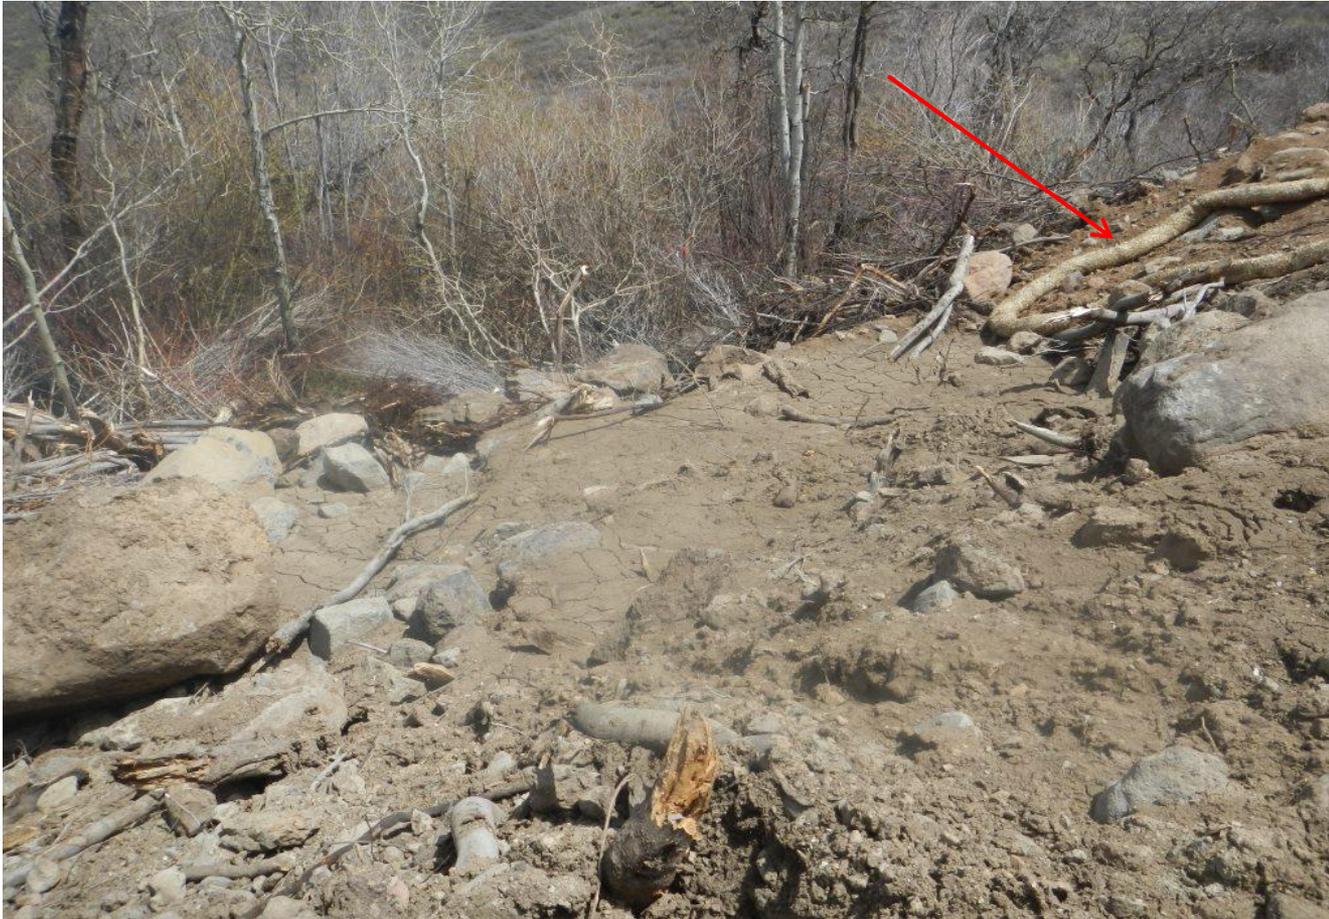
Photo#16:
Sediment deposition at base of fill slope & ineffective, bypassed BMP indicated by arrow.

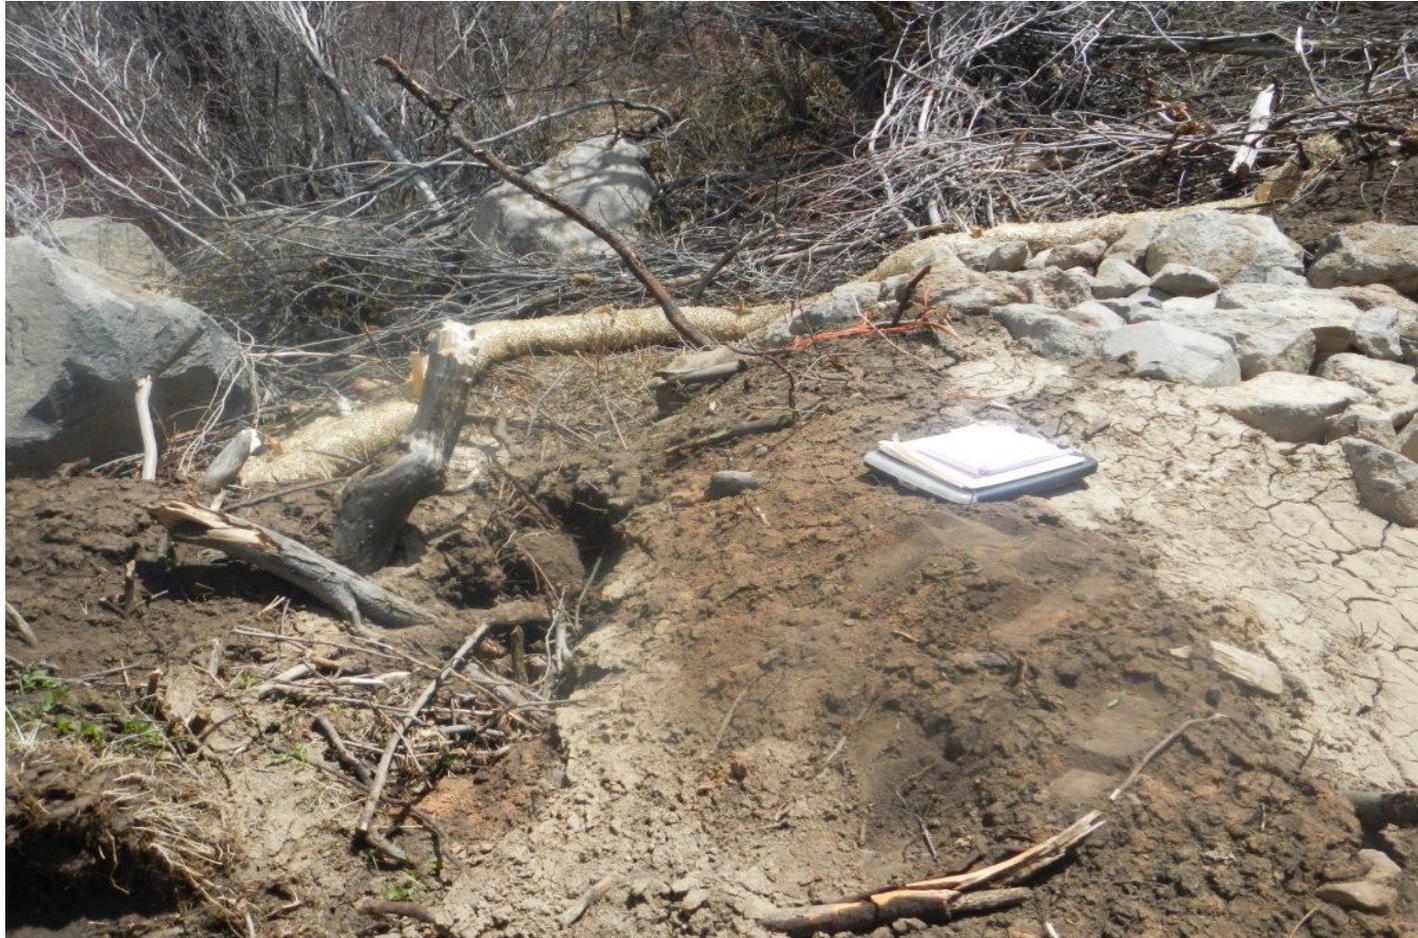
Photo#17:
Bmp overwhelmed and now being bypassed at base of fill slope.

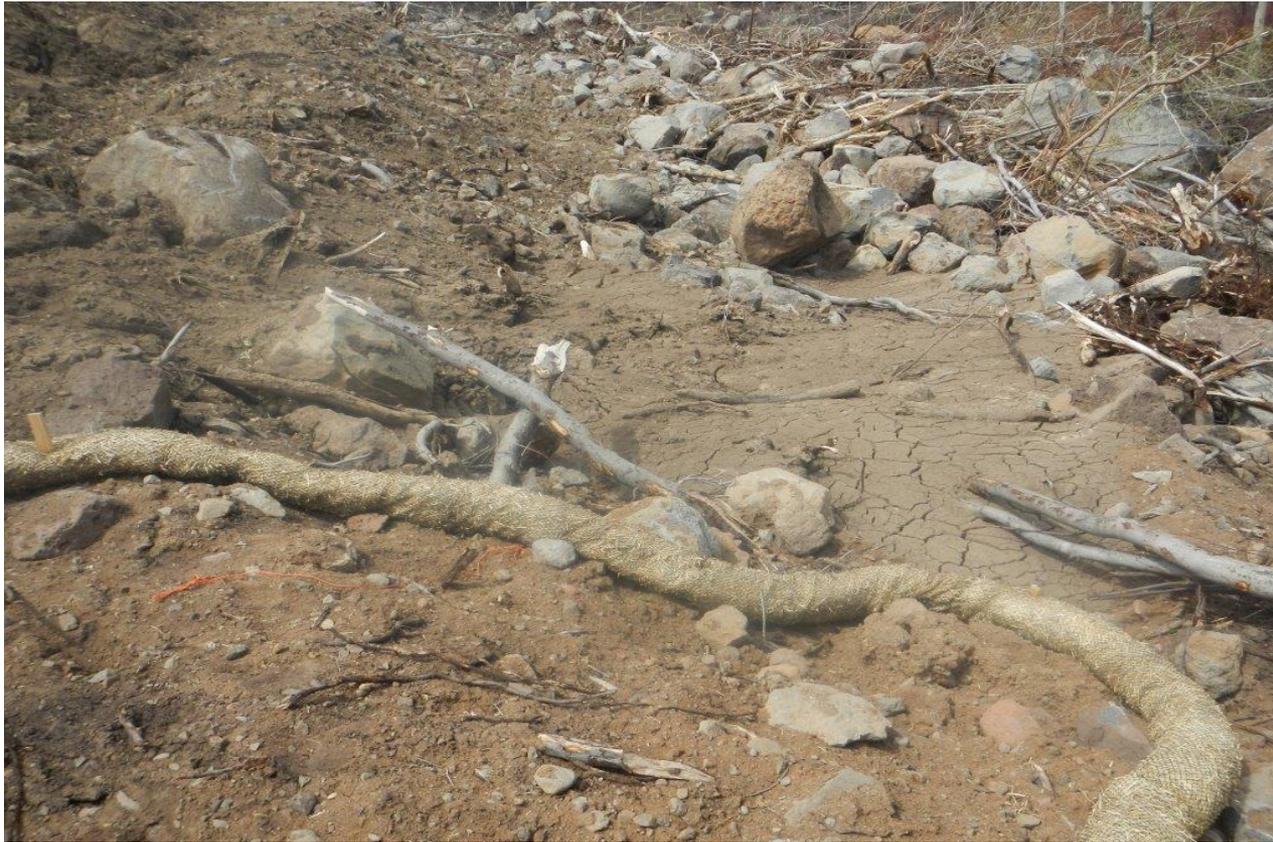
Photo#18:
Ineffective BMP at base of fill slope.

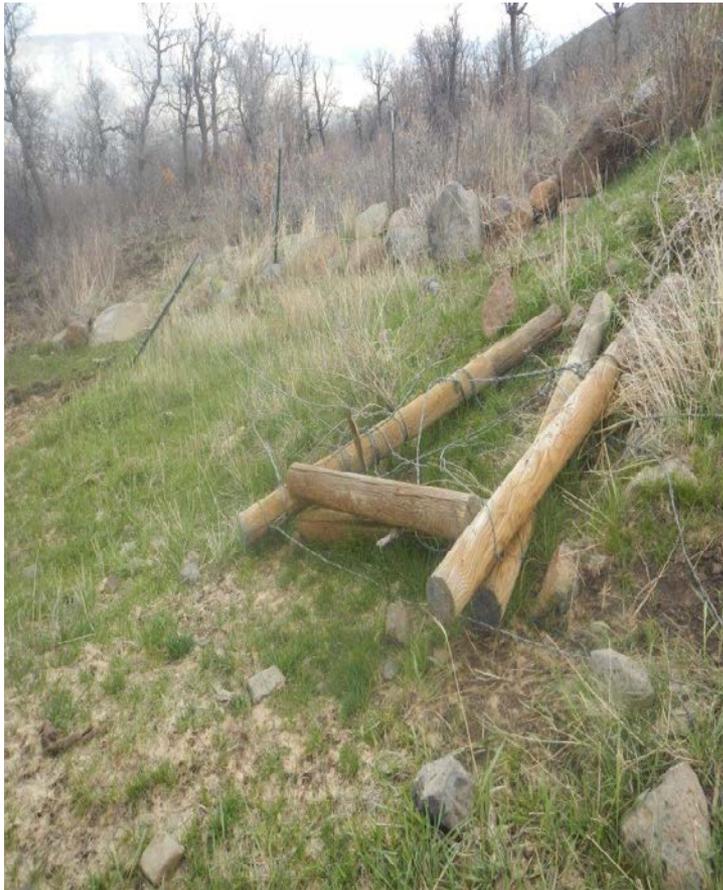
Photo#21:
Down fencing materials have not been removed.

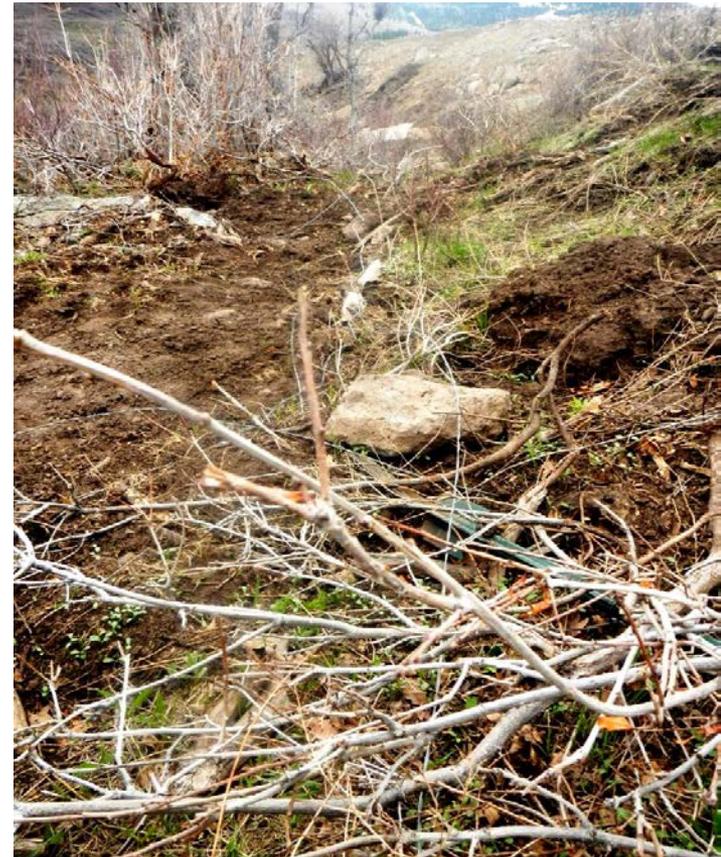
Photo#22:
Barbed wire has not been rolled up.

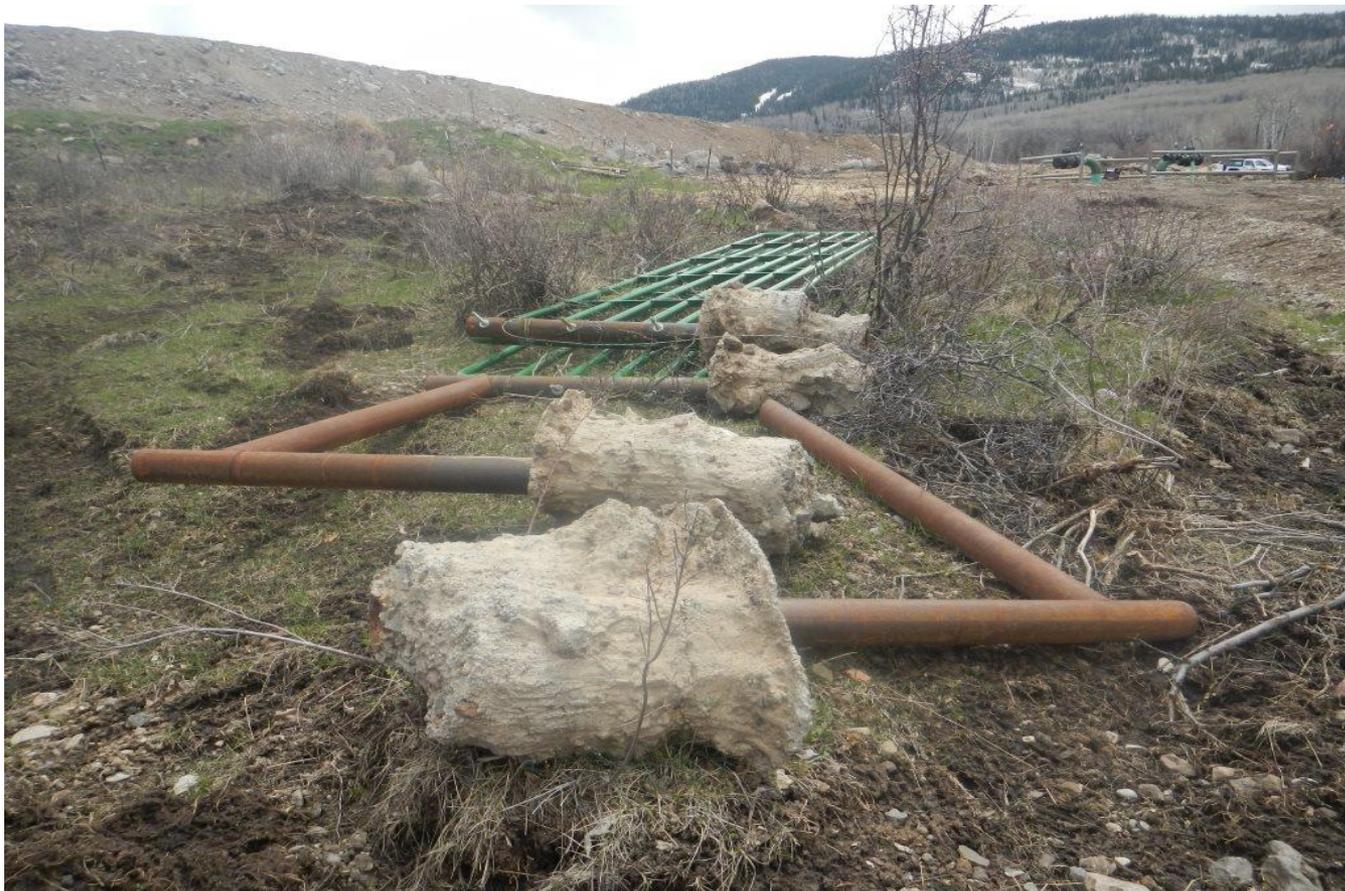
Photo#23:

Unused materials have become debris.
