Inspection Photos
Location Name: UPRR PAN AM AP #1
Facility ID # 241568

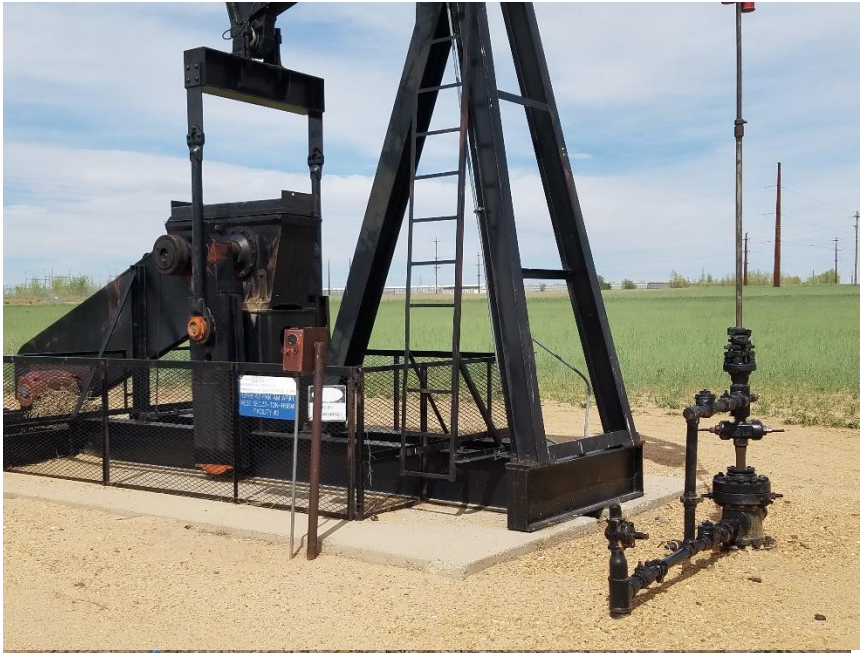
Photo 1. Wellhead

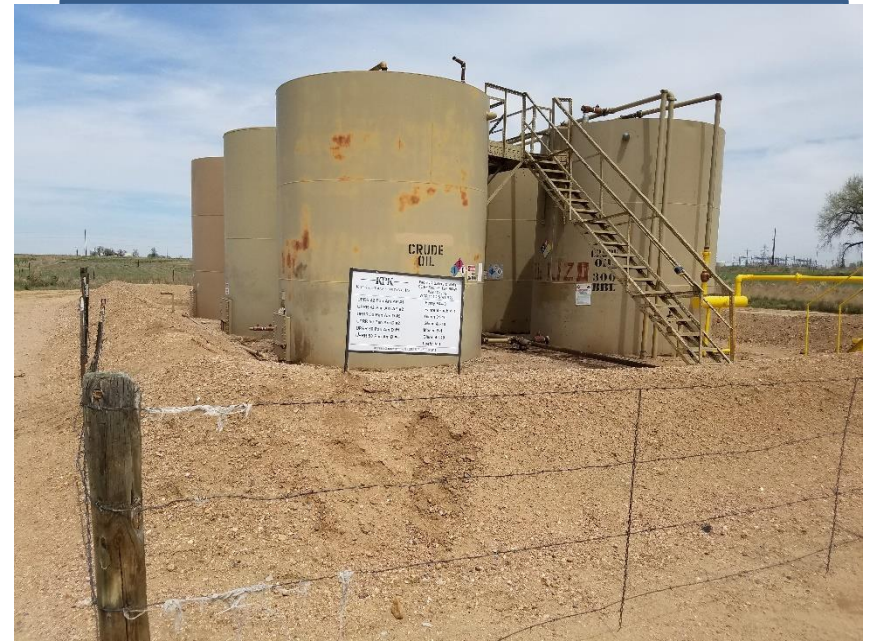
Photo 2. Tank battery

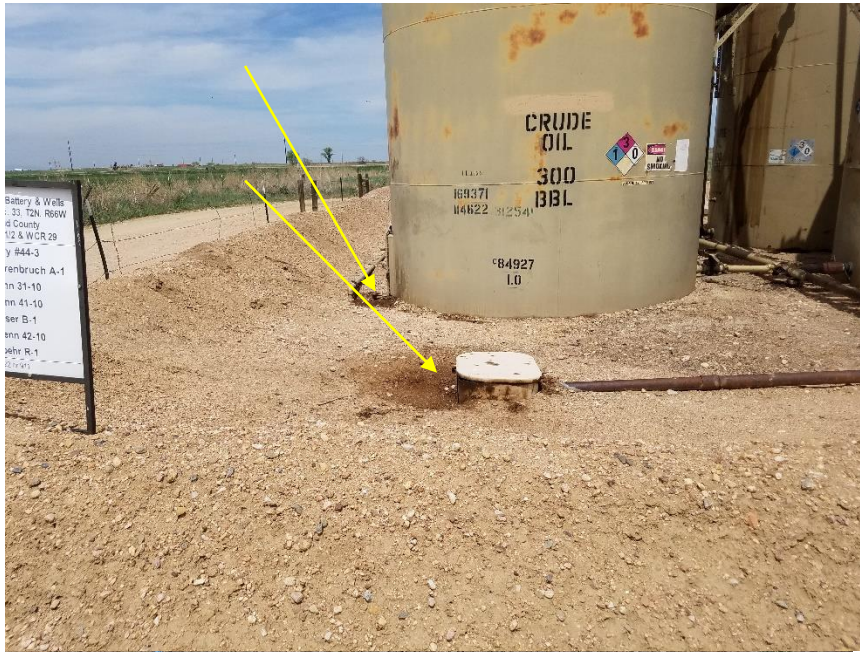
Photo 3. Stained soil near load out and west side of tank.

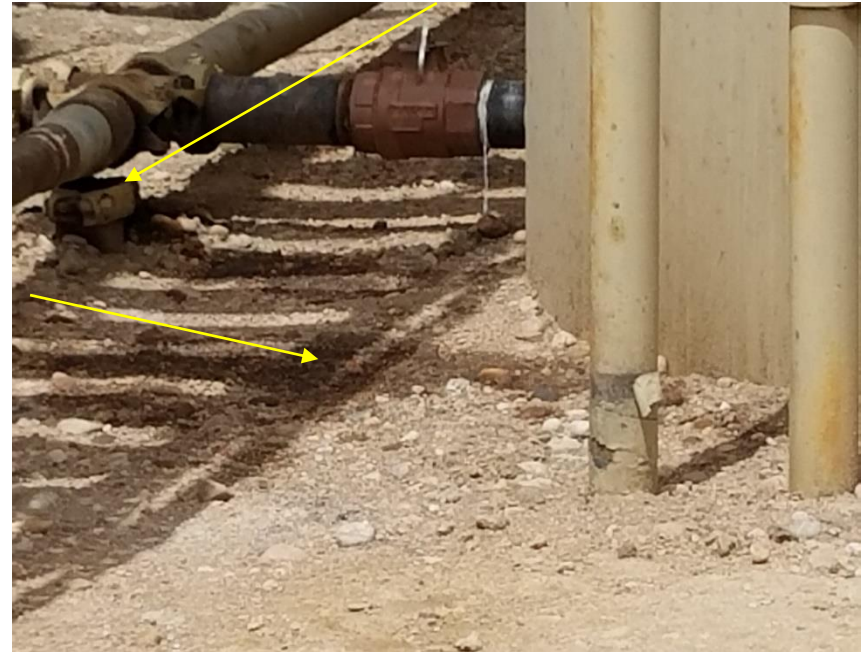
Photo 4. Unmarked riser and stained soil center of crude oil Tanks

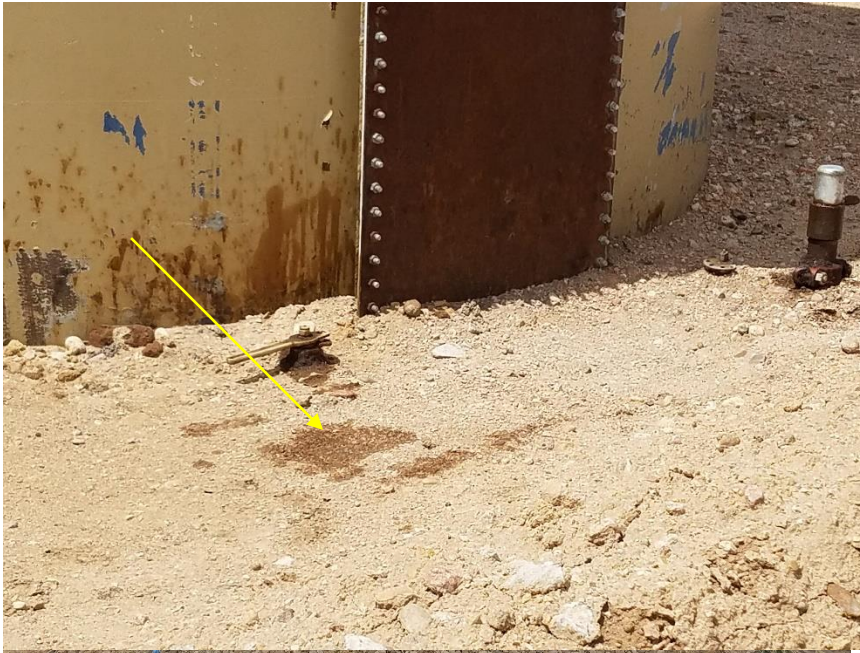
Photo 5. Stained soil south side of tanks

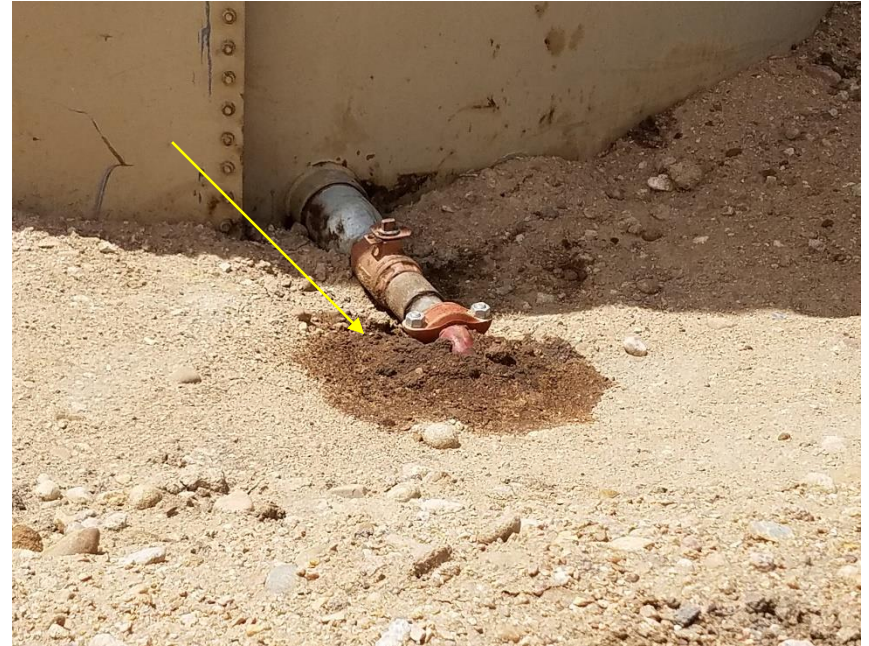
Photo 6. Stained soil near outlet of tank

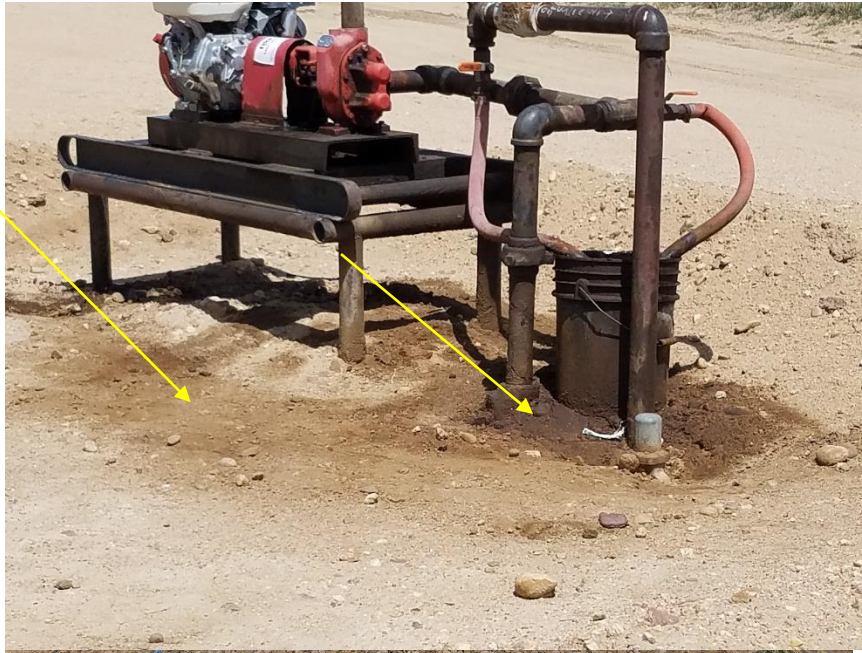
Photo 7. Stained soil near transfer pump

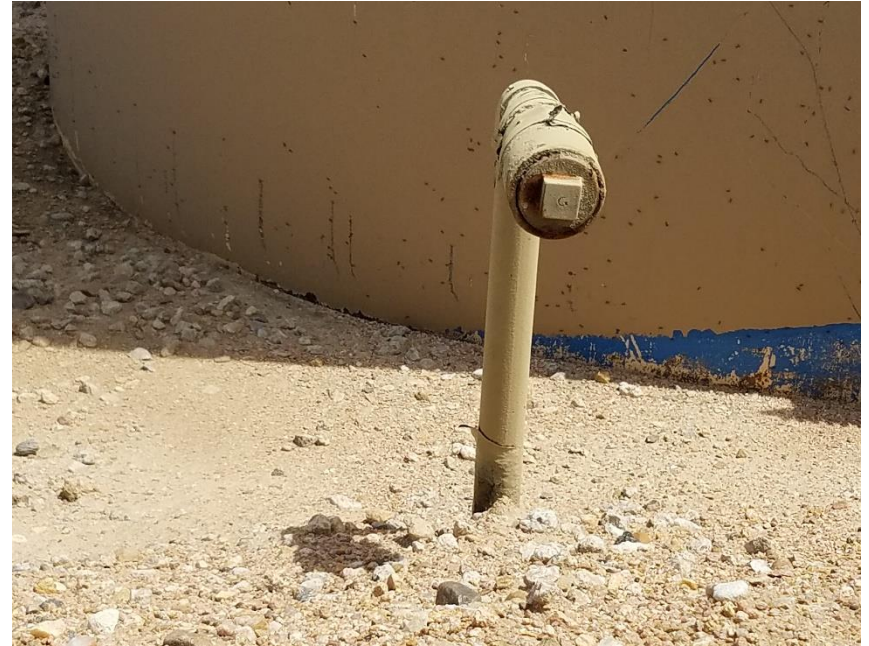
Photo 8. Unmarked riser on east side of crude oil tanks

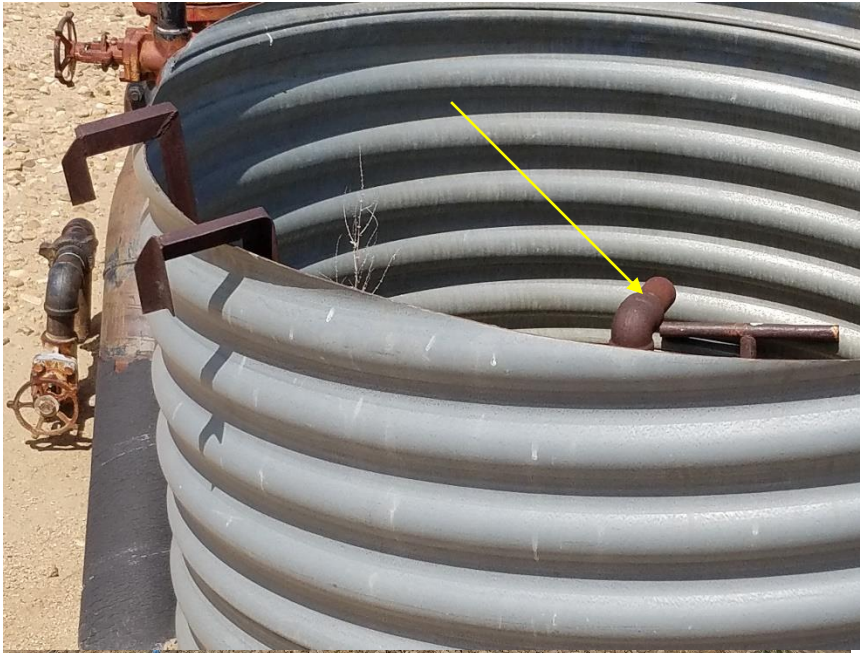
Photo 9. 2 unmarked risers inside containment near meter house, second riser is not visible in picture.

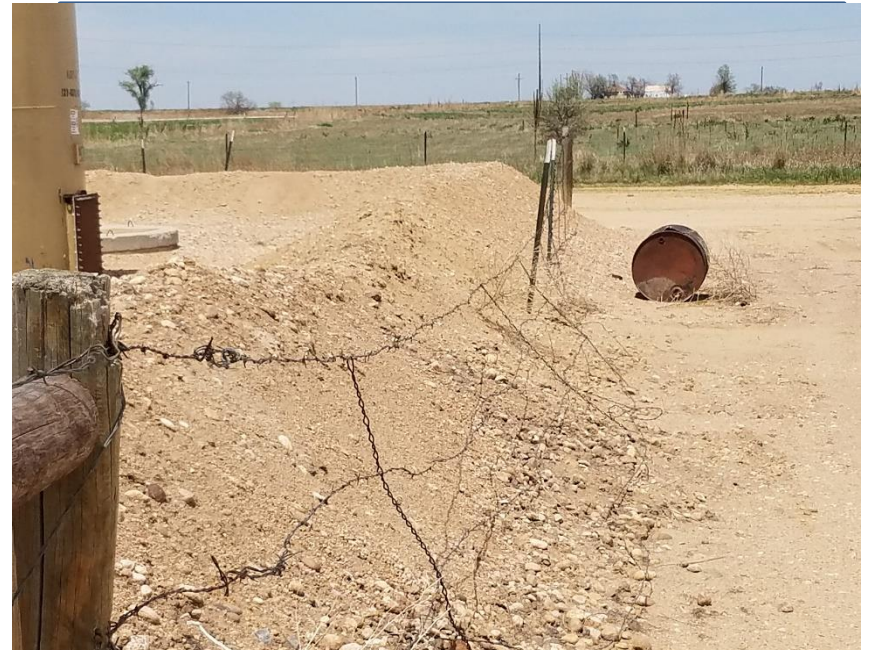
Photo 10. Fence in disrepair
