Interim Reclamation Inspection

Operator: CRESTONE PEAK RESOURCES OPERATING LLC- #10633

Location ID: 435070

Inspection Photos
Location Name: BOHRER /19H-E168
Location ID: 435070

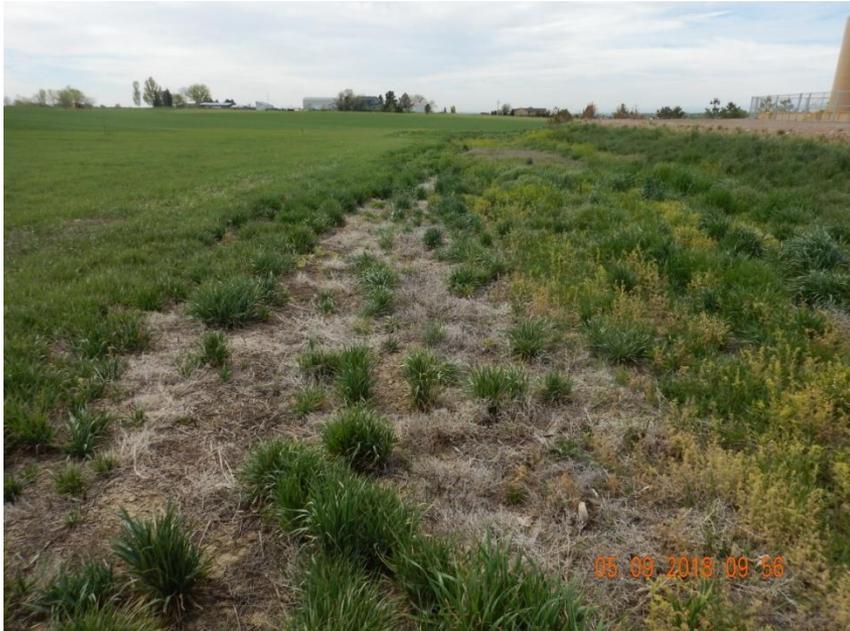
Photo 1. Photo taken from the northeastern location on May 9, 2018, facing South. Operator failed to perform interim reclamation activities by 4/30/18. Interim reclamation areas are not reflective of reference area vegetative levels. Undesirable weed species were observed throughout and there is not uniform establishment of desirable species.

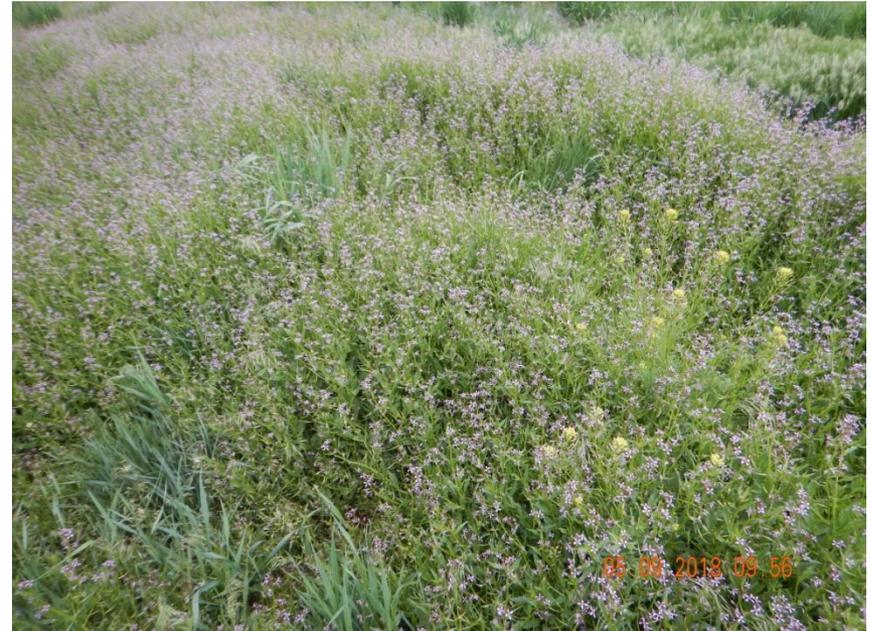
Photo 2. Photo taken from the eastern location on May 9, 2018, facing North. Photo of *Chorispora tenella* (Purple Mustard) which is an invasive species.

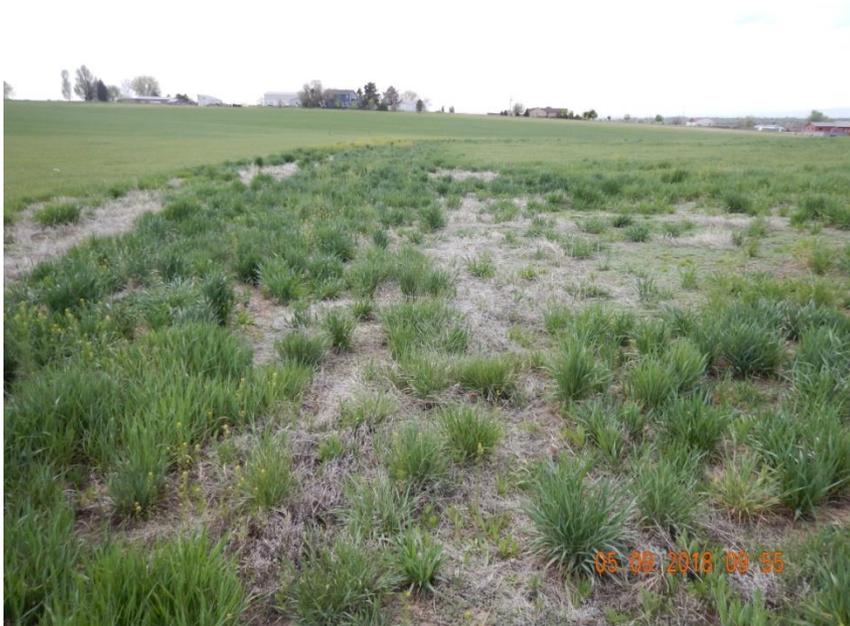
Photo 3. Photo taken from the eastern location on May 9, 2018, facing South. See comments under Photo 1.

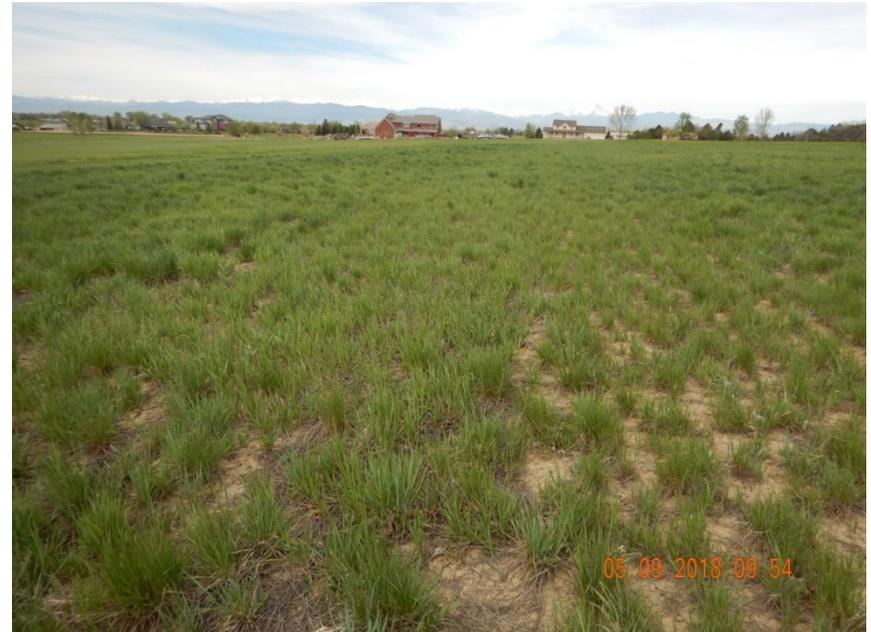
Photo 4. Photo taken from the southeastern location on May 9, 2018, facing West. Photo illustrates establishment of desirable species. This area does not appear to need additional reclamation activities.

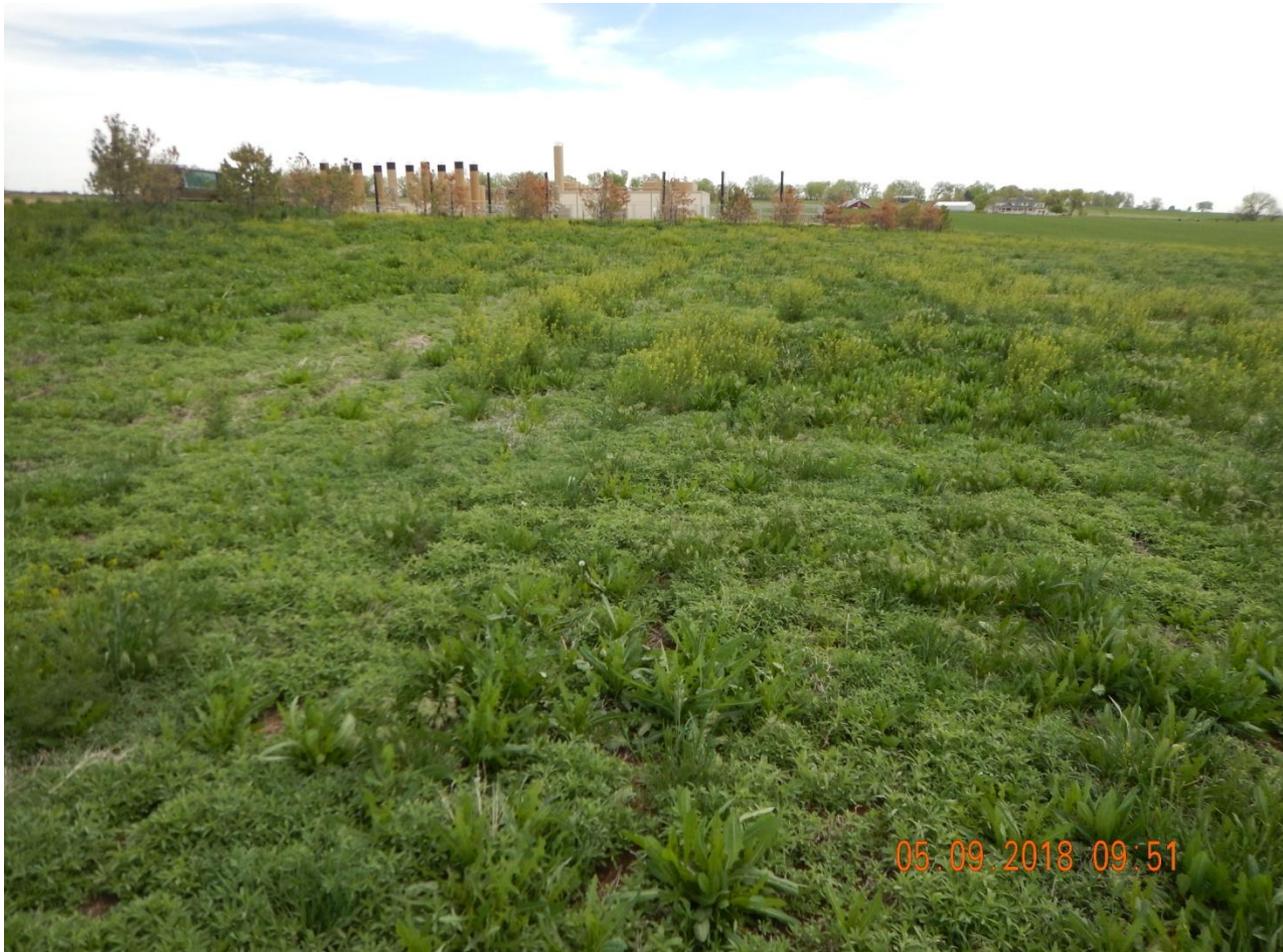
Photo 5. Photo taken from the southern location on May 9, 2018, facing East. See comments under Photo 1. This area has a high abundance of Kochia and other undesirable species.

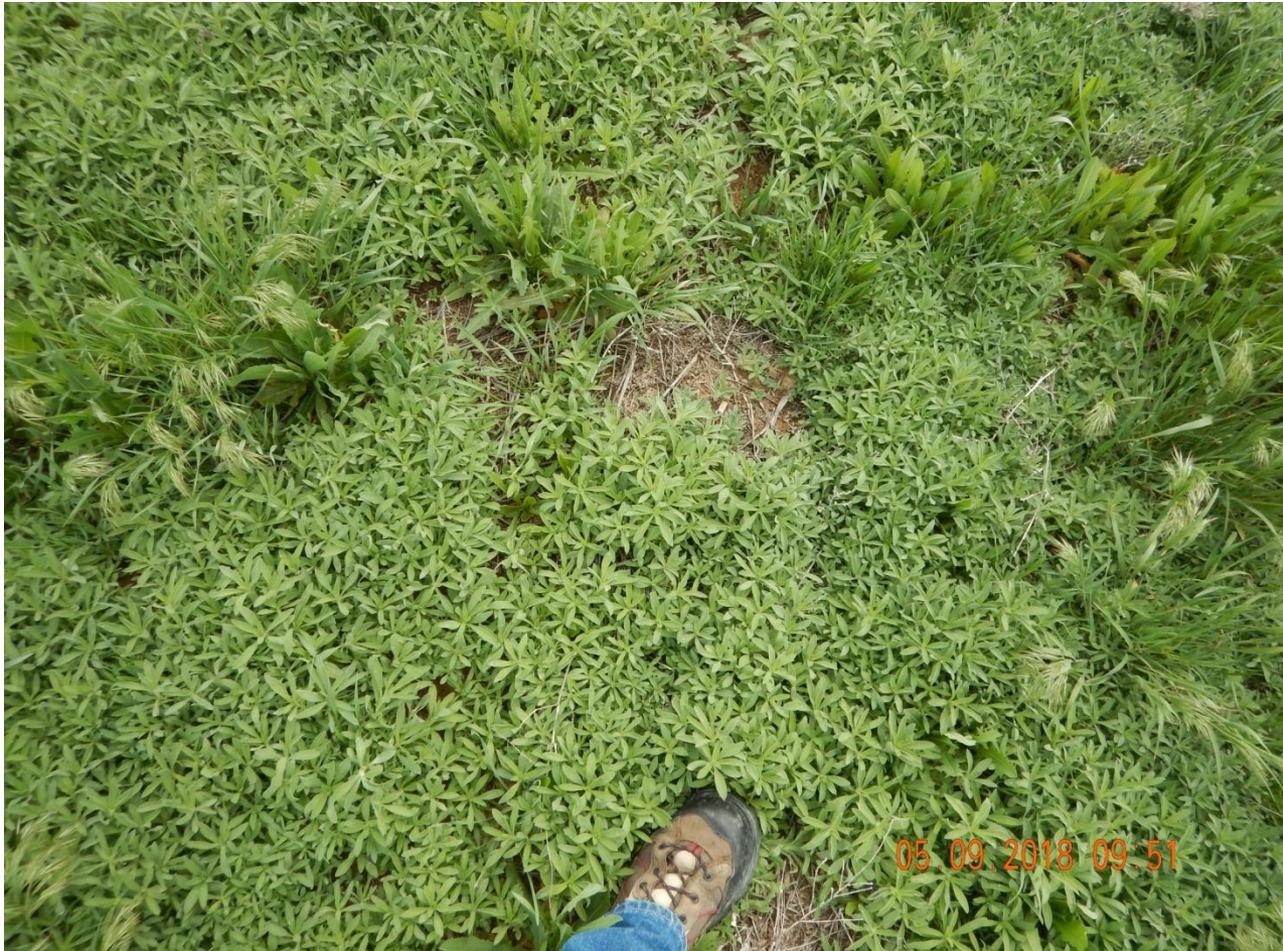
Photo 6. Close-up photo taken from the previous photo location (Photo 5). Photo illustrates the Kochia rosettes and cheatgrass with little, to no, establishment of desirable species.

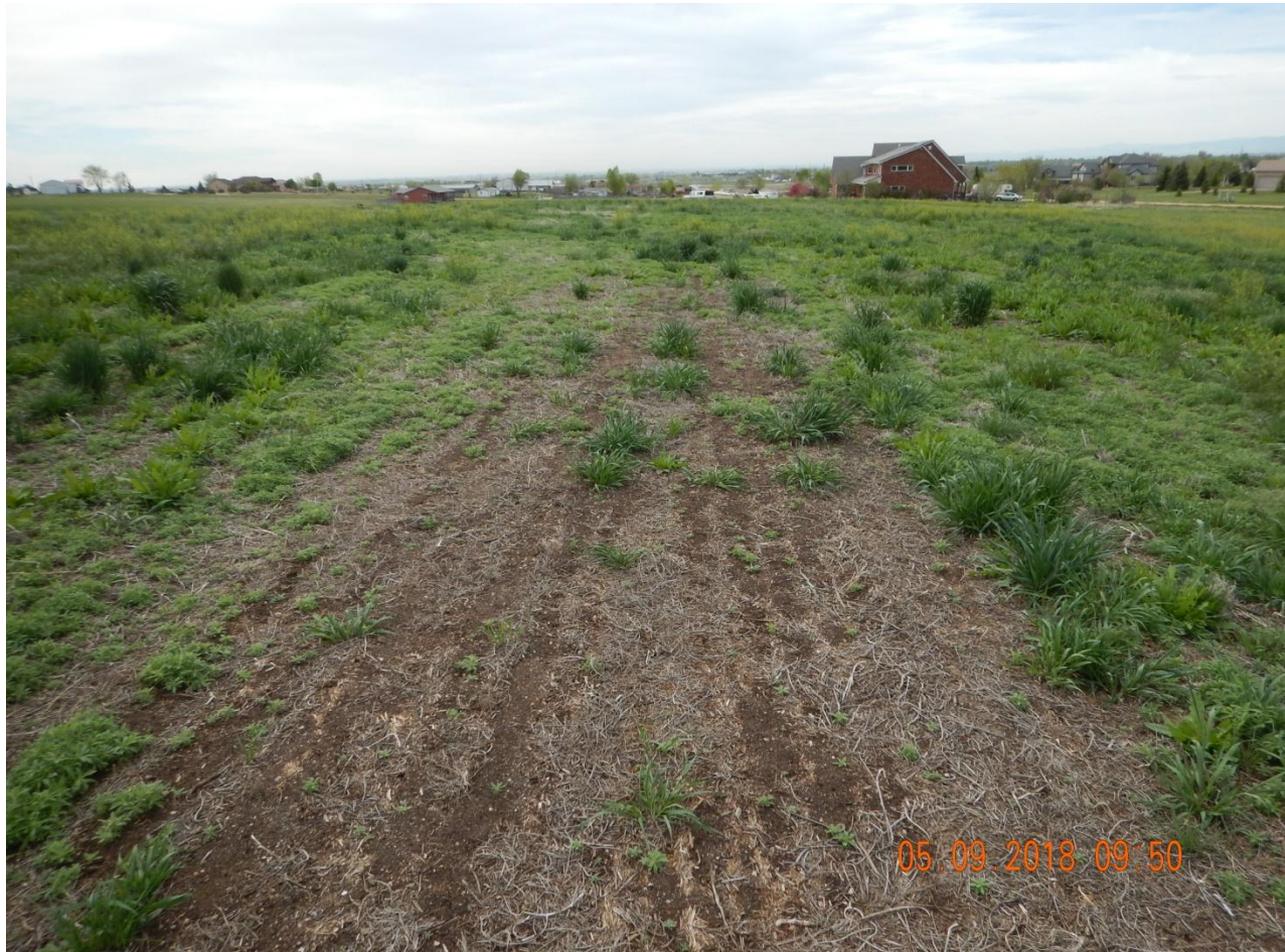
Photo 7. Photo taken from the western location on May 9, 2018, facing South. See comments under Photo 1.

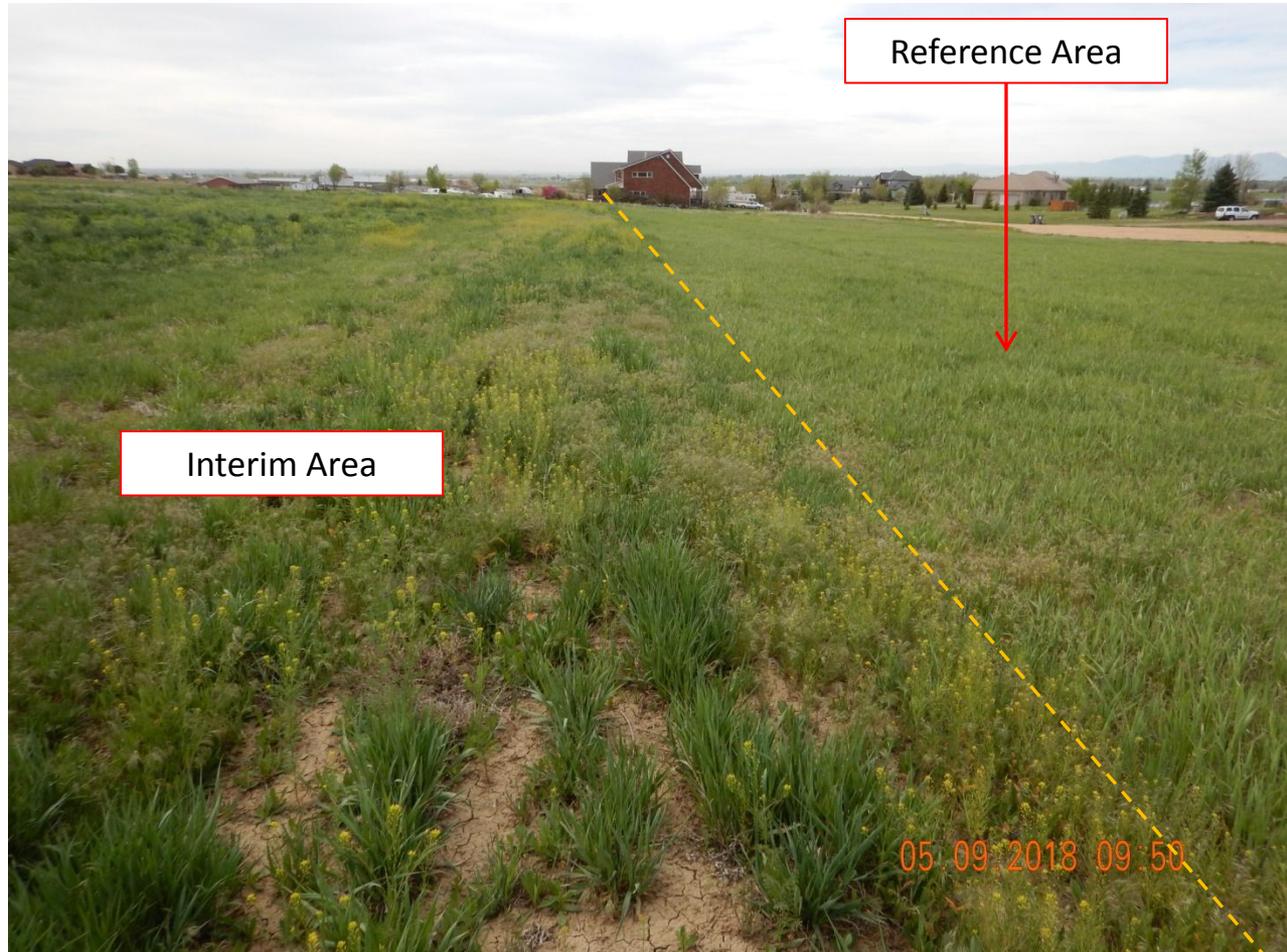
Photo 8. Reference photo taken from the western location on May 9, 2018, facing South. Photo illustrates that interim areas are not reflective of reference area vegetation.

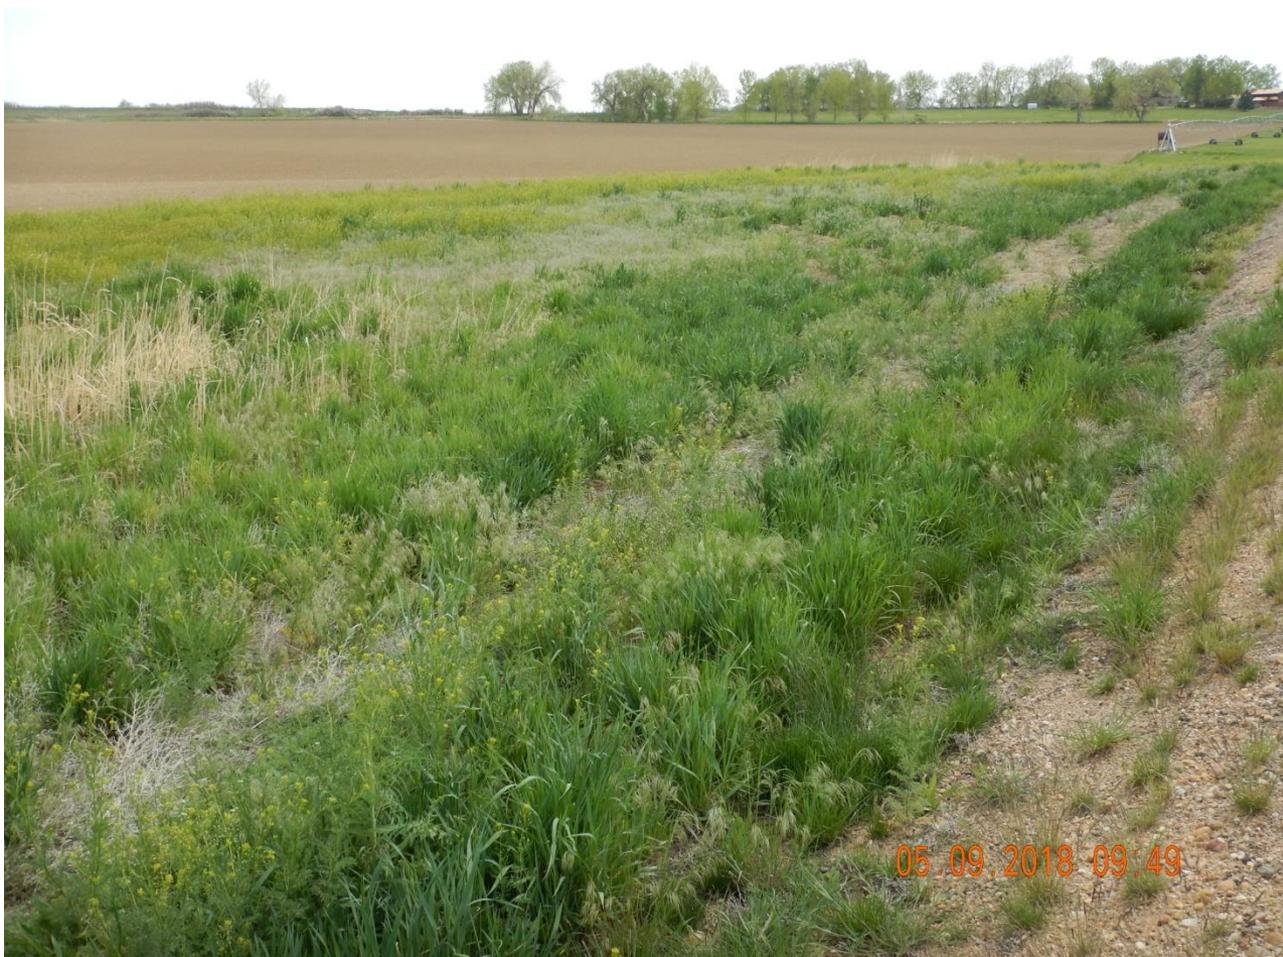
Photo 9. Photo taken from the northern location on May 9, 2018, facing East. See comments under Photo 1.

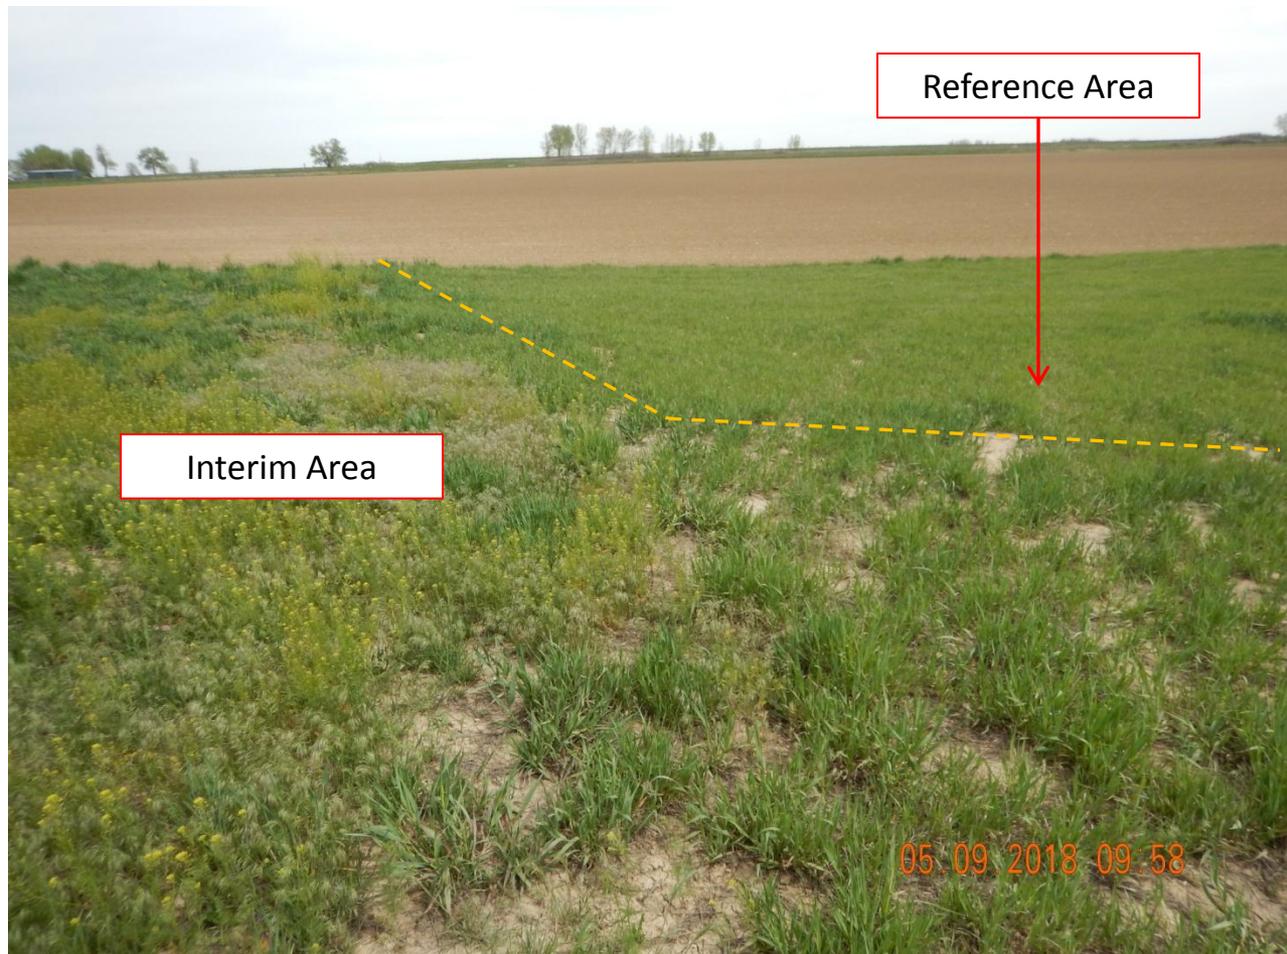
Photo 10. Photo taken from the northern location on May 9, 2018, facing North. Photo illustrates that interim areas are not reflective of reference area vegetation.

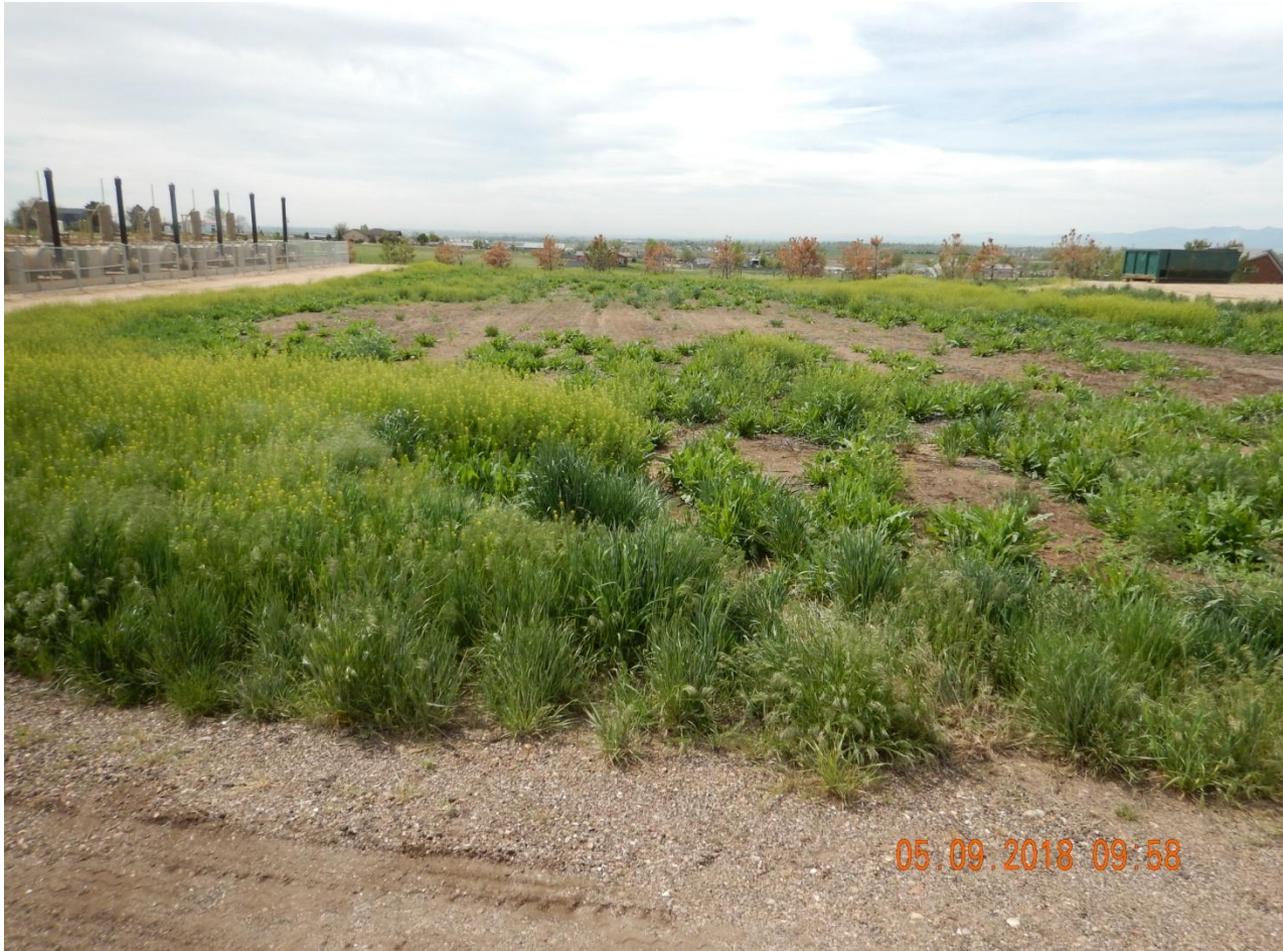
Photo 11. Photo taken from the central location on May 9, 2018, facing South. See comments under Photo 1.
