Construction and Stormwater Inspection

Operator: NICKEL ROAD OPERATING LLC #10669

Location ID: 454131

Inspection Document #: 682403558

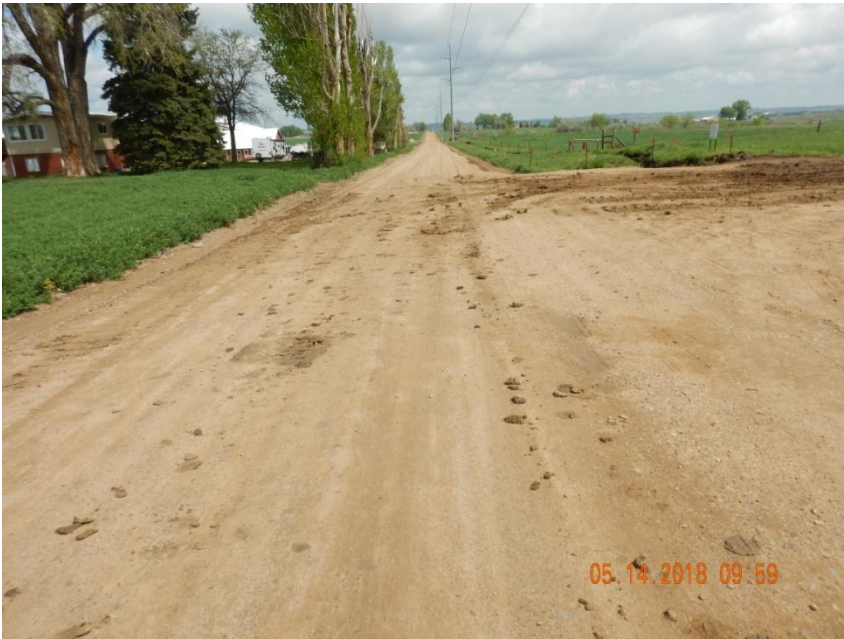
Photo 1. Photo taken from the entrance of the location, facing North. Operator has failed to install a vehicle tracking device to prevent track of material offsite.

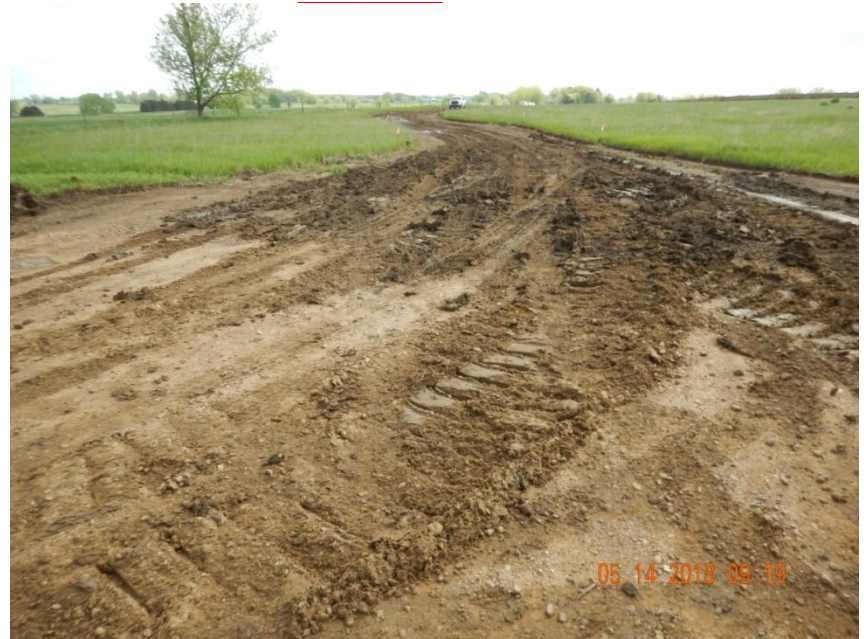
Photo 2. Photo taken from the entrance of the location, facing East. See comments under Photo 1.

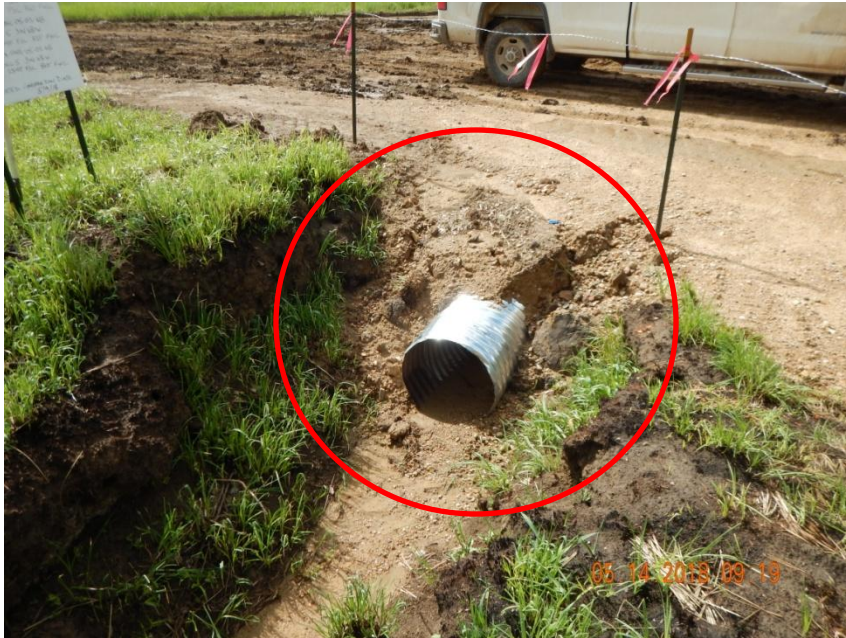
Photo 3. Photo taken from the entrance of the location at culvert #1, facing South. Culverts have been installed along the roadside ditch. Operator needs to stabilize around the culvert to minimize erosion and install inlet/outlet protection.

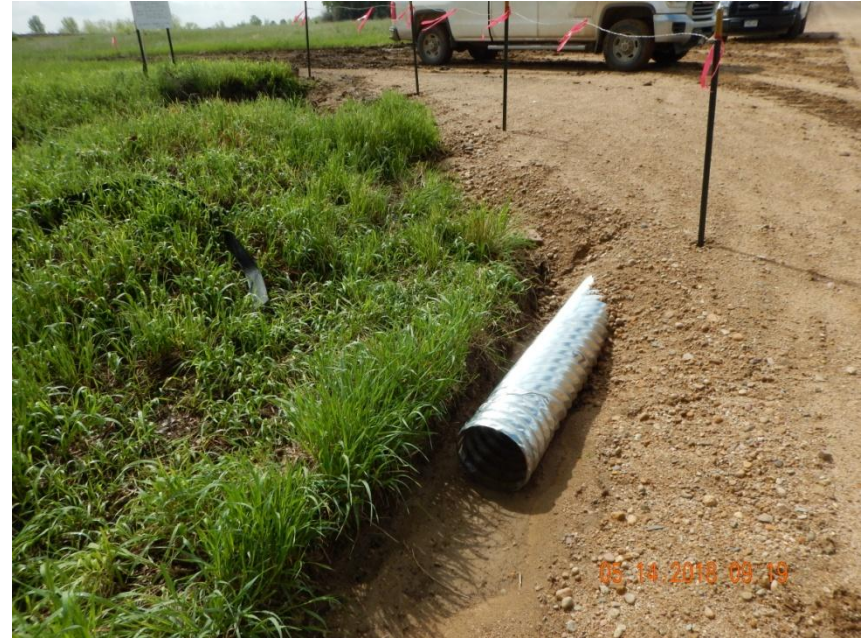
Photo 4. Photo taken from the entrance of the location at culvert #2, facing South. See comments under Photo 3.

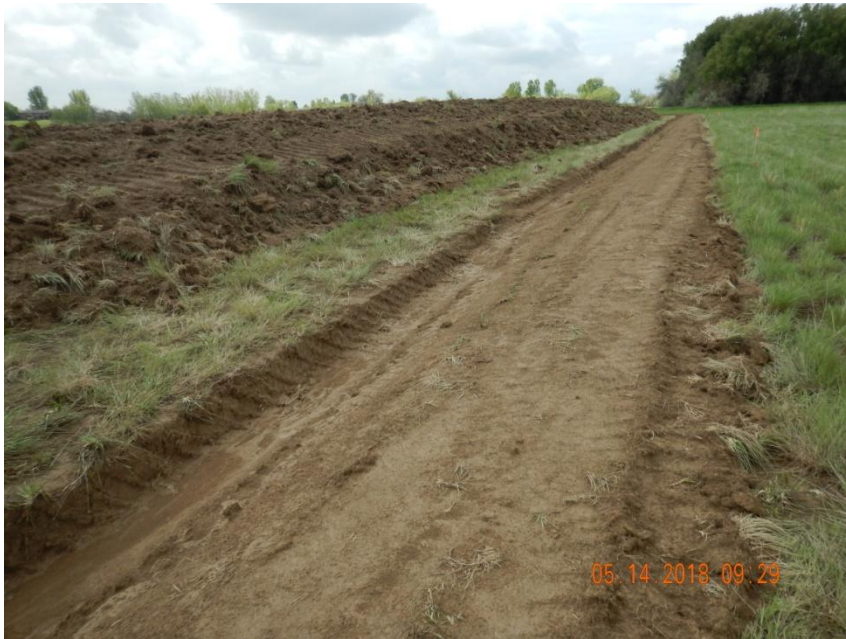
Photo 5. Photo taken from the western perimeter of the location, facing South. Ditch and berm has been installed around the perimeter of the location. Topsoil has been stockpiled along the western perimeter. Does not appear the Operator has salvaged all the topsoil from the location.

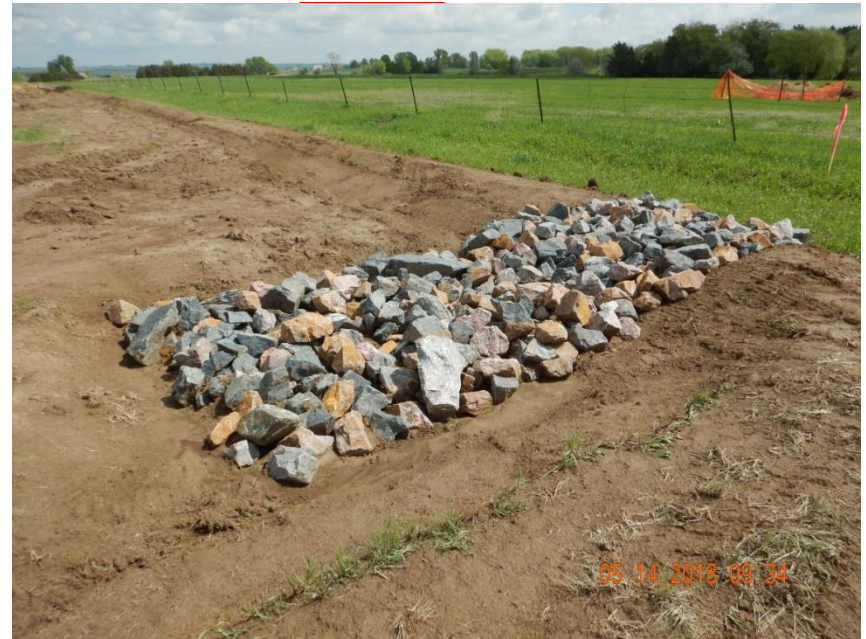
Photo 6. Photo taken from the southeast perimeter of the location, facing North. Rip-rap has been installed in conjunction with the ditch and berm BMP. This would not be considered a sediment trap.

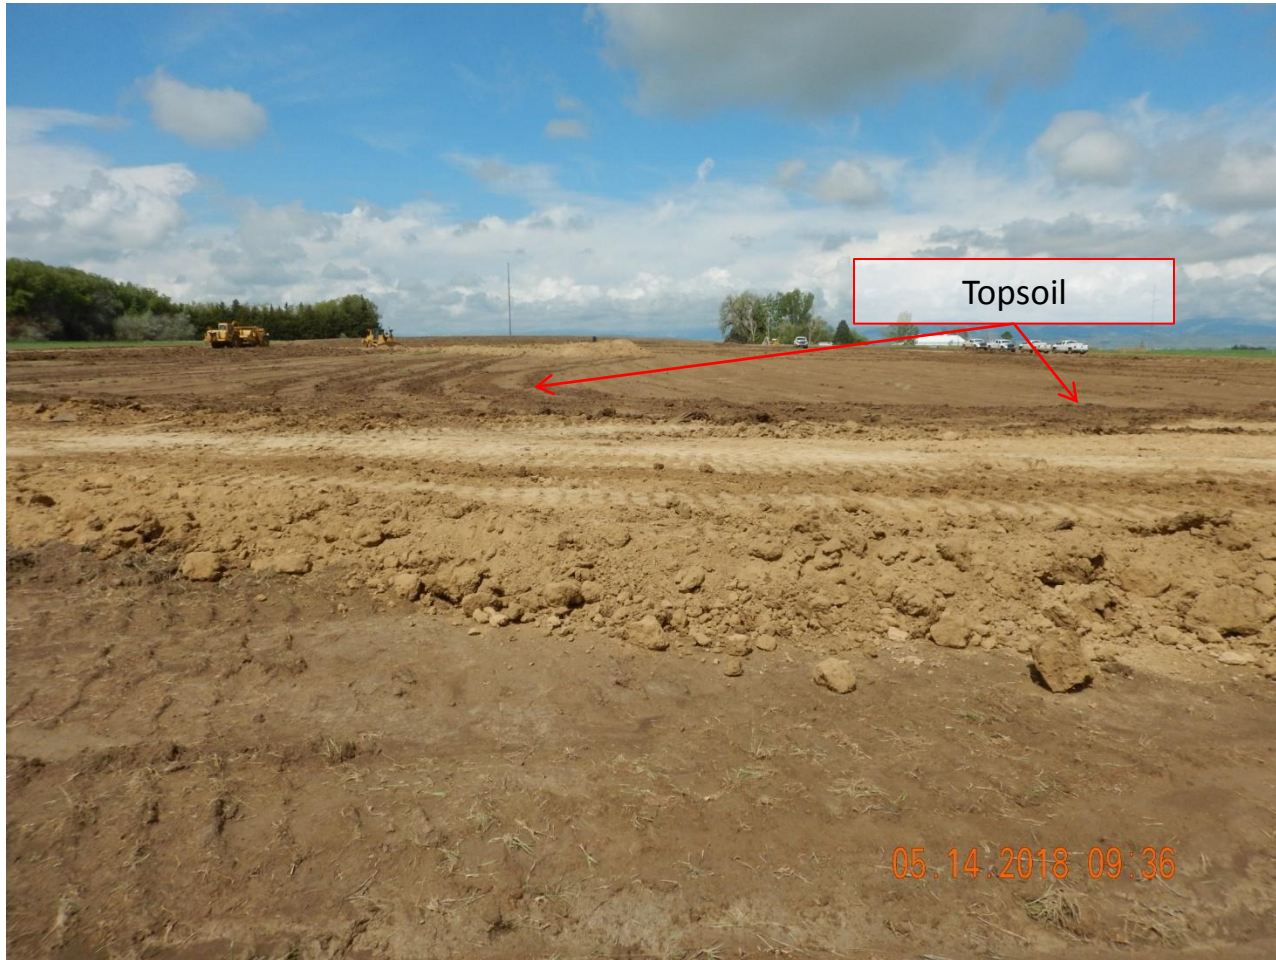
Photo 7. Photo taken from the eastern perimeter of the location, facing North. Based off field observations, Operator has failed to salvage all the topsoil from the location.

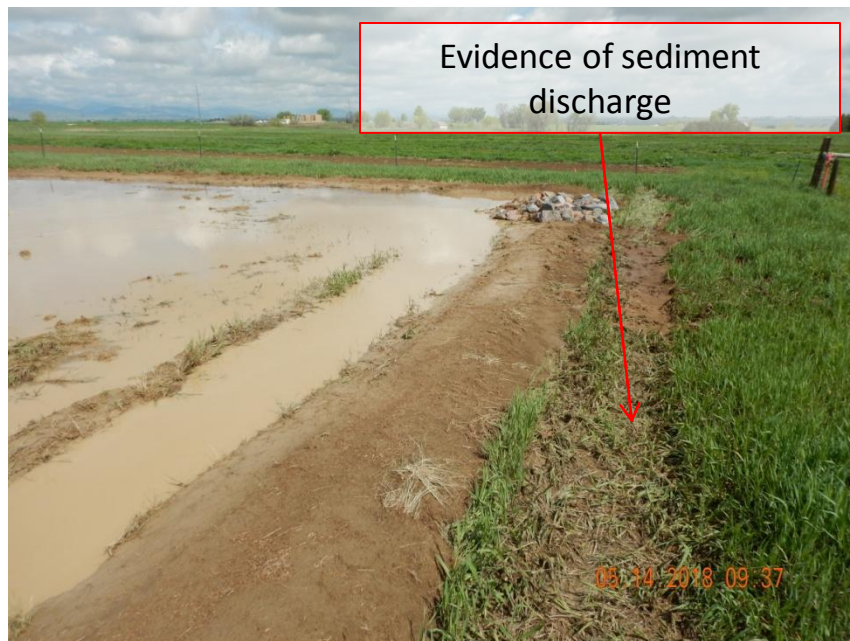
Photo 8. Photo taken from the northwest perimeter of the location, facing North. Sediment laden stormwater has discharged off location. Ditch and berm BMP and rip-rap are not sufficient to prevent sediment laden stormwater from discharging off location. Operator needs to installed sufficient erosion and sediment control BMP immediately.

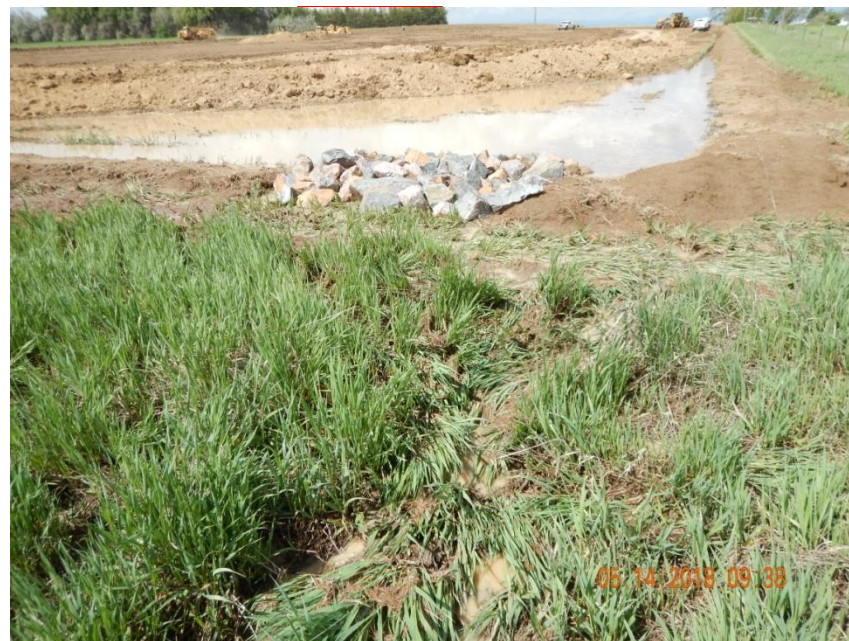
Photo 9. Photo taken from the northwest perimeter of the location, facing West. See comments under Photo 8. Photo illustrates sediment laden discharge actively discharging off location.

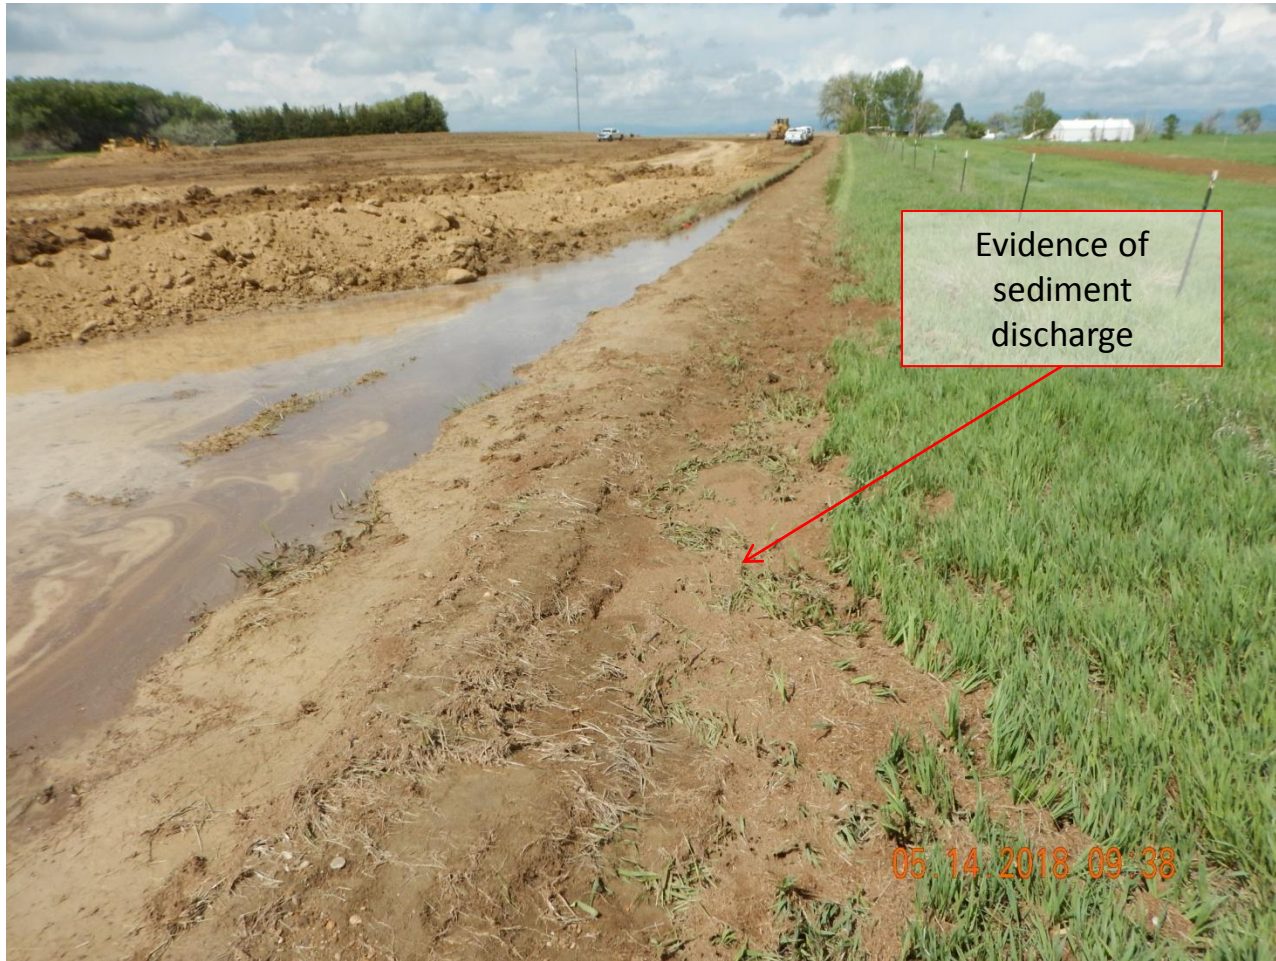
Photo 10. Photo taken from the northwest perimeter of the location, facing West. See comments under Photo 8.
