Final Reclamation and Stormwater Inspection

Operator: SRC ENERGY INC- #10311

Location ID: 424103

Inspection Photos
Location Name: HOAGLAND /44-4
Location ID: 424103

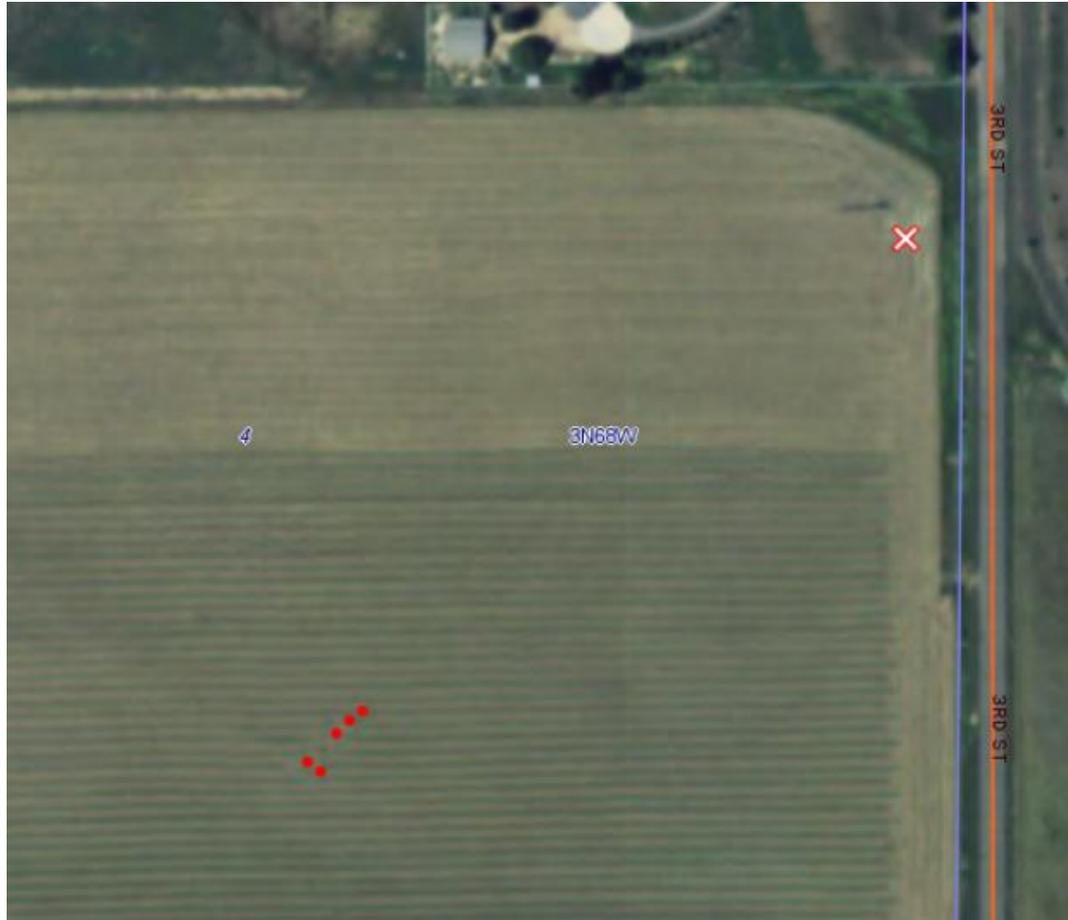
Aerial imagery photo taken 2011 before oil and gas development. Red "x" indicates approximate southeast corner of tank battery and red dots are the approximate well locations.

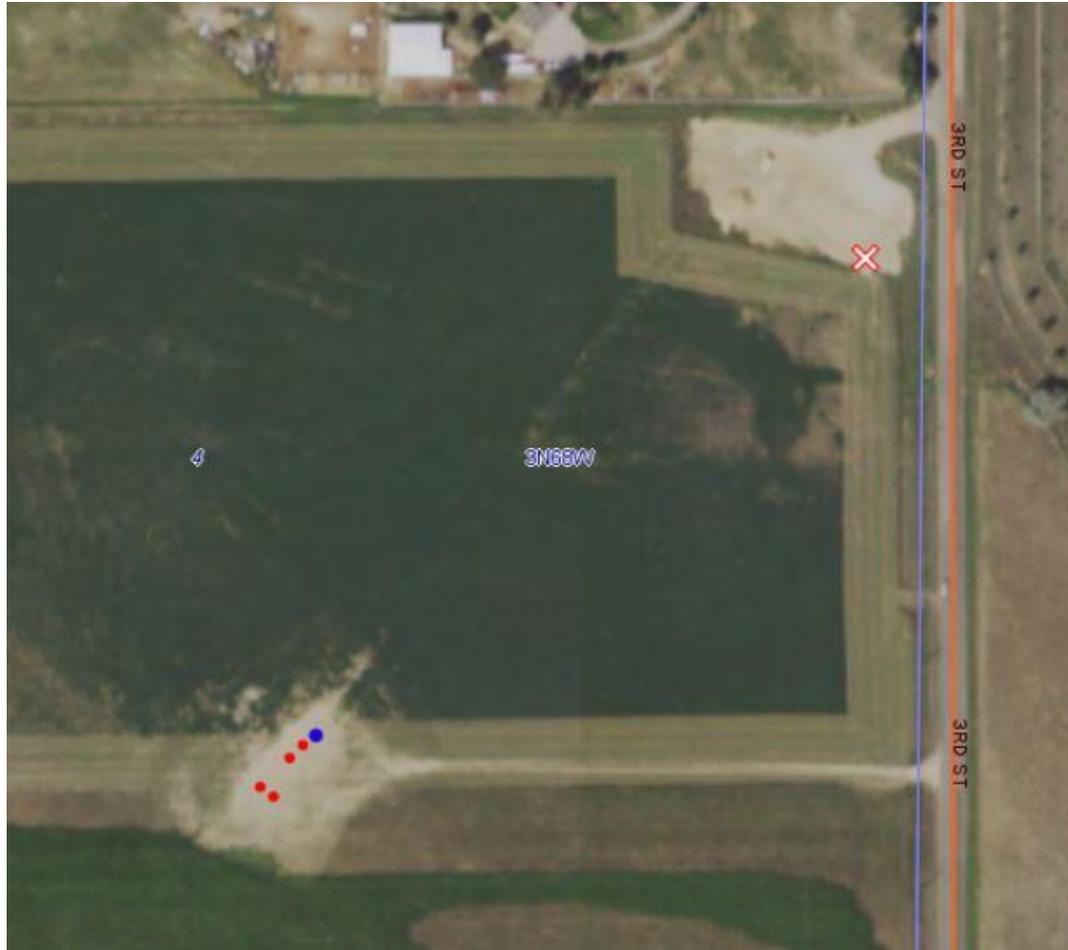
Aerial imagery photo taken 2017. Photo illustrates the well location, battery location, and access roads.

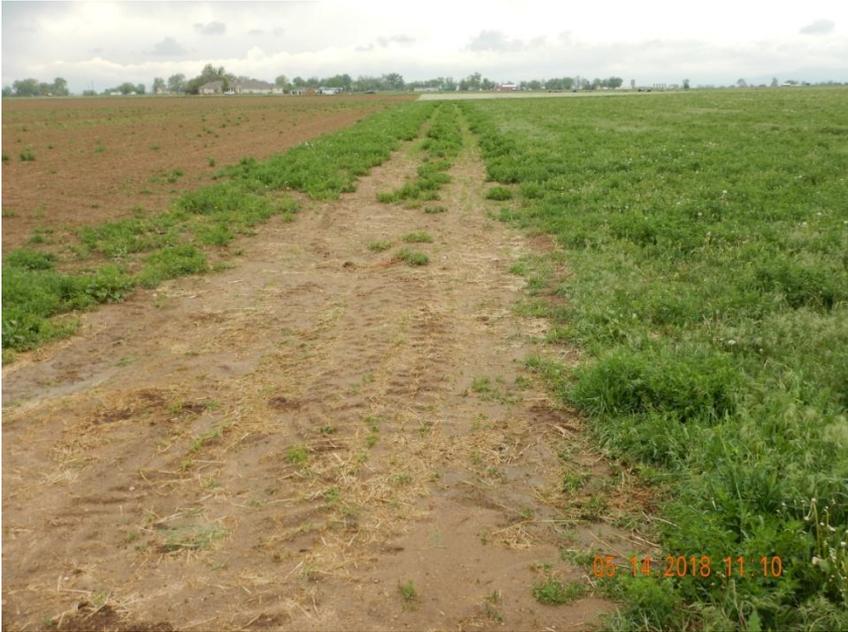
Photo 1. Photo taken from the entrance of the well location off 3rd street, facing West. Appears the Operator is attempting to reclaim the access road with the evidence of drilling rows and straw crimped mulch. Some germination of grass species was evident along portions of the access road but did not observe any reference area vegetation (alfalfa). Operator shall continue to monitor and manage this site until the location meets Rule 1004 standards.

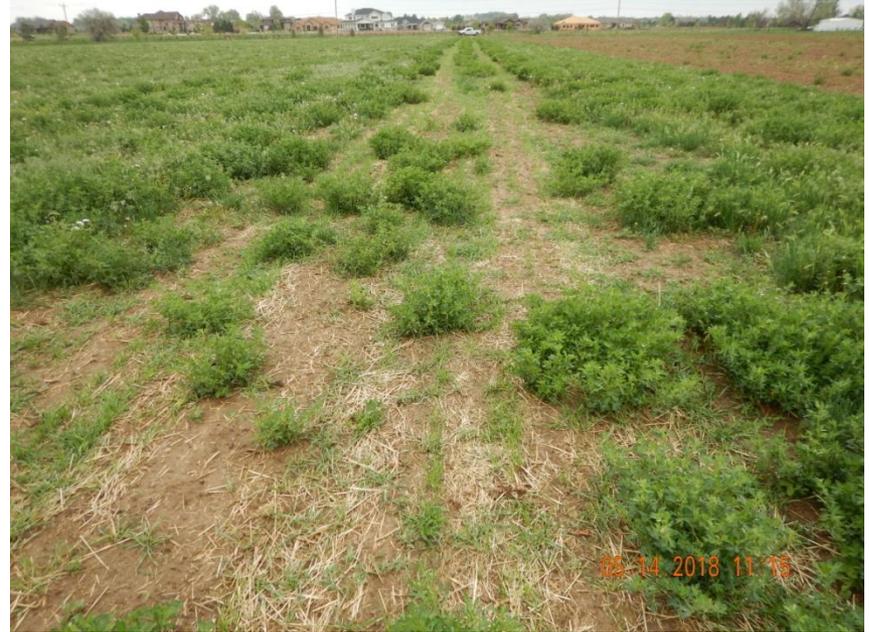
Photo 2. Photo taken from a portion of the access road, facing East. See comments under Photo 1.

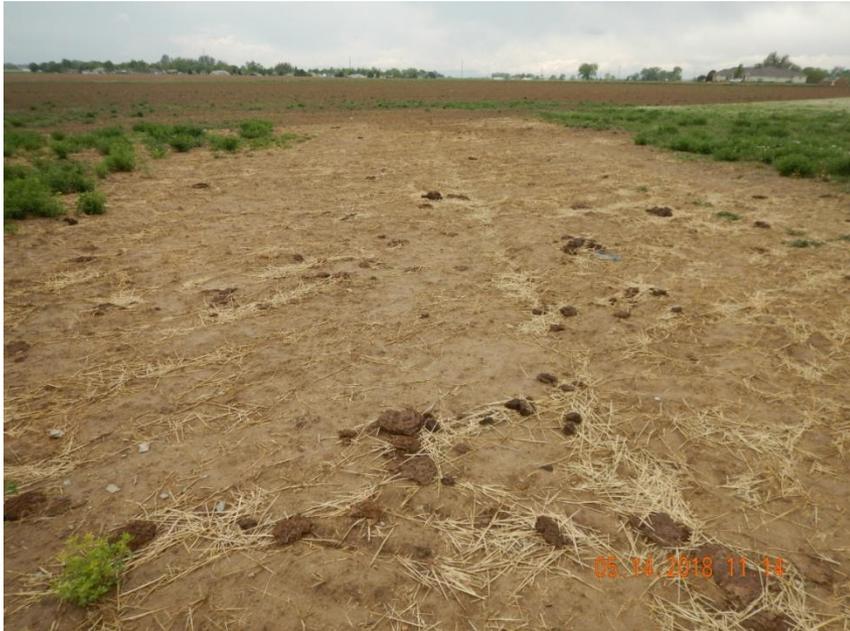
Photo 3. Photo taken from the well location, facing South. Did not observe any germination of grass species or alfalfa throughout any portion of the well location.

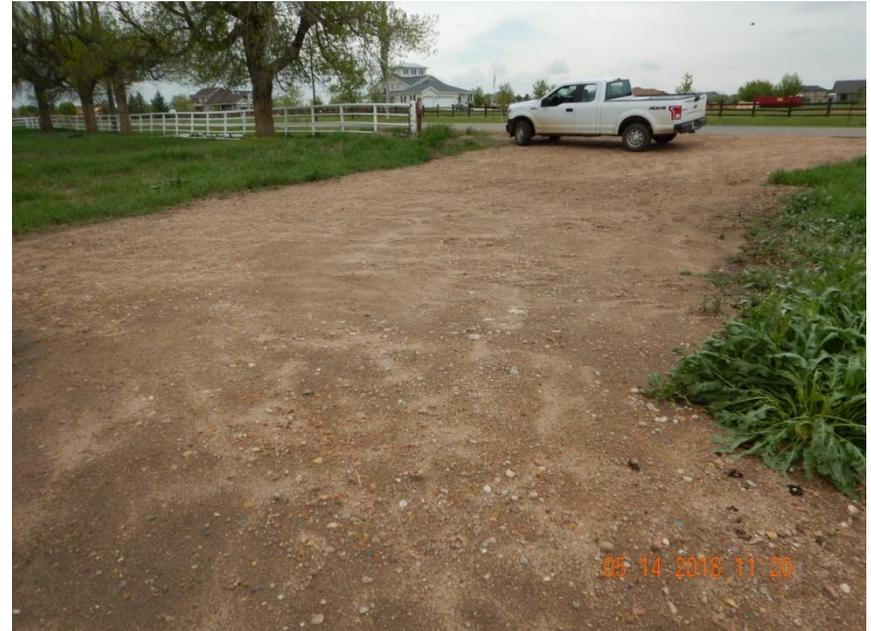
Photo 4. Photo taken from the tank battery location, facing Northeast. Operator has failed to reclaim a portion of the access road.

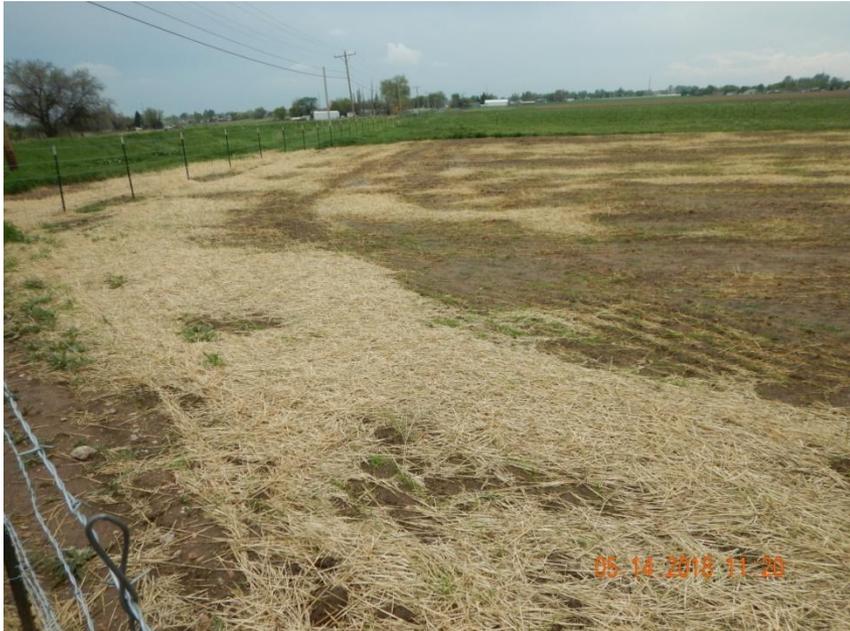
Photo 5. Photo taken from the northeast battery location, facing South. Appears the Operator has performed final reclamation activities. Perimeter fence has been installed around the battery location. Some germination of grass species was evident along portions of the access road but did not observe any reference area vegetation (alfalfa).

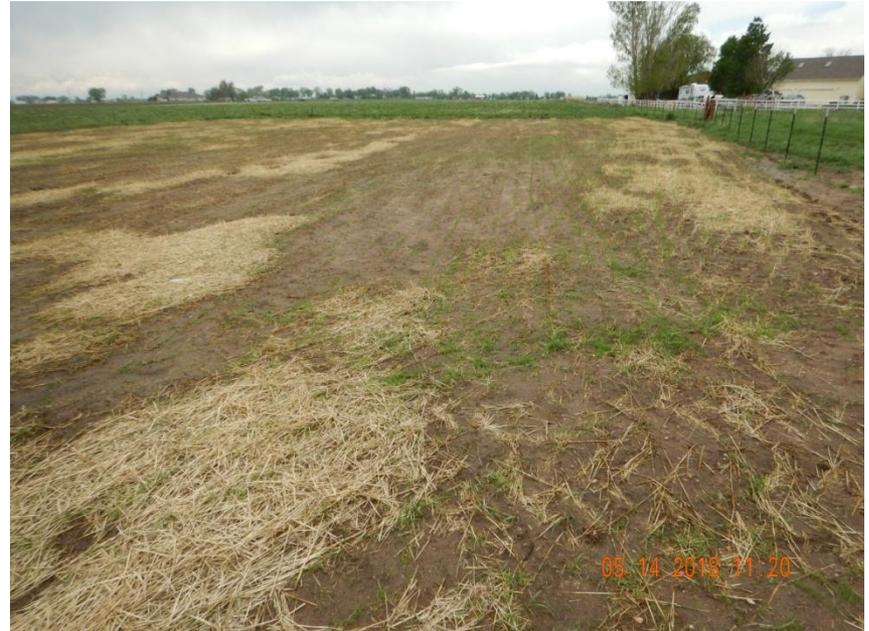
Photo 6. Photo taken from the northeast battery location, facing West. See comments under Photo 5.
