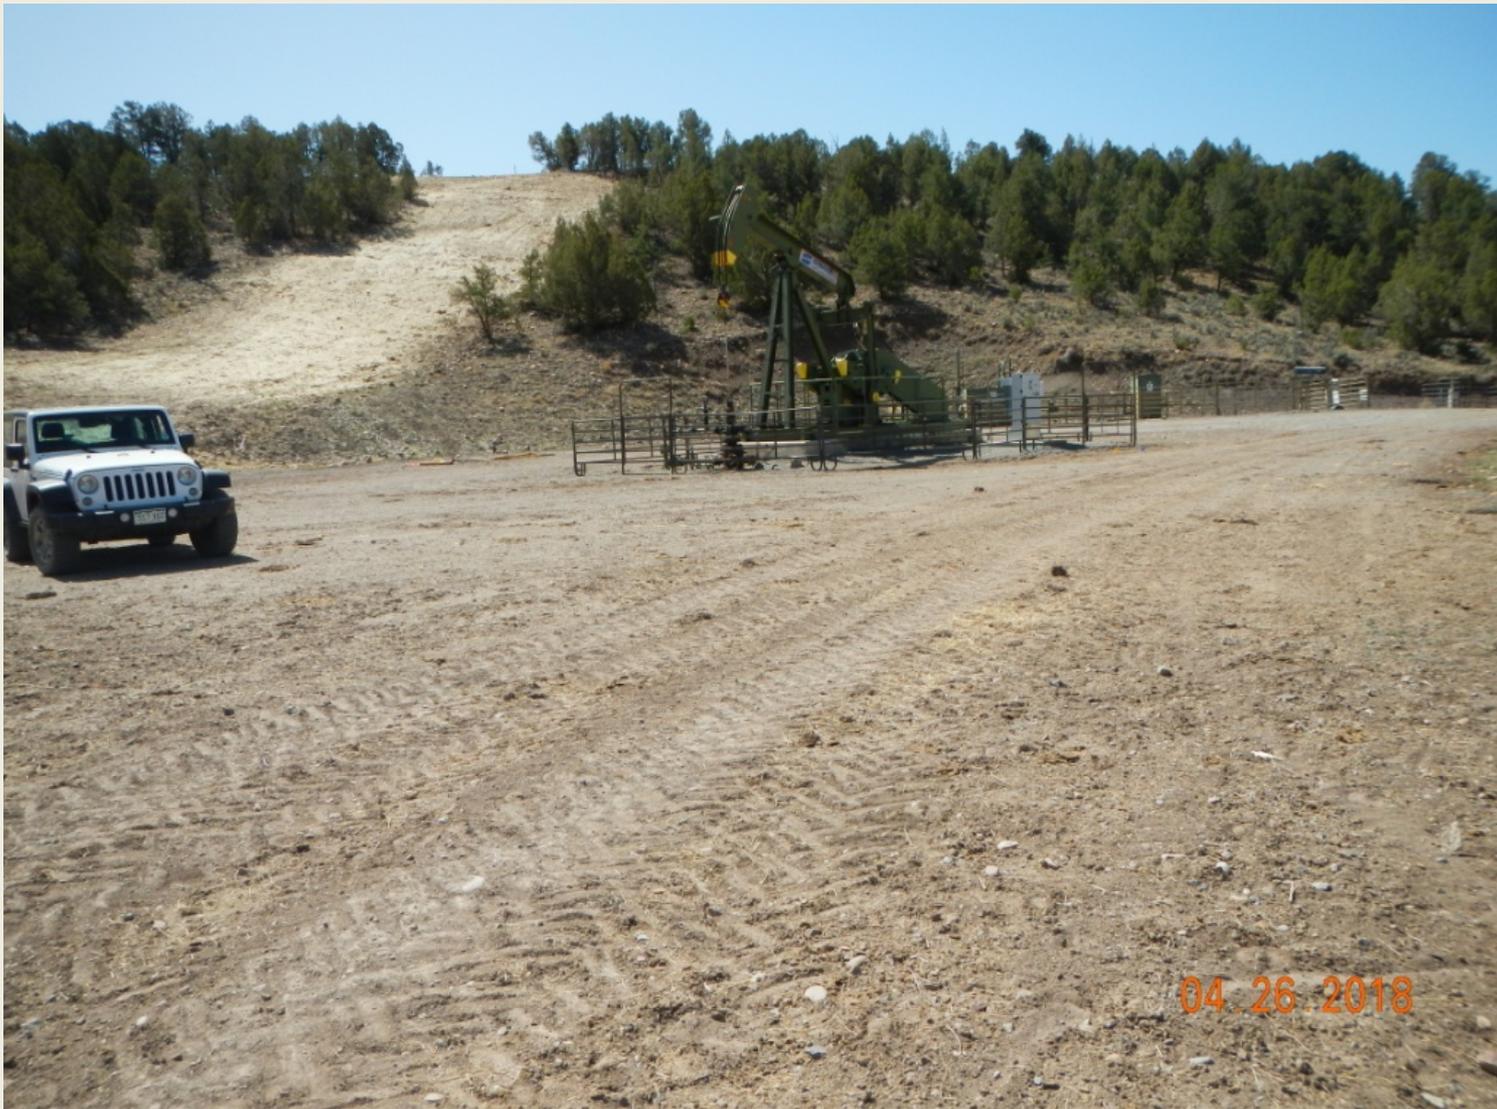
**Photo 1. View of the project area from the northeastern corner facing center.**

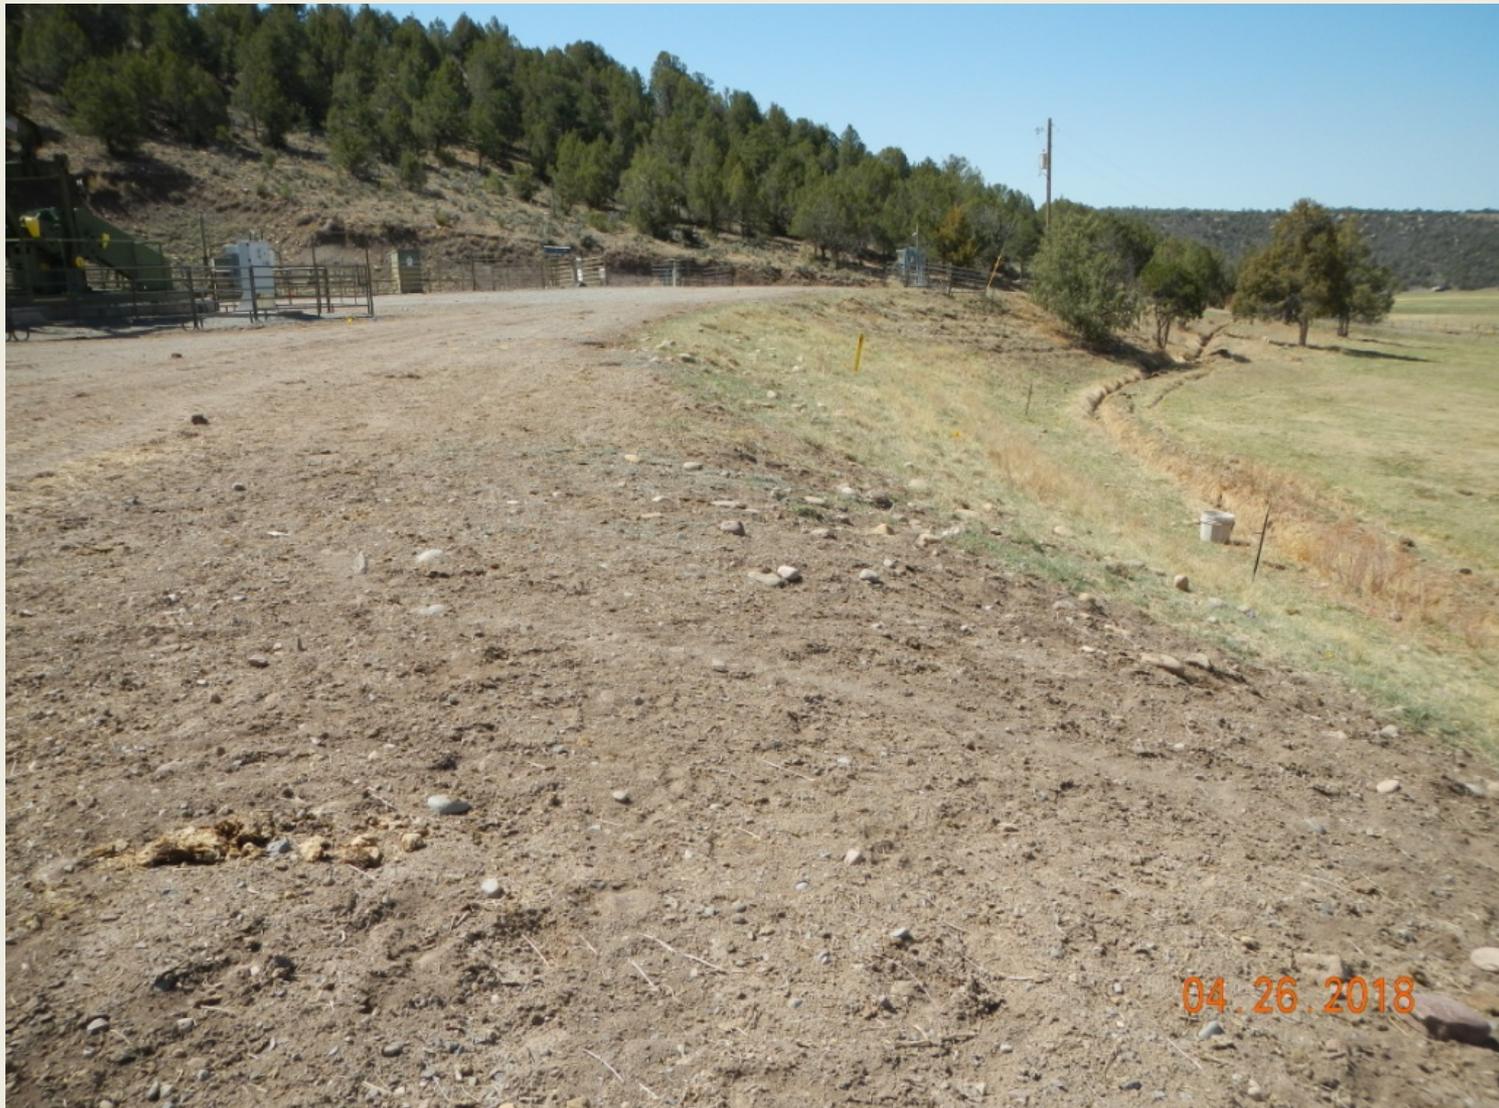
**Photo 2. View of the northern portion of the project area from the northeastern corner of the working area facing westward. Revegetation is progressing on fill slope.**

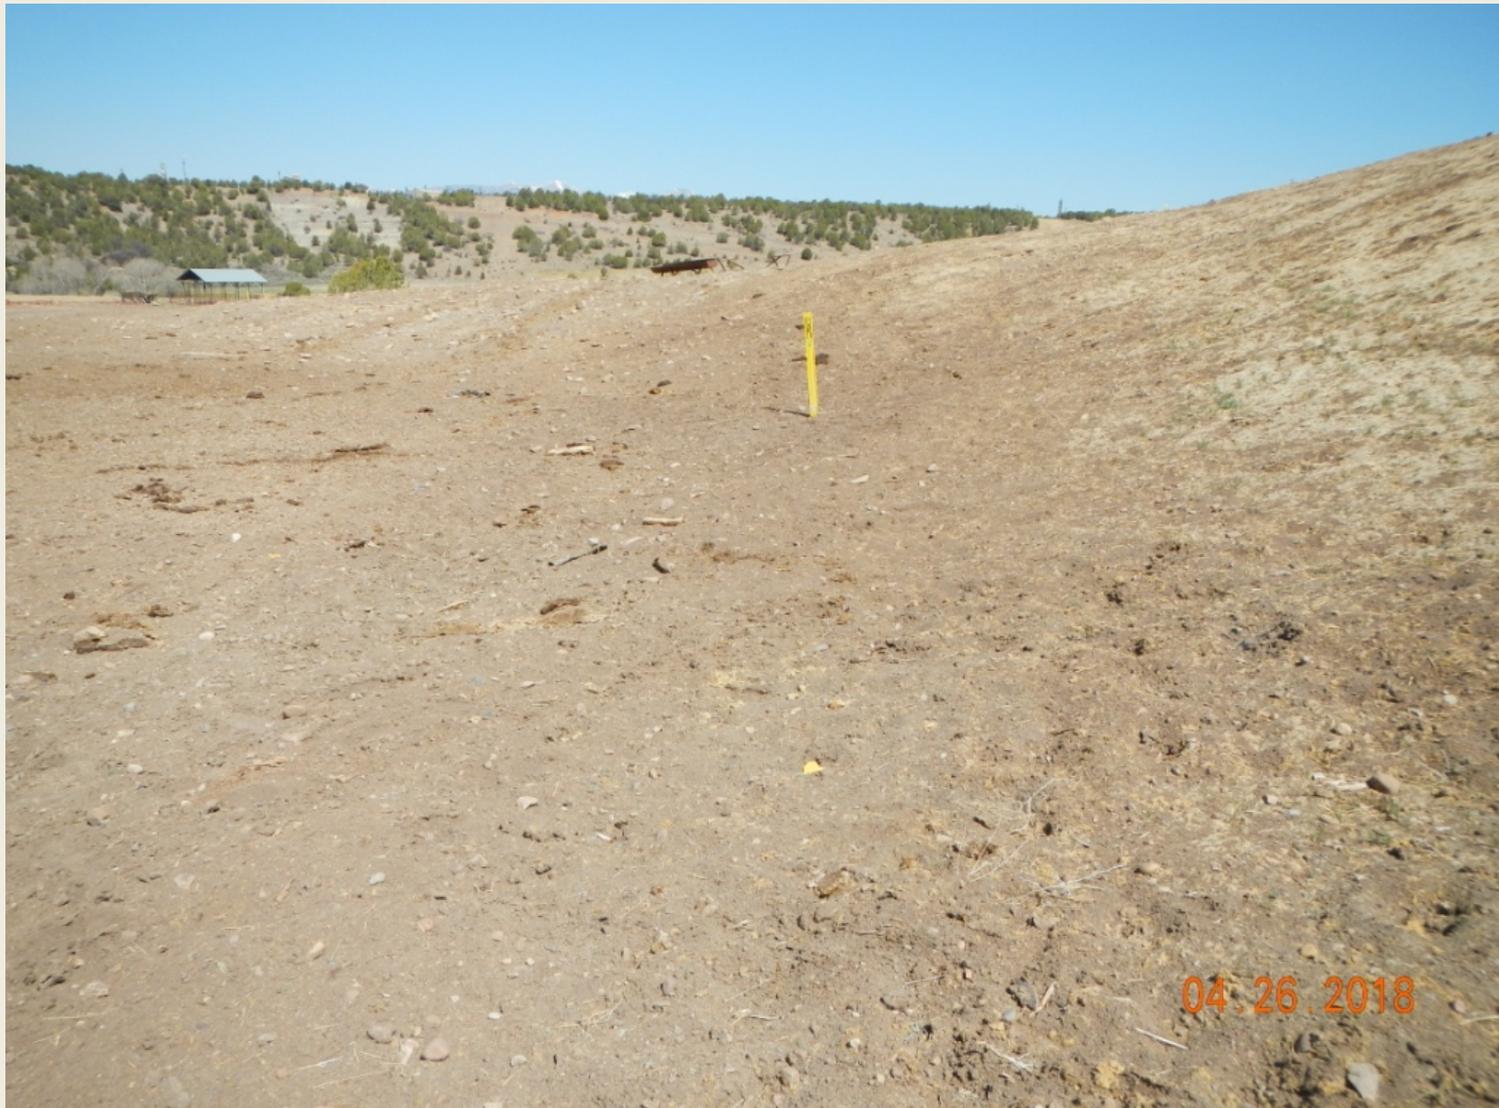
**Photo 3. View of the eastern portion of the project area from the southeastern corner of the working area facing northward. Slope is recently disturbed and seeded.**

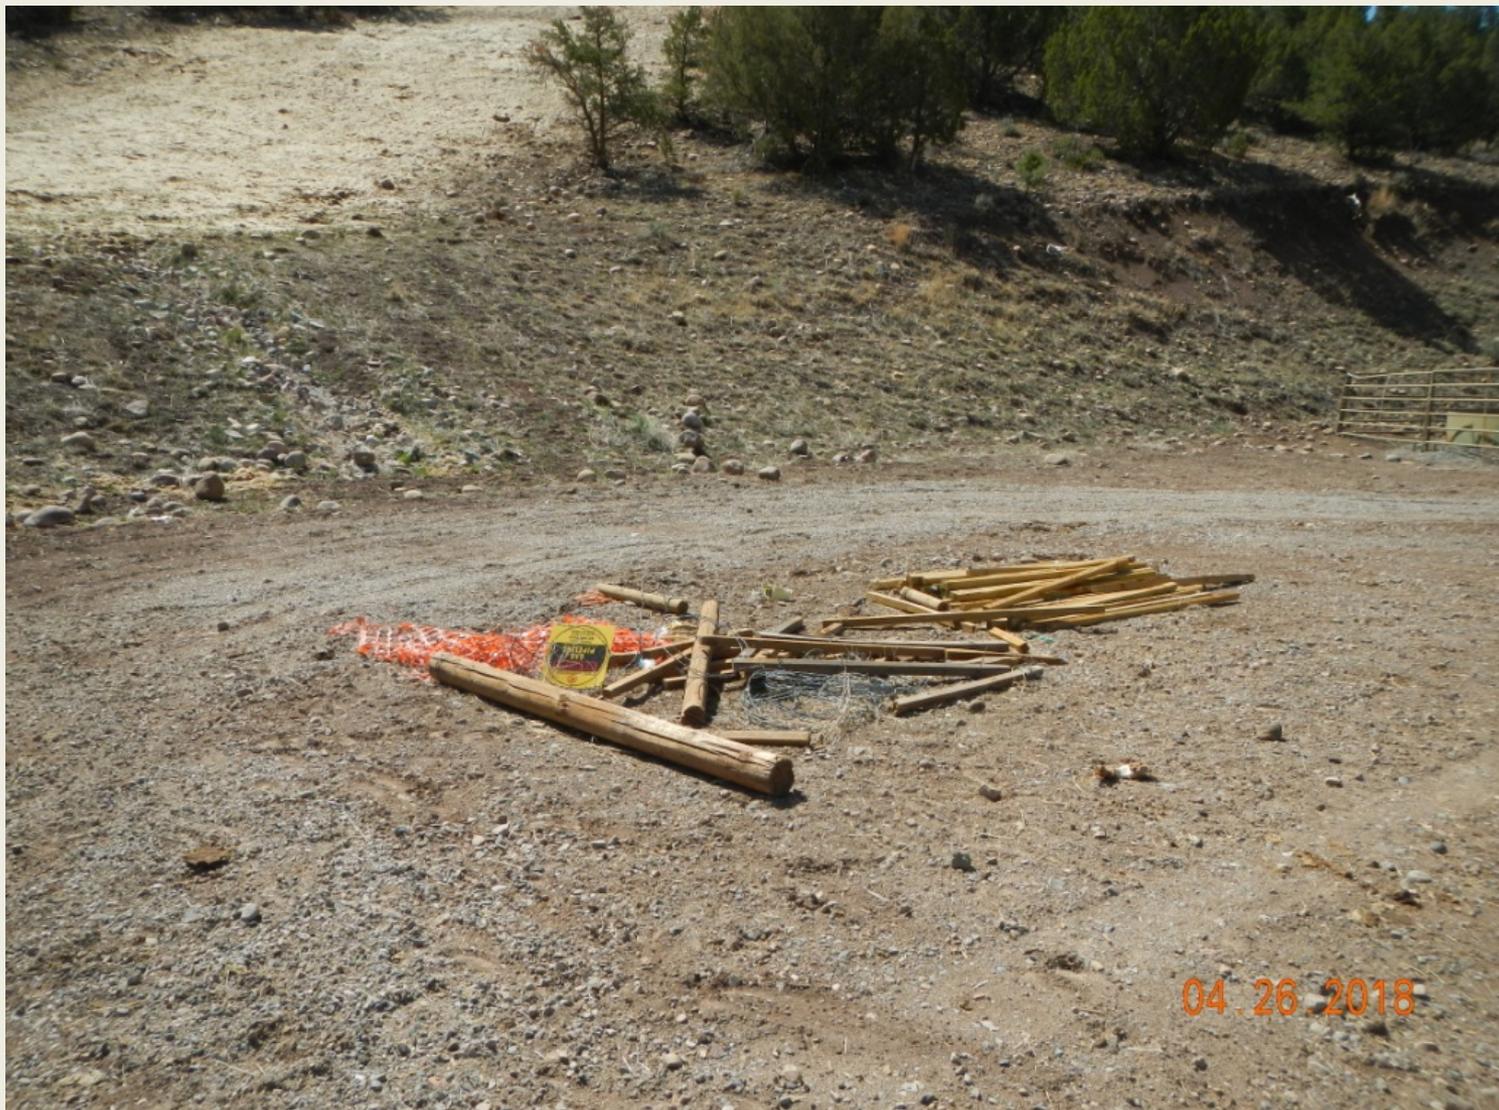
**Photo 4. View of debris in the southern portion of the working area, needs to be removed.**

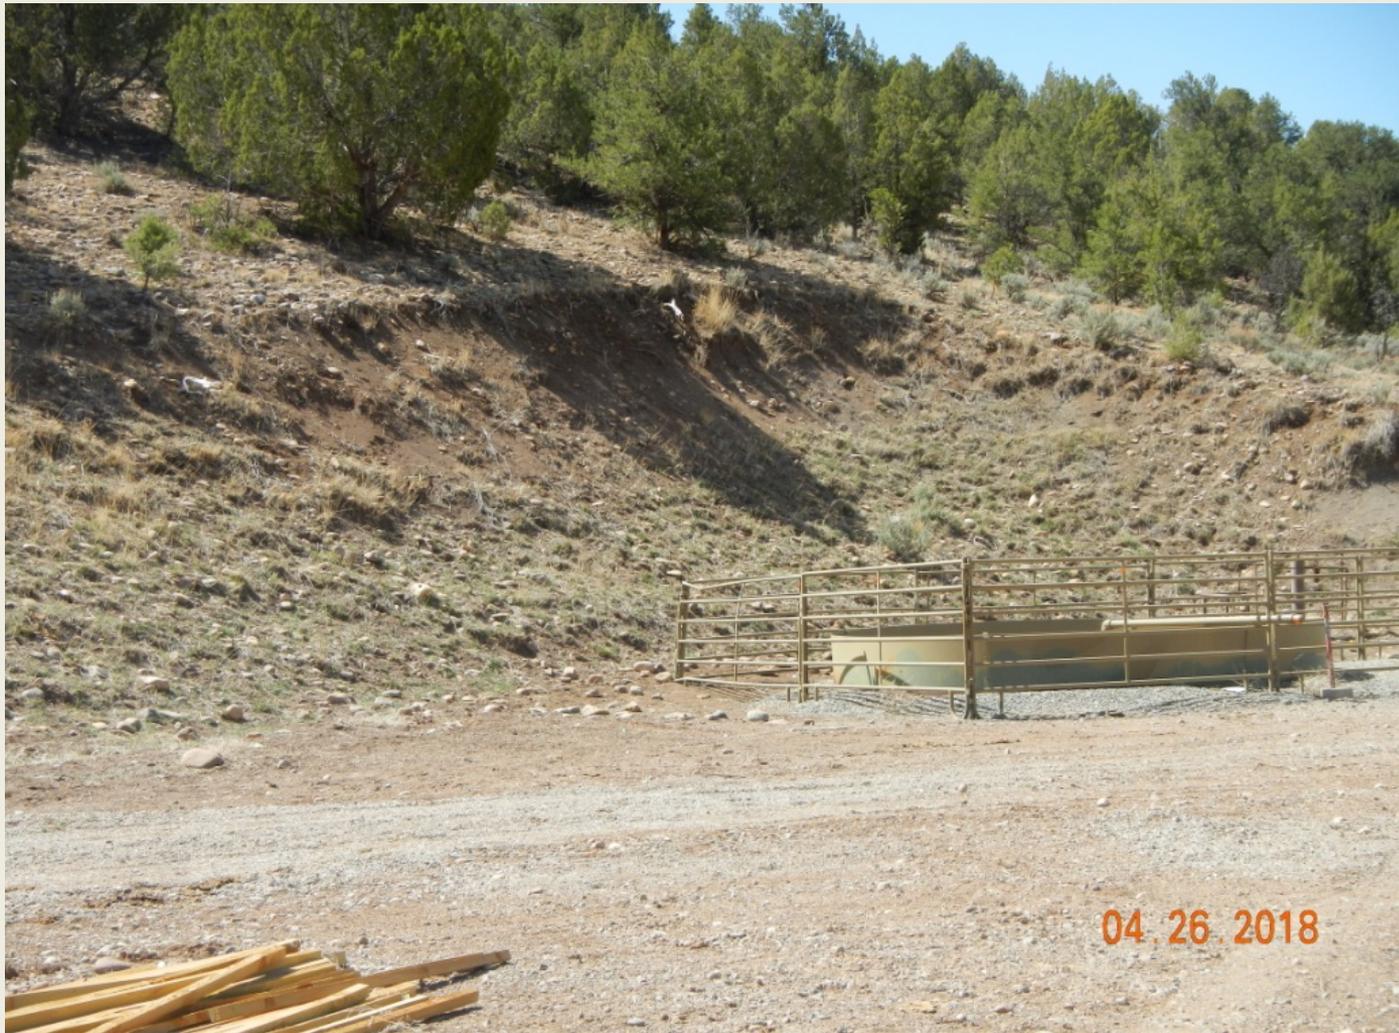
**Photo 5. View of the southwestern portion of the project area.**

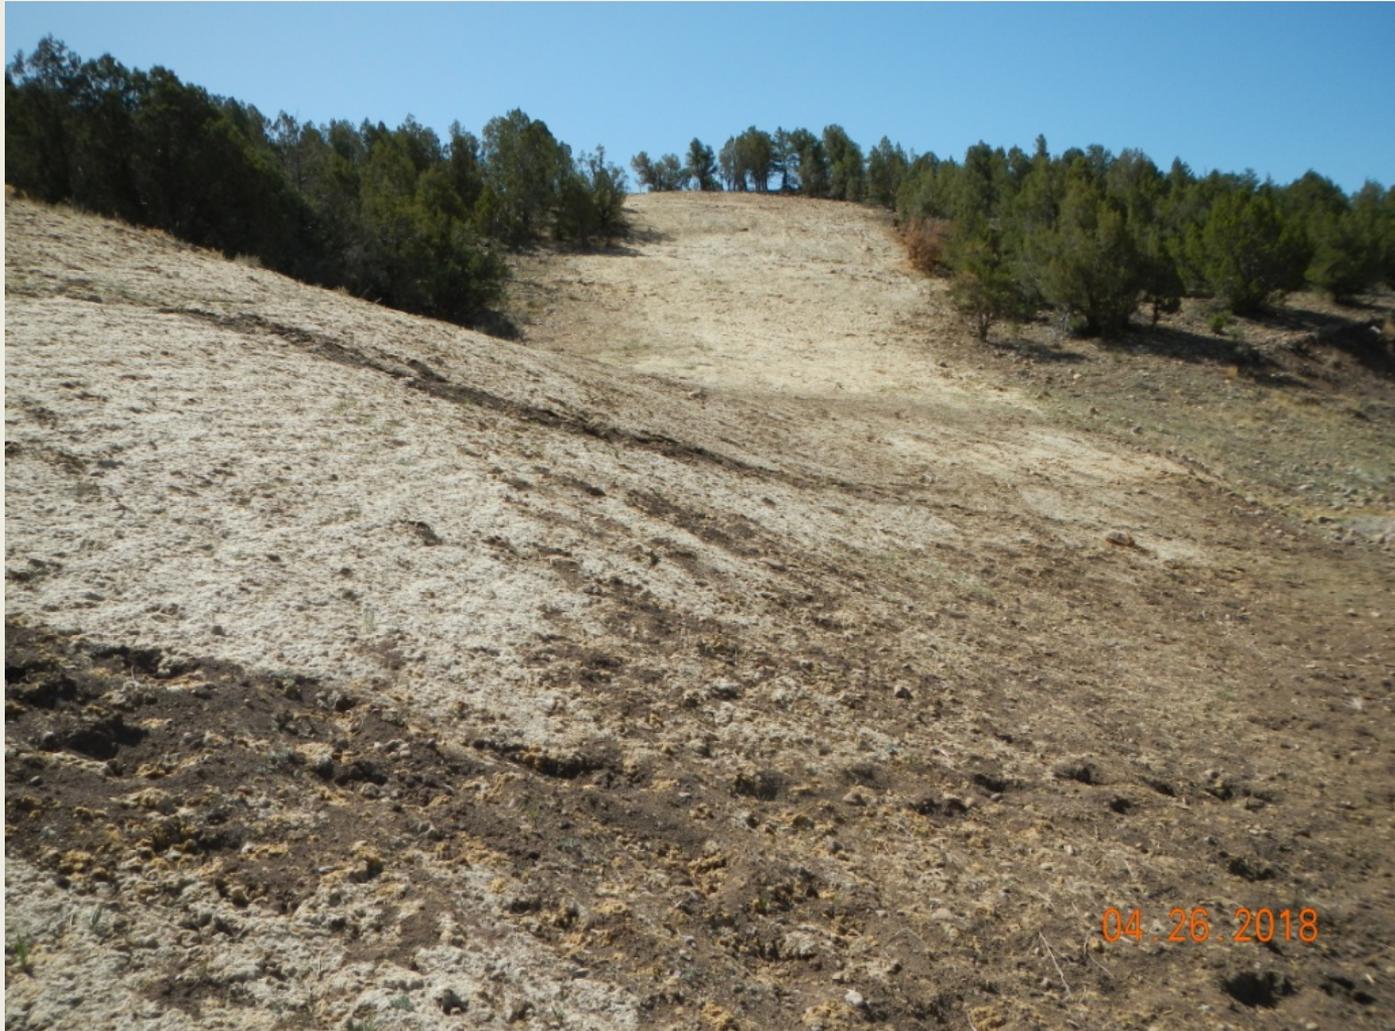
**Photo 6. View of recently disturbed right of way. Area is seeded, but needs careful monitoring due to the aerial extent of disturbance and dry growing conditions.**

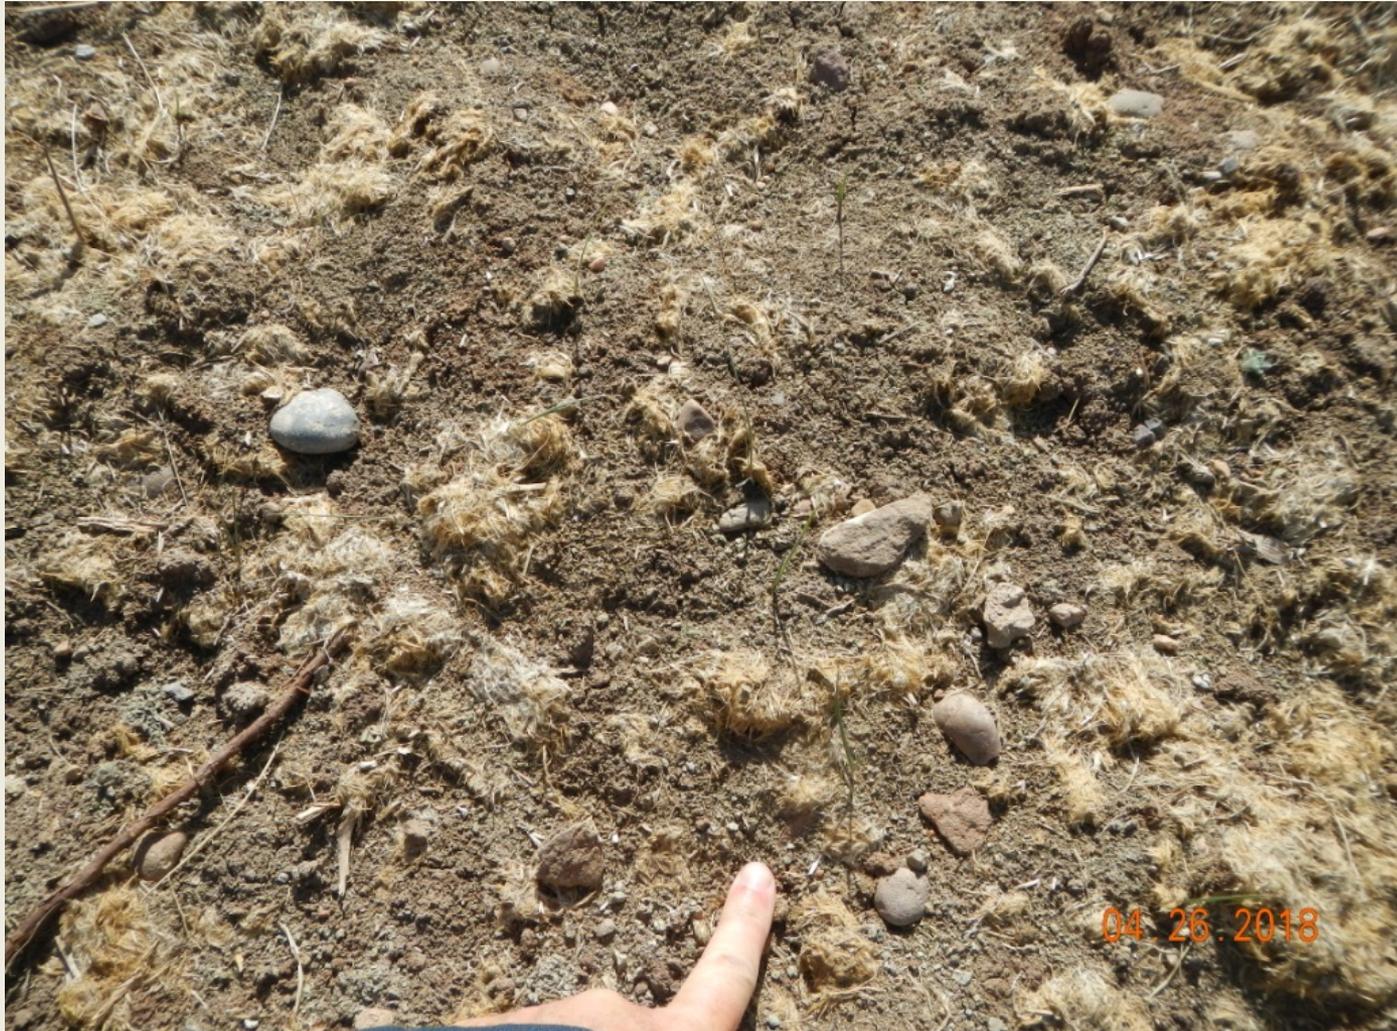
**Photo 7. Closeup view of seedlings in area recently seeded.**
