Interim Reclamation Inspection

Operator: KERR MCGEE OIL & GAS ONSHORE LP- #47120

Location ID: 441199

Location Name: WILSON RANCH /5C-27HZ

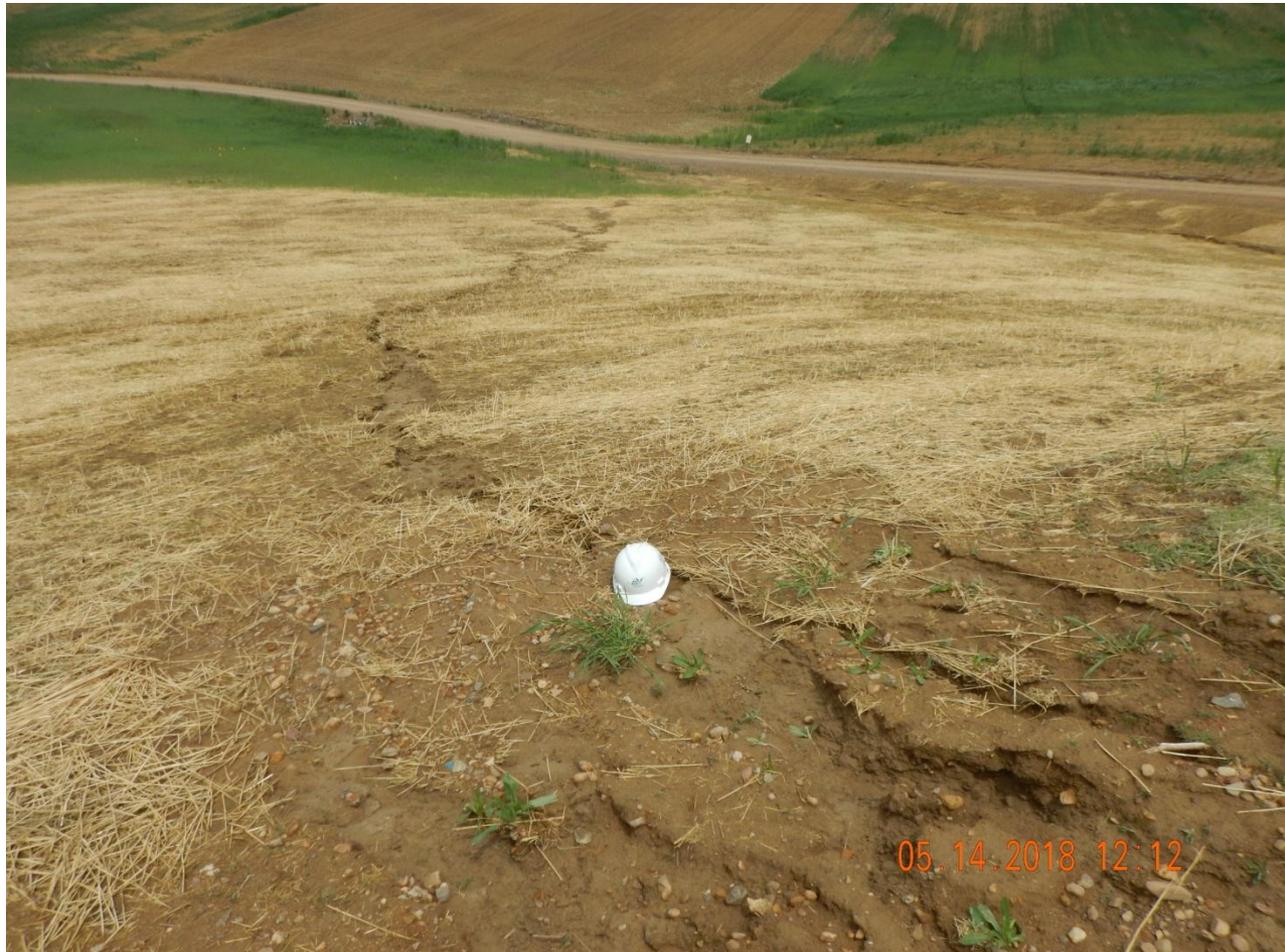
Photo 1. Photo taken of the northeast battery location, facing North. Appears stormwater runoff from the battery location is causing rill erosion off location and impacting interim areas.

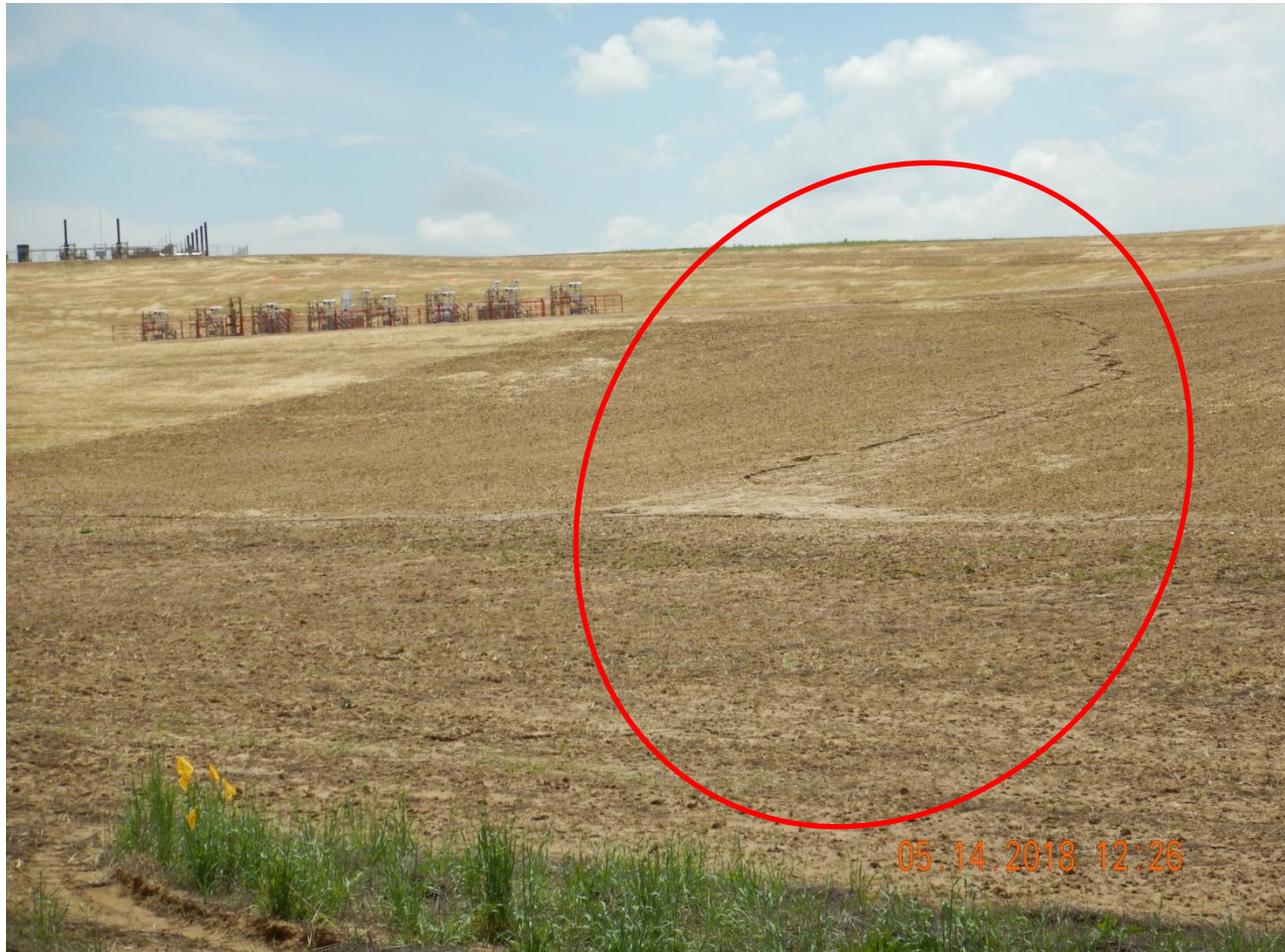
Photo 2. Photo taken north of the well location, facing South. Appears stormwater runoff from the well location is causing rill erosion off location.

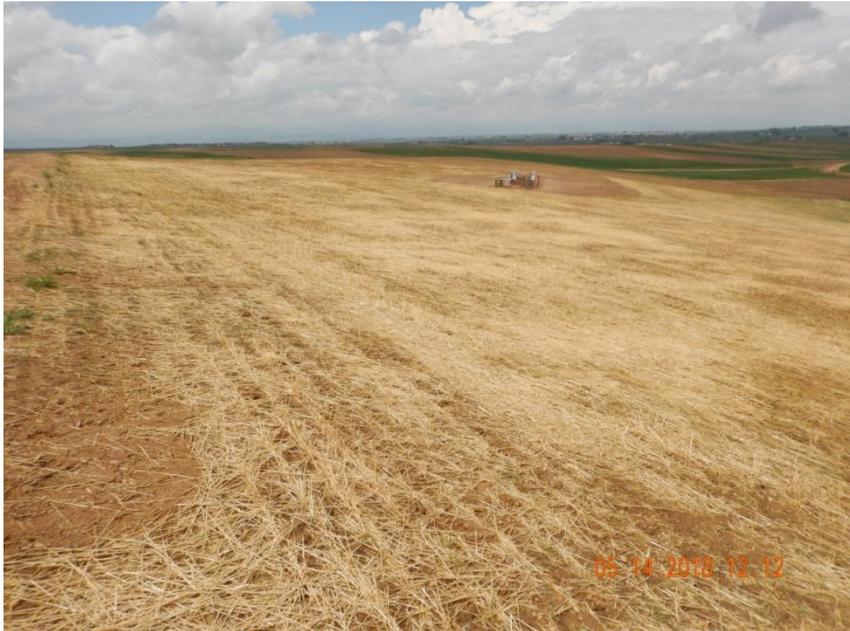
Photo 3. Photo taken of the northeast battery location, facing West. Appears the Operator has performed interim reclamation activities to reduce disturbance areas only needed for production operations, with the evidence of drilling rows and straw crimped mulch. Operator shall continue to monitor and manage this site until the location meets Rule 1003 standards.

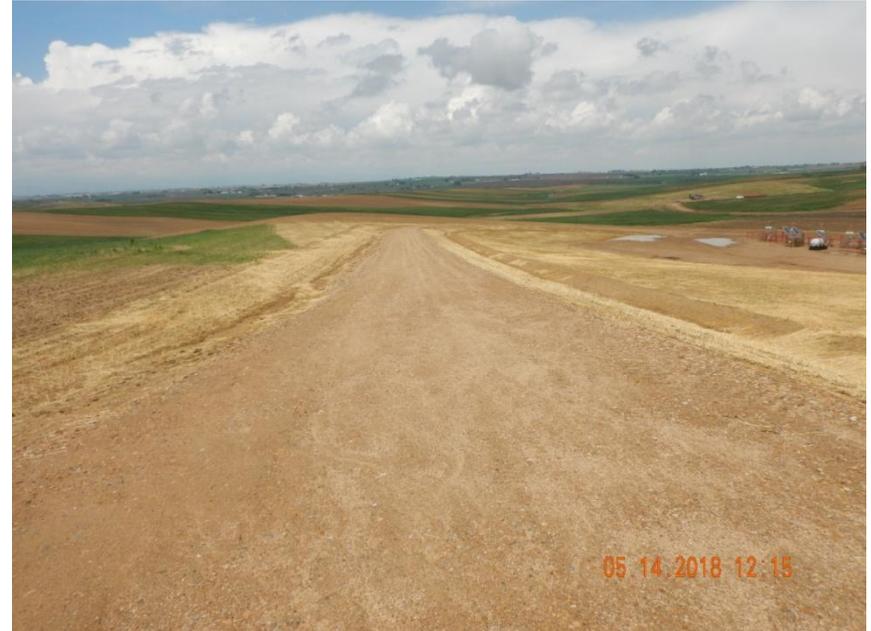
Photo 4. Photo taken of the northwest well location, facing North. See comments under Photo 3.

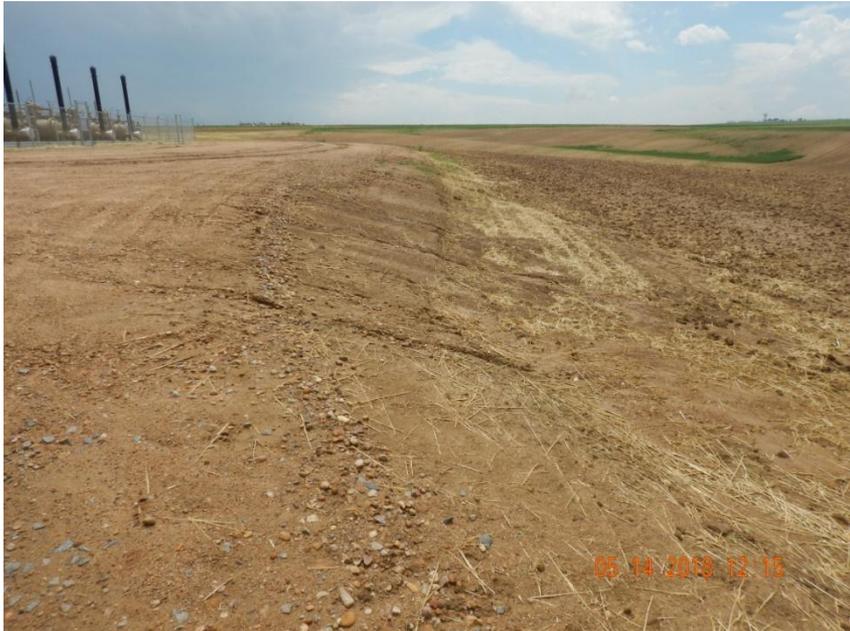
Photo 5. Photo taken of the northwest well location, facing South. Rill erosion evident along portions of the northeastern well location and along the access road.

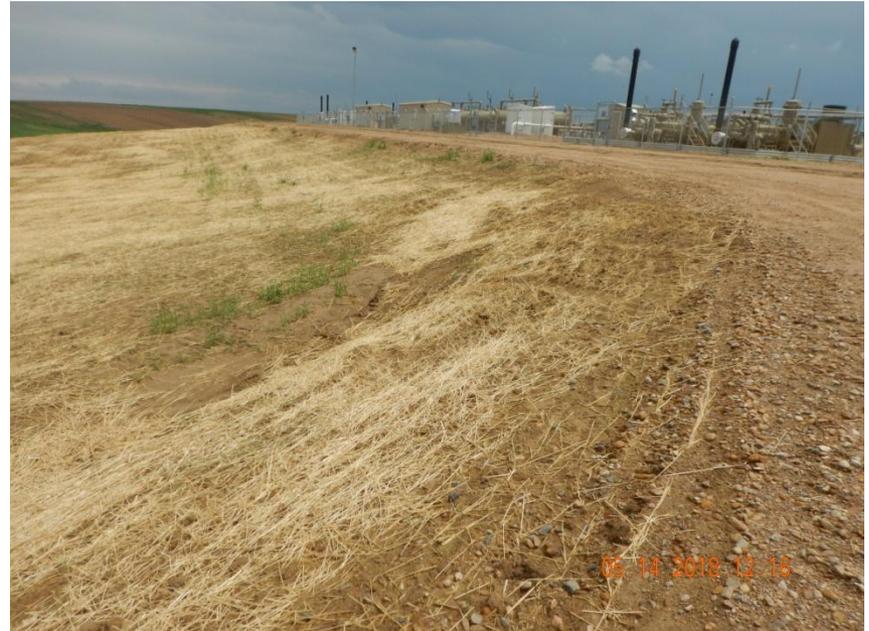
Photo 6. Photo taken of the northwest well location, facing East. See comments under Photo 3.

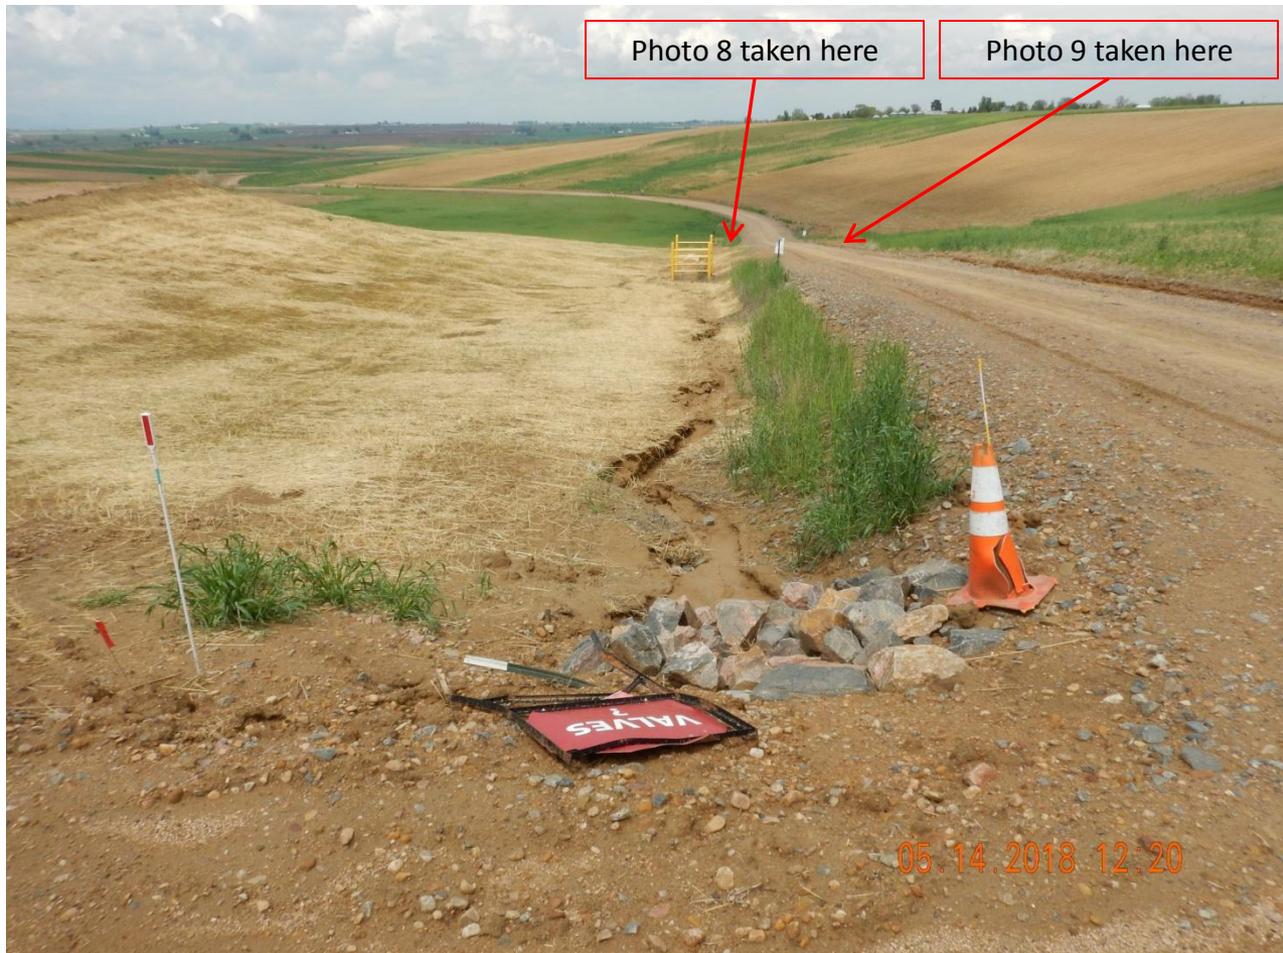
Photo 7. Photo taken from the entrance of the location, facing North. Appears the outlet protection BMP for the culvert is not properly functioning to minimize rill erosion along the eastern perimeter of the location.

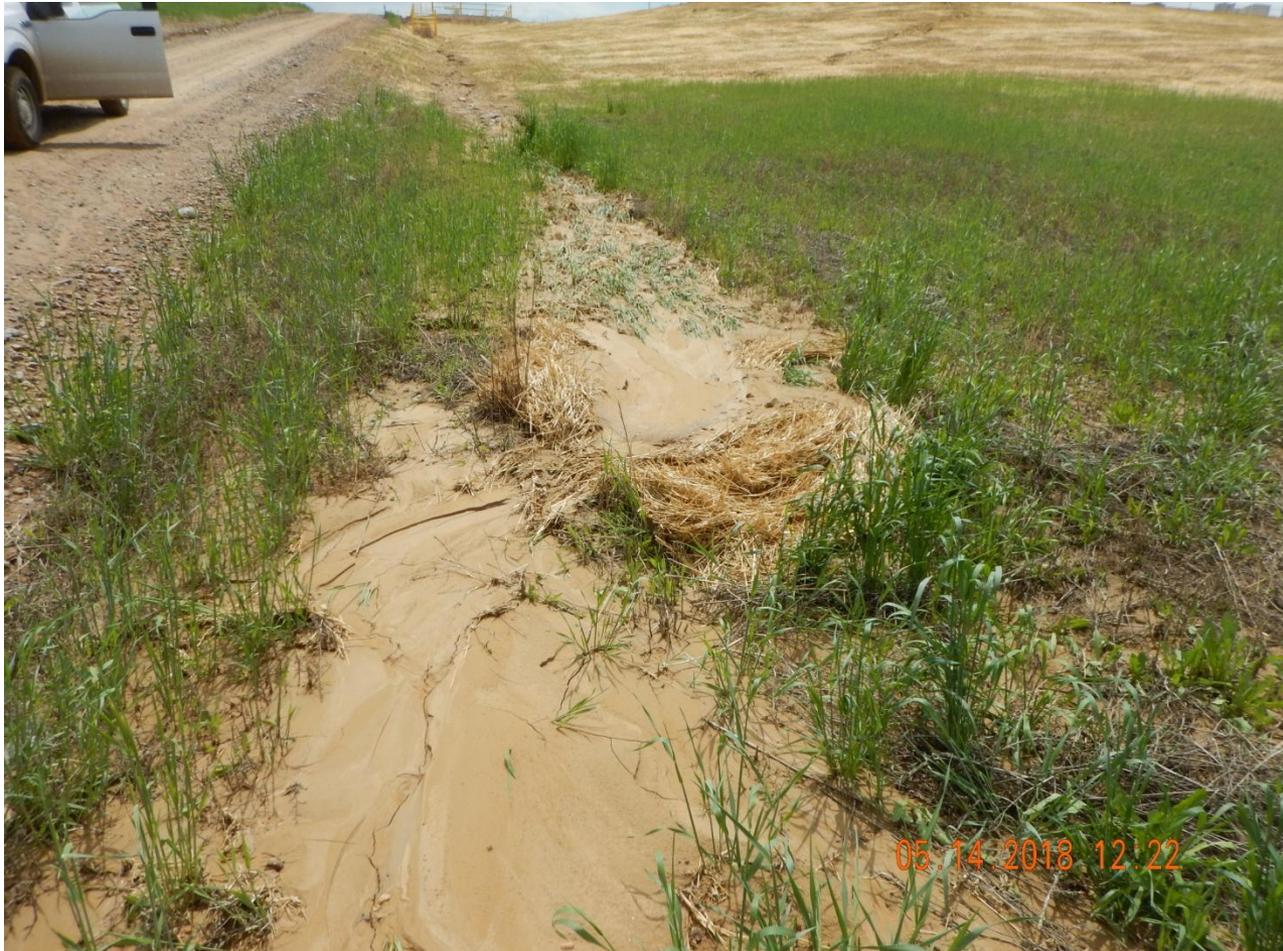
Photo 8. Photo taken from a portion of the sediment accumulation caused by rill erosion, facing South.

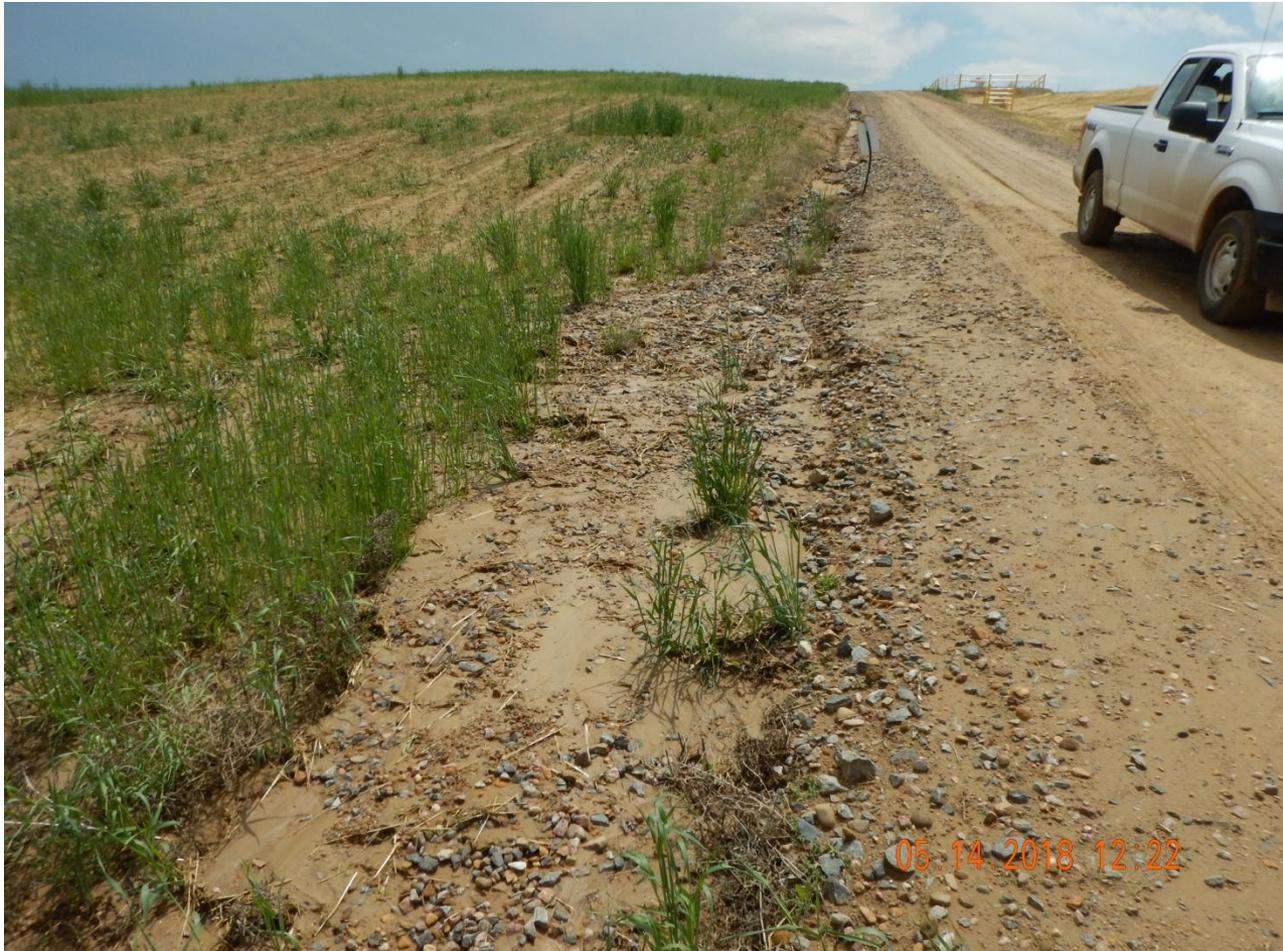
Photo 9. Photo taken from the east side of the access road, facing South. Photo illustrate sediment accumulation from rill erosion along the access road. There were no observed BMPs being implemented along the access road to minimize erosion.

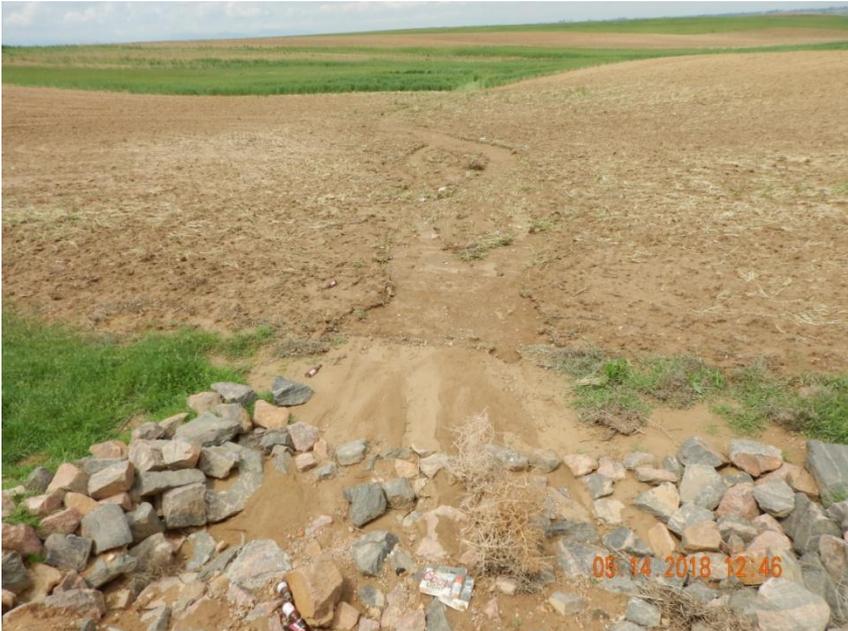
Photo 10. Photo taken from a portion of the access road, facing North. Approximate location in lat/long (40.277356, -104.973795). Rill erosion evident beyond the outlet protection of the culvert. Outlet protection in need of maintenance.

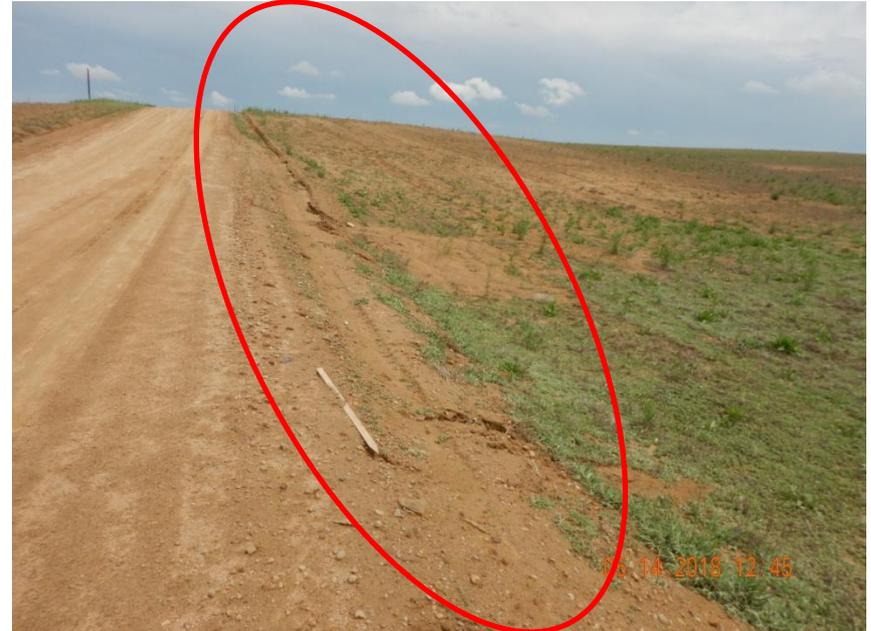
Photo 11. Photo taken from the opposite side of the access road, facing East. Rill erosion evident along portions of the access road. There were no observed BMPs being implemented along the access road to minimize erosion.

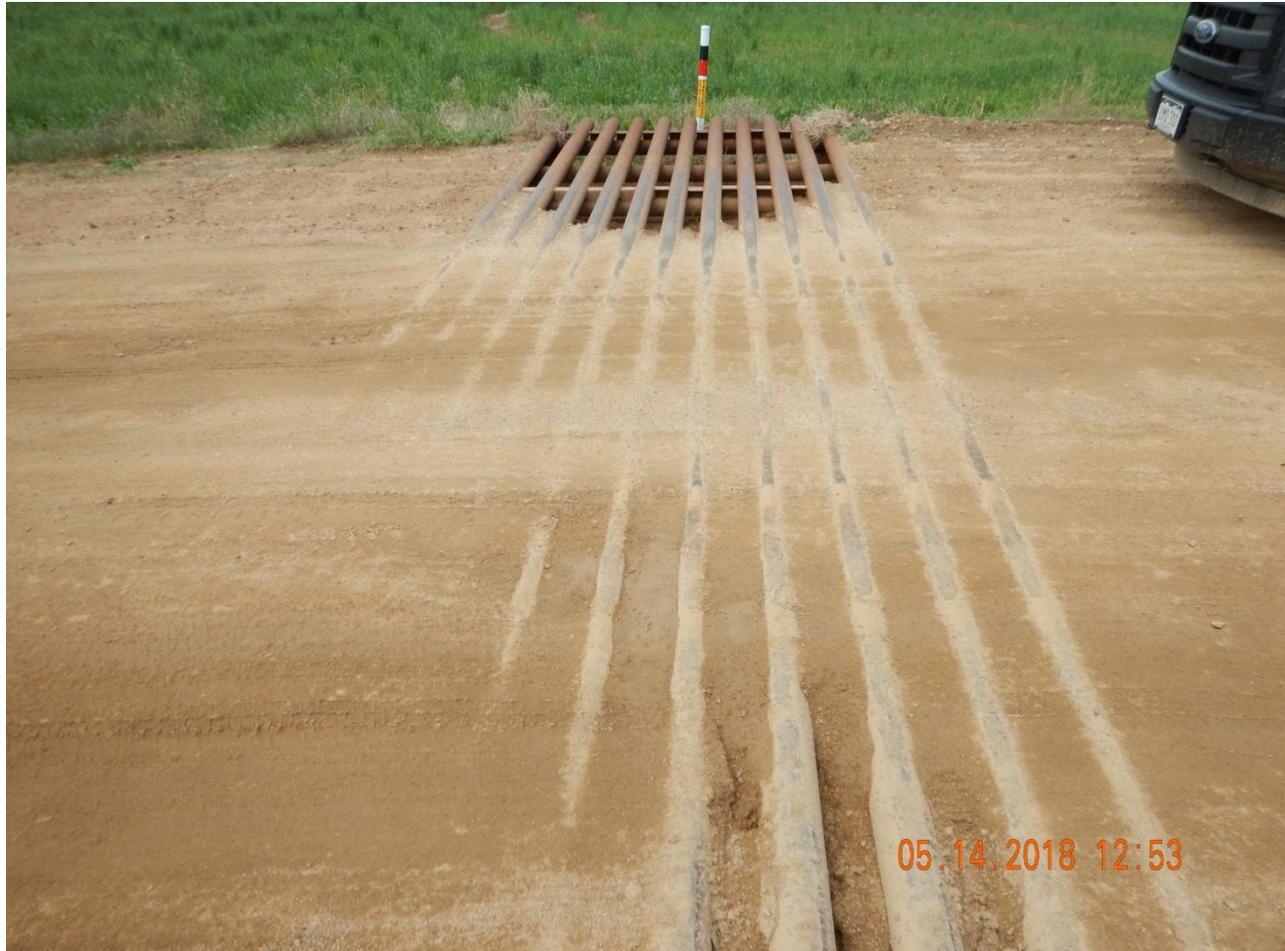
Photo 12. Photo taken from a portion of the access road. Cattle guard in need of maintenance. A similar inspection will be sent to the other Operator that also uses this BMP and access road. Both Operator's will need to coordinate to perform the required maintenance for this BMP.
