**Inspection Photo**  
**Clough 521-16**  
**API# 045-13505**  
**Inspection # 689301117**

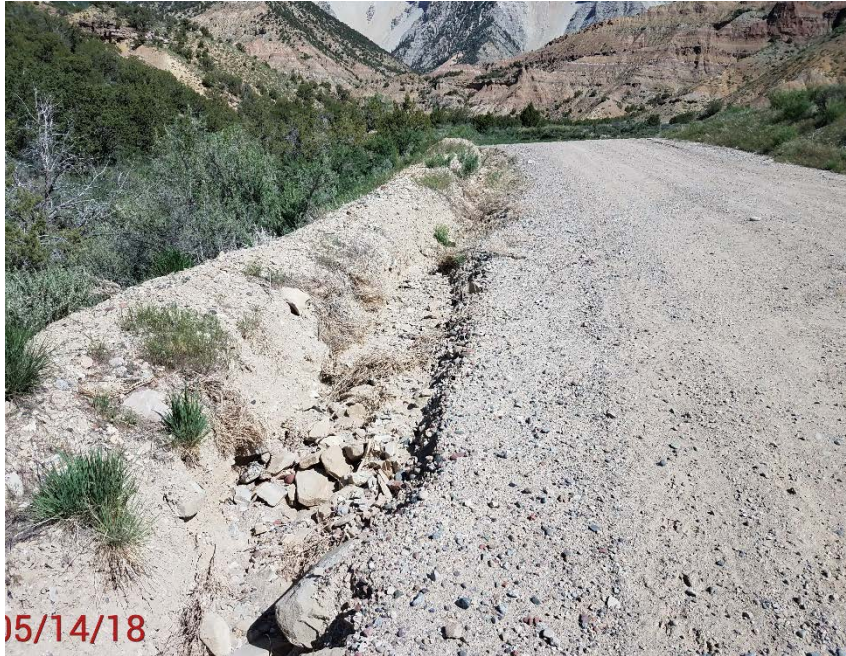
**Location Photo #3, Erosion on the west side of the access road, near location. Looking uphill**

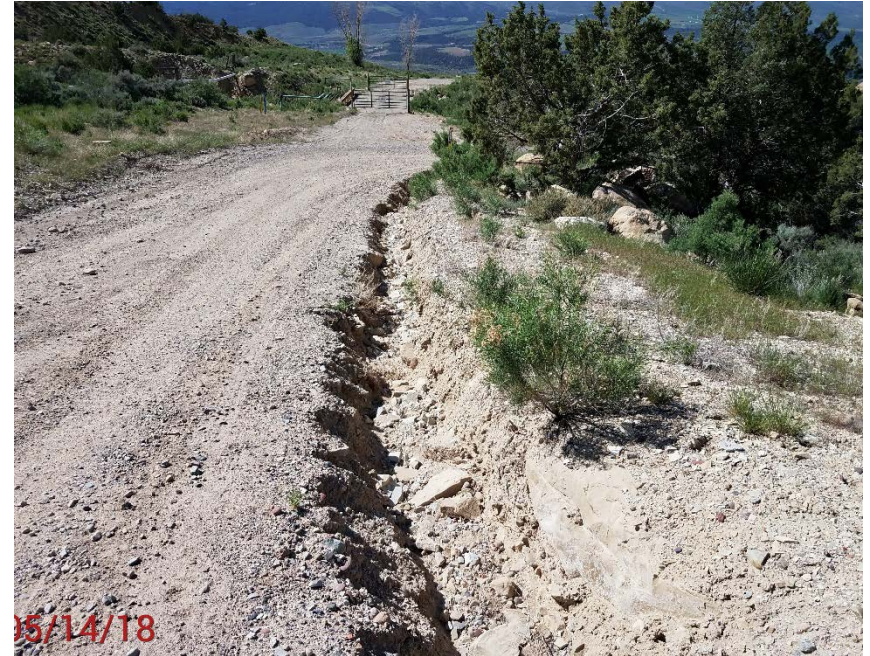
**Location Photo #4, Erosion on the side of the access road looking South downhill .**

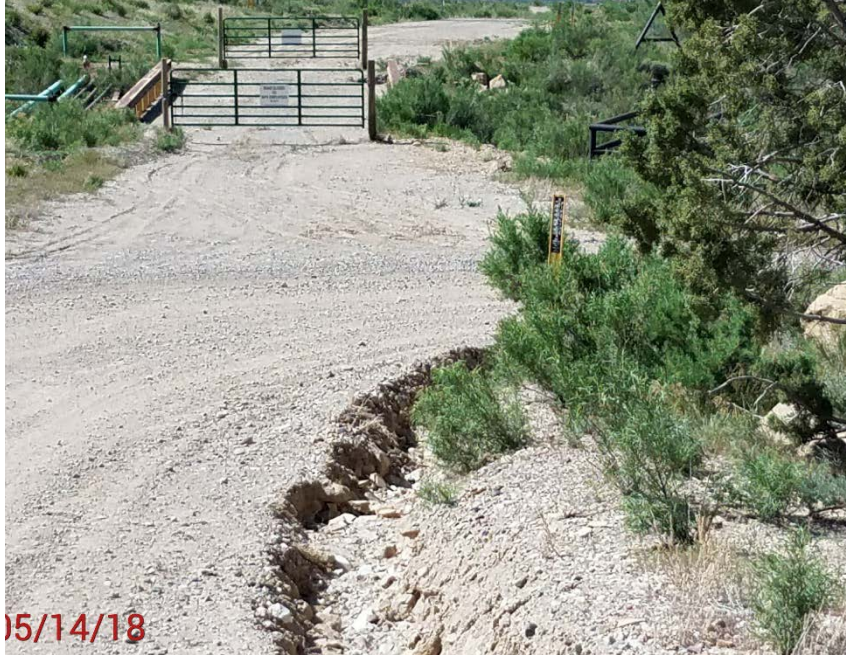
**Location Photo #5, Corner of access road  
near road closed gates**

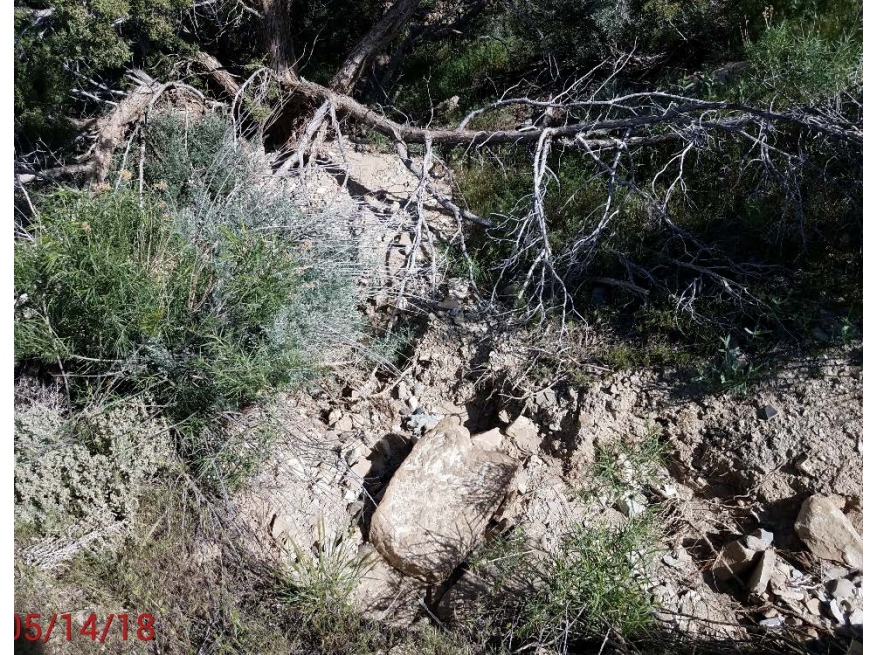
**Location Photo #6, Bottom of the curve near  
the culvert.**
