Inspection Photo
Federal RWF 312-16
API# 045-10028
Inspection # 689301119

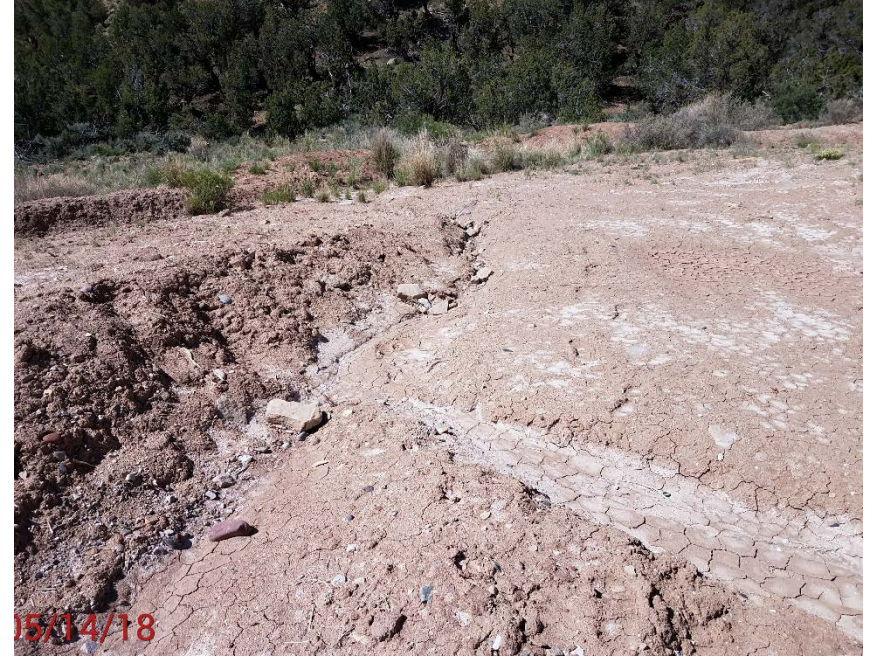
**Location Photo #2, Erosion on South west
end of location**

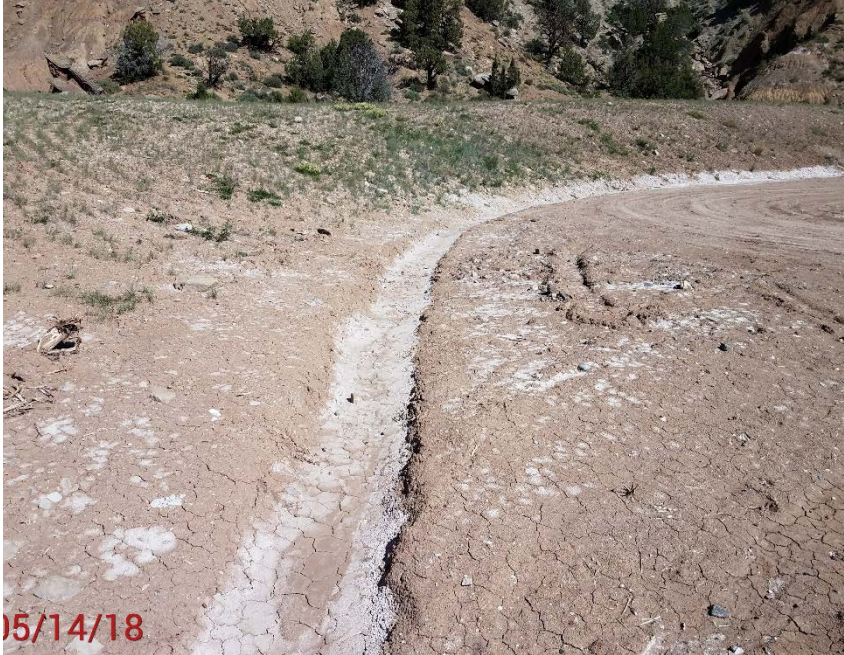
Location Photo #3, storm water issue

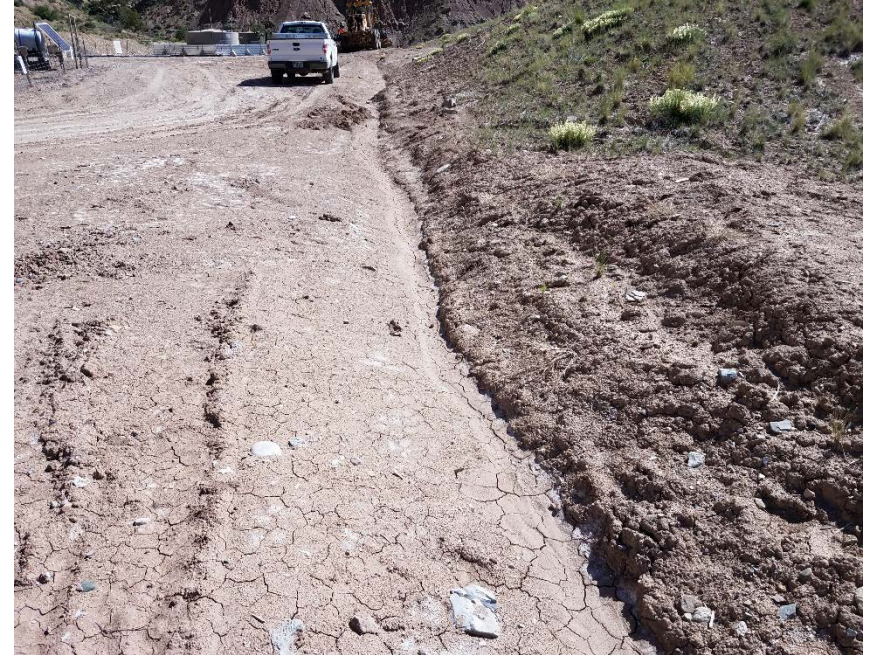
Location Photo #4, ditch along south side of location, storm water issue

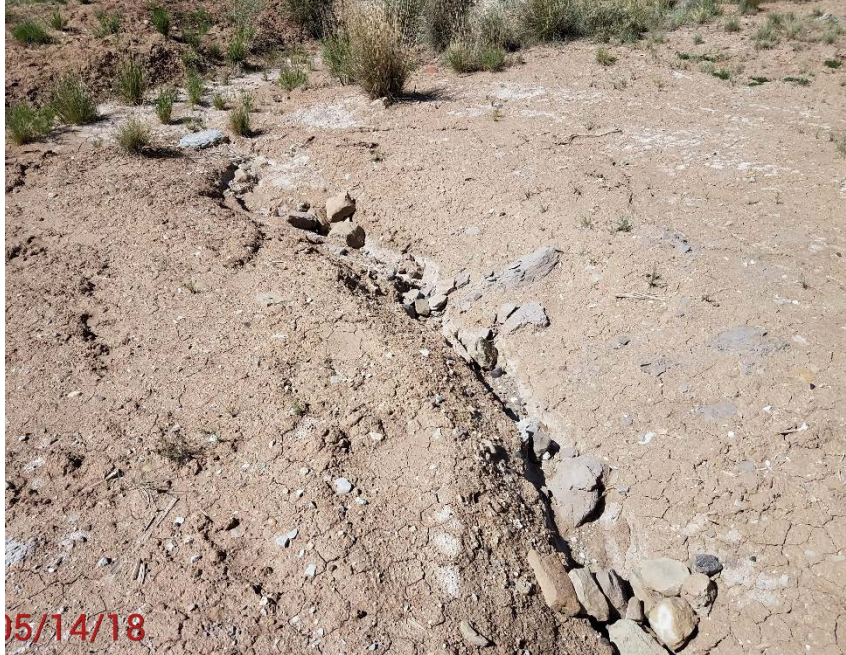
Location Photo #5, Storm Water issue on west end of location

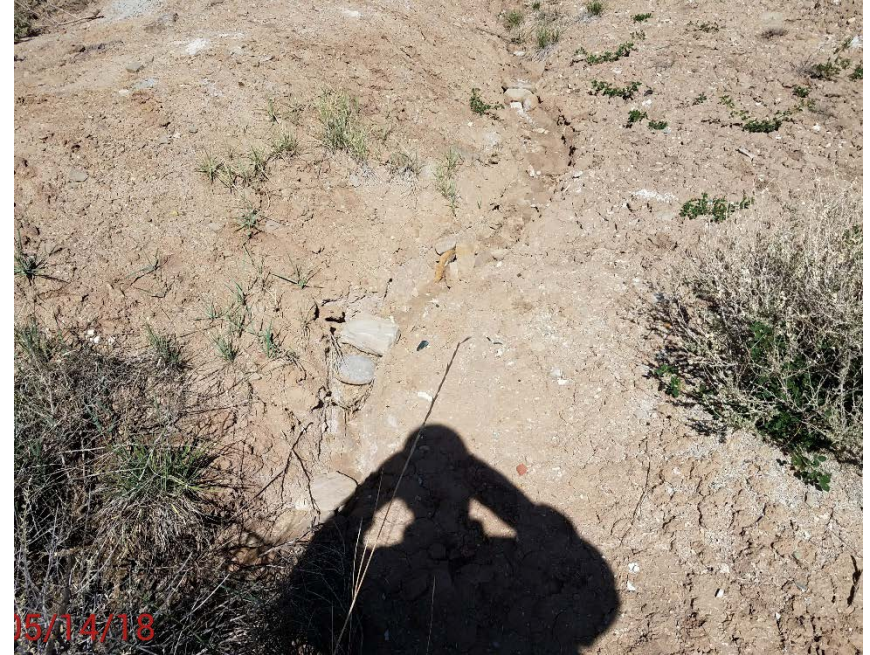
Location Photo #6, Storm Water issue on west end of location

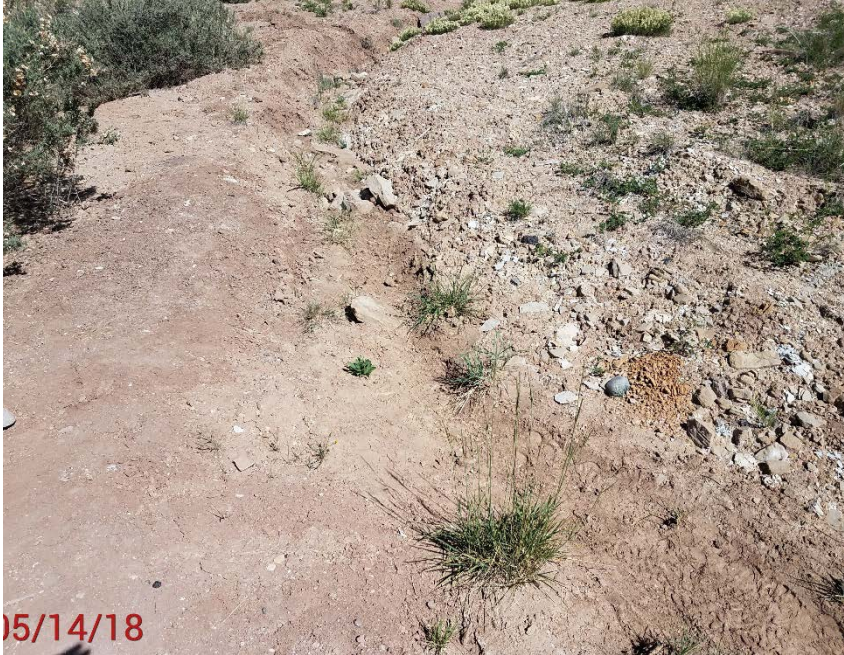
Location Photo #7, Storm water issue on north side of location

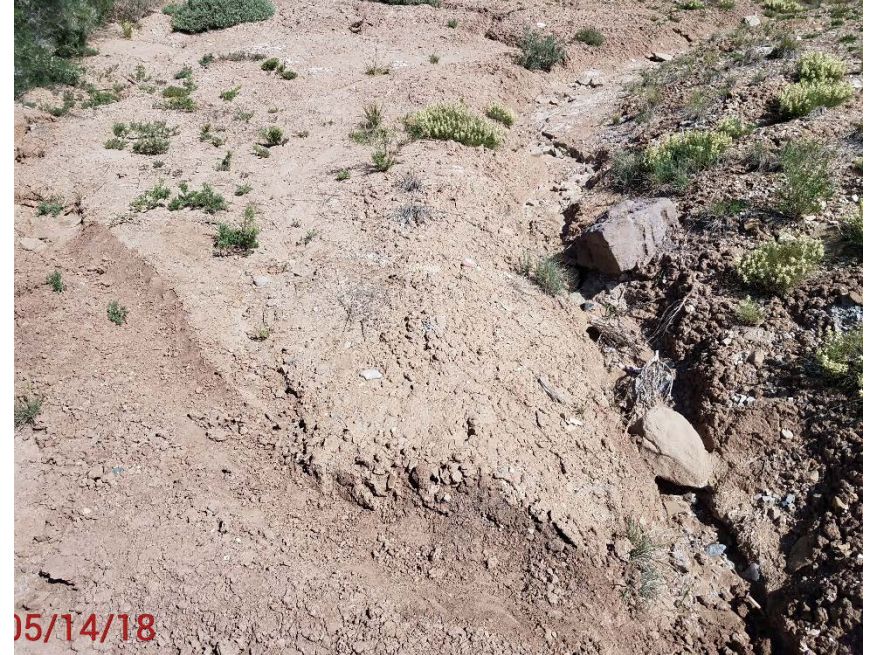
Location Photo #8, Storm water issue on north side of location

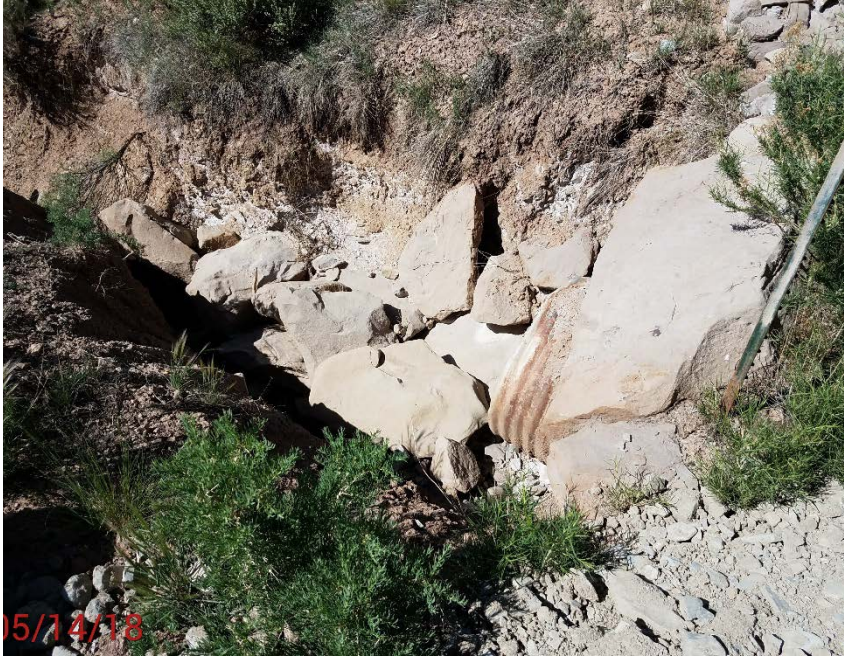
Location Photo #9, Culvert under access road downhill side.

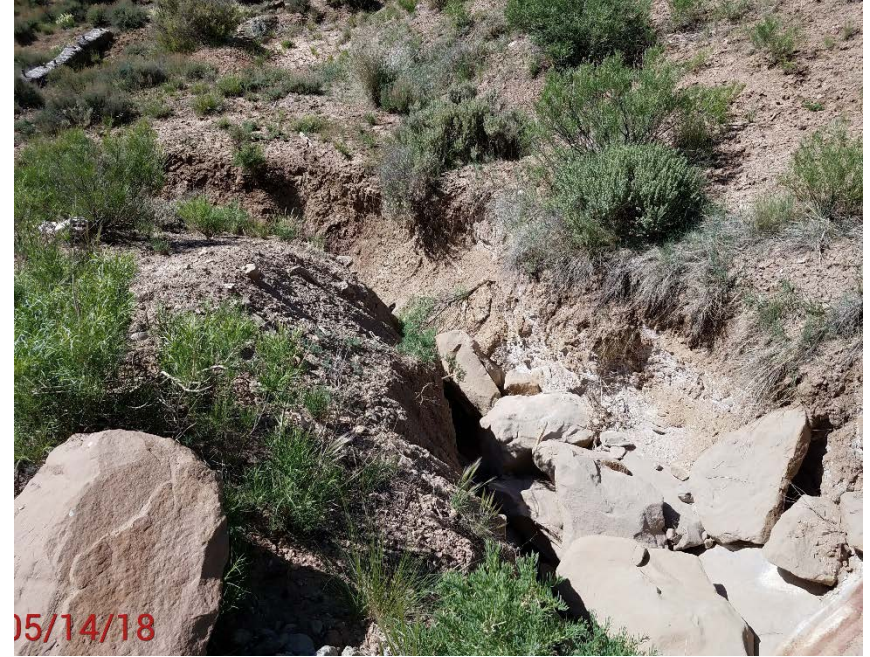
Location Photo #10, Culvert under access road downhill side.

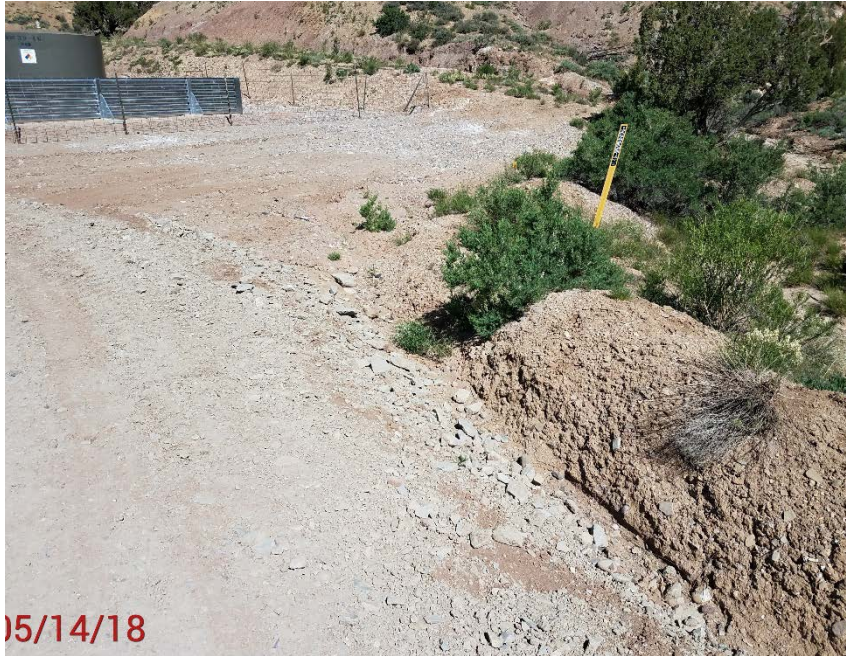
Location Photo #11, Erosion near end of location by access road

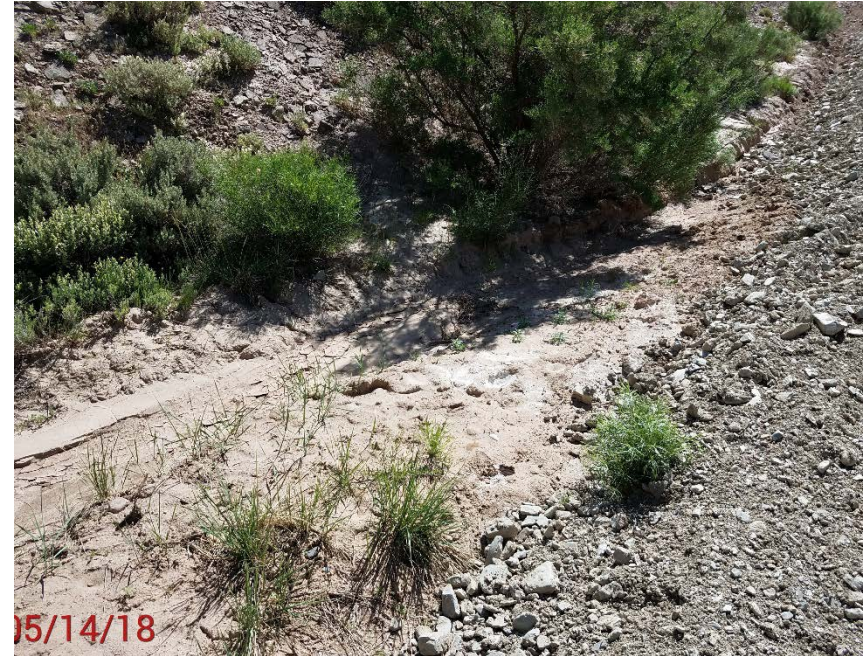
Location Photo #12, Erosion near end of location by access road

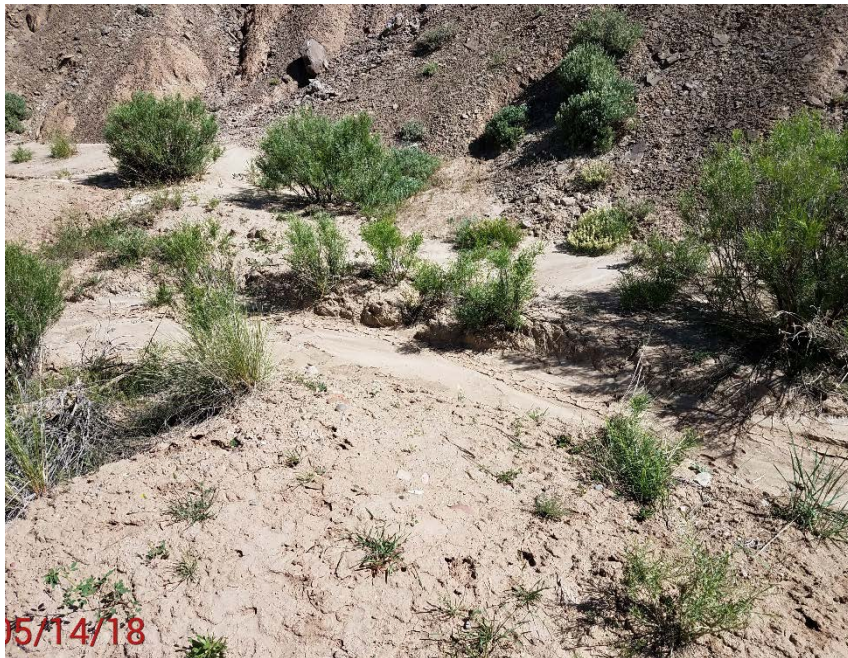
**Location Photo #13, Ditch Erosion along
access road near the Y**

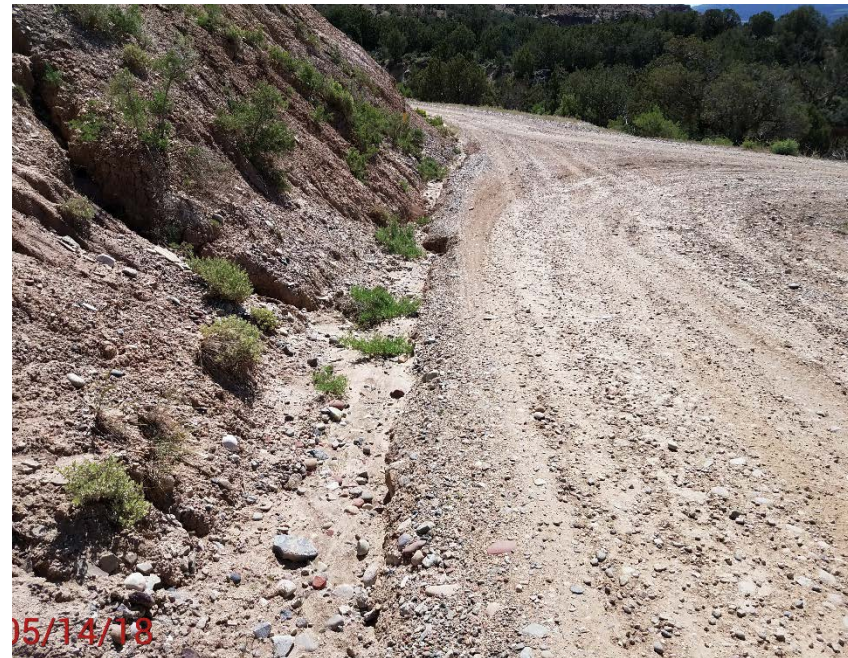
**Location Photo #14, Ditch Erosion along
access road near the Y**
