Well Name : Bullseye 22

API # : 067-09814

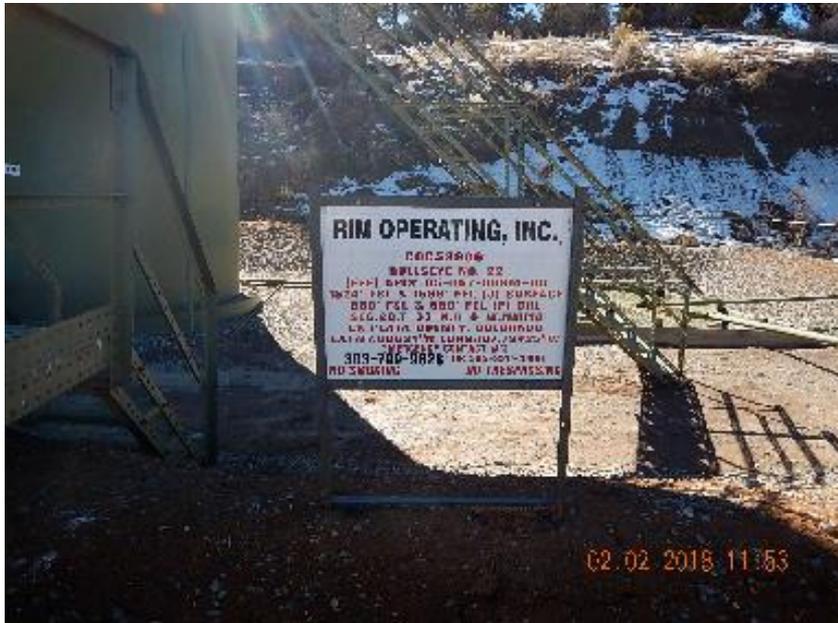
Photo 1: Wellhead sign previous inspection.

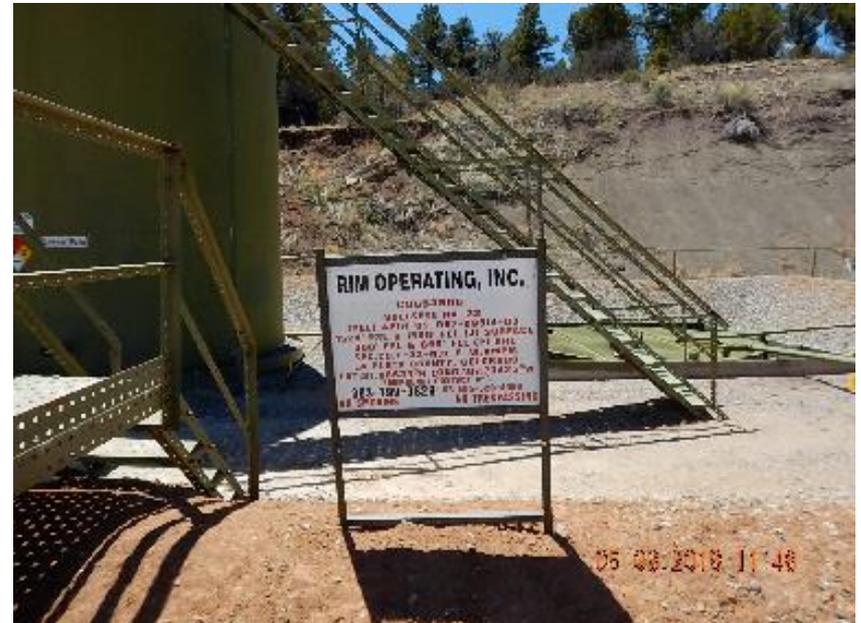
Photo 2: Wellhead sign.

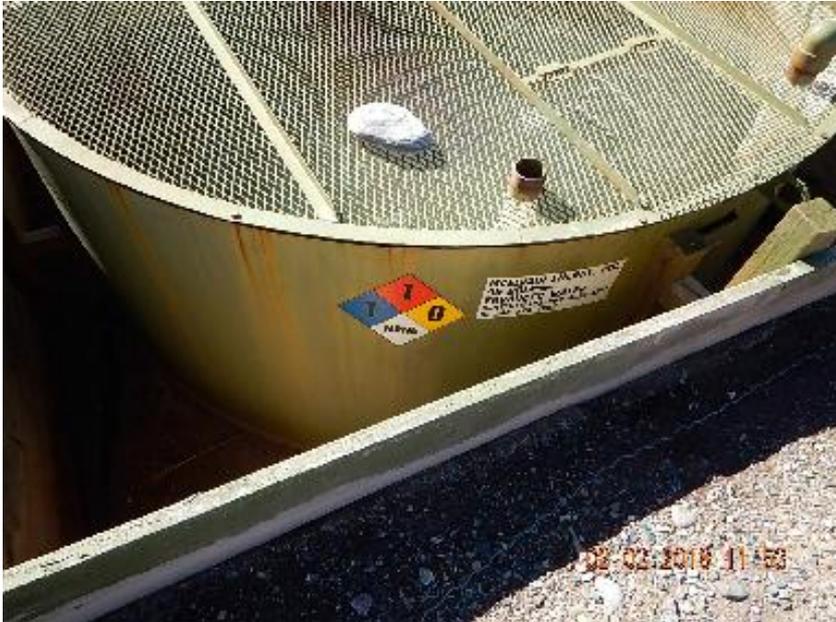
Photo 3: Below grade tank labels previous inspection.

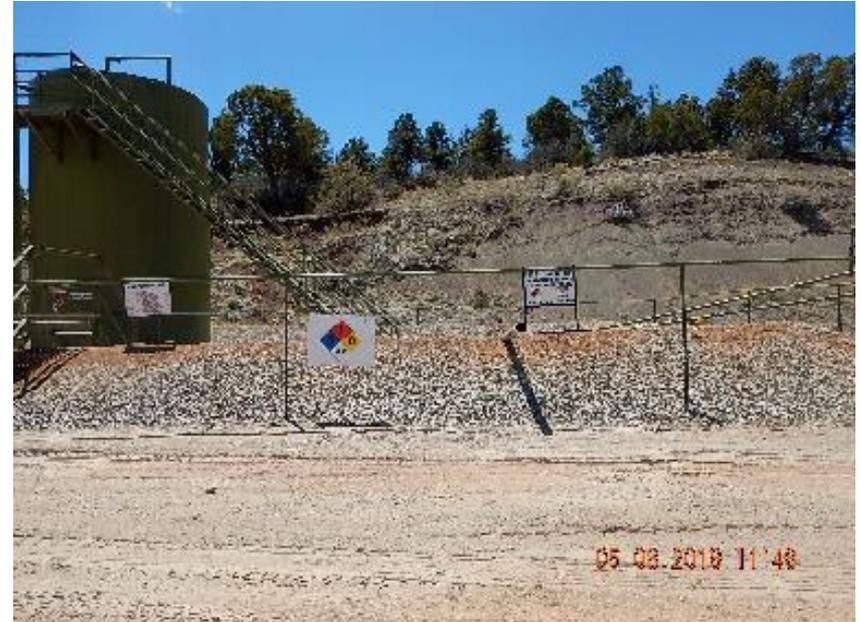
Photo 4: New tank signage.

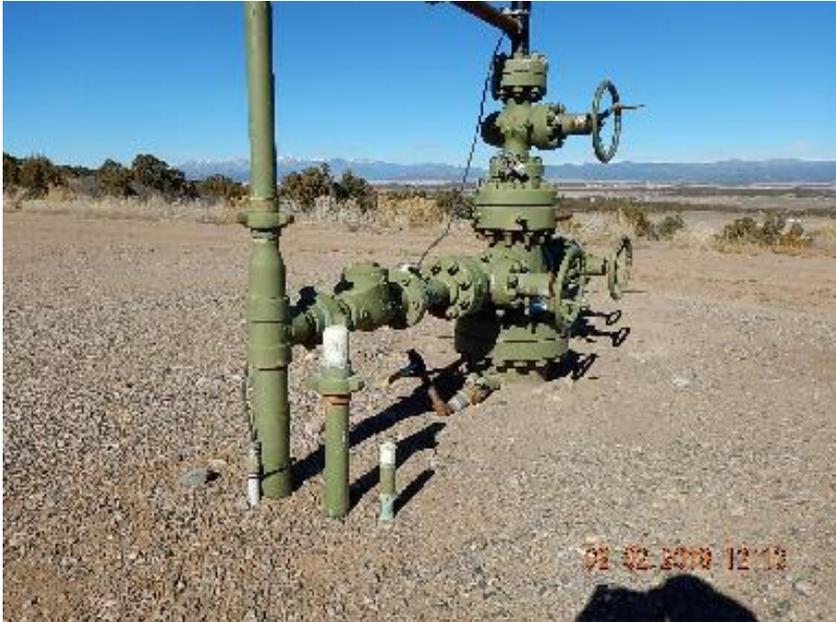
Photo 5: Risers at wellhead previous inspection.

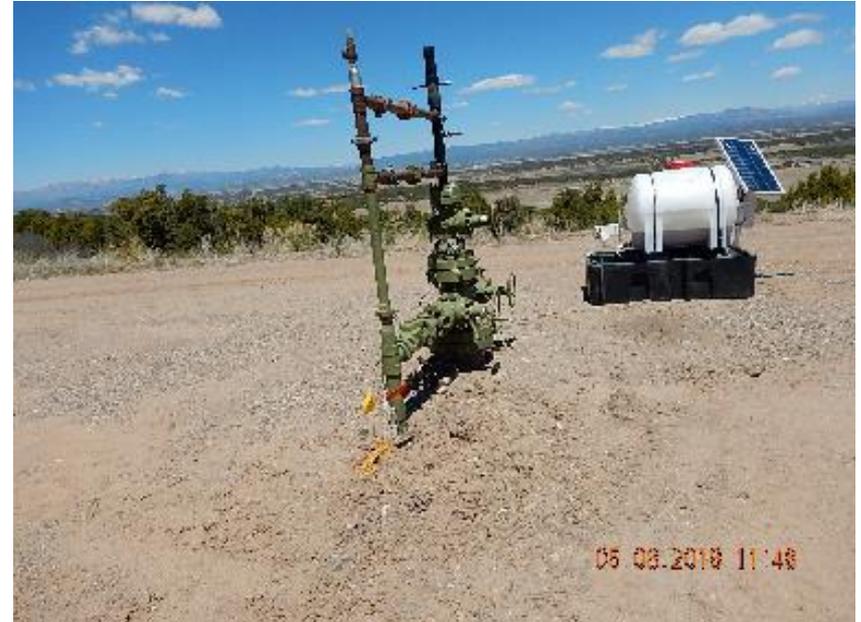
Photo 6: Wellhead after risers abandoned.

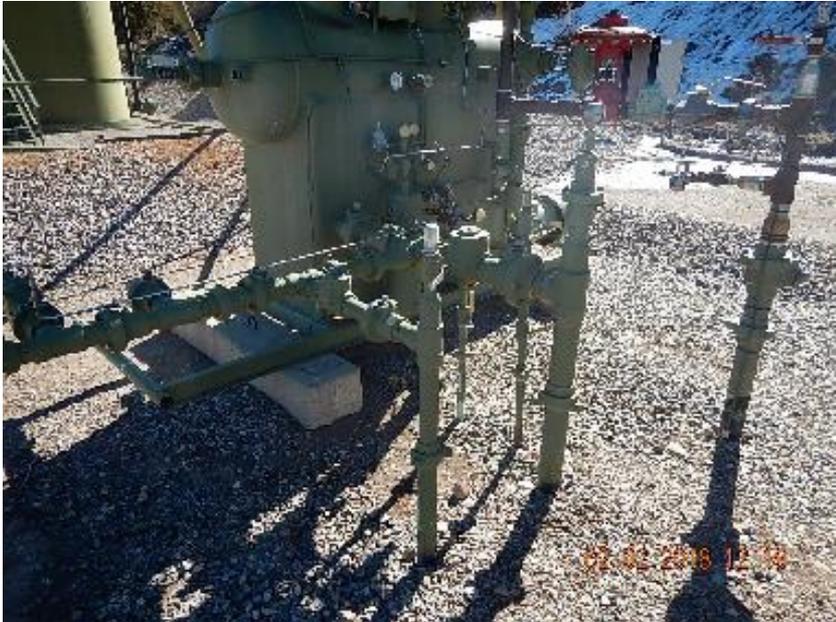
Photo 7: Flow lines at separator previous inspection.

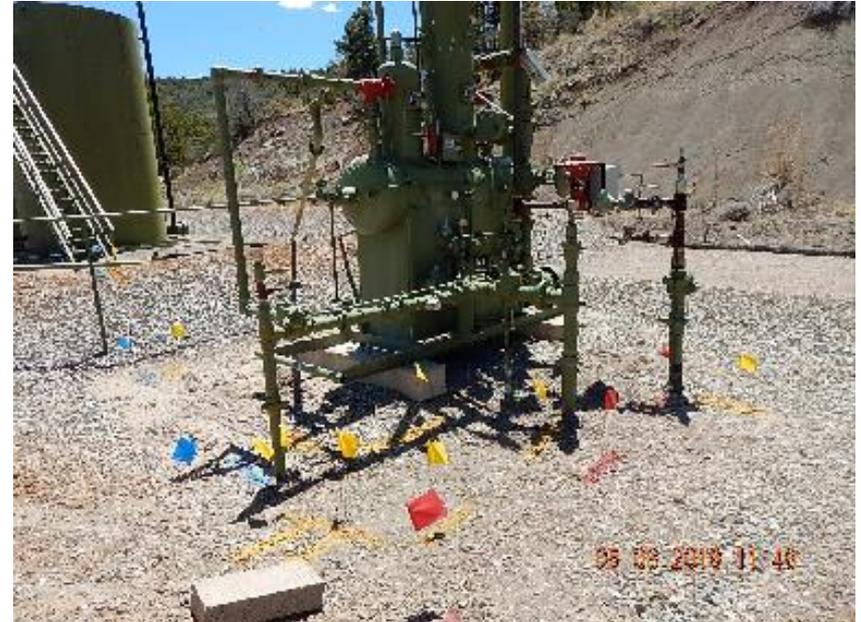
Photo 8: Separator after flow lines abandoned.

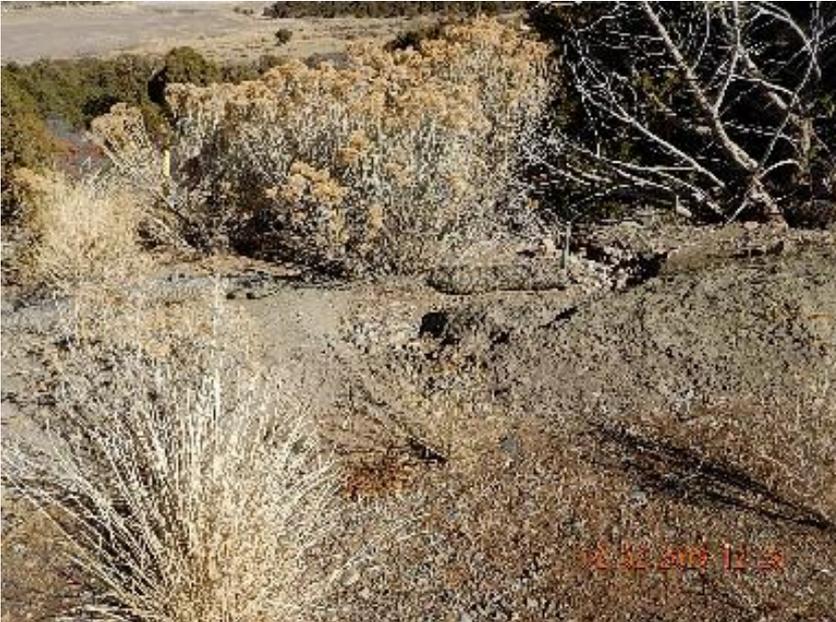
Photo 9: Breach in berm NE corner with erosion channel in background previous inspection.

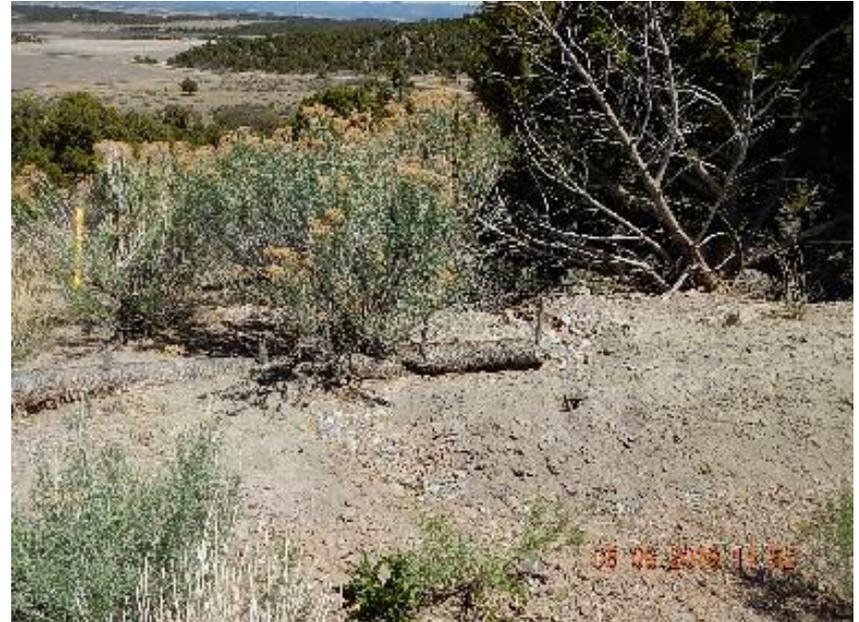
Photo 10: Breach in berm with erosion channel in background. Corrective action not completed.

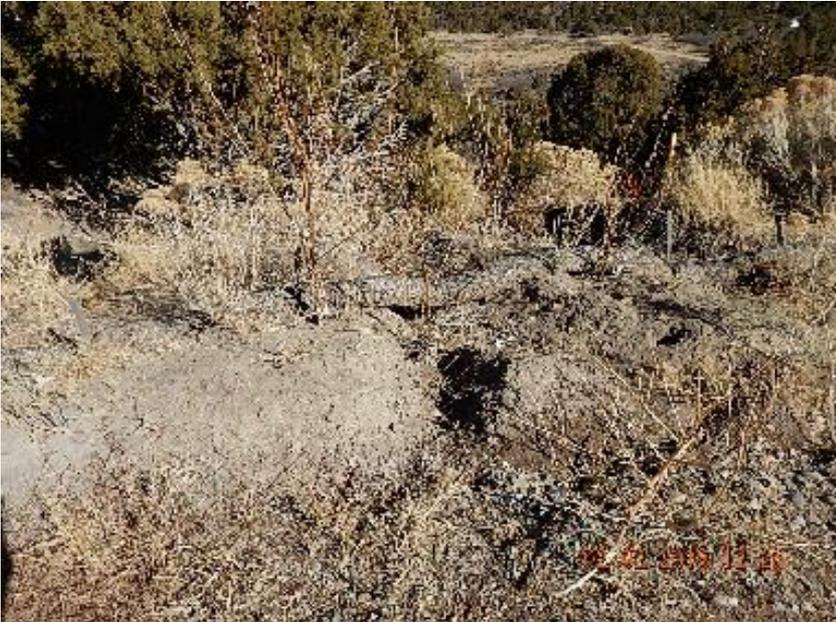
Photo 11: Breach in berm and undercut straw wattle previous inspection.

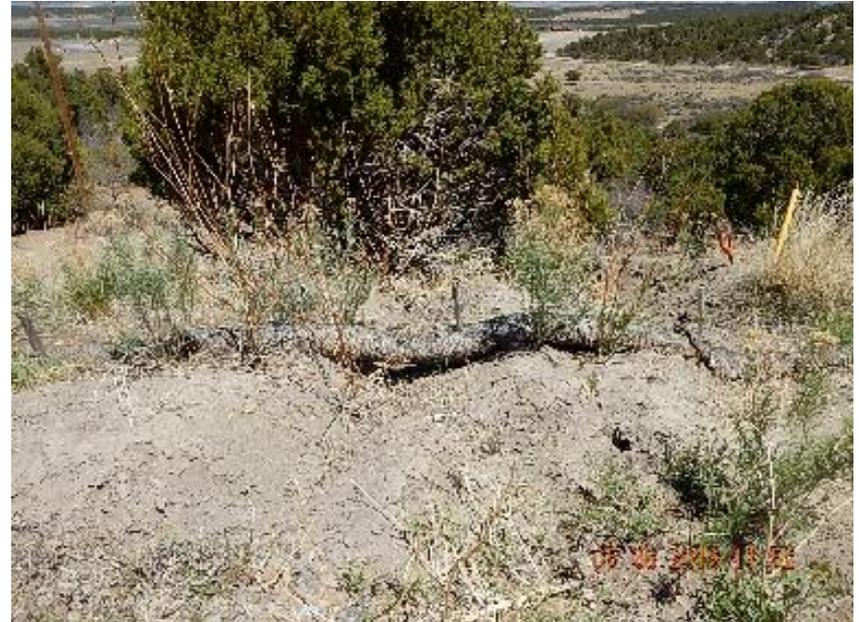
Photo 12: Breach in berm and undercut straw wattle. Corrective action not completed.

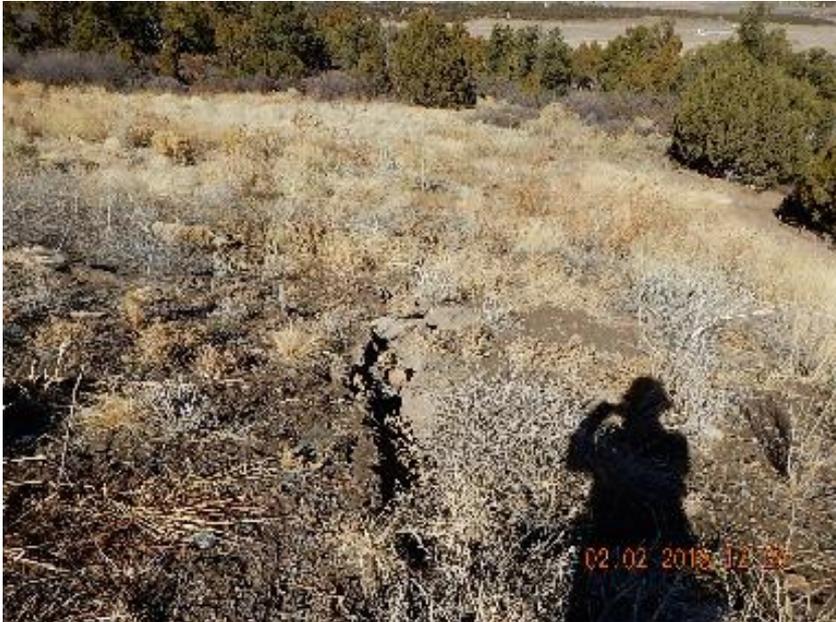
Photo 13: Erosion channel on fill slope.

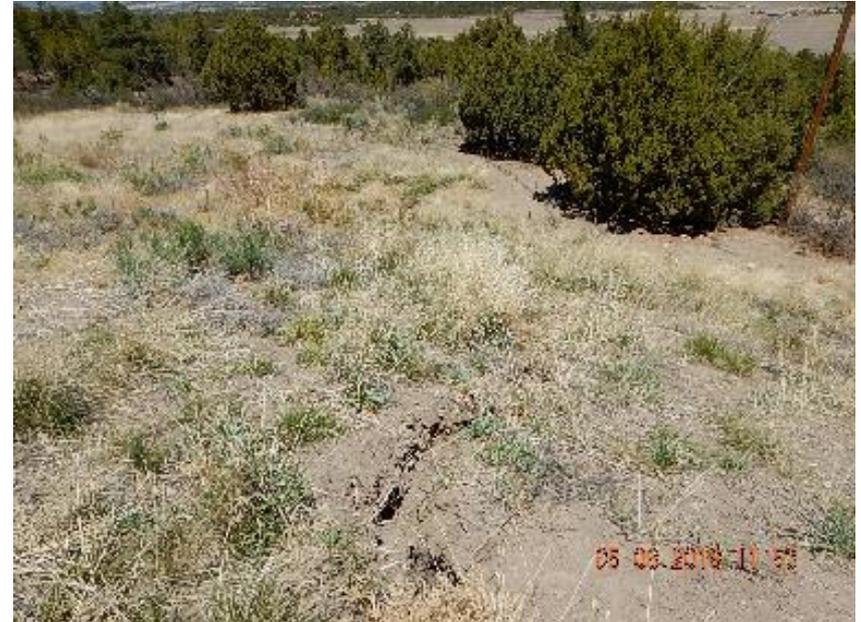
Photo 14: Erosion channel on fill slope.
Corrective action not completed.

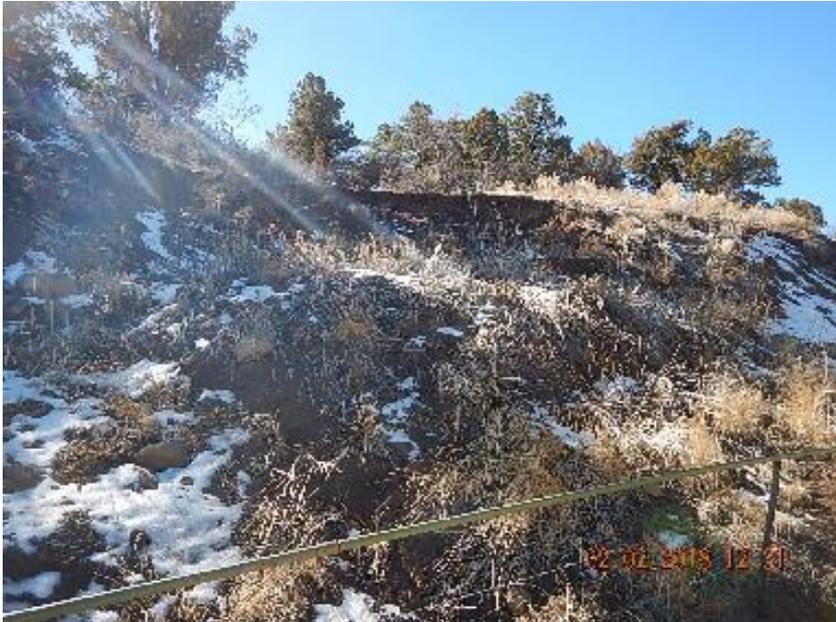
Photo 15: Cut slope slide area behind tank battery previous inspection.

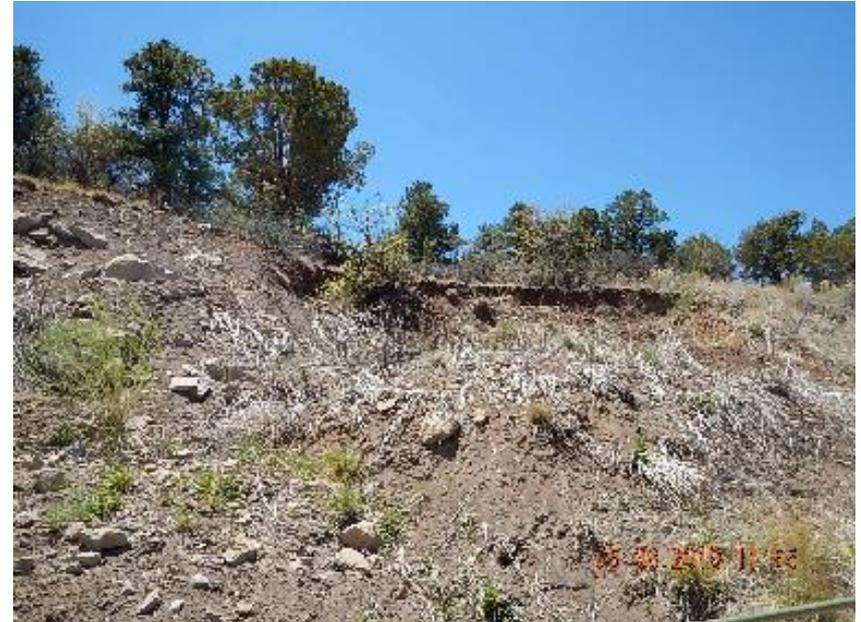
Photo 16: Cut slope slide area behind tank battery. Corrective action not completed.

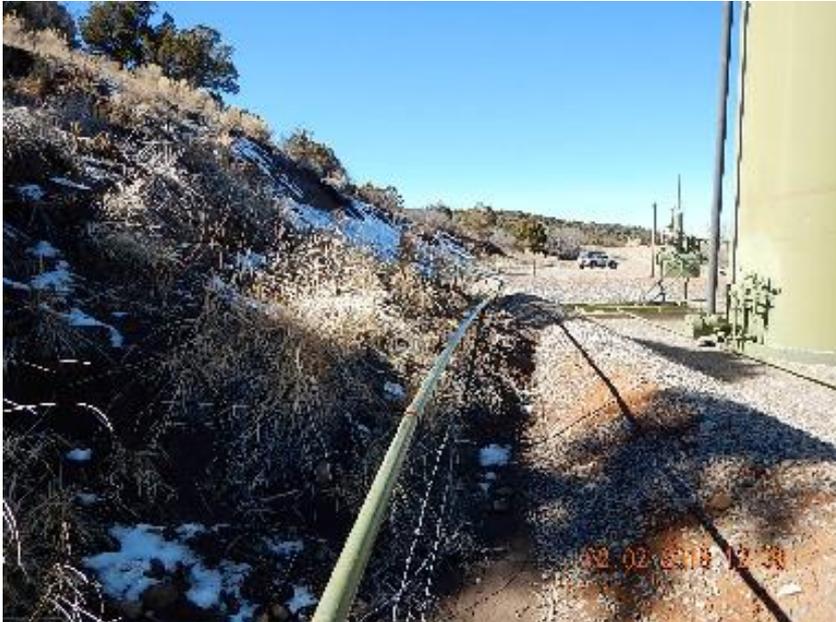
Photo 17: Slide pushing into tank battery fencing previous inspection.

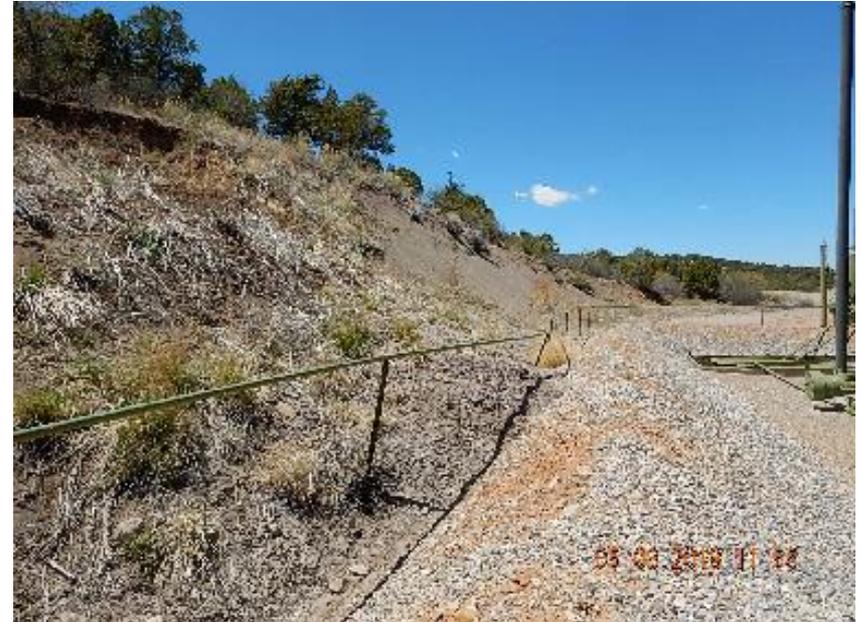
Photo 18: Slide pushing into tank battery fencing. Corrective action not completed.

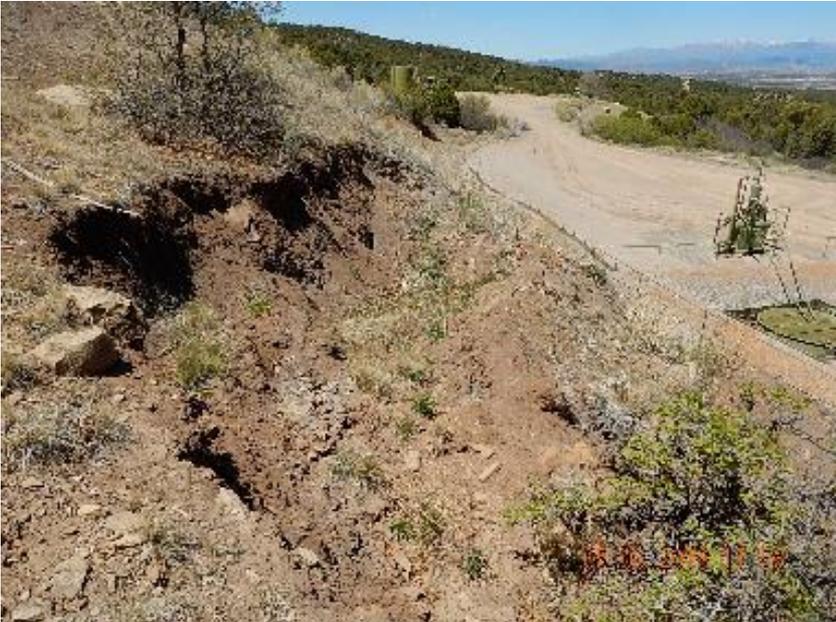
Photo 19: View at top of cut slope slide area.

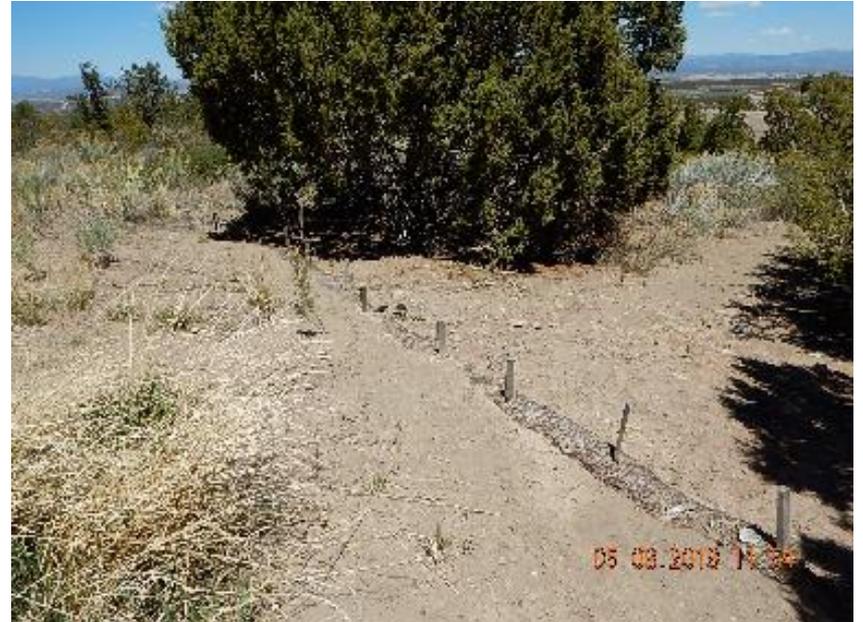
Photo 20: Full waddles at bottom of fill slope.
