Inspection Photos
Location Name: New Cache 8-44
Location ID: 310877

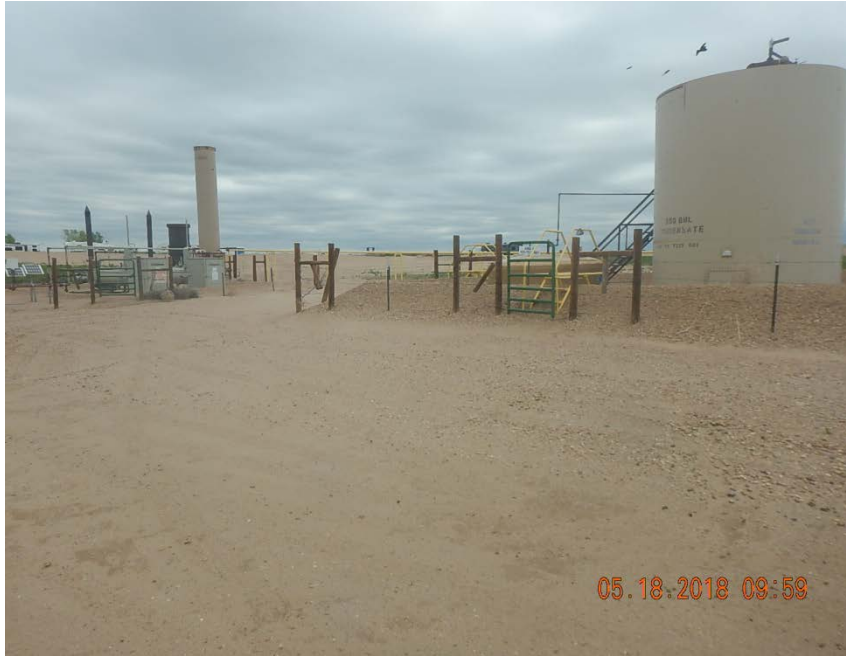
Photo 1: Location, looking NE

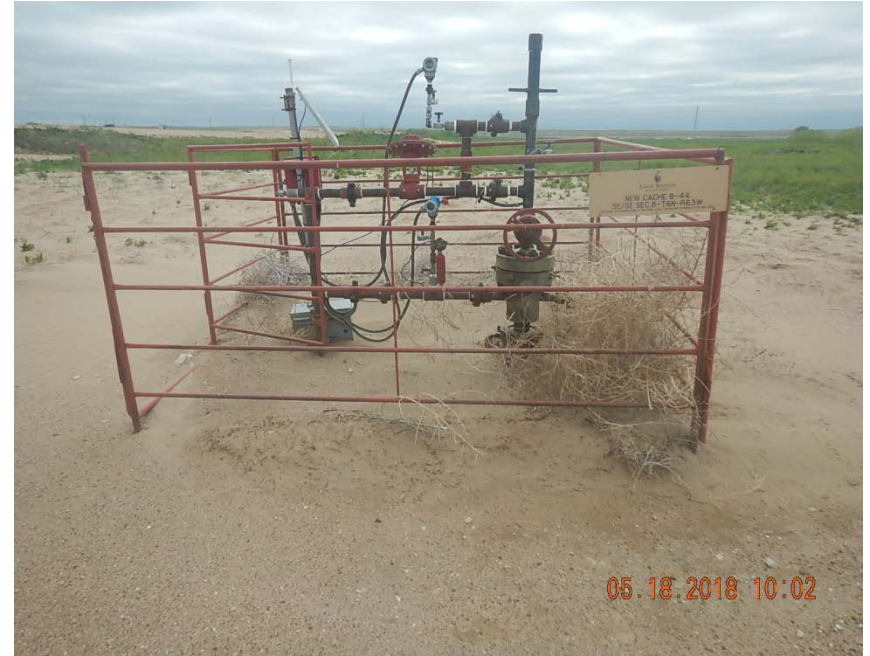
Photo 2: Wellhead, looking E

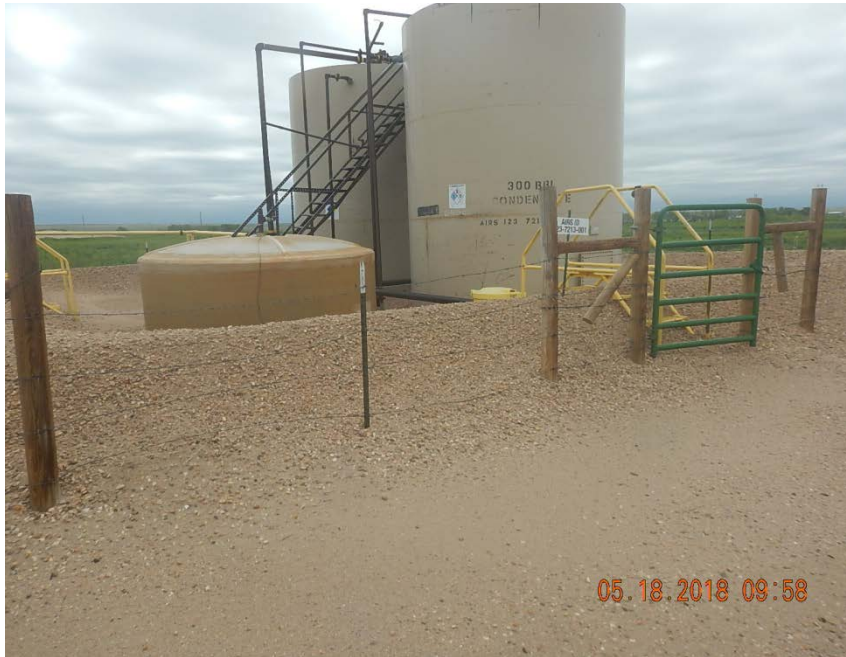
Photo 3: No sign at battery

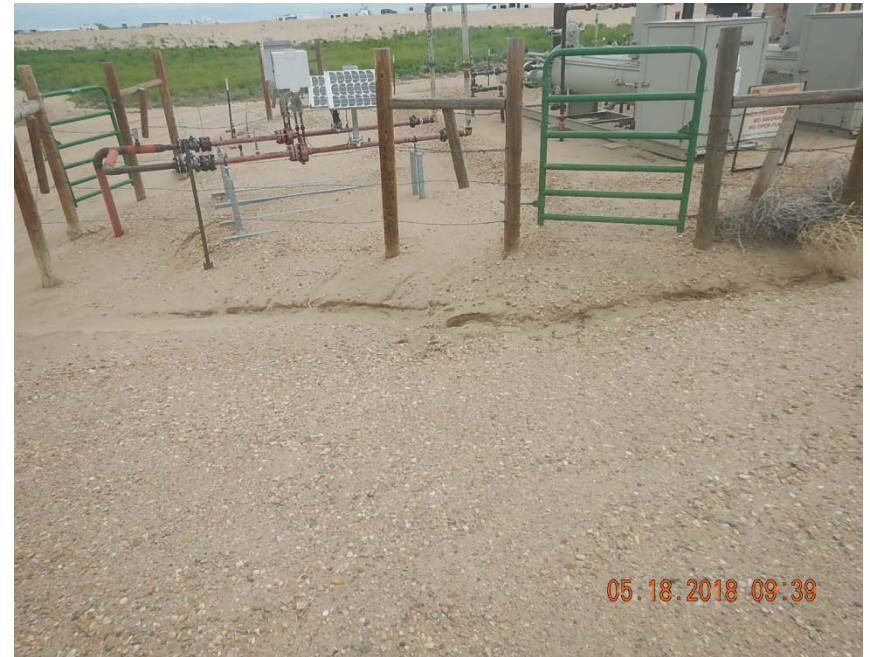
Photo 4: Stormwater erosion at SW side of separators

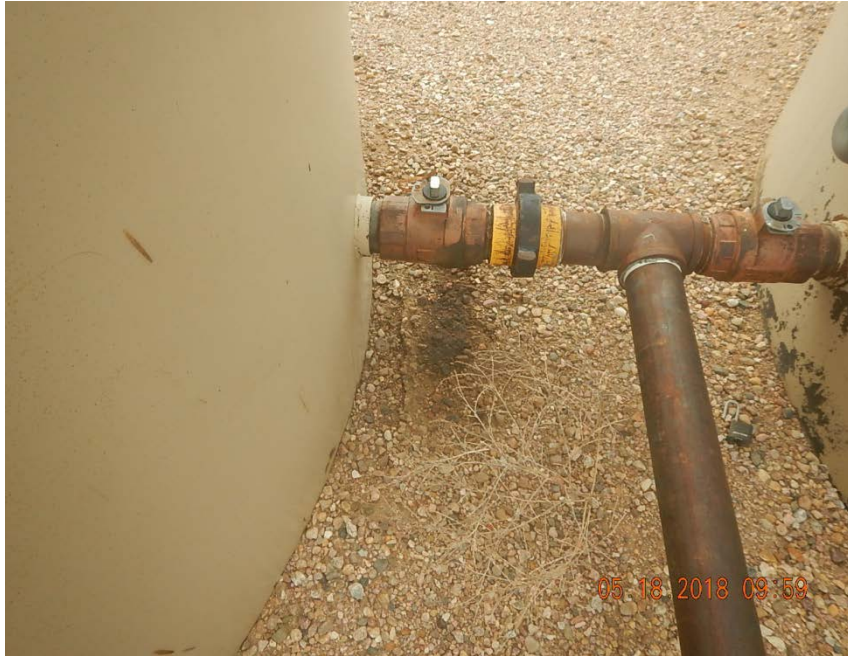
Photo 5: Stained soil at fitting.

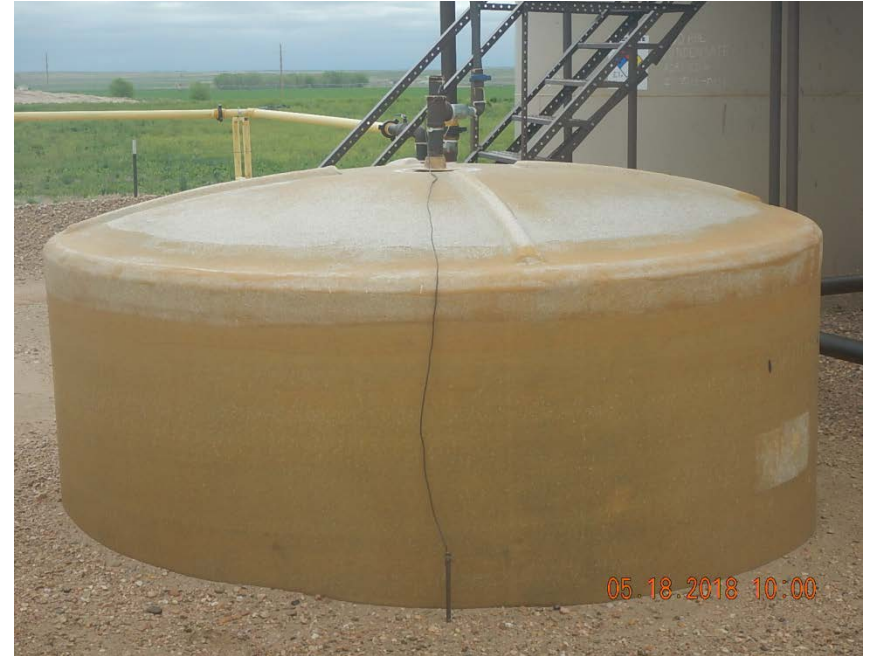
Photo 6: no contents, capacity on fiberglass vault
