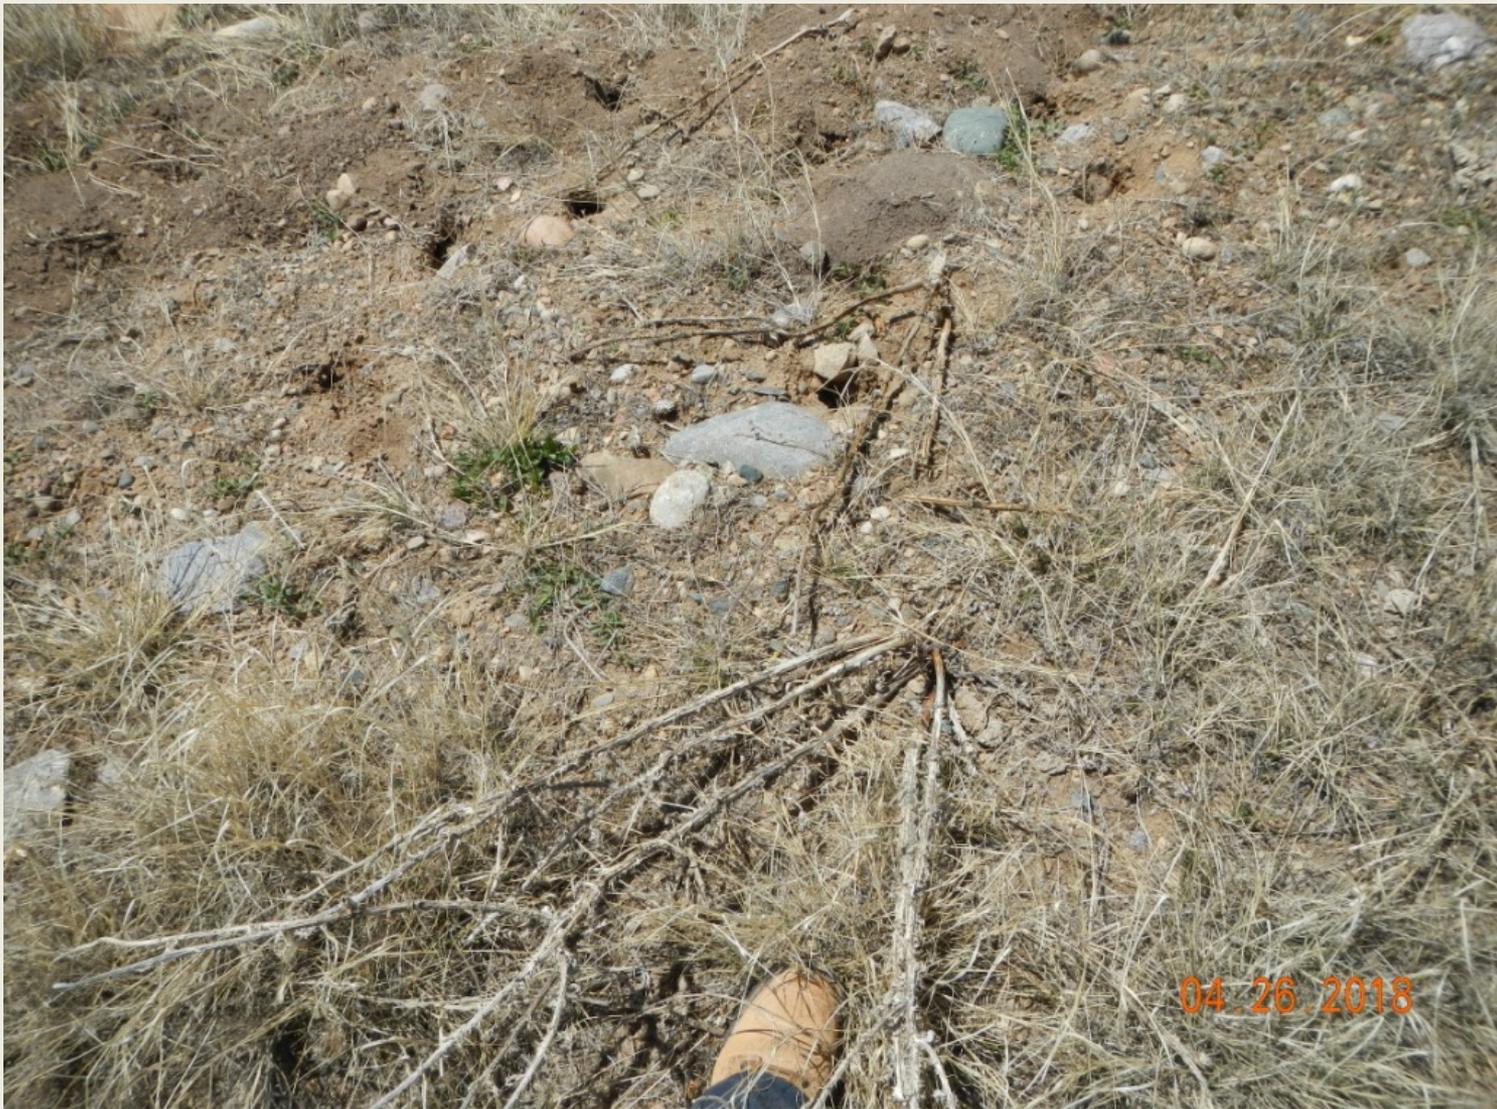
**Photo 4. View of musk thistles from the previous season.**

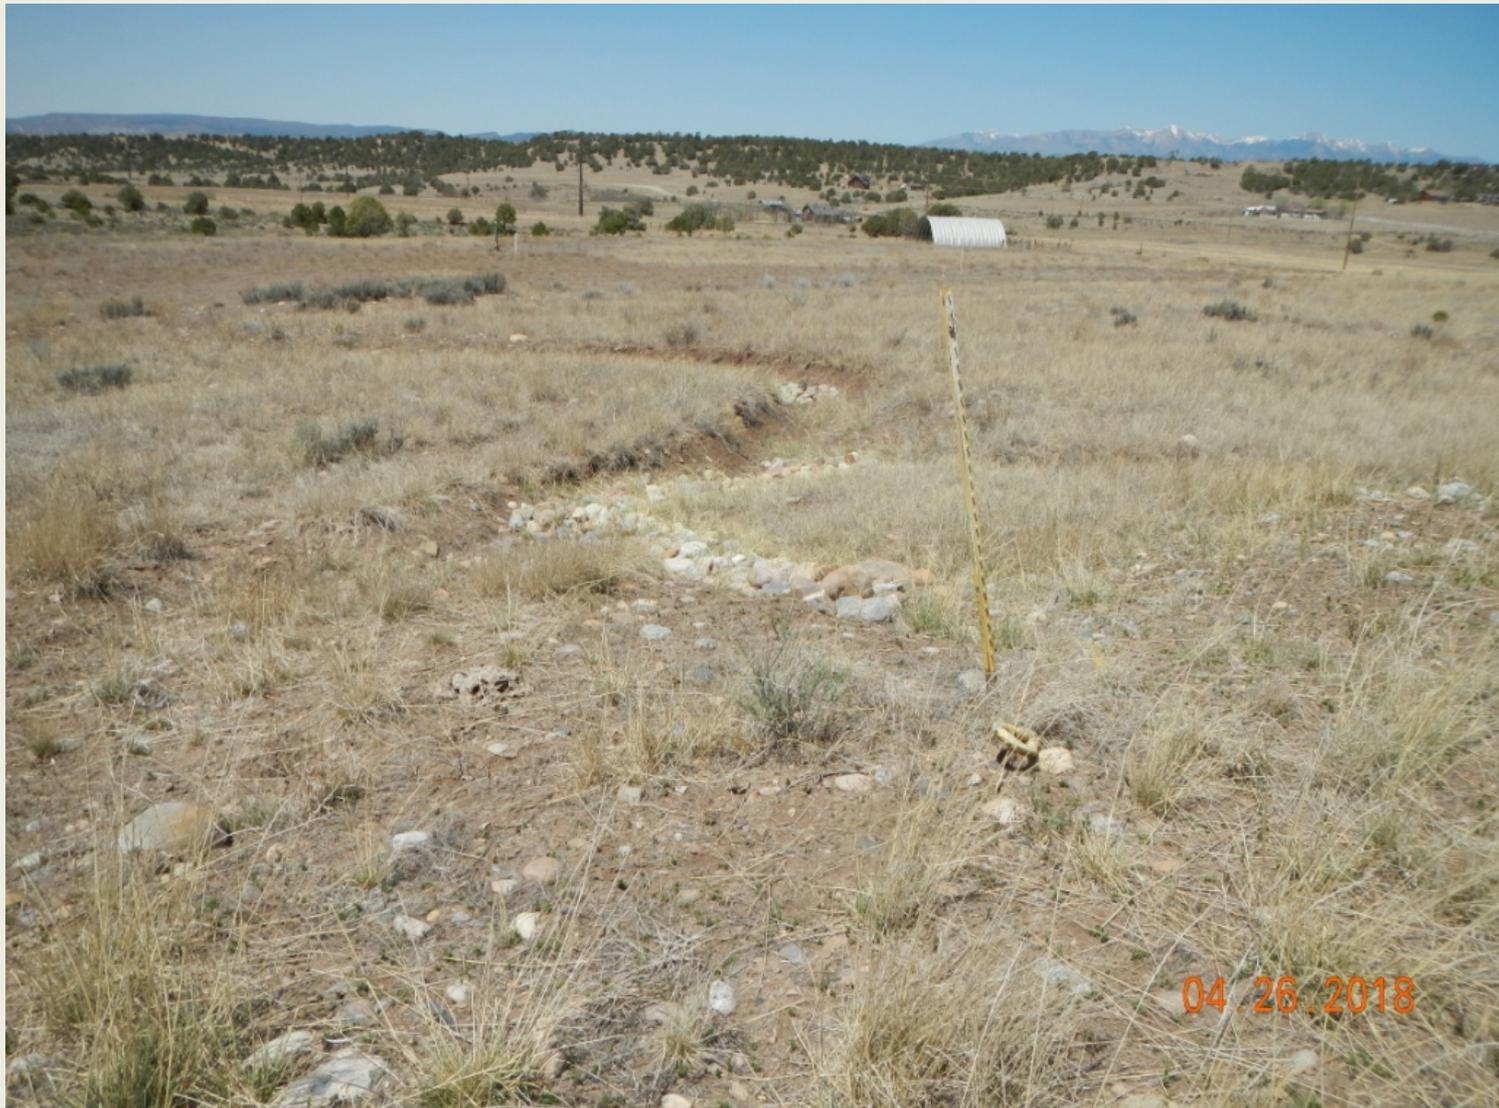
**Photo 5. View of stormwater controls within the western portion of the project area appear to be added after erosional channel was formed.**

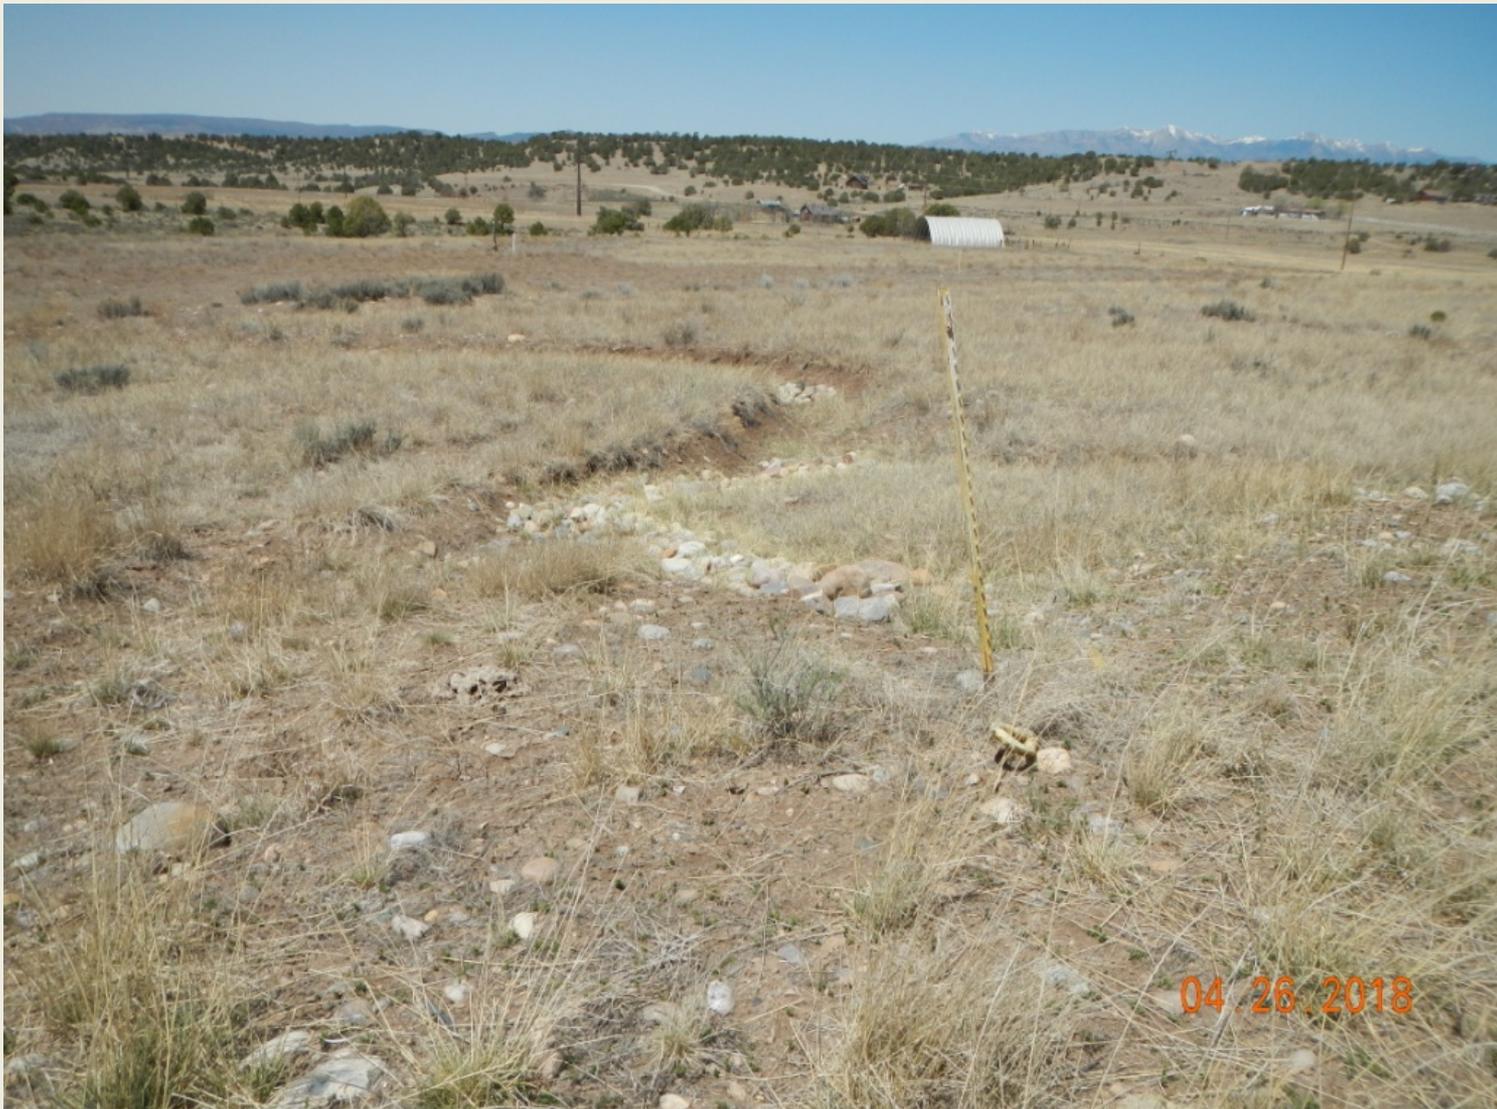
**Photo 5. View of stormwater controls within the western portion of the project area appear to be added after erosional channel was formed.**

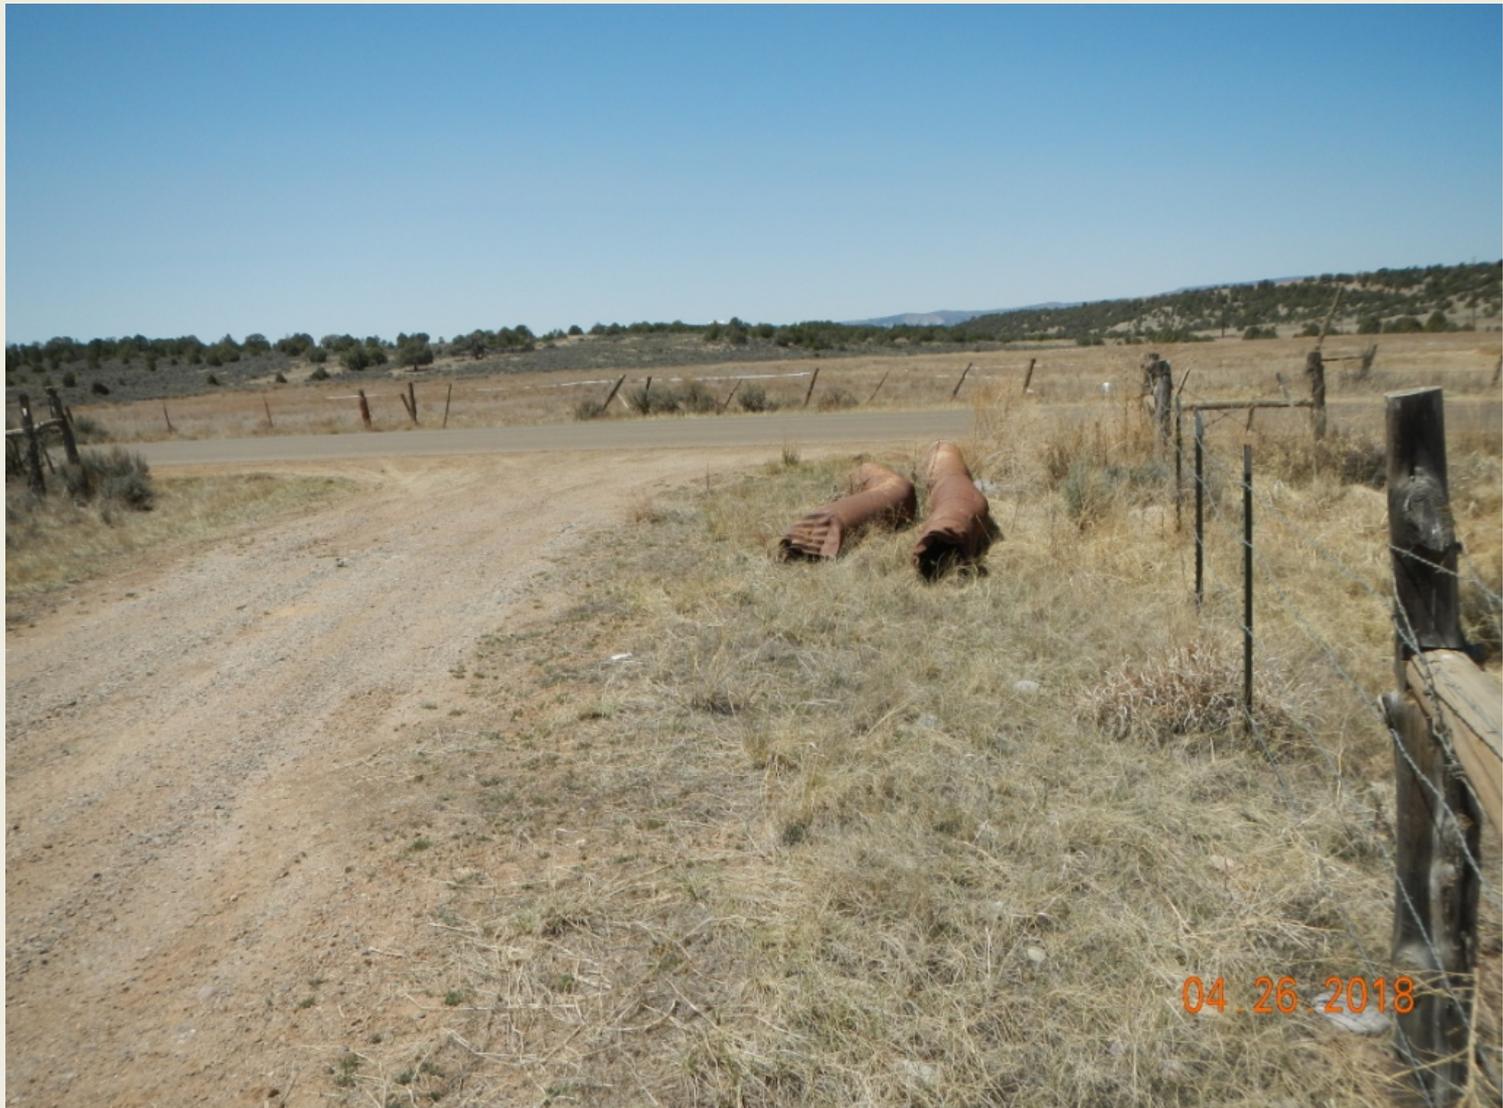
**Photo 5. View of culverts at the entrance to the access road need to be removed.**
