Argenta 34-10 #33-3

Corrective Actions Taken on the Argenta 34-10 #33-3 INC.

Hilcorp Energy Company

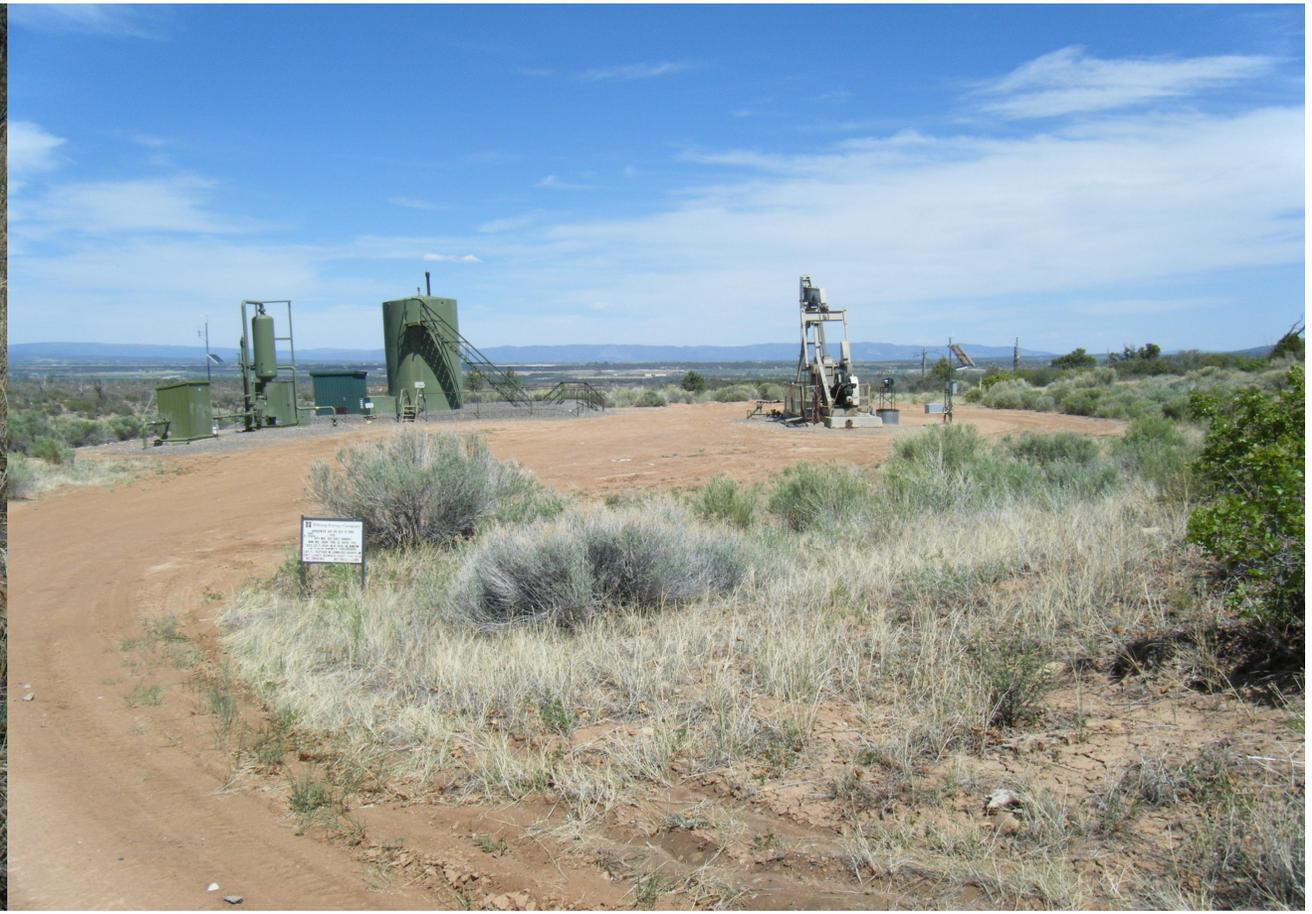
ARGENTA 34-10 33-3 FRC
DWR # 70909-F FEE
API NO. 05-067-08641
NW/NE, 990' FNL & 1425' FEL
SEC.33,T-034-N,R-010-W,NMPM
LA PLATA COUNTY, COLORADO
LAT:37.1521194 N LONG:107.93412 W
EMERGENCY NUMBER (505) 324-5170
NO SMOKING NO TRESPASSING

Storm Water management controls have been established to stabilize erosion in the Southeastern portion of the project area.
