Well Name : Carter Ute 107
API # : 067-07459

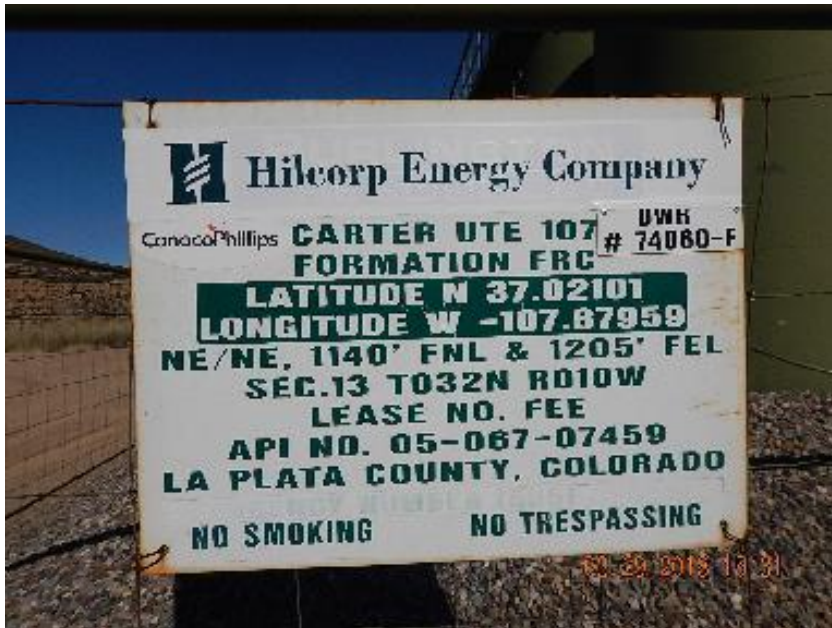
Photo 1: Wellhead sign previous inspection.

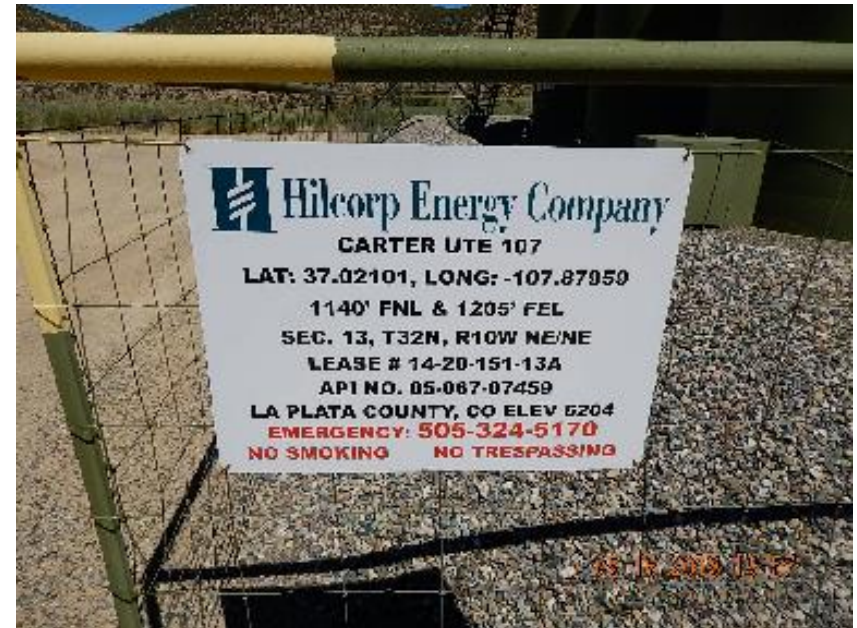
Photo 2: Wellhead sign.

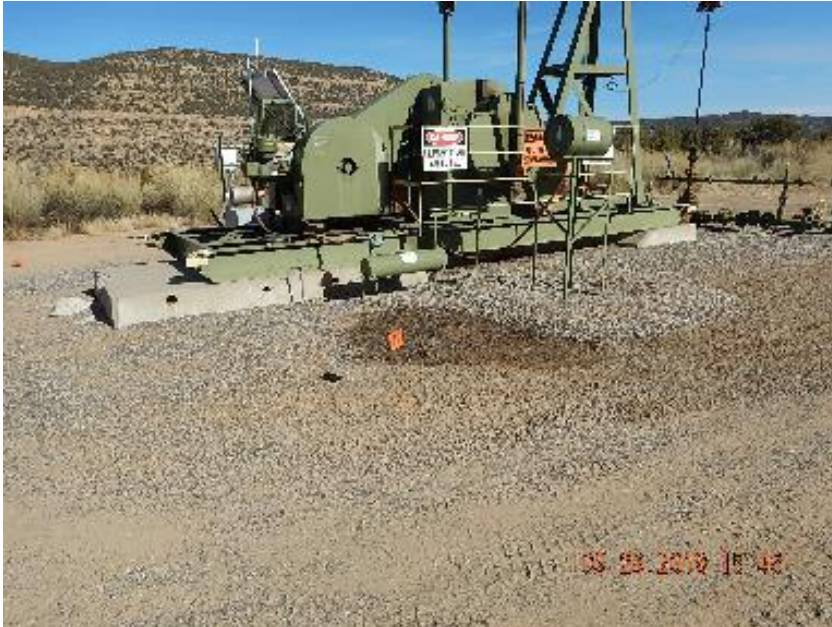
Photo 3: Impacted soil and gravel NW side of pump jack previous inspection.

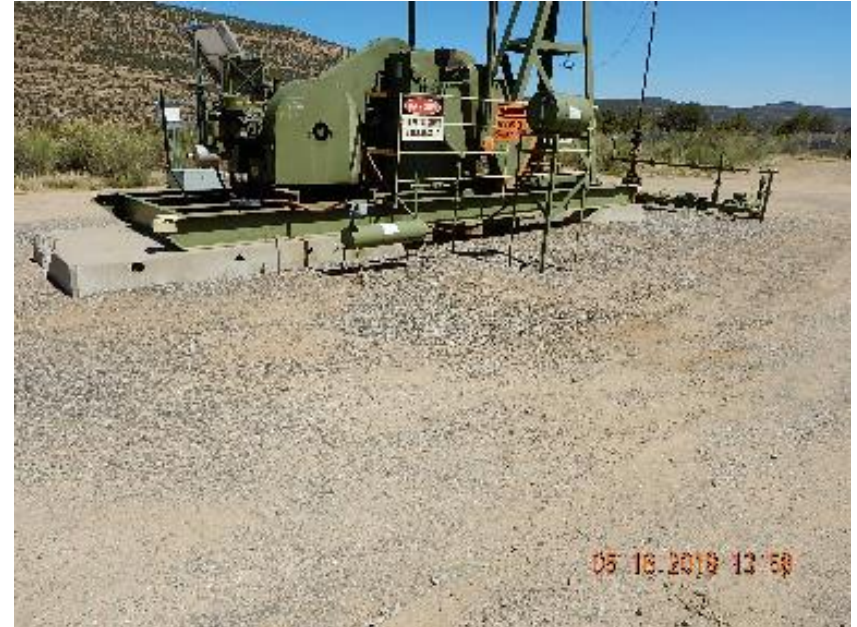
Photo 4: Mediated area on NW side of pump jack.

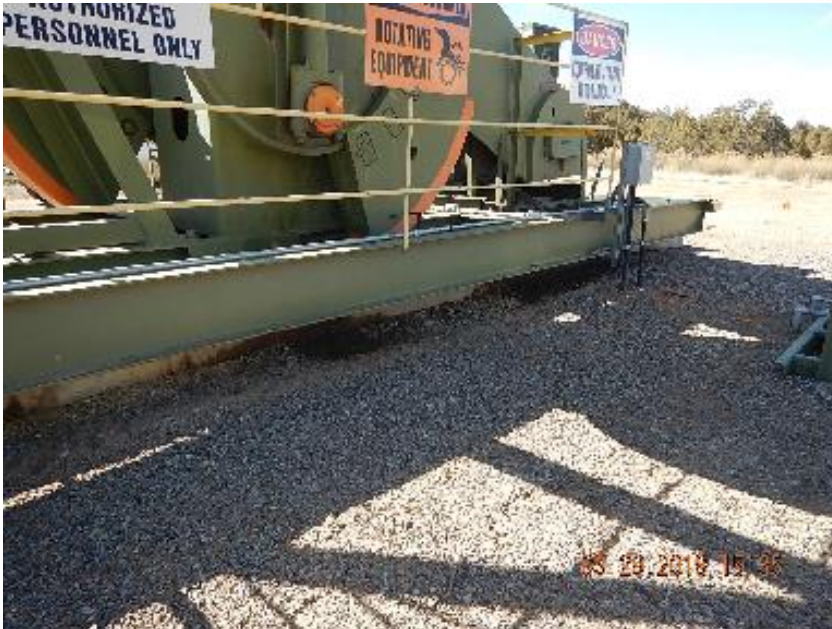
Photo 5: Impacted soil and gravel along concrete base of pump jack previous inspection.

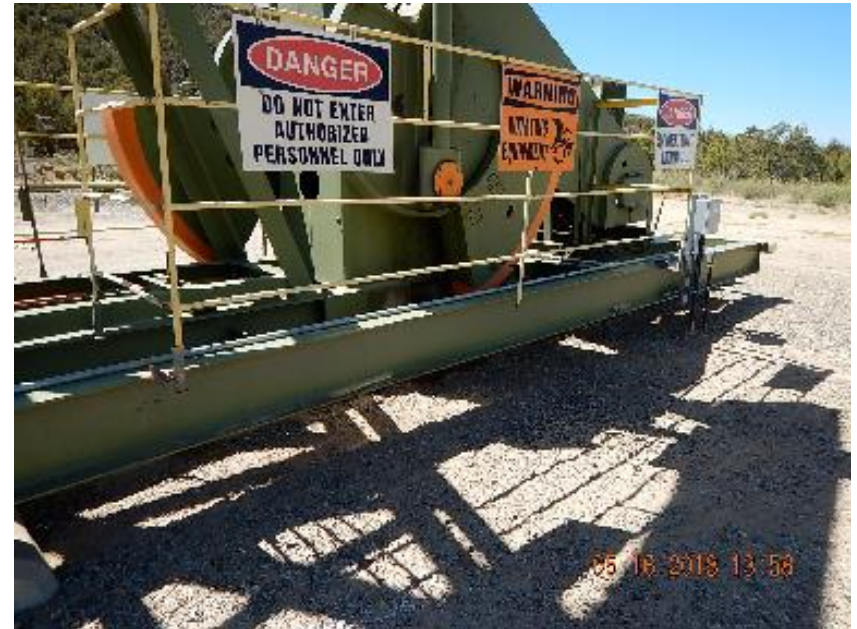
Photo 6: Mediated area along concrete base of pump jack.

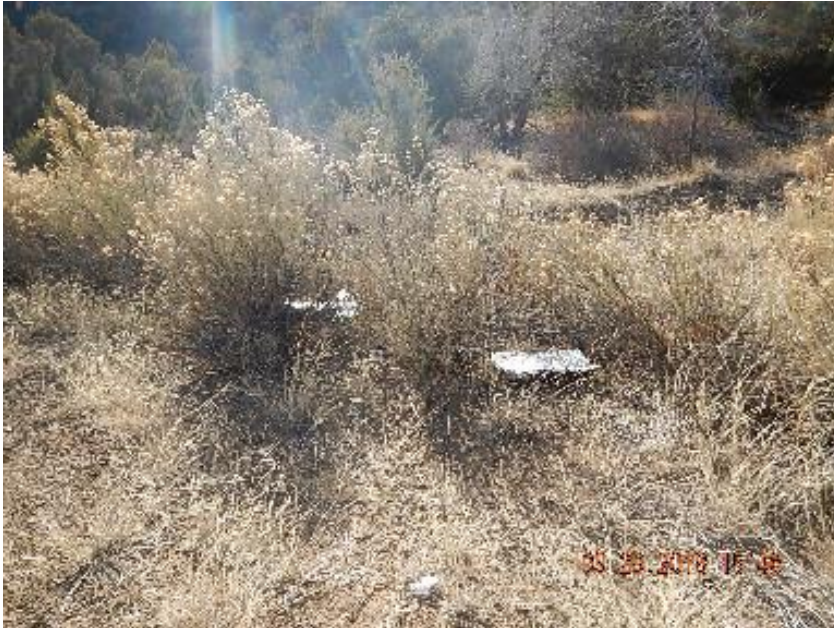
Photo 7: Insulation along NW perimeter of location previous inspection.

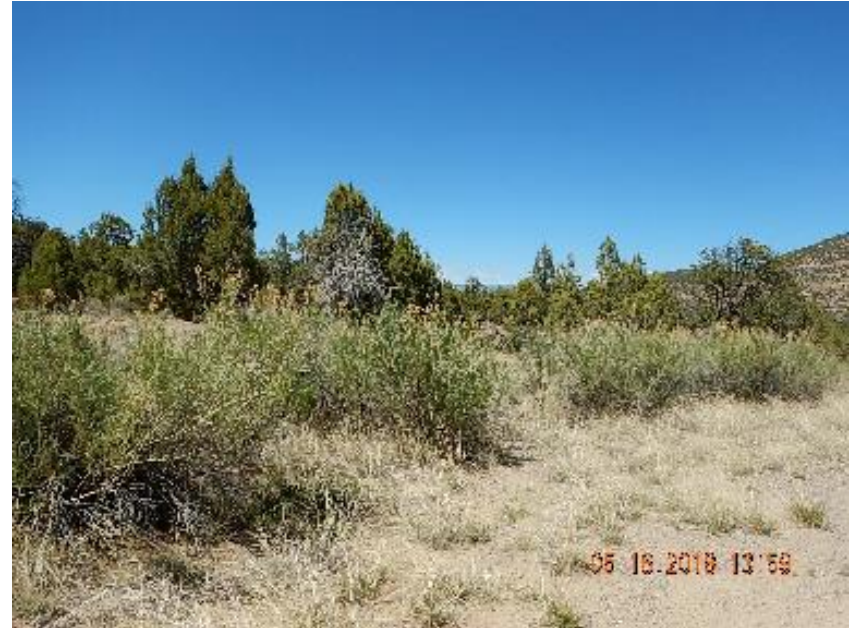
Photo 8: Insulation debris removed along NW perimeter.

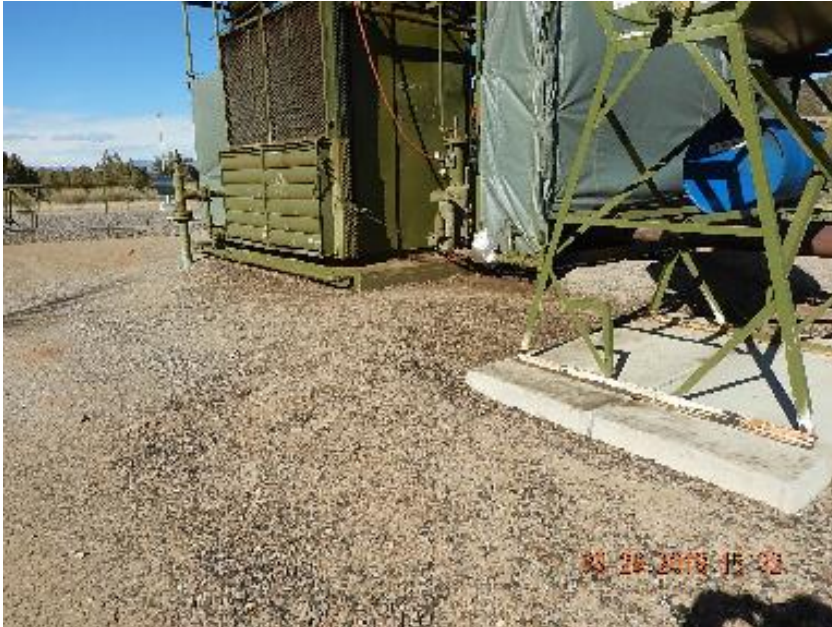
Photo 9: Impacted soil and gravel on S and SW side of compressor unit previous inspection.

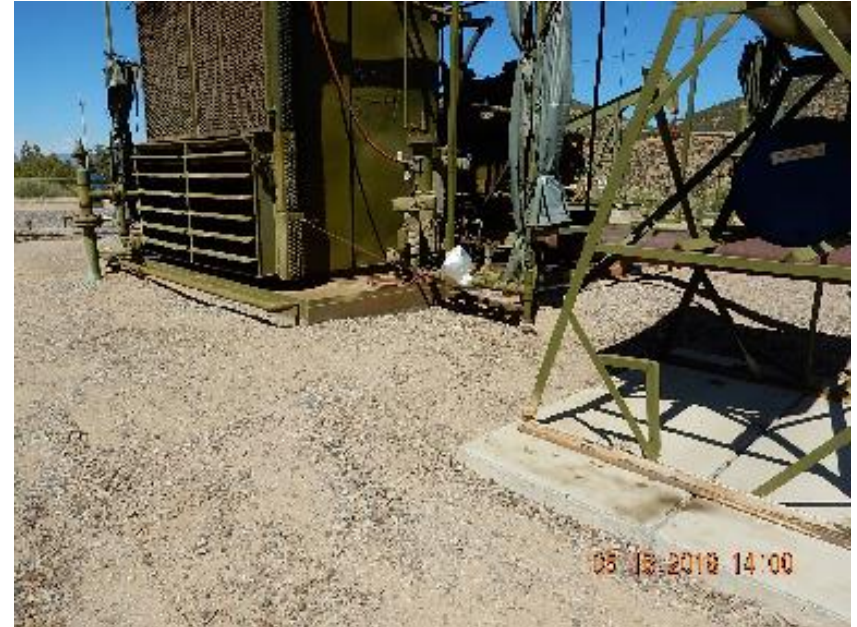
Photo 10: Mediated soil and gravel on S and SW sides of compressor unit.

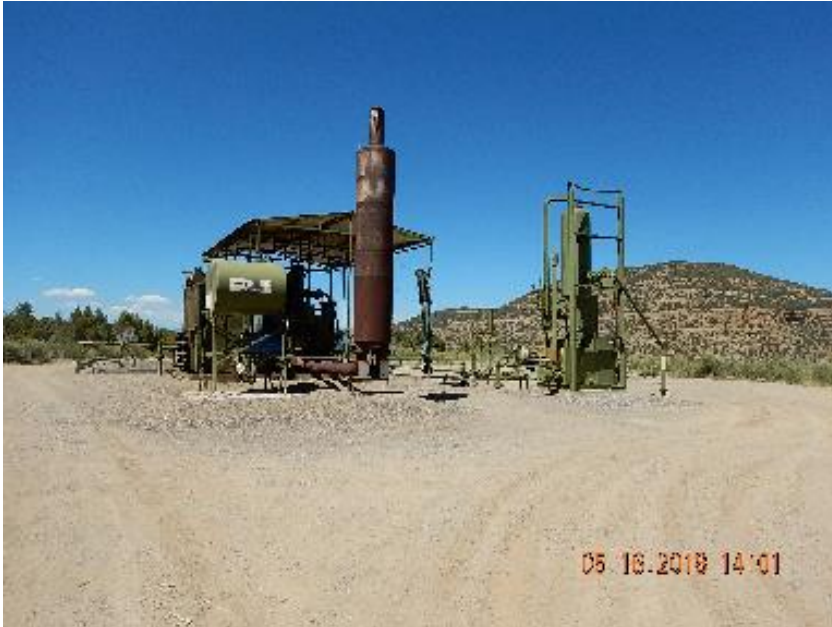
Photo 11: Location overview.

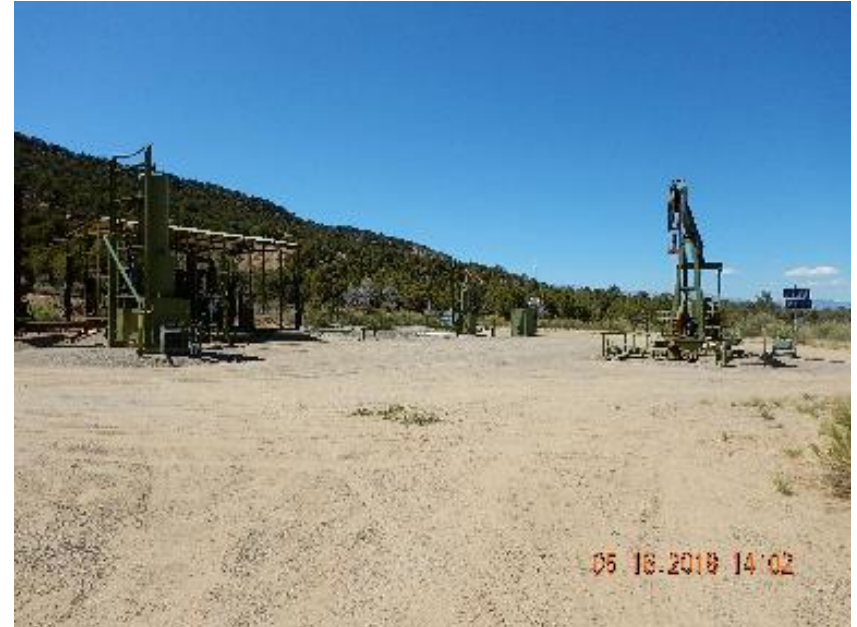
Photo 12: Location overview.

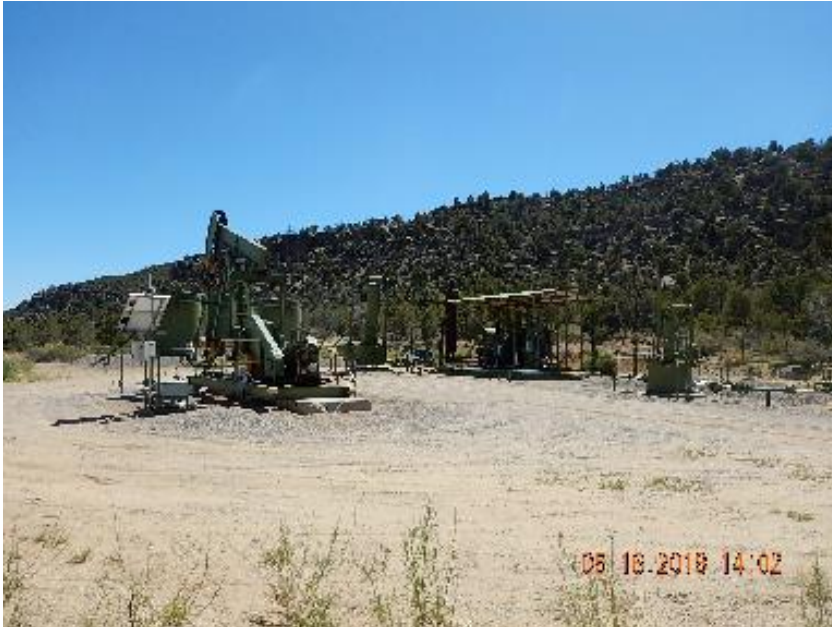
Photo 13: Location overview.

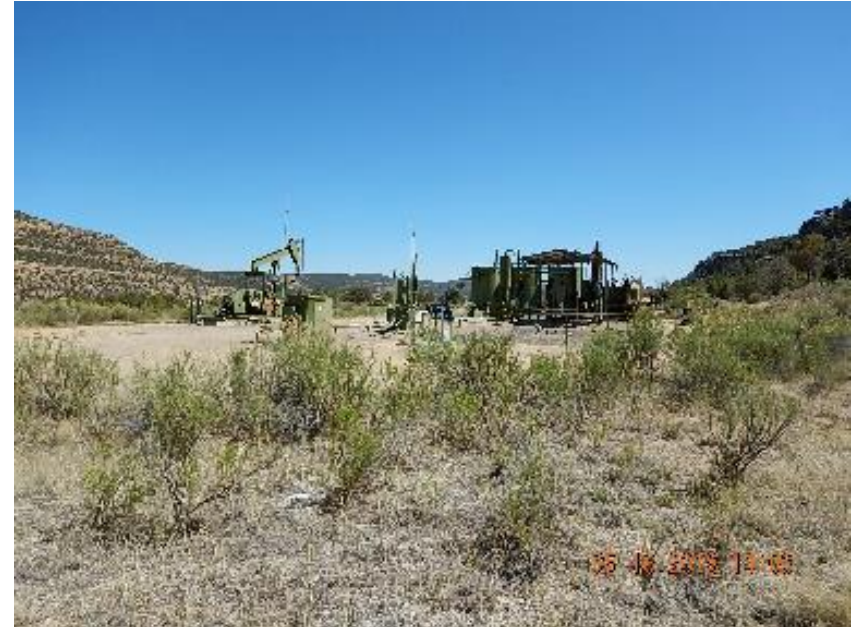
Photo 14: Location overview.
