Inspection Photos

Operator: WIEPKING-FULLERTON ENERGY LLC -
96340

Location ID: 436303

Inspection Doc. Number: 682503363
Lincoln County, CO

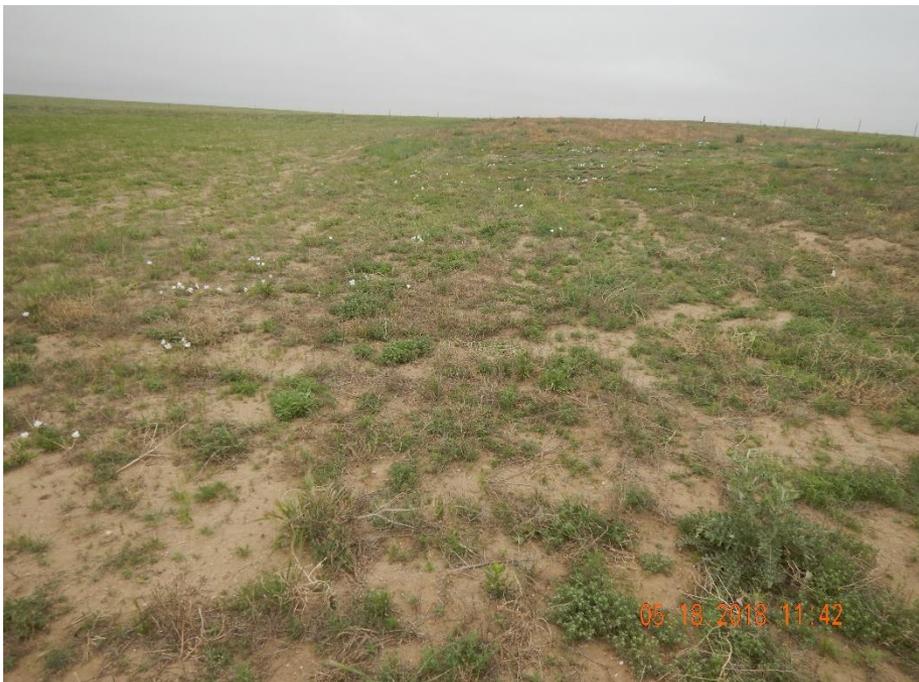
Photo 1: Photo taken from the northeast corner of the location, facing west. Photo shows reclamation of the well location appears to be progressing towards reclamation standards and requirements; desirable vegetative germination and establishment evident.

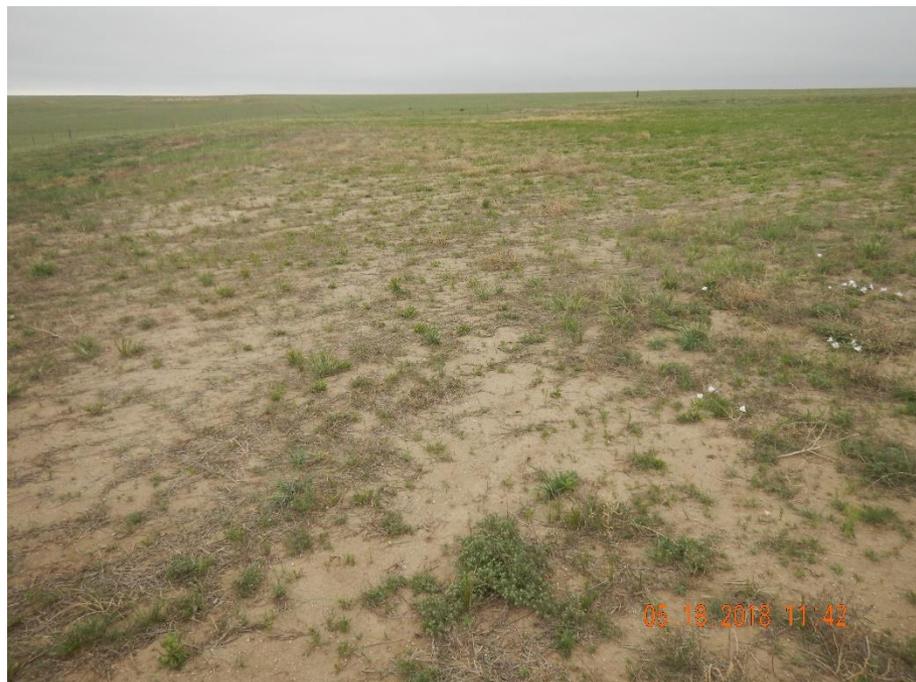
Photo 2: Photo taken from the northeast corner of the location, facing west. See comments under photo 1.

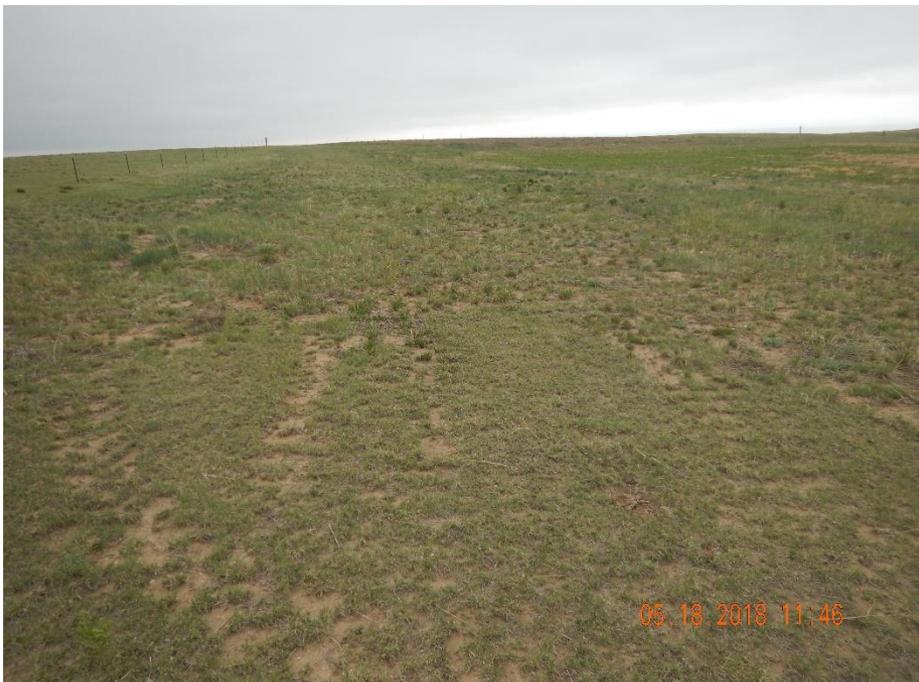
Photo 3: Photo taken from the southwest corner of the location, facing north. See comments under photo 1.

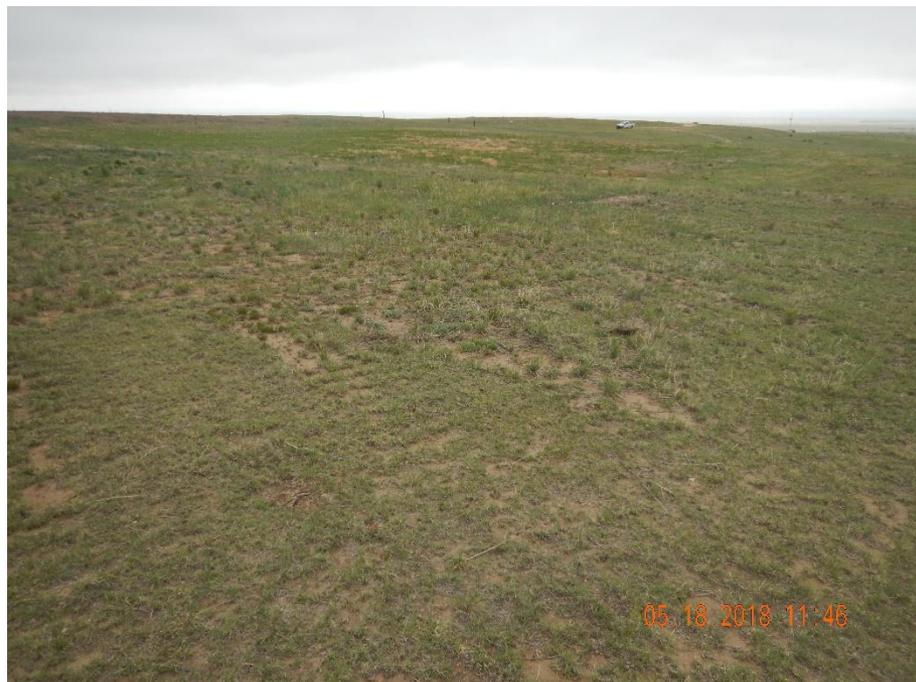
Photo 4: Photo taken from the southwest corner of the location, facing northeast. See comments under photo 1.

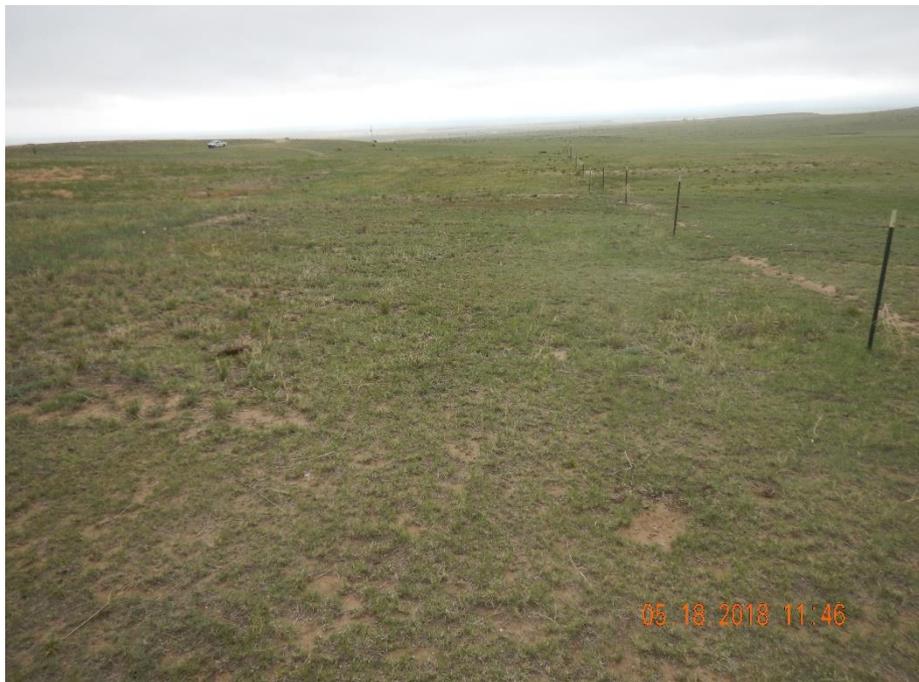
Photo 5: Photo taken from the southwest corner of the location, facing east. See comments under photo 1.

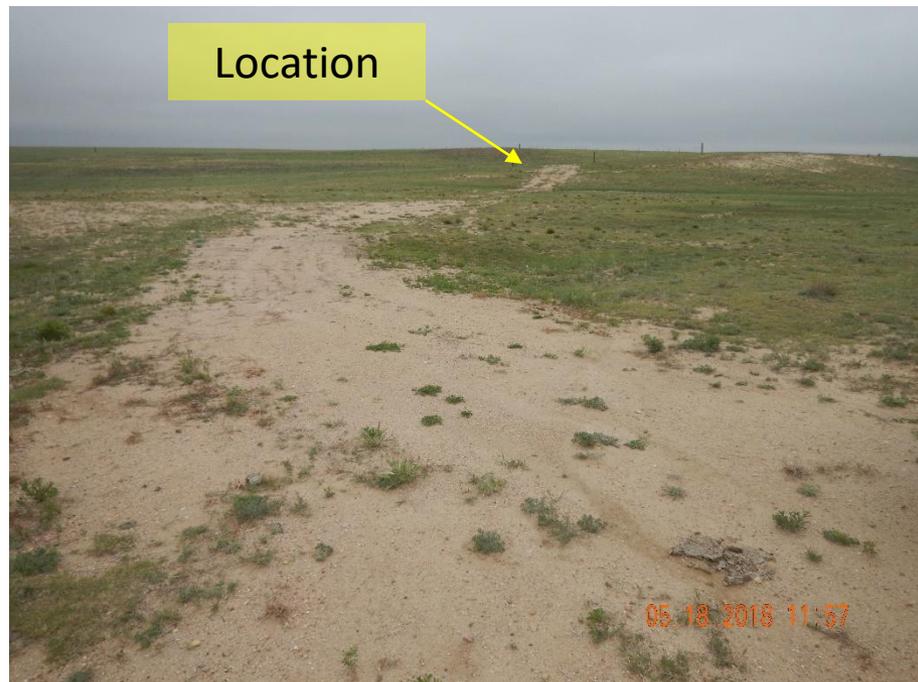
Photo 6: Photo taken from where the access road turns from south to west, facing west towards the location. Photo shows the access road has not been reclaimed and still remains.

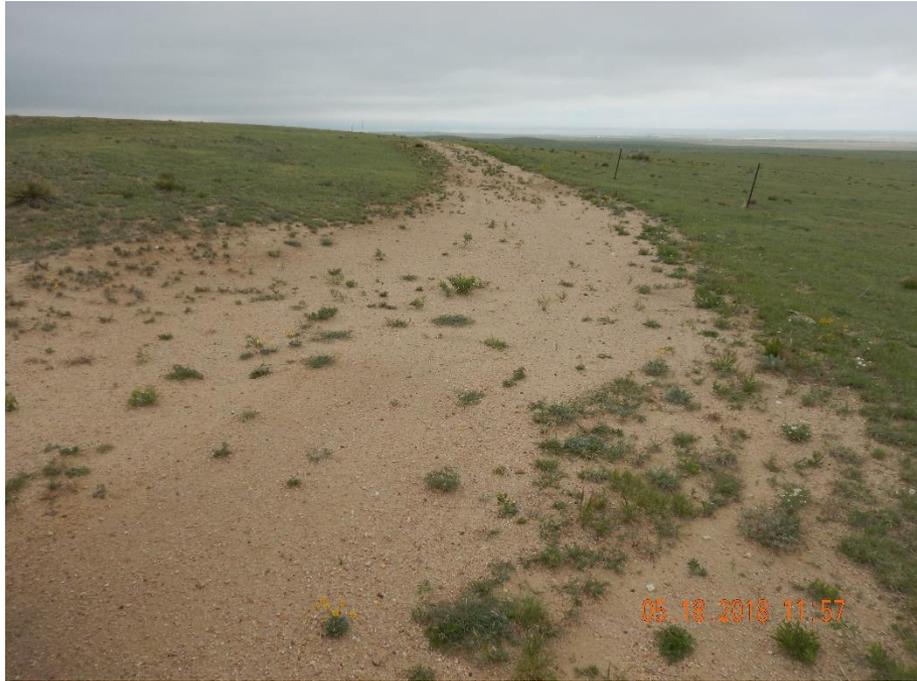
Photo 7: Photo taken from where the access road turns from south to west, facing north. Photo shows the access road has not been reclaimed and still remains.

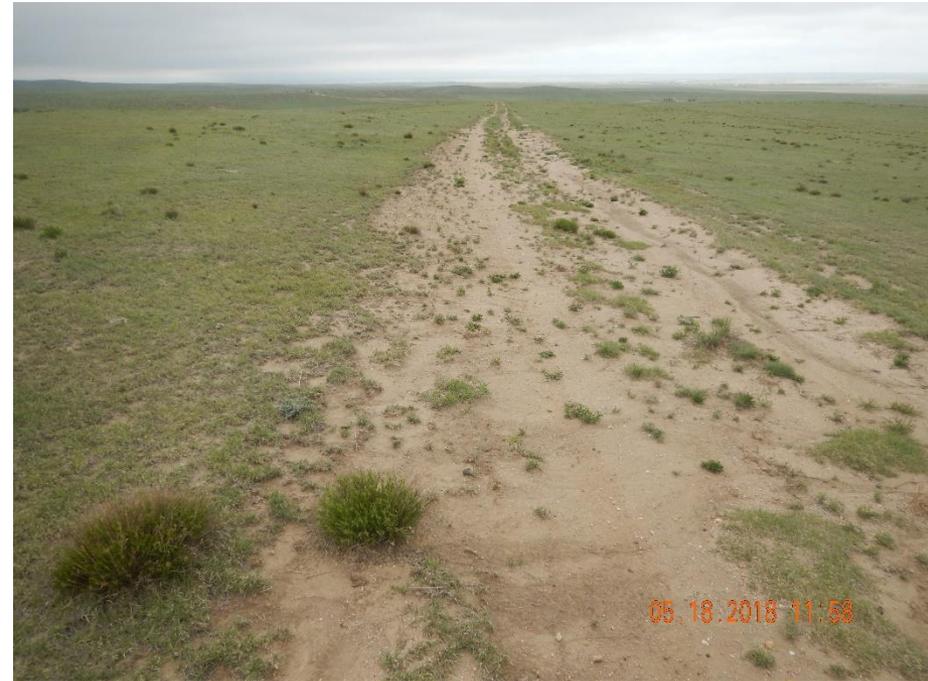
Photo 8: Photo taken from the access road, facing north. Photo shows the access road has not been reclaimed and still remains.

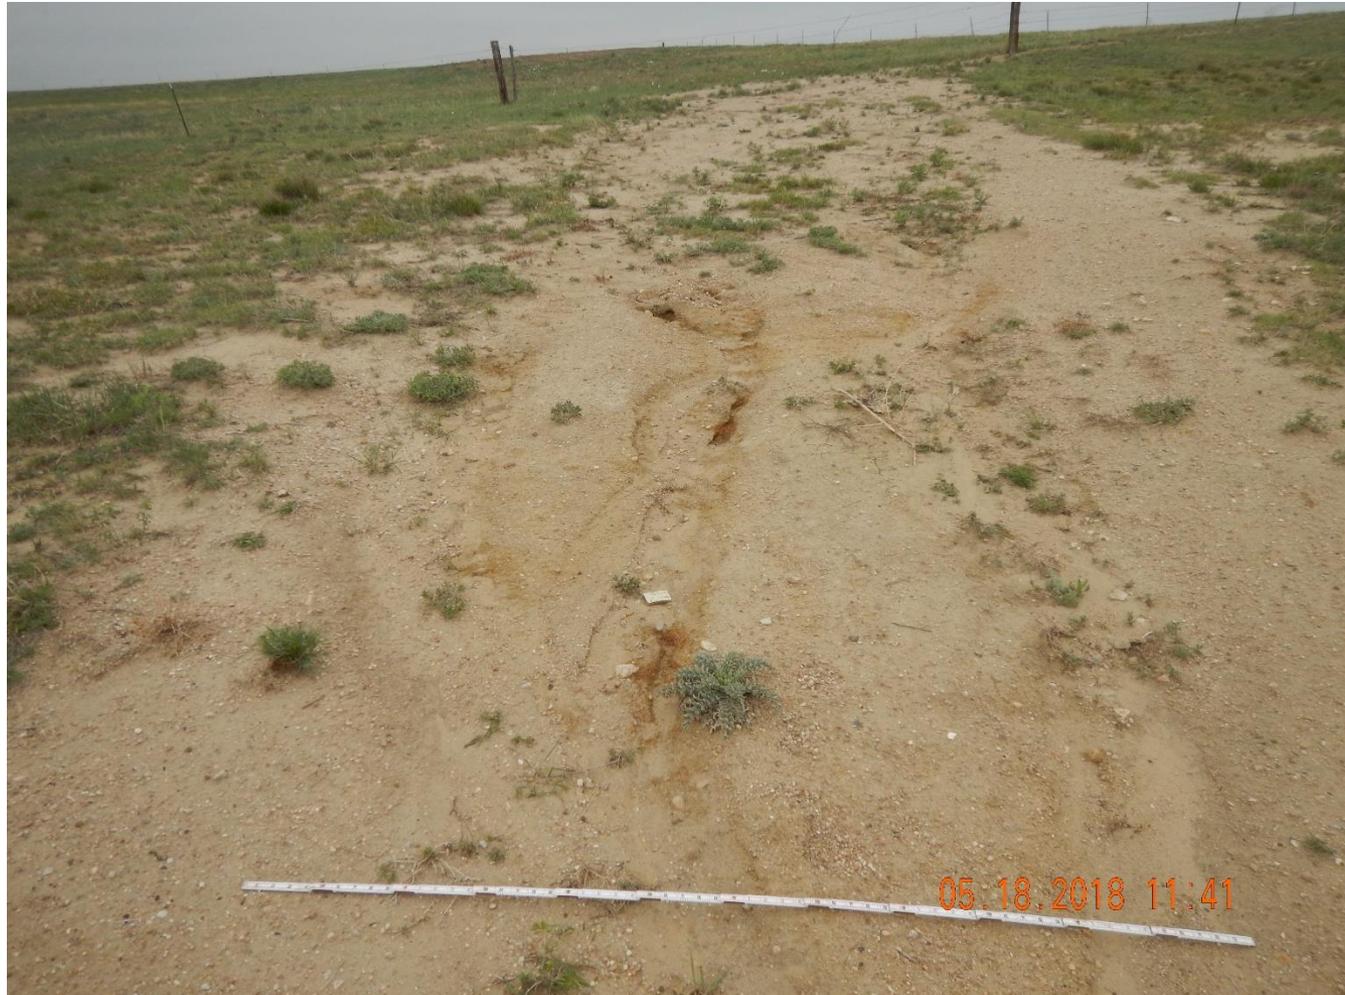
Photo 9: Photo taken from the access road to the immediate east of the location. Photo shows stormwater erosion degradation occurring along access road. 6 foot measuring stick for reference.

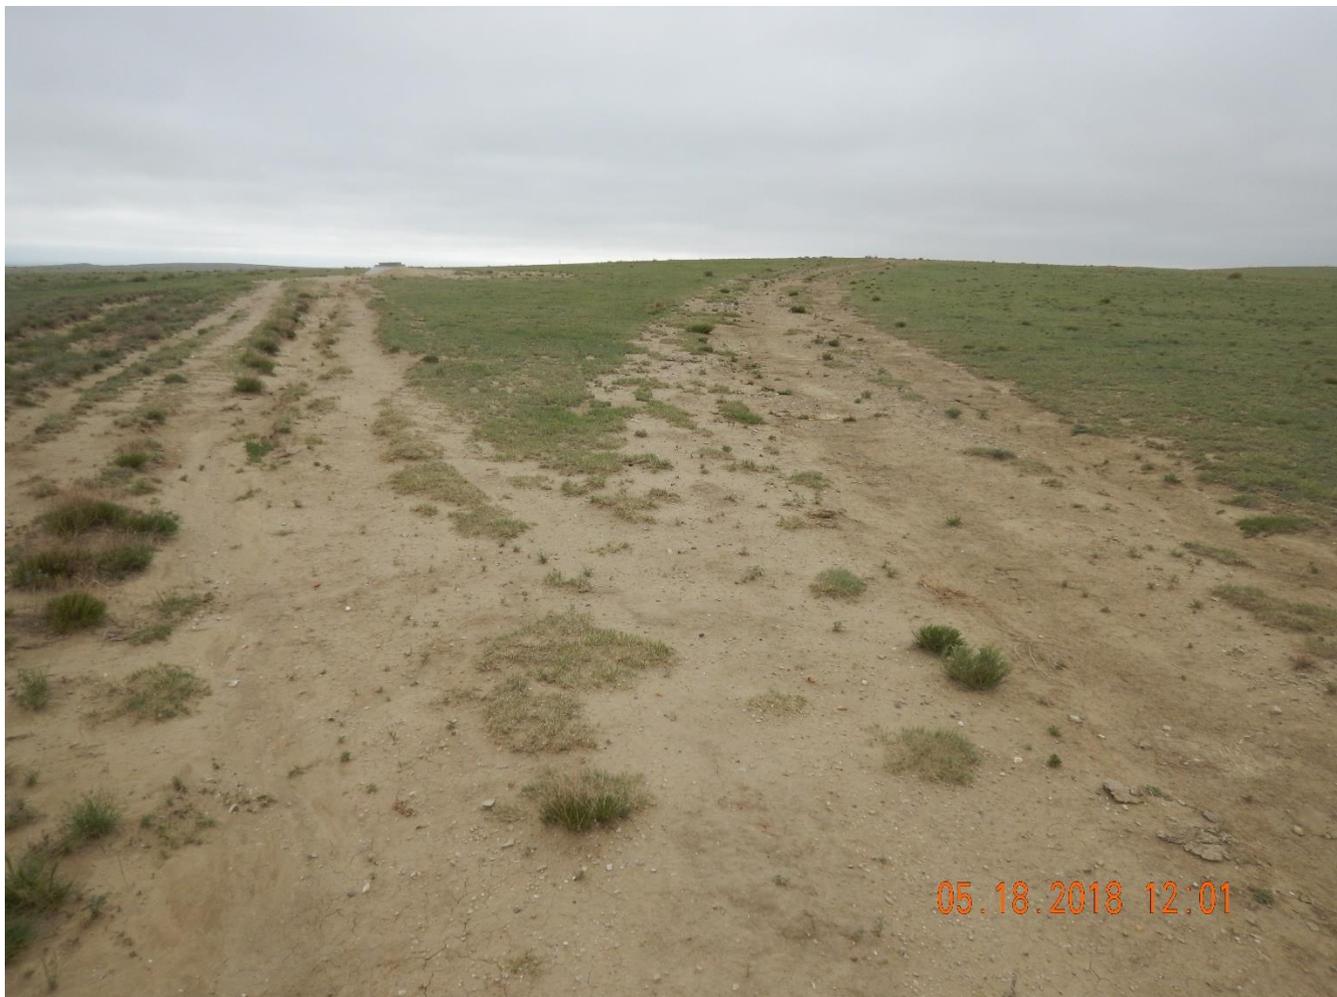
Photo 10: Photo taken from the fork of the road to the northeast of the location. The portion of road veering to the right at the fork is the oil and gas access road leading to the location. The section of road to the left appears to be a portion of the road that pre-existed the oil and gas location and access road.

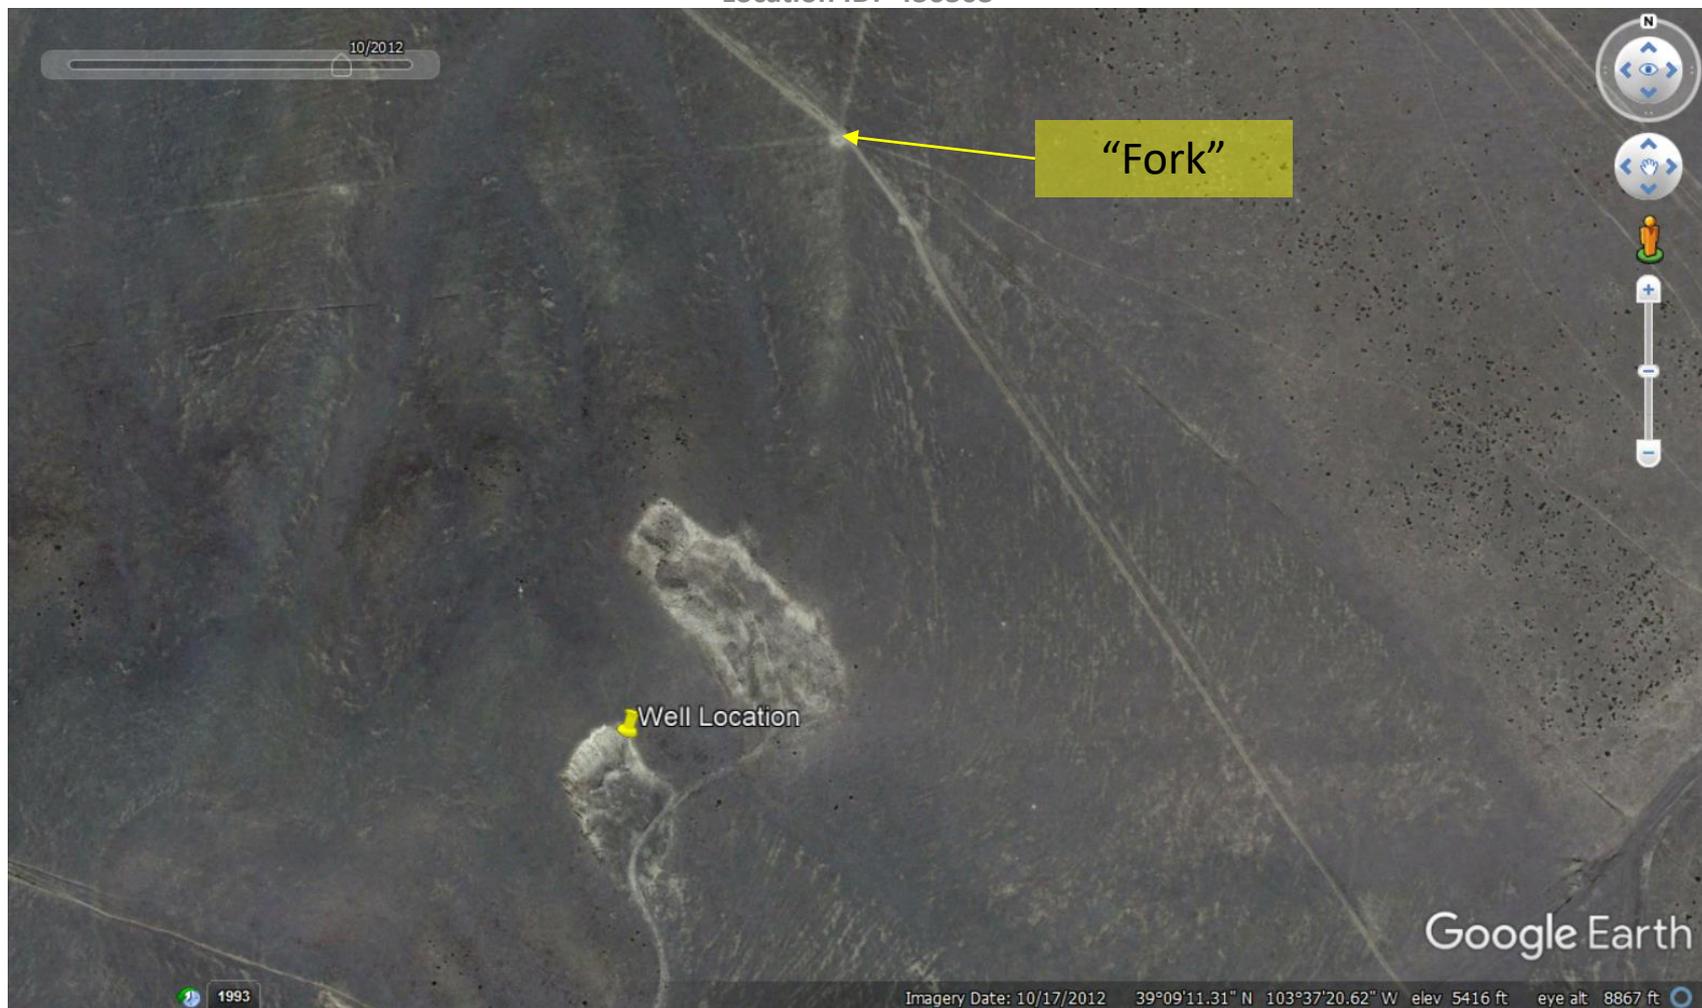
Photo 9: Historic aerial imagery dated 10/17/2012. Well was spud 3/19/2014. Photo shows access road leading to the location from the fork seen in photo 8 was not pre-existing.

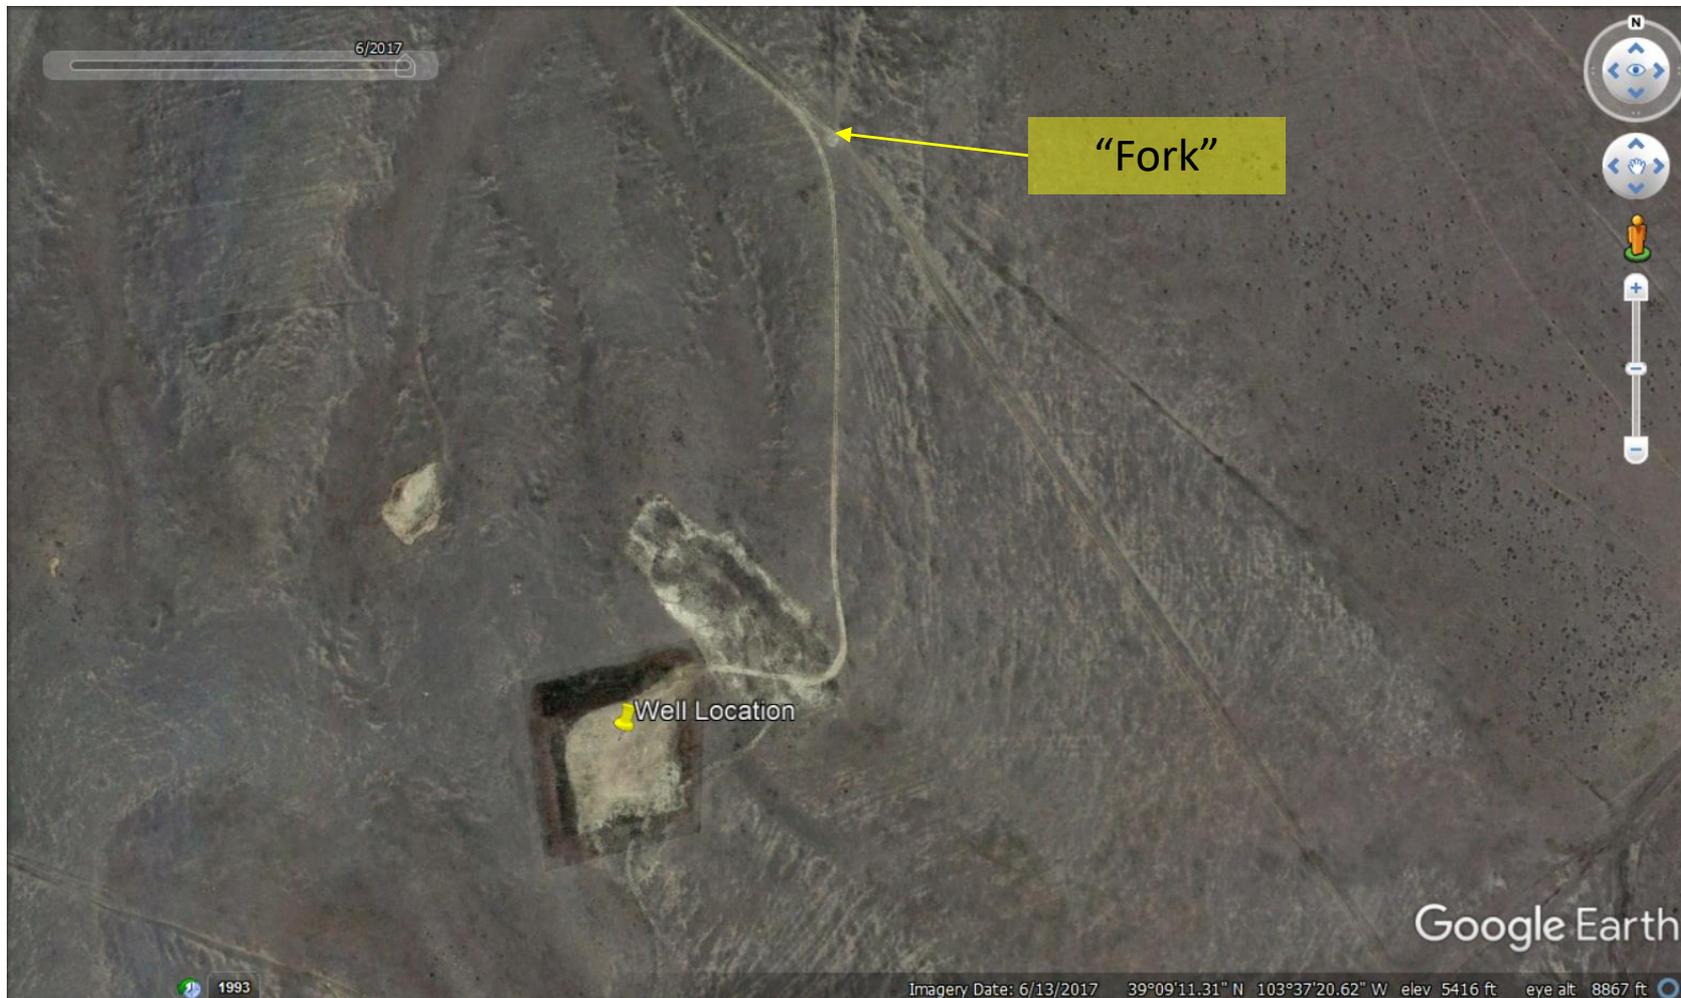
Photo 10: Most current, available aerial imager, dated 6/13/2017. Photo shows access road remains after the plugging and abandonment of the location.

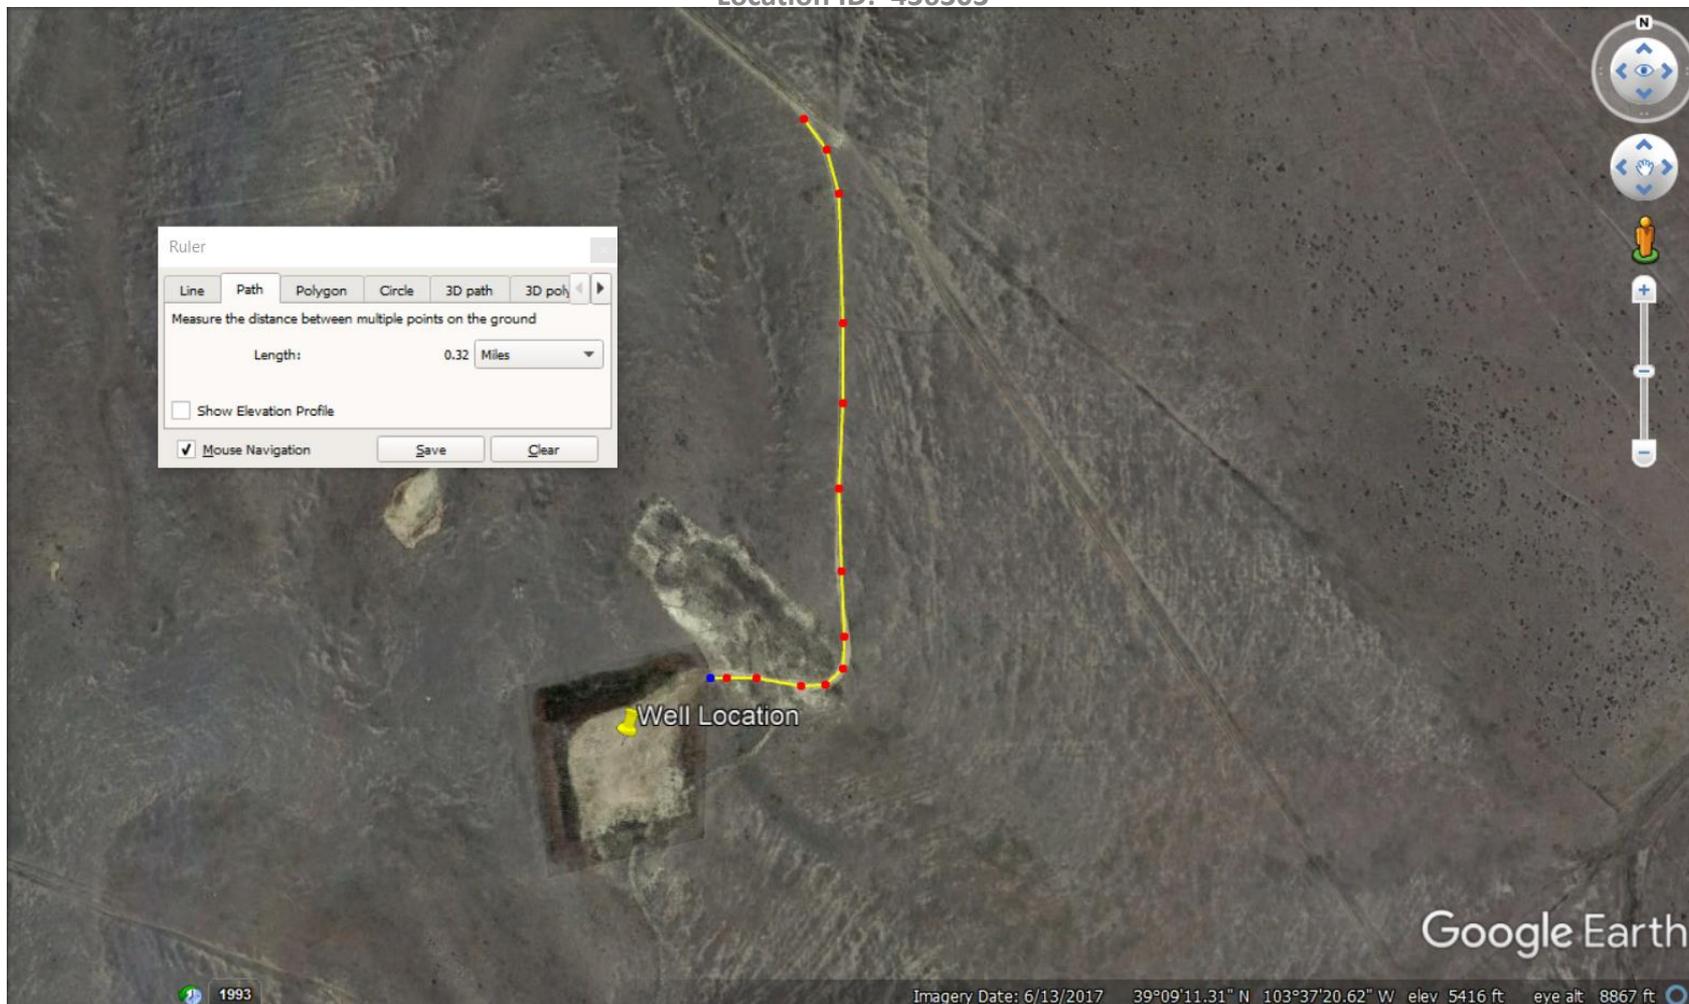
Photo 11: Most current, available aerial imager, dated 6/13/2017. Photo shows approximately 0.3 mile of access road has not been reclaimed.
